CITY OF MERCER ISLAND **REVISED**

CITY COUNCIL REGULAR VIDEO MEETING

TITLE:	AB 6002: Draft ADA Transition Plan	<input checked="" type="checkbox"/> Discussion Only <input type="checkbox"/> Action Needed: <input type="checkbox"/> Motion <input type="checkbox"/> Ordinance <input type="checkbox"/> Resolution
RECOMMENDED ACTION:	Receive report. No formal action required.

City of Mercer Island ADA Transition Plan

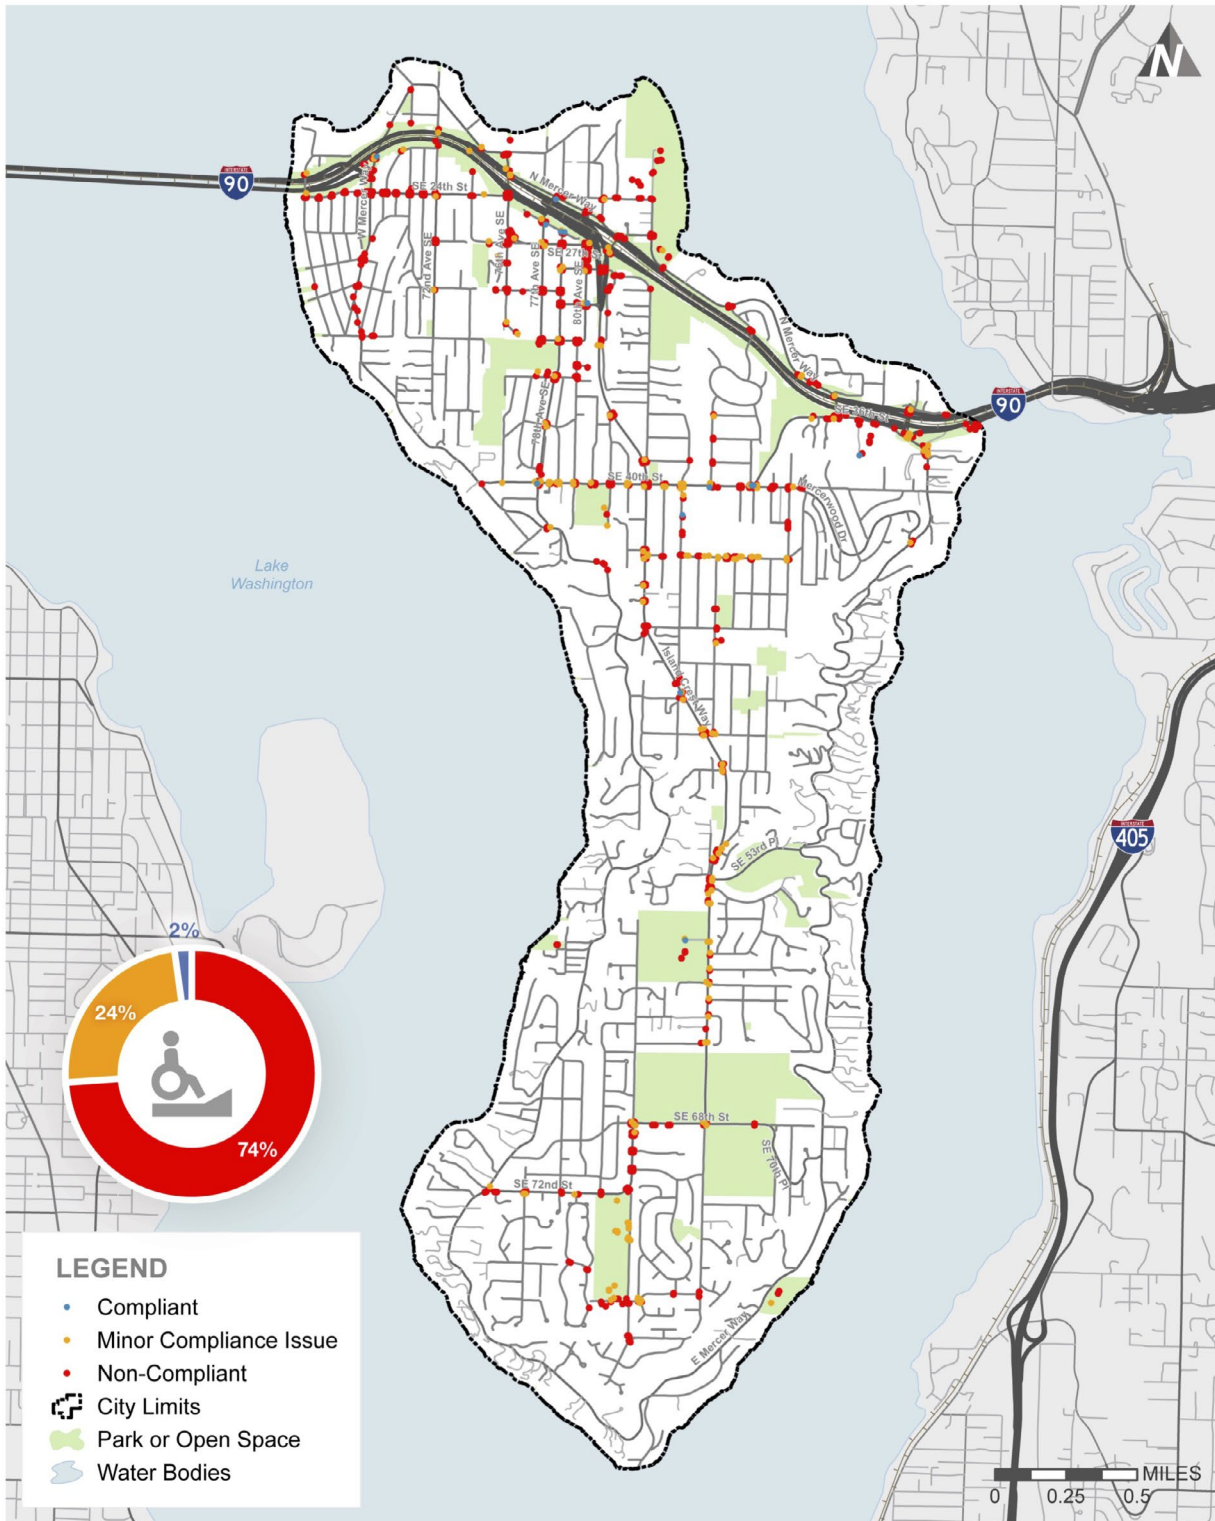
Non-Compliant Curb Ramp

- Non-compliant ramp width, i.e., the ramping area is not present or too narrow (Figure 2-8).
- Non-compliant running slope, i.e., the ramp running slope is too steep (Figure 2-9). 288 curb ramps have running slopes greater than 8.3%.
- Non-compliant cross slope, i.e., the cross slope is too steep (Figure 2-10). 503 curb ramps have cross slopes greater than 2%, 312 of which have cross slopes greater than 3%.
- Several minor non-compliant features, such as flare slope, detectable warning surface (DWS) placement, receiving ramp, etc.

Curb Ramp Compliance	Total	
	Miles	% of Total
Significant Compliance Issue	589	74%
Minor Compliance Issue	187	24%
Compliant Ramps	16	2%
Total	792

Curb ramps are designed and constructed to tie into the existing roadway. As noted previously, steep or otherwise constrained locations may make it infeasible to meet ADA grade standards. When it is not feasible to remove all curb ramp barriers, ramps may be built to the maximum extent feasible (MEF) to satisfy ADA requirements. This planning level Self-Evaluation did not examine whether non-compliant ramps were built to the maximum extent feasible. See Section 5.1 for additional information regarding MEF documentation.

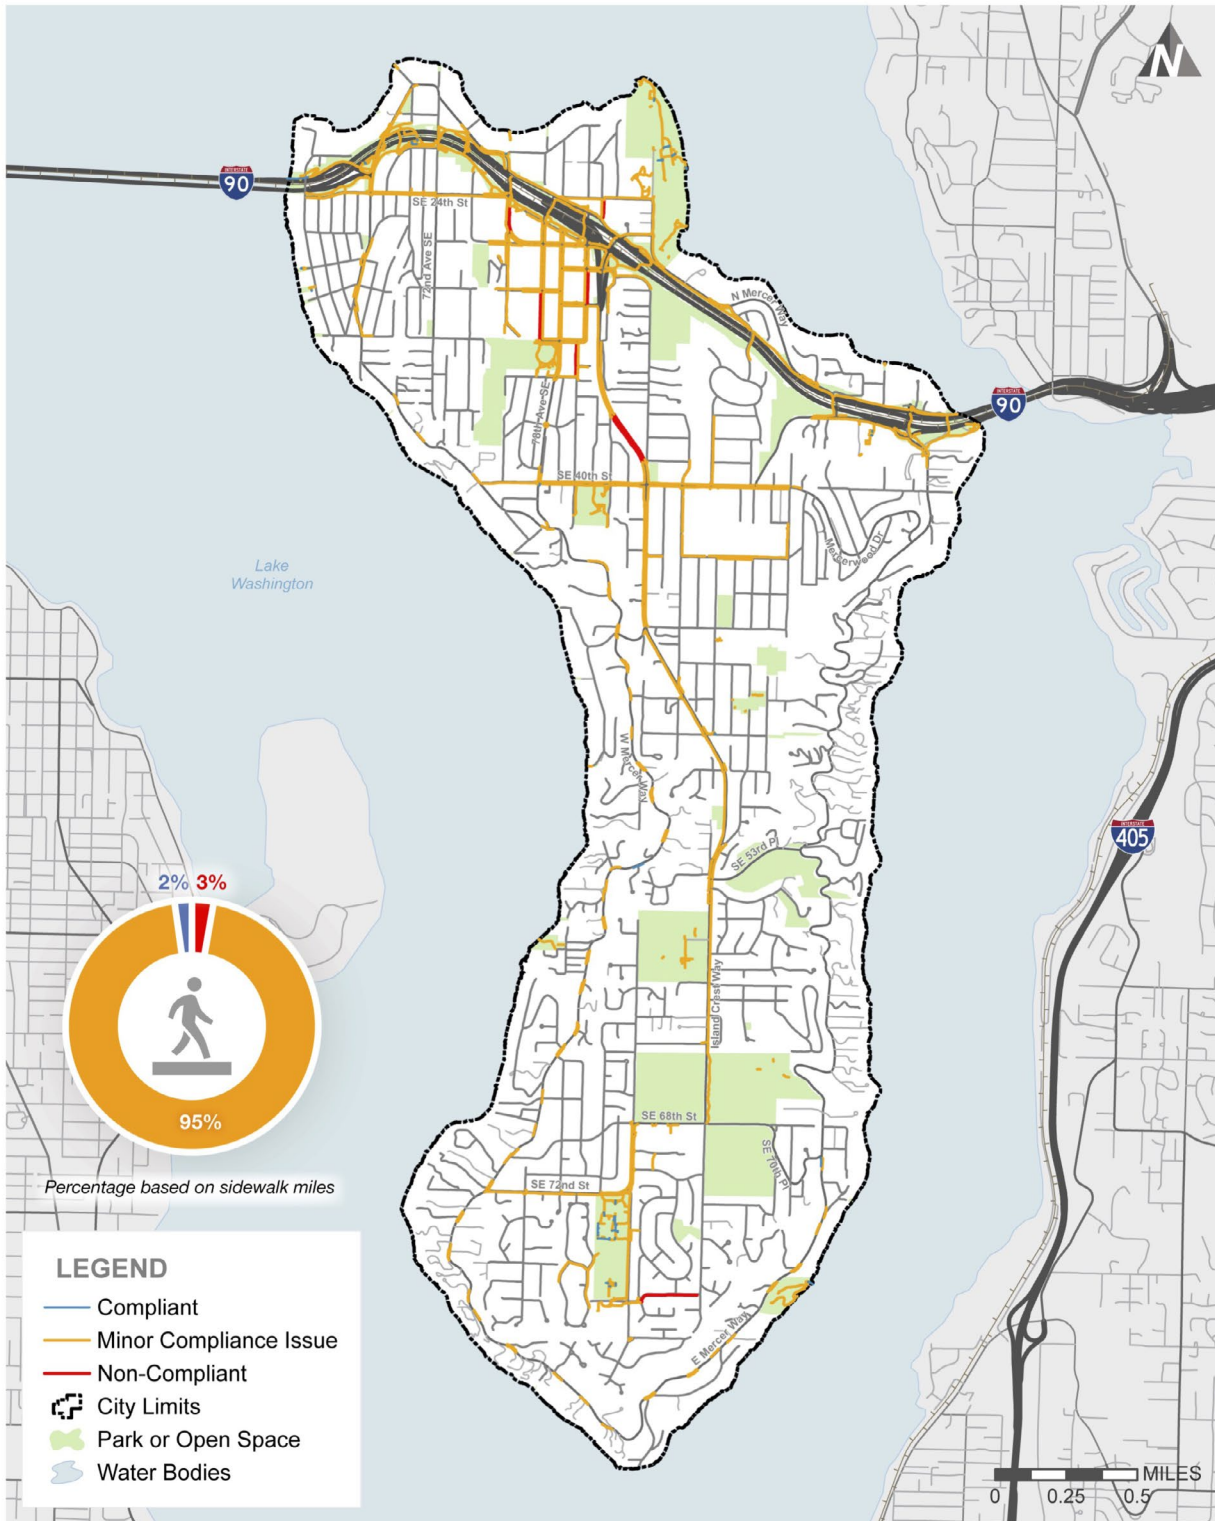
Non-Compliant Sidewalk

Approximately 34 miles of sidewalk were inventoried with approximately 98% not meeting ADA standards (see Table 2-2 and Figure 2-12). Grinding, patch repair, and full reconstruction are potential solutions for removing the sidewalk barriers depending on the severity of the barrier.

Sidewalk Compliance	Total	
	Miles	% of Total
Significant Compliance Issue	1	3%
Minor Compliance Issue	32	95%
Compliant	1	2%
Total	34

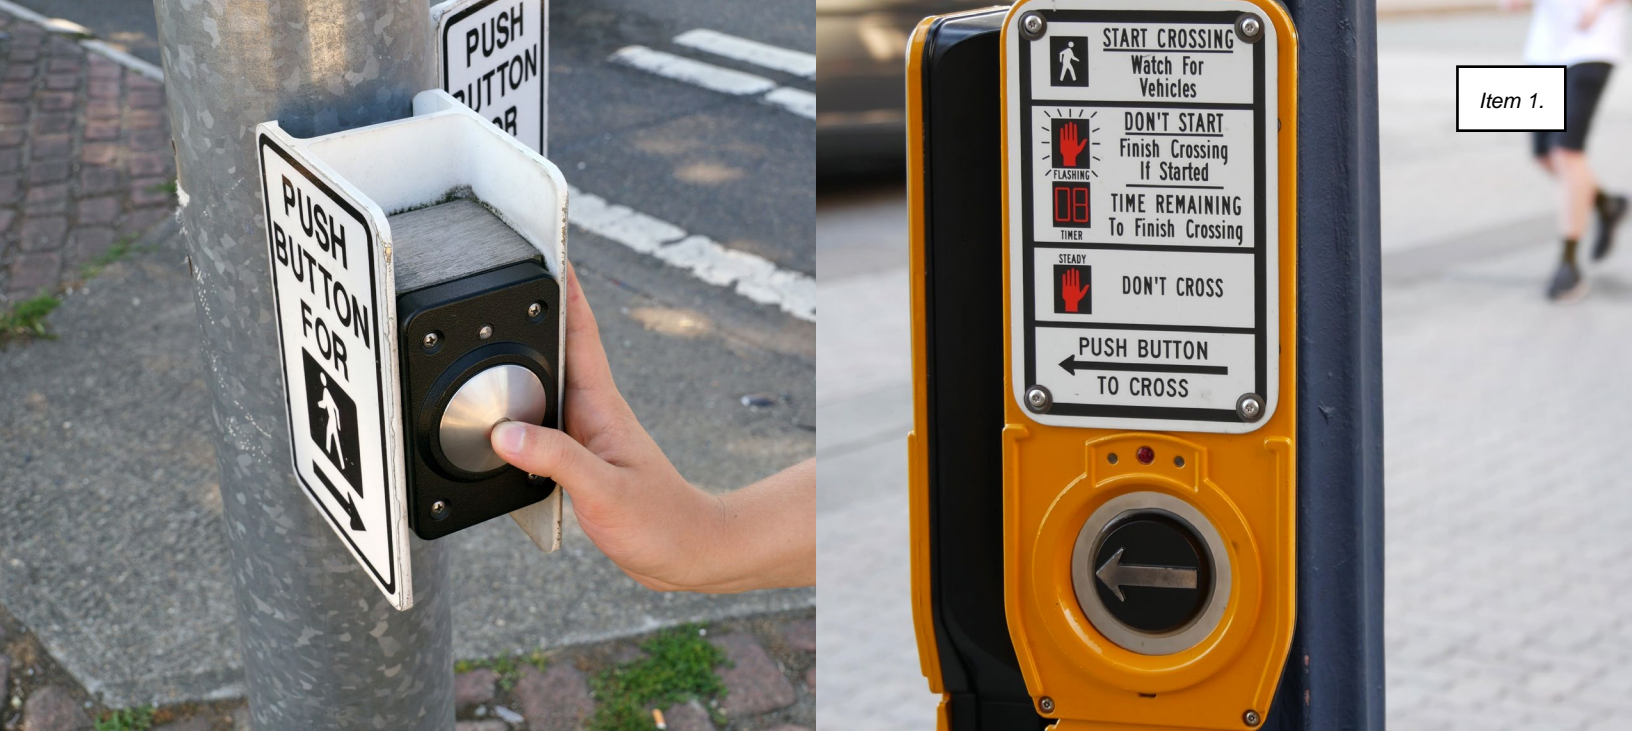
Figure 2-17 “H-style” (left) and APS-style pedestrian pushbutton (right)

All of the 84 inventoried pedestrian pushbuttons were not fully ADA compliant. The non-compliant pedestrian pushbuttons include non-APS style buttons to be replaced and APS-style buttons to be reprogrammed or relocated.

Approximately 86% of pedestrian pushbuttons in the city are an older “H-style” design (see Figure 2-17 top). This style of pushbutton can be upgraded to increase accessibility but must be fully replaced with an accessible pedestrian signal (APS)-style pushbutton to achieve full ADA compliance (see Figure 2-17).

The requirement to use APS-style pushbuttons is relatively new and lack of compliance is typically due to a crossing not being upgraded over time to reflect evolving requirements. Pushbuttons are typically upgraded to APS-style in groups rather than individually. As a result, APS-style additions and upgrades usually occur on an intersection-by-intersection basis.

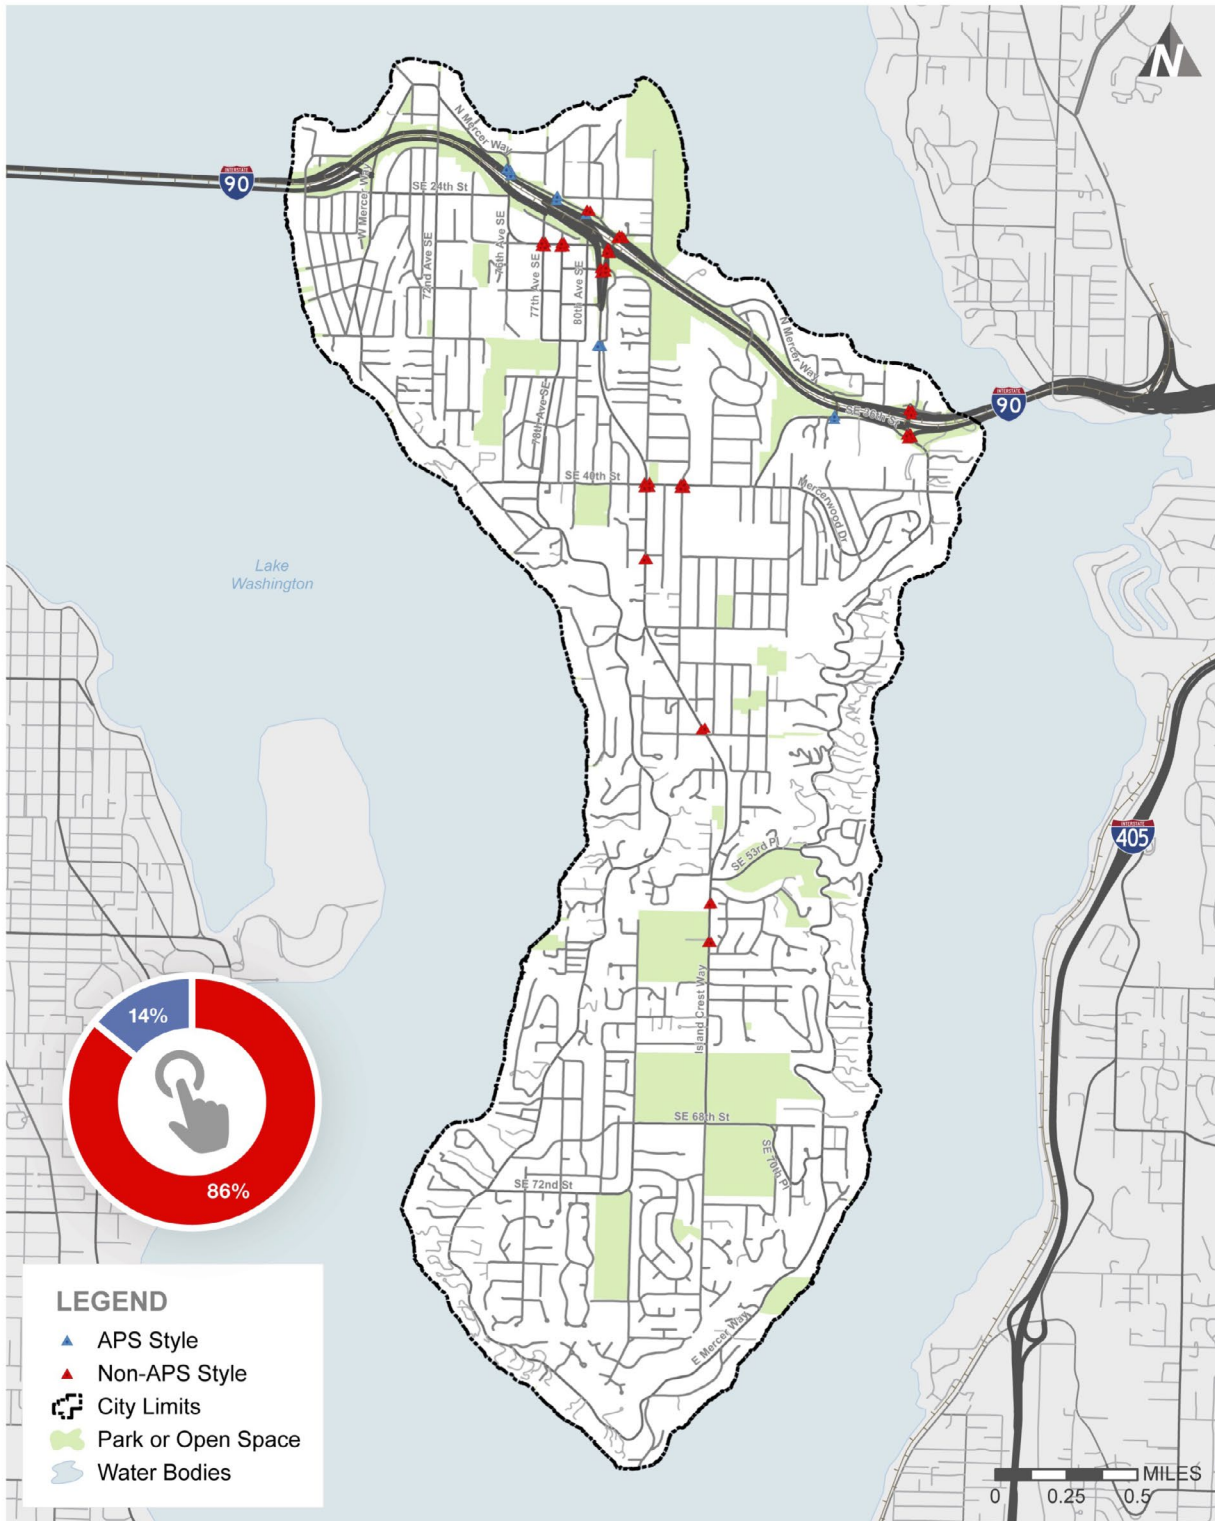
Signal Push Buttons: APS and Non-APS

Figure 2-18 demonstrates the type and locations of these pushbuttons throughout the city.

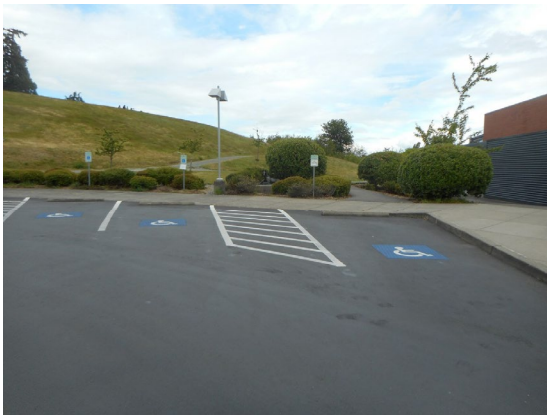
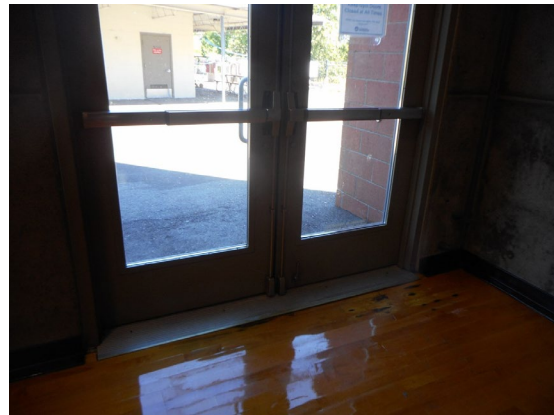
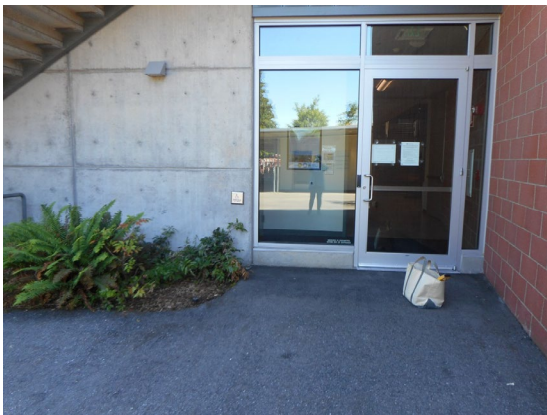
Community and Events Center

- Upper Left: Accessible parking signs are mounted too low.
- Upper Right: Exterior entry to the gymnasium has paving with an excessive slope.
- Lower Left: Lower level entry door lacks a paved accessible route to the automatic door opener button.

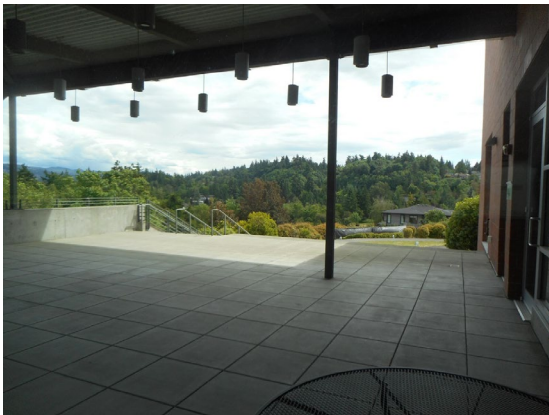
Community and Events Center

Upper Left: Terrace does not provide edge protection &/or a guardrail between terrace and seating steps.

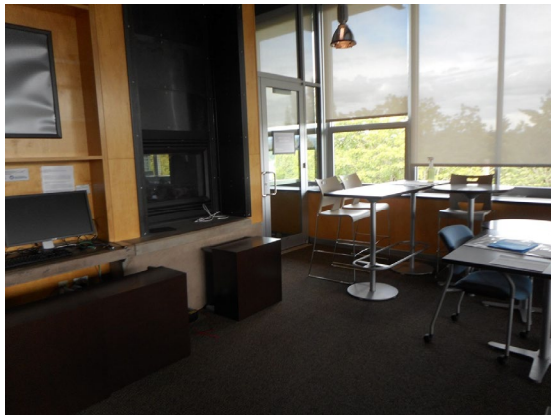
Community and Events Center

Upper Left: Landing Rm. & Game Rm. require tables with accessible seating.

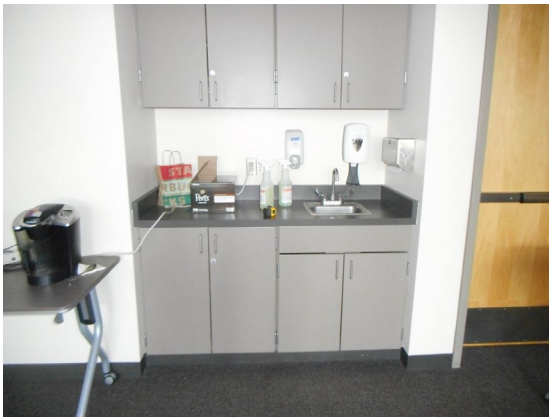
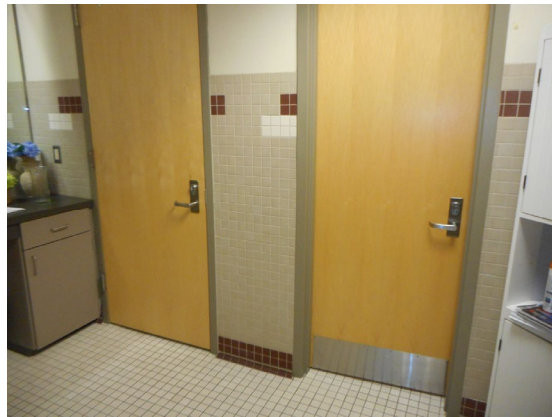
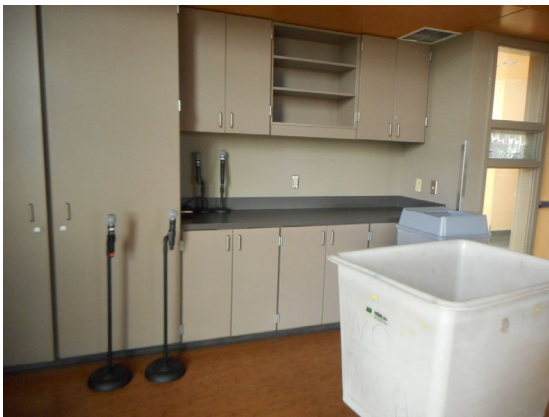
Community and Events Center

- Upper Left: Entry level meeting rooms have countertops with sinks above the required 34" max. AFF height, and do not provide the forward approach knee space below sink.
- Upper Right: Slater Rm. public restroom does not provide an accessible stall of the min. required size.
- Lower Left: Mercer Rm. above countertop outlets and switches are not accessible for a side reach.

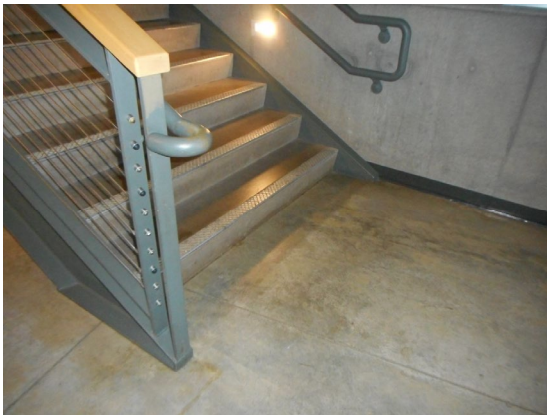
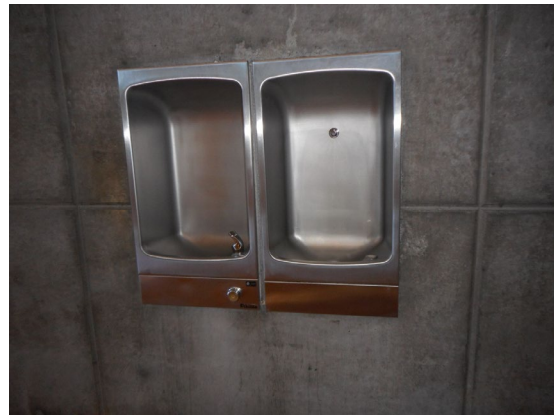
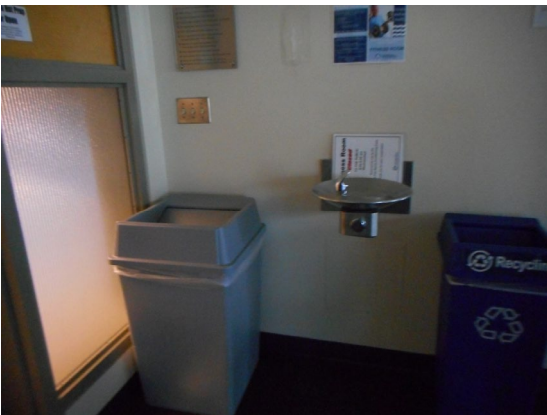
Community and Events Center

- Upper Left: Stair handrail protrudes into the accessible route.
- Upper Right: Gymnasium does not provide an accessible drinking fountain at required height, and with a forward approach knee space.
- Lower Left: Fitness Rm. drinking fountain is mounted at standing person height. An accessible drinking fountain at required height, and with a forward approach knee space is required.

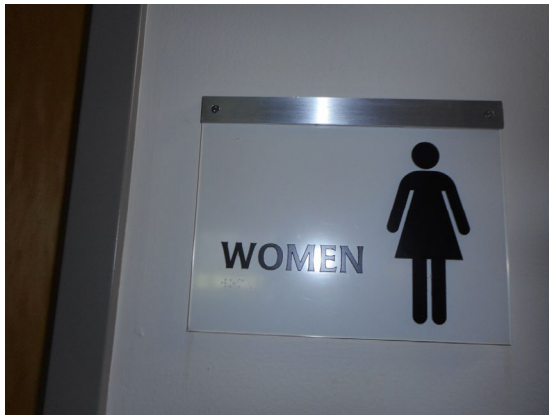
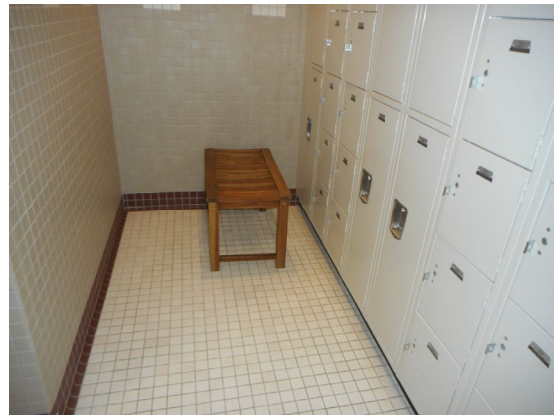
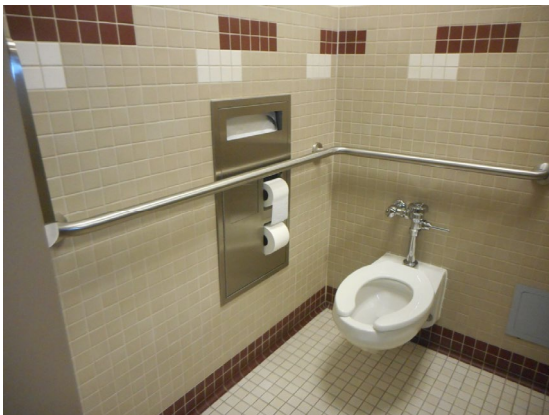
Community and Events Center

- Upper Left: Restroom signage does not provide the International Symbol of Accessibility.
- Upper Right: Locker room benches do not provide the required back support, and are not of the required size for accessibility. Each locker room requires an accessible bench.
- Lower Left: Toilet in the accessible stall is required to be 16" min. - 18" max. from the side wall. Many of these toilets are mounted too far from wall.

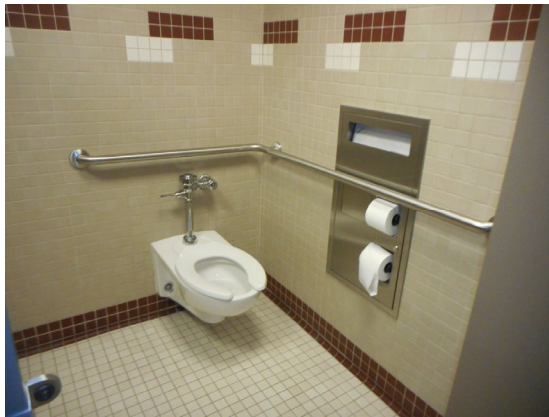
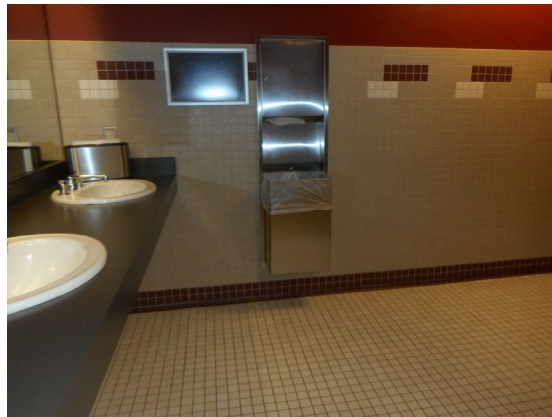
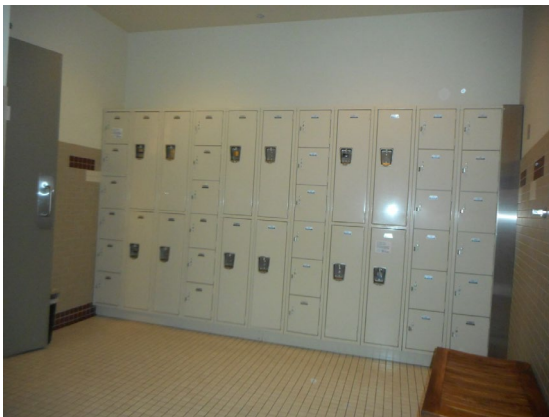
Community and Events Center

- Upper Left: The length of the L-shaped grab bar section behind toilet is too short. Many grab bars are mounted too high. 1-1/2" between the grab bar and adjacent surface is required. Dispenser encroaches on clearance.
- Upper Right: Height of the sink rim exceeds the max. 34" AFF.
- Lower Left: At least one of the large lockers must be accessible.

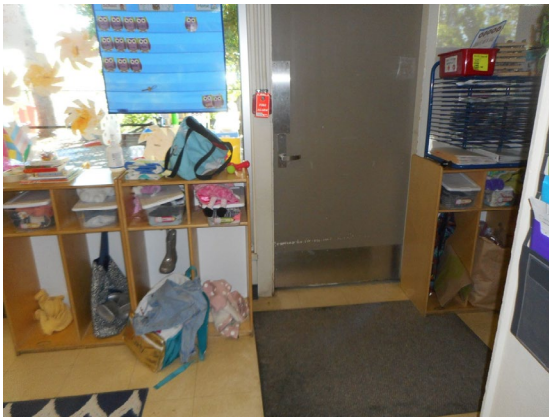
Community and Events Center

Upper Left: Cabinetry blocks the required door maneuvering clearance at Daycare entry door.

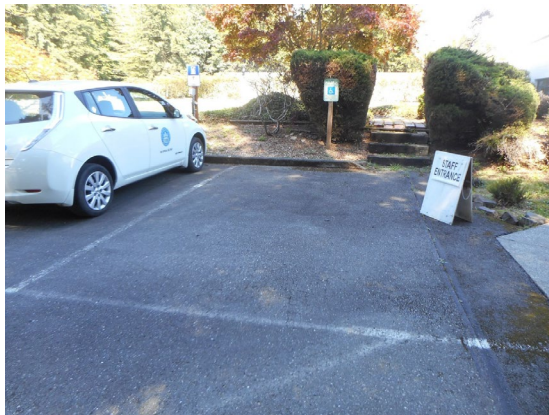
Maintenance Building

Upper Left: Accessible parking sign is required to be remounted to 60" min. above pavement to bottom surface.

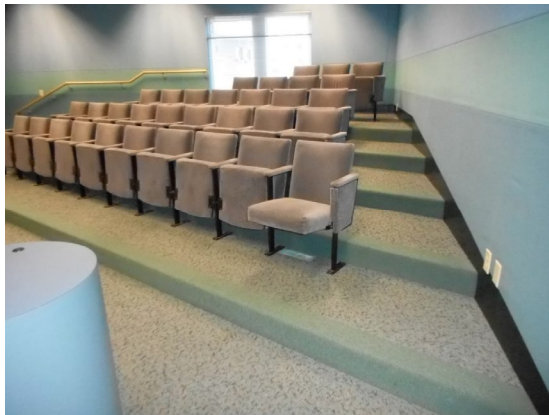
City Hall

- Upper Left: Council Room requires accessible seating adjacent to a companion seat.
- Upper Right: Speaker's podium in Council Room to provide a forward approach to accessible microphone.
- Lower Left: Ramp to judge's platform in Council Room requires additional handrail.

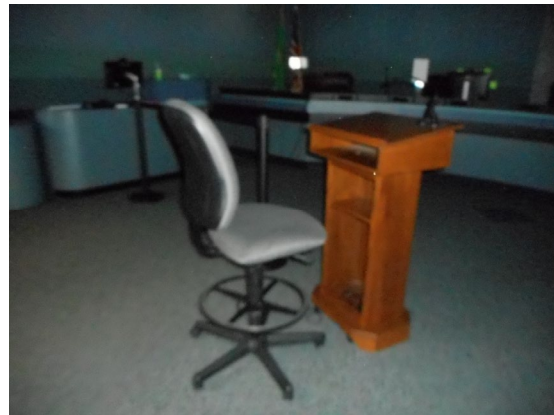
ITEM 22: COUNCIL CHAMBERS	Replace the control with an accessible model and/or relocate to an accessible height.	Existing speaker podium platform is 42" AFF and has a microphone mounted on it. No forward approach with knee & toe space is provided. Control is required to be 15" min. - 48" max. for an unobstructed approach. Controls over obstructions between 10" - 24" deep and 34" max. high shall be 46" max. high for a parallel approach and 44" max. high for a forward approach with knee space.	P	O	1	2	1 EA	\$1,500

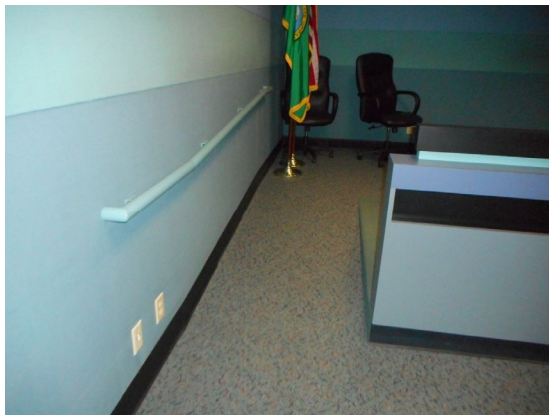
LOCATION	RECOMMENDATION	COMMENTS	TYPE	RESP CODE	PRI	QTY	UNITS	BUDGET
Interior Accessible Routes								
Barrier	651	The ramp lacks compliant handrails OR the existing handrails are not compliant in configuration.						
			Citation	2010 ADA Stds. 505.5, 505.7.2, 405.8

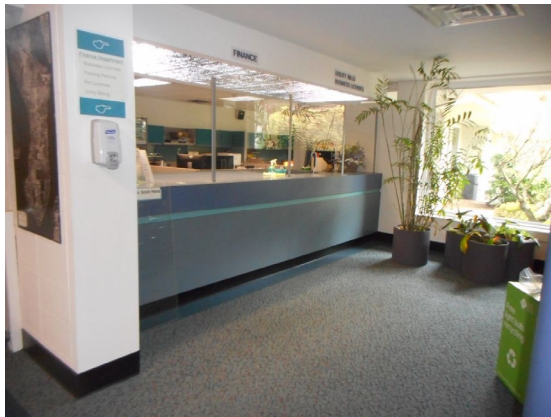
City Hall

Upper Left: Business License area requires an accessible counter.

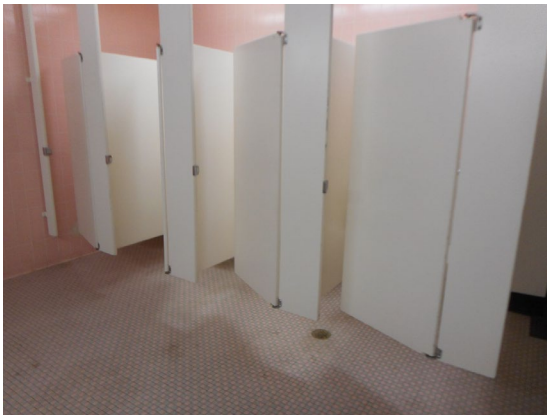
City Hall

- Upper Left: Restrooms adjacent to Licensing area shall provide an accessible stall.
- Upper Right: Men's restroom adjacent to Licensing area shall provide an accessible urinal.
- Lower Left: Men's restroom adjacent to Licensing area shall provide an accessible lavatory with compliant knee & toe space.

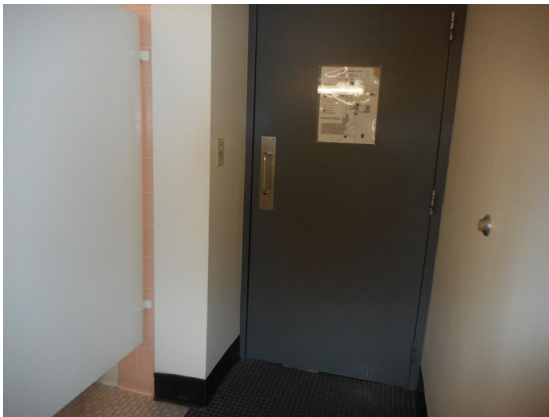
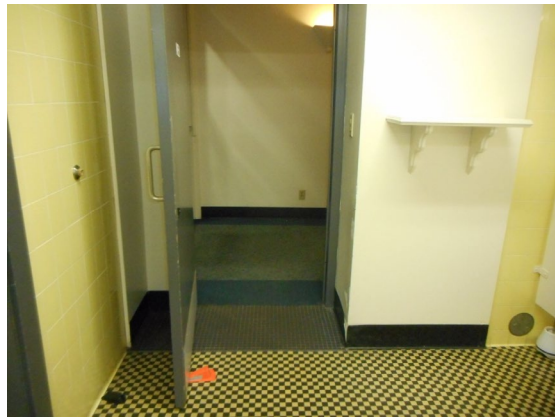
City Hall

- Upper Left: Restroom entry doors require min. 18" maneuvering clearance on pull side (or a power door operator).
- Upper Right: Restroom entry doors require min. 18" maneuvering clearance on pull side (or a power door operator).
- Lower Left: Women's restroom near Licensing shall have at least one lavatory with accessible controls on faucets, and exposed pipes isolated from contact.

LOCATION	RECOMMENDATION	COMMENTS	TYPE	RESP CODE	PRI	QTY	UNITS	BUDGET
Doors								
ITEM 12: MEN'S RESTROOM - ADJACENT TO LICENSING AREA	Reverse the swing direction of the door to swing out from restroom.	Ensure door maneuvering spaces are min. 18" at pull side and min. 12" at push side (if equipped with latch & closer). Provide clear floor space min. 60" perpendicular to door for front / pull side approach and 48" perpendicular to door for front or side / push side approach (latch & closer). Doors are allowed to be recessed 8" max. from the face of door to face of wall surface. See additional Dimensions for other approaches in 404.2.4.1 Existing entry door lacks the 18" width on the pull side, and is recessed 18" on the bathroom side of the door.	P	O	1	2	1 EA	\$810

LOCATION	RECOMMENDATION	COMMENTS	TYPE	RESP	CODE	PRI	QTY	UNITS	BUDGET	
Doors										
ITEM 15: WOMEN'S RESTROOM - ADJACENT TO LICENSING AREA	Reverse the swing direction of the door to swing out from restroom.	Ensure door maneuvering spaces are min. 18" at pull side and min. 12" at push side (if equipped with latch & closer). Provide clear floor space min. 60" perpendicular to door for front / pull side approach and 48" perpendicular to door for front or side / push side approach (latch & closer). Doors are allowed to be recessed 8" max. from the face of door to face of wall surface. See additional Dimensions for other approaches in 404.2.4.1 Existing entry door lacks the 18" width on the pull side, and is recessed 18" on the bathroom side of the door.	P	O		1	2	1	EA	\$810

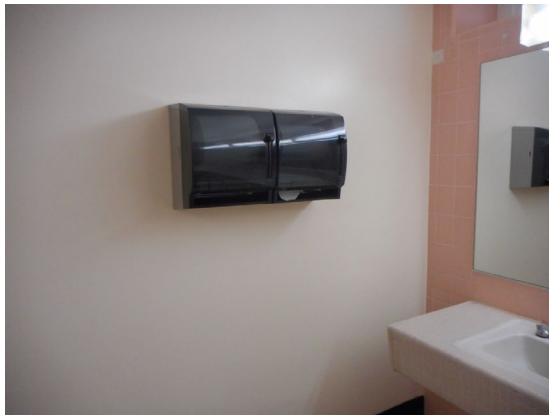
City Hall

- Upper Left: Dispensers present protruding object hazard, requiring relocation or permanent barrier located below.
- Upper Right: Baby changing tables require relocation due to height.
- Lower Left: Wheelchair accessible toilets are required to be 16" min. - 18" max. from side wall. Relocation required at some toilets.

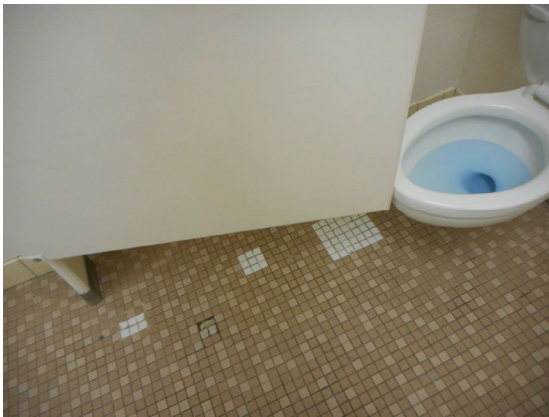
City Hall

LOCATION	RECOMMENDATION	COMMENTS	TYPE	RESP CODE	PRI	QTY	UNITS	BUDGET
Restrooms / Bathrooms								
Barrier	675	The stall door swing encroaches on clear floor space within stall, or the door is not located on the wide side of the stall, or the door is more than 4" from side panel.	Citation	2010 ADA Stds. 604.8.1.2

- Upper Left: Women's restroom near Courtroom: door to accessible compartment located on wrong side of compartment and swings in.
- Upper Right: Women's restroom near Courtroom: toilet location should be adjusted. Flush control should be on open side.
- Lower Left: Men's restroom near Courtroom: one urinal should be accessible.

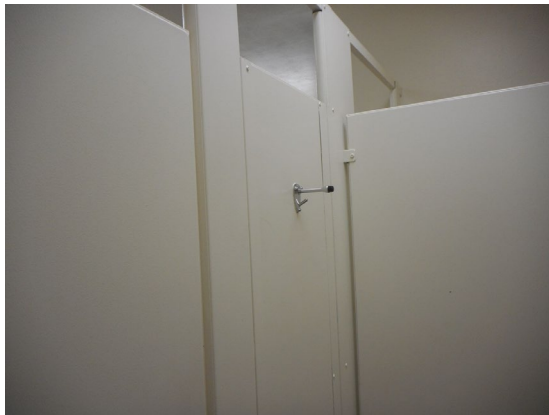
City Hall

- Upper Left: Coat hooks and dispensers in accessible toilet stalls shall be mounted at accessible heights.
- Upper Right: Rubber mats at entries shall be secured.
- Lower Left: Drinking fountain near courtroom entry should be a hi-low type for both wheelchair users and standing persons.

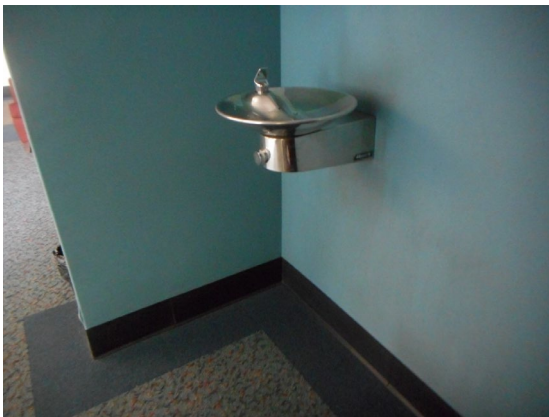
LOCATION	RECOMMENDATION	COMMENTS	TYPE	RESP CODE	PRI	QTY	UNITS	BUDGET
Drinking Fountains								
Barrier	757	The water fountain is not accessible to standing persons with a spout outlet located 38" to 43" high.						
			Citation	2010 ADA Stds. 602.7

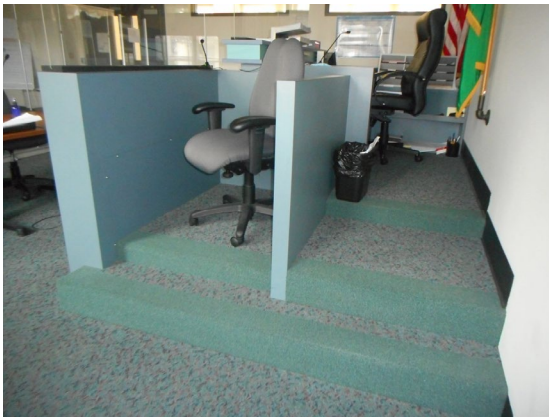
City Hall

- Upper Left: Courtroom: witness box and judge's platform have stairs (no accessible route).
- Upper Right: Courtroom: juror's area has stairs (no accessible route).
- Lower Left: Courtroom: court clerk counter required to be lowered to 36" AFF max.

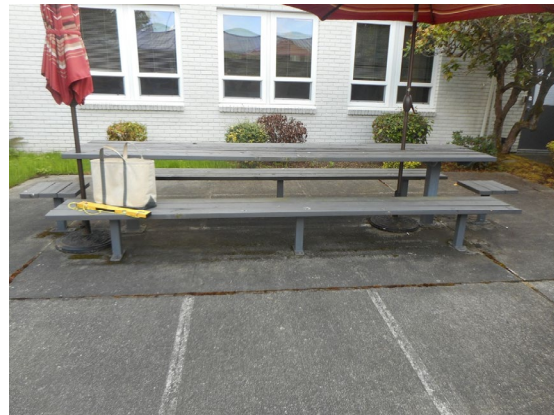
LOCATION	RECOMMENDATION	COMMENTS	CITATION	TYPE	RESP CODE	PRI	QTY	UNITS	BUDGET
Built In Elements									
Barrier	482	The dining or work surface lacks 5% seating and standing spaces that are accessible, or existing tables exceed max. 34" high or lack knee clearance 27" high, 30" wide and 17" deep, or are not on an accessible route, or lack dispersion throughout seating and standing spaces.	2010 ADA Stds. 902.1, 226, 226.2						
ITEM 8: ACCESSIBLE PICNIC TABLE IN COURTYARD - NORTH OF COURTROOM		Provide additional accessible picnic table in courtyard with surface 34" max. above grade and knee space 30" min. wide, 27" min. high and 17" min. deep on one end of table.	Existing picnic table is not accessible.	P	O	1	2	1	EA \$2,500

- Upper Left: Exterior sidewalk approaching main entry has an excessive slope.
- Upper Right: Picnic table requires an accessible seat.
- Lower Left: Police Lobby: Service call button should be at accessible height. Countertop shall be lowered to 36" max. AFF.

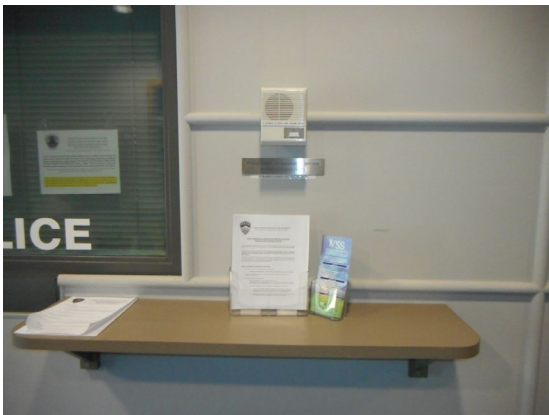
ITEM 23: POLICE LOBBY	Replace the control with an accessible model and/or relocate to an accessible height, with no countertop below.	Control is required to be 15" min. - 48" max. for an unobstructed approach. Controls over obstructions between 10" - 24" deep and 34" max. high shall be 46" max. high for a parallel approach and 44" max. high for a forward approach with knee space. Existing condition: "Push for Service" button / speaker is mounted at 60" AFF and above a countertop.	P	O	1	2	1 EA	\$220

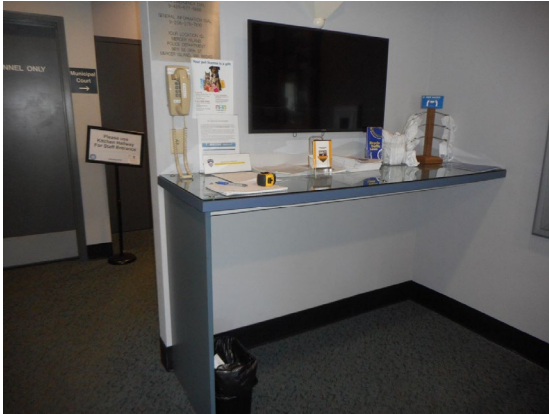
City Hall

Upper Left: Police Lobby; telephone and counter should be lowered to accessible height.

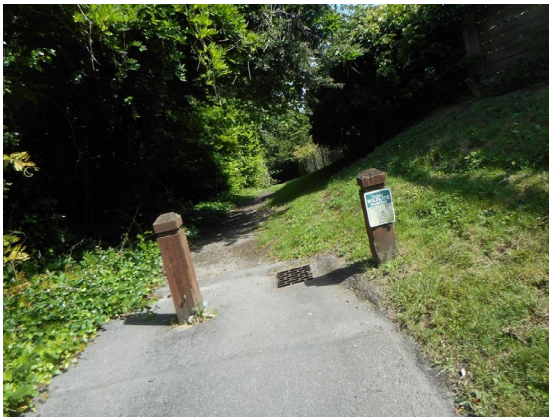
77th Ave. SE Street End

Upper Left: Park entry lacks an accessible route. No parking is provided.

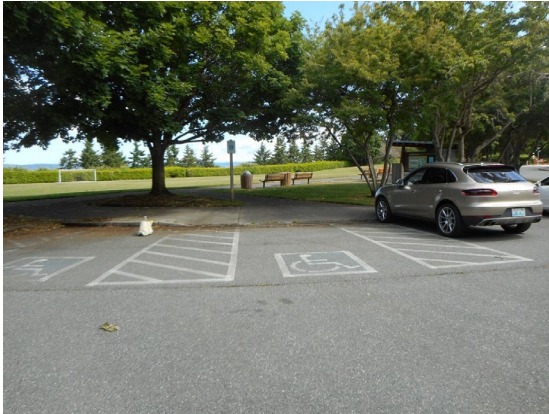
Aubrey Davis Park

- Upper Left: Accessible parking sign is required on westernmost stall in the western parking lot
- Upper Right: 30"x48" clear floor space is required on one end of bike rack.
- Lower Left: 30"x48" clear floor space is required on one end of bench.

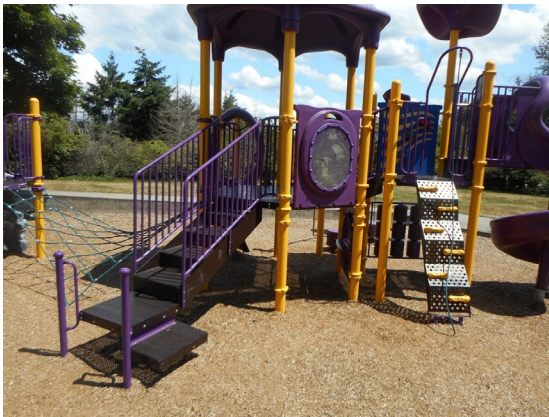
Upper Left: Ground surfaces of all play areas must be compliant and require periodic inspections & maintenance.

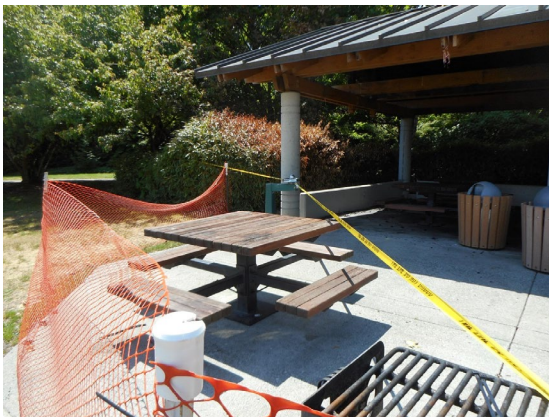
Lower Left: 5% of picnic table seating should be accessible.

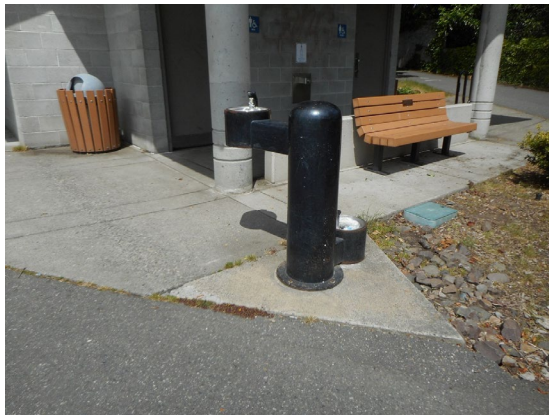
- Upper Left: Only low level drinking fountain is provided. Hi-low drinking fountain required.
- Upper Right: Toilet in Men's restroom by Feroglia Fields should be relocated (centerline is in excess of 18" from corner).
- Lower Left: 1 urinal in Men's restroom by Feroglia Fields should be lowered to accessible height (17" max. AFF).

LOCATION	RECOMMENDATION	COMMENTS	TYPE	RESP CODE	PRI	QTY	UNITS	BUDGET	
Drinking Fountains									
Barrier	751	There are not a min. of 2 water fountains provided OR there is not a water fountain that meets the requirements for both wheelchair accessibility and for standing persons (hi-low).	Citation	2010 ADA Stds. 211.2

ITEM 3: PARK ENTRY AREA		Replace the fountain with a hi-low model.							
		Where provided, min. 2 water fountains are required. 1 is required to meet 602.1 - 602.6 for clear floor space, height, operable parts, and water flow, and 1 is required to meet 602.7 which is height for standing persons. If a water fountain is provided that meets both requirements, it may be substituted for 2 fountains. Spout outlets shall be 36" max. AFF or ground. Drinking fountains for standing persons: Spout outlets of drinking fountains for standing persons shall be 38" min. and 43" max. AFF. Existing condition: A single non-accessible fountain is provided.	P	O	1	4	1	EA \$4,400	
Barrier	754	The drinking fountain lacks a 30"x48" clear floor space for a front approach OR the clear floor space slope exceeds 2% in all directions.	Citation	2010 ADA Stds. 602.2

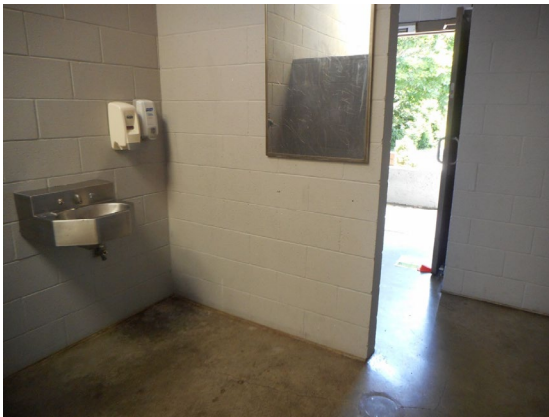
- Upper Left: Mirrors in both restrooms by Feroglia Fields should be relocated to above sinks at 40" max. AFF.
- Upper Right: Doors are located on wrong side of accessible stalls at restrooms by Feroglia Fields and should be relocated.
- Lower Left: Flush control in Women's restroom by Feroglia Fields should be repaired or replaced due to operation difficulty.

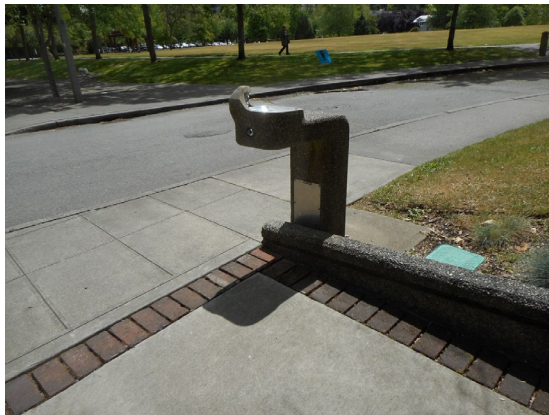
- Upper Left: Only low level drinking fountain is provided. Hi-low drinking fountain is required for both wheelchair users and standing persons.
- Upper Right: Restroom signage lacks Braille.
- Lower Left: Women's restroom: toilet location should be adjusted, rear wall grab bar is required, and dispensers should be relocated within accessible reach ranges.

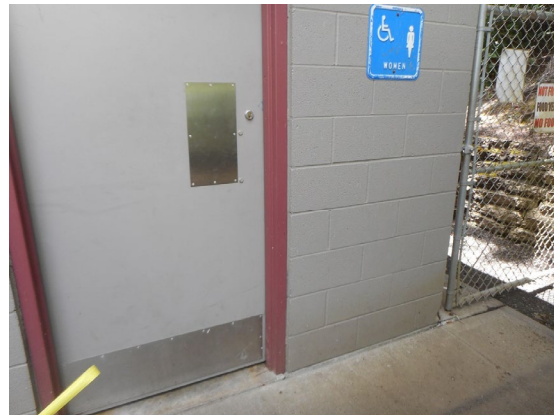
LOCATION	RECOMMENDATION	COMMENTS	TYPE	RESP	CODE	PRI	QTY	UNITS	BUDGET
Signage									
Barrier	713	The permanent room sign lacks raised letters and braille characters OR the raised letters characters do not meet the requirements.	Citation	2010 ADA Stds. 216, 703.3, 703.2, 703.5

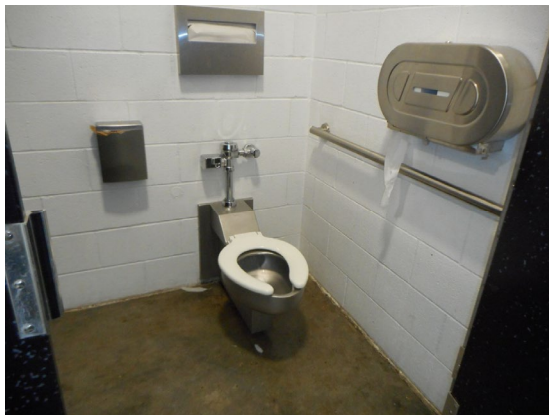
LOCATION	RECOMMENDATION	COMMENTS	TYPE	RESP CODE	PRI	QTY	UNITS	BUDGET
Restrooms / Bathrooms								
Barrier	680	The toilet lacks compliant side and/or rear grab bars.						
			Citation	2010 ADA Stds. 604.5

ITEM 13: WOMEN'S RESTROOM - ACCESSIBLE STALL	Install new grab bar on rear wall.	Grab bars should be 1-1/4" - 2" in diameter, 33" - 36" AFF, with 1-1/2" min. between the wall and the grab bar. Rear grab bar min. 24" long from centerline of toilet at transfer side; side wall grab bar min. 54" long from rear wall. Existing condition: Side wall has a compliant grab bar. Rear wall has no grab bar.	P	O	1	3	1	EA \$1,150
Barrier	683	The toilet paper dispenser is not mounted 7" to 9" in front of the toilet edge measured to the center of the fixture, or min. 15" to max. 48" high OR is located less than 12" above the grab bar or less than 1-1/2" below the grab bar.						
			Citation	2010 ADA Stds. 604.7

ITEM 19: WOMEN'S RESTROOM	Relocate or lower the dispensers.	Dispensers are required to be max. 48" high for a front and parallel approach, and 44" max. for a forward reach over an obstruction between 20" and 25" deep. Existing condition: soap dispenser has 22" deep reach to controls mounted at 46" AFF.	P	O	1	3	1 EA	\$150

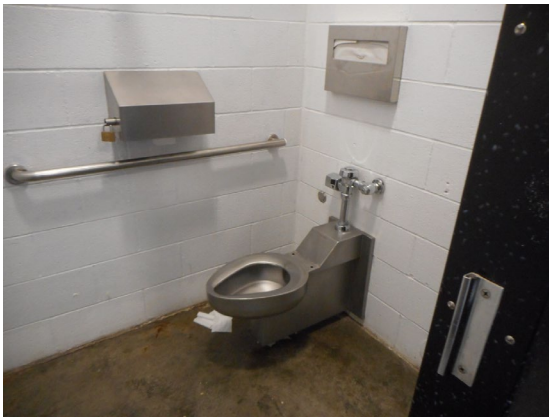
Upper Left: Men's restroom: toilet seat height is non-compliant, rear wall grab bar is required, dispensers shall be relocated within accessible reach ranges.

ITEM 11: MEN'S RESTROOM - ACCESSIBLE TOILET	Install a lift seat. Note that due to this toilet being a stainless steel toilet without a seat, a new toilet may be necessary to be installed for compliance.	Top of existing stainless steel toilet measures 16-1/4" AFF.	P	O	1	3	1 EA	\$210
Barrier	680	The toilet lacks compliant side and/or rear grab bars.	Citation	2010 ADA Stds. 604.5

ITEM 12: MEN'S RESTROOM - ACCESSIBLE STALL	Reinstall side wall grab bar. Install new grab bar on rear wall.	Grab bars should be 1-1/4" - 2" in diameter, 33" - 36" AFF, with 1-1/2" min. between the wall and the grab bar. Rear grab bar min. 24" long from centerline of toilet at transfer side; side wall grab bar min. 54" long from rear wall. Existing condition: Side wall has a grab bar that needs to be relocated to be 54" min. from the corner (53" measured). Rear wall has no grab bar.	P	O	1	3	1 EA	\$1,150

ITEM 17: MEN'S RESTROOM	Relocate or lower the dispensers to compliant heights.	Dispensers are required to be max. 48" high for a front and parallel approach, and 44" max. for a forward reach over an obstruction between 20" and 25" deep. Existing condition: soap dispenser has 22" deep reach to controls mounted at 46" AFF.	P	O	1	3	1 EA	\$150

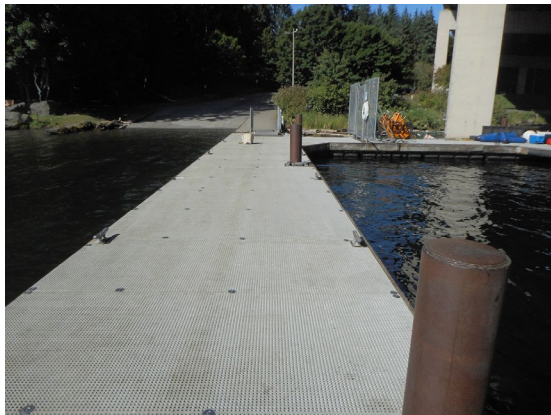
LOCATION	RECOMMENDATION	COMMENTS	TYPE	RESP CODE	PRI	QTY	UNITS	BUDGET	
Recreation - Boating Facilities									
Barrier	862	The slope at gangway with LESS than 30'-0" total run at a facility with less than 25 total boat slips exceeds 8.33% OR has cross slope that exceeds 2% OR is a ramp that lacks handrails.	Citation	2010 ADA Stds. 1003.2.1

Upper Left: Gangway to boat launch pier requires an accessible route.

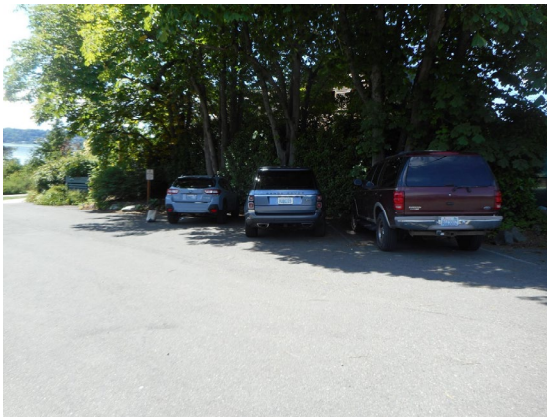
- Upper Left: Parking is provided for 3 vehicles, however no accessible parking is provided.
- Upper Right: Knee clearance at accessible picnic table seat is encroached on by steel supports.
- Lower Left: Bench requires an adjacent clear floor space at one end.

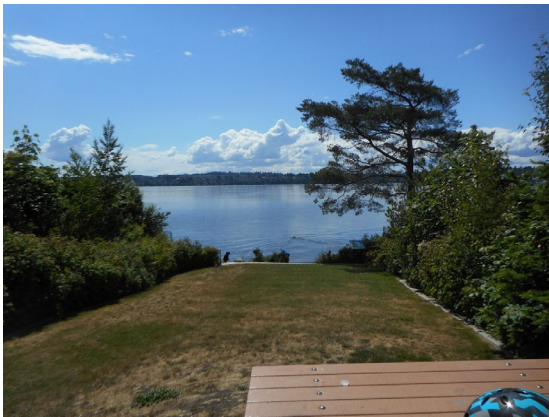
Upper Left: Accessible sidewalk ends at picnic table.
Upper Right: No accessible route is provided to the beach.
Lower Left: No accessible route is provided to the beach.
