CITY OF MERCER ISLAND **REVISED**

CITY COUNCIL REGULAR VIDEO MEETING

TITLE:	AB 6002: Draft ADA Transition Plan	<input checked="" type="checkbox"/> Discussion Only <input type="checkbox"/> Action Needed: <input type="checkbox"/> Motion <input type="checkbox"/> Ordinance <input type="checkbox"/> Resolution
RECOMMENDED ACTION:	Receive report. No formal action required.

City of Mercer Island ADA Transition Plan

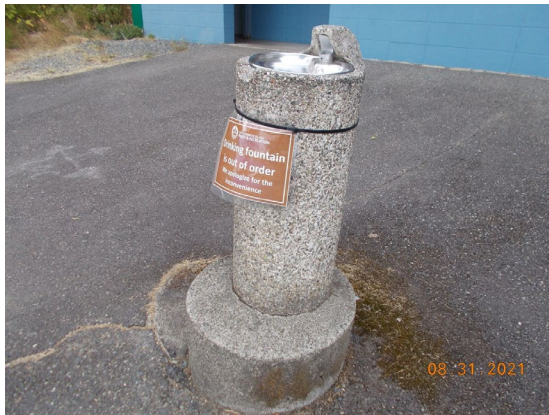
- Upper Left: Hi-low drinking fountain required adjacent to restrooms.
- Upper Right: Hi-low drinking fountain required adjacent to upper picnic area.
- Lower Left: An accessible route is lacking to picnic table in upper picnic area.

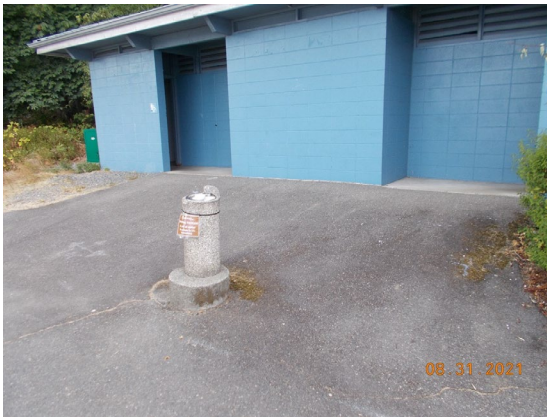
Upper Left: Route to restrooms has an excessive slope.

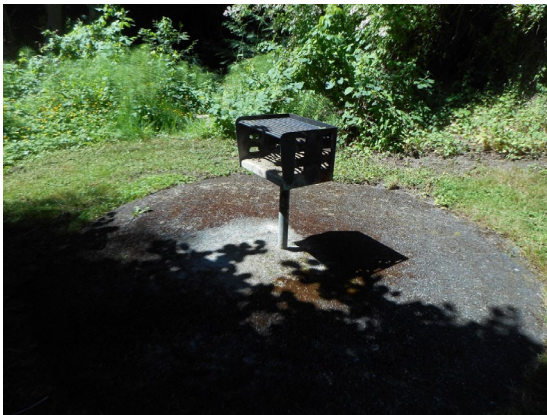
- Upper Left: 30"x48" clear floor space, paved and level, is required at BBQ grill closest to accessible picnic table.
- Upper Right: 30"x48" clear floor space, paved and level, is required at one end of one of the benches by the sand play area.
- Lower Left: 5% of picnic tables in each seating area require an accessible seat.

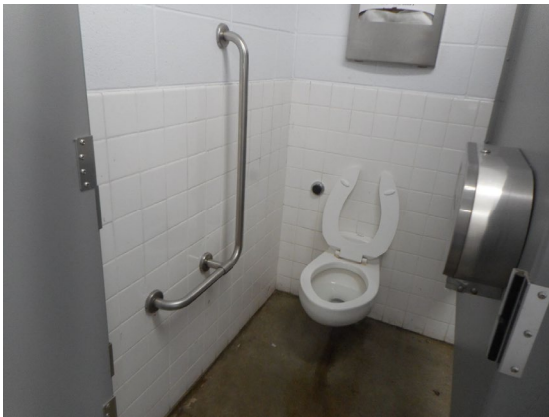
Upper Left: Restrooms are substantially non-accessible. Accessible stall in each restroom is non-compliant in size, grab bars are not compliant, flush control in Women's is incorrectly located, turn-around not provided in Men's restroom. Other issues were recorded.

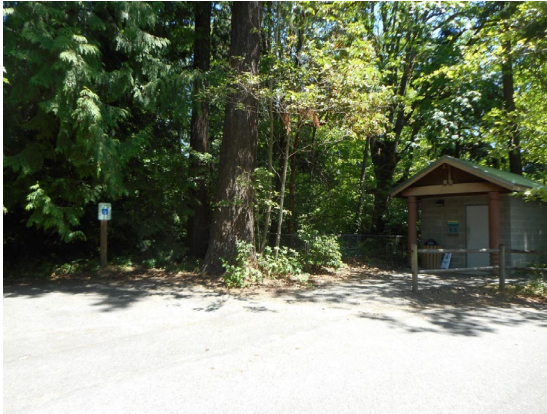
- Upper Left: Van accessible parking sign is mounted too low.
- Upper Right: Pavilion lacks a picnic table with an accessible seat with knee & toe clearance. 5% of picnic tables in each seating area require an accessible seat.
- Lower Left: Bench lacks a paved clear floor space at one end.

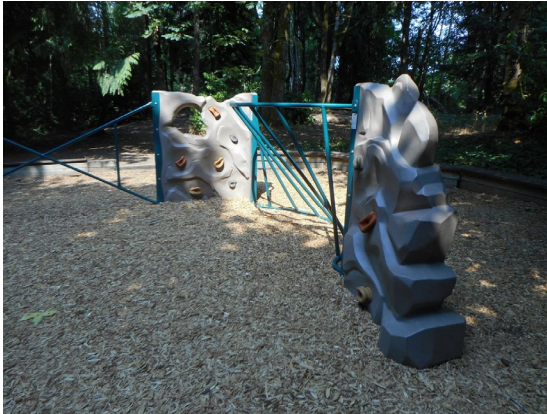
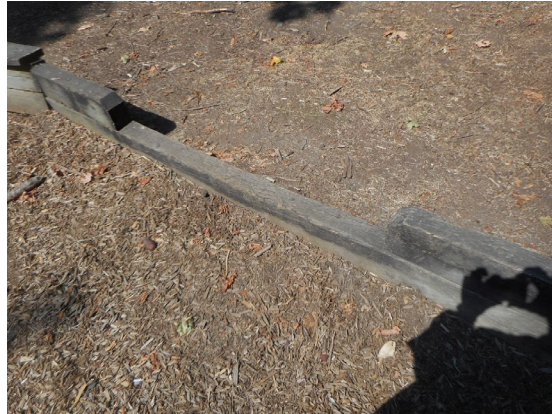
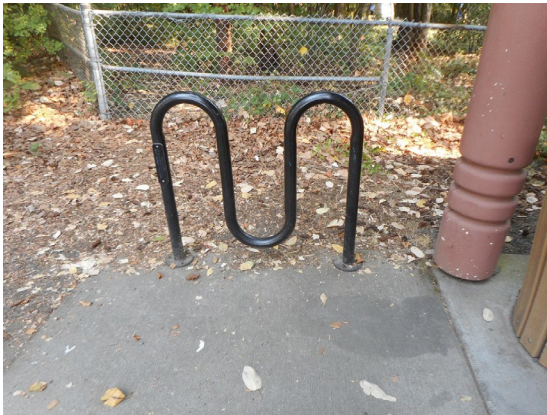
Deane's Children's Park

- Upper Left: Play area requires compliant ground surfaces, which must be periodically inspected and maintained.
- Upper Right: Wood border at play areas block accessible route. Removal of wood border and installation of ramp to play areas required.
- Lower Left: Bike rack lacks an adjacent (paved) clear floor space along one side.

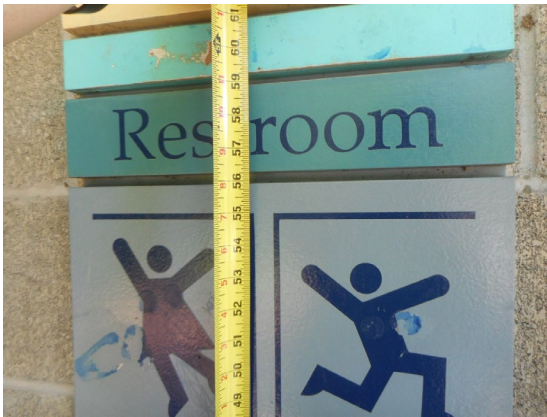
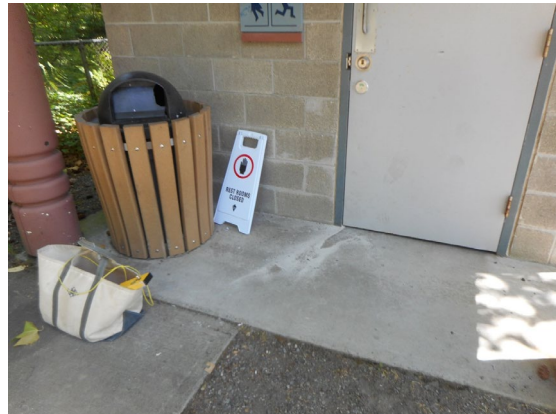
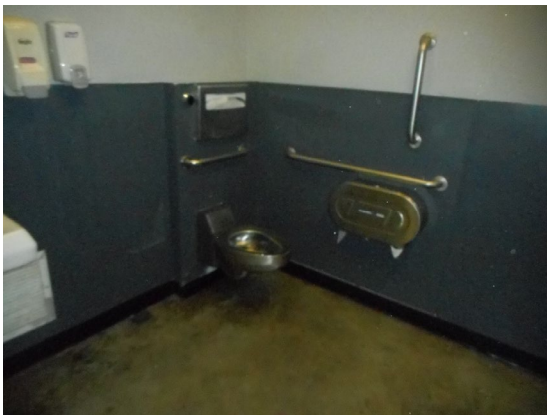
Deane's Children's Park

- Upper Left: Restroom signage lacks raised lettering, and is non-compliant in mounting height.
- Upper Right: Entry door into restroom lacks sufficient area for door maneuvering clearance. Concrete walk to be enlarged, and garbage can relocated.
- Lower Left: Grab bars at toilet are non-compliant in length & height. Wall surface behind toilet to be revised for grab bar. Seat cover dispenser lacks a forward approach. Toilet non-compliant for children's use.

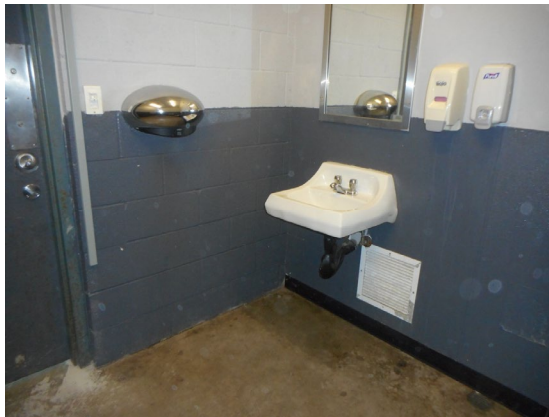
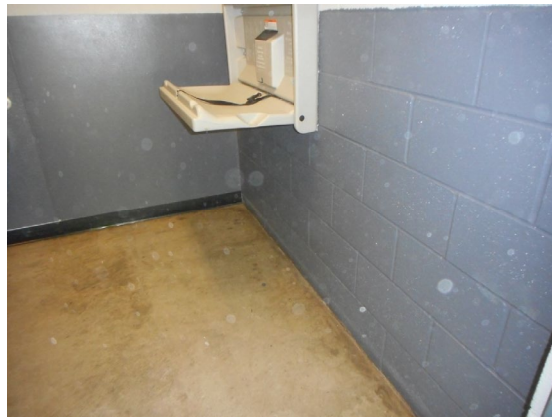
Deane's Children's Park

Upper Left: Lavatory does not provide knee & toe clearance and is mounted too high for children's use. Mirror is mounted too high.

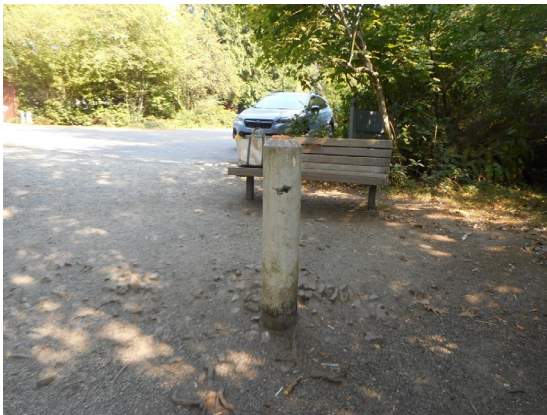
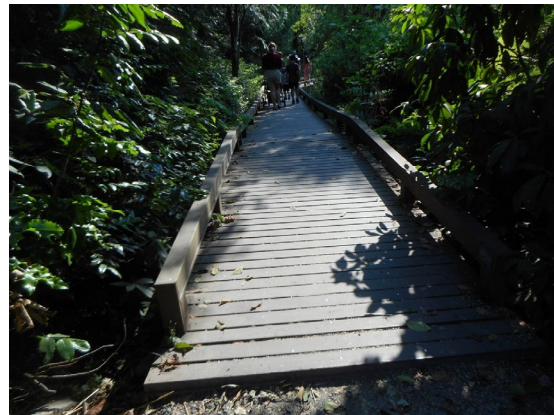
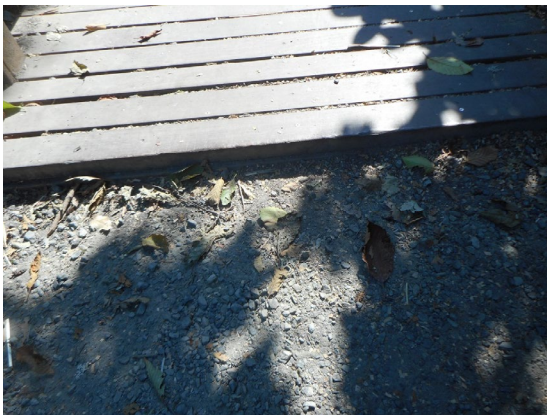
- Upper Left: Park lacks a paved accessible route to bench, and one end of the bench required a paved clear floor space.
- Upper Right: Boardwalk lacks an accessible route to it.
- Lower Left: Boardwalk ends have level changes exceeding 1-1/2".

ITEM 3: ACCESSIBLE BENCH		Recommendation: Provide level clear floor space (concrete pad) adjacent to one end of the bench.		P	O	7	2	5 SF \$125
				Although not required under 2010 ADA scoping, E&A recommends for at least 5% of benches provide compliant 30"x48" clear floor space to one side of the bench. Existing condition: Adjacent to each side of the bench is a dirt path, and no clear floor space is provided.				
Total for Building: Ellis Pond								\$478

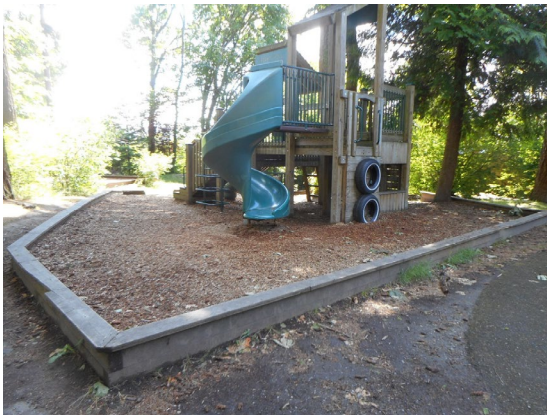
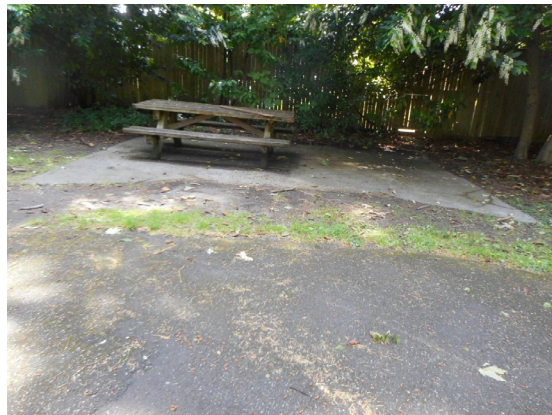
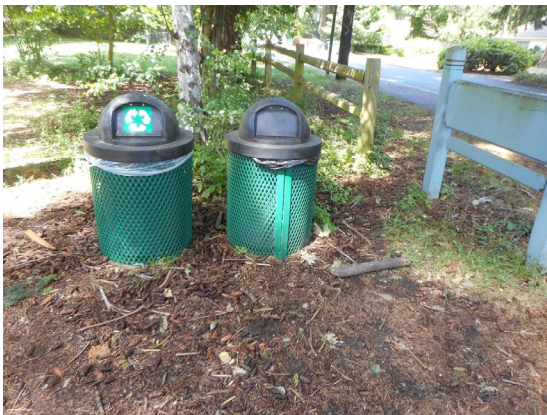
First Hill Park

Upper Left: Ground surfaces of all play areas must be compliant and require periodic inspections & maintenance. An accessible route is required into the play area.

ITEM 3: ENTRY TO PLAY AREAS	Cut through wooden borders at both play areas as required to provide accessible route to play areas 44" min. wide (per Code).	Entrance is required to be 36" min. wide per ADA (but 44" min. wide per Code). Existing condition: One play area has entry 42" wide cut into wooden border; other play area has no entry through wooden border.	P	O	1	1	2	EA	\$1,000
Barrier	510	The site amenity (ball field, playground, bench, picnic table, BBQ, etc.) lacks an accessible route to it.	Citation	2010 ADA Stds. 206.2.2

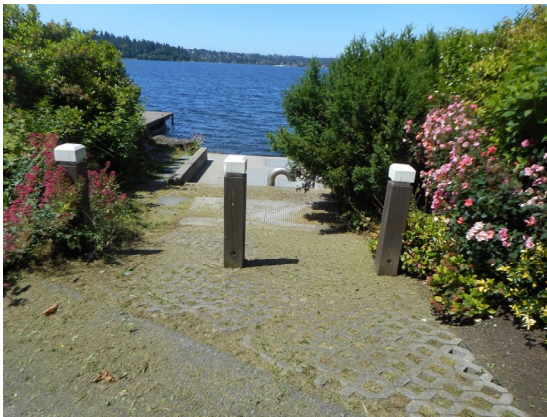
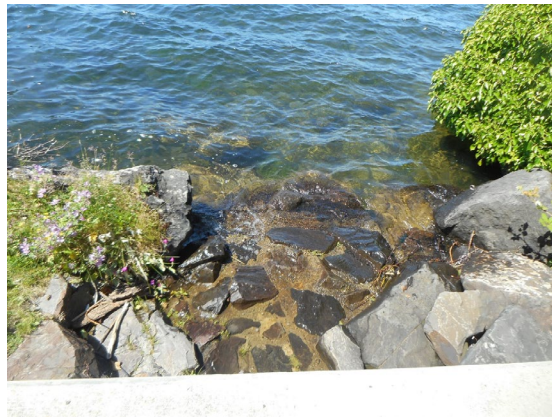
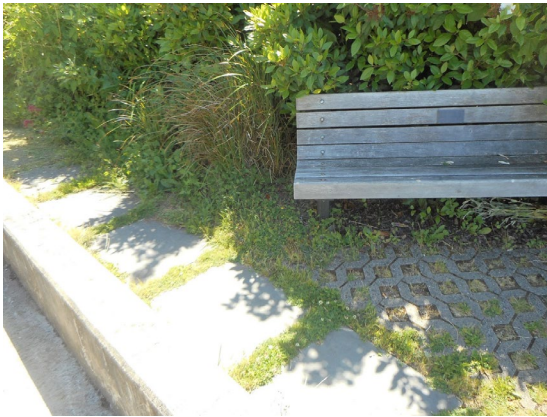
- Upper Left: Site has a path consisting of pavers and stepping stones. No accessible route is provided to site amenities.
- Upper Right: Stone steps to beach. No accessible route is provided.
- Lower Left: Bench requires an adjacent clear floor space at one end, and an accessible route.

ITEM 2: ACCESSIBLE BENCH		Recommendation: Provide level clear floor space (concrete pad) adjacent to one end of the bench.	Although not required under 2010 ADA scoping, E&A recommends for at least 5% of benches provide compliant 30"x48" clear floor space to one side of the bench. Existing condition: Bench is provided, however no adjacent clear floor space is provided.	P	O	7	2	10 SF \$250
Total for Building: Forest Landing								\$1,133

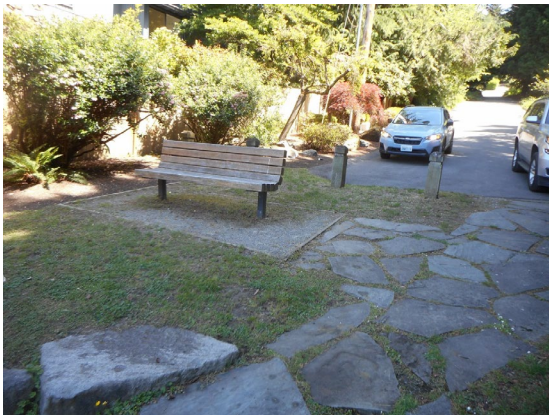
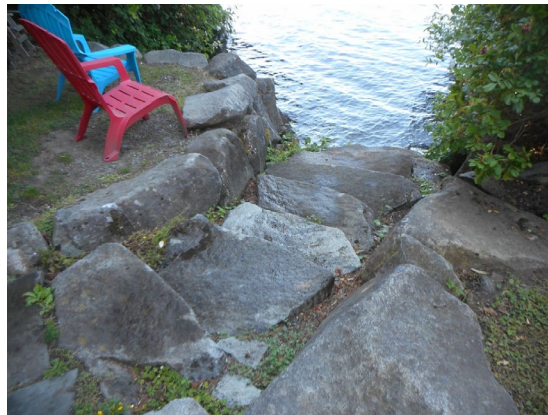
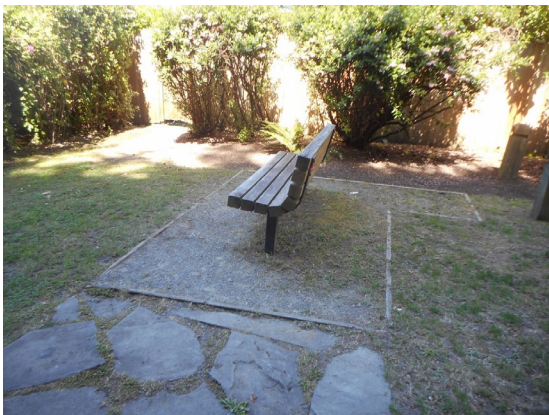
Upper Left: A paved accessible route is lacking to the bench.

ITEM 2: ACCESSIBLE BENCH		Recommendation: Provide level clear floor space (concrete pad) adjacent to one end of the bench.	Although not required under 2010 ADA scoping, E&A recommends for at least 5% of benches provide compliant 30"x48" clear floor space to one side of the bench. Existing condition: Adjacent to each side of the bench is loose gravel, and no clear floor space is provided.	P	O	7	2	10	SF	\$250
Total for Building: Franklin Landing										\$1,663

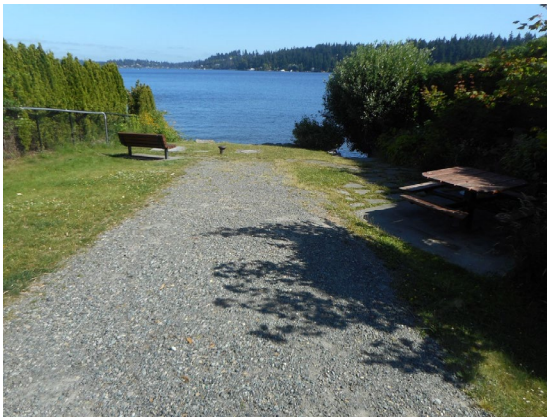
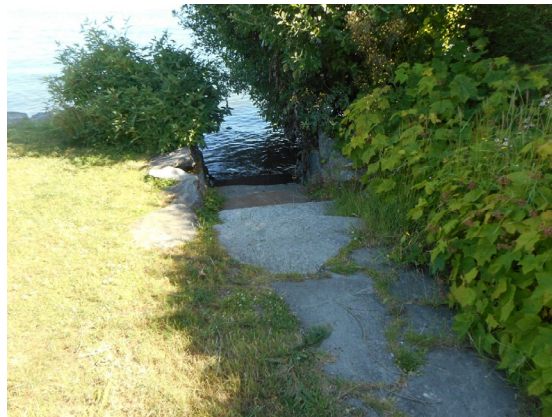
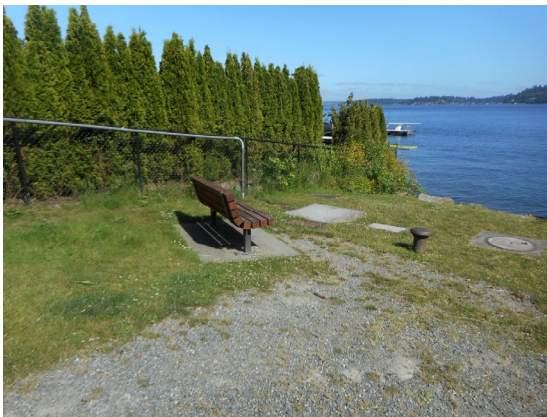
Upper Left: A paved accessible route is lacking to the picnic table, bench, and waterfront. Picnic table does not provide an accessible seat area with a paved clear floor space below.

ITEM 3: PICNIC TABLE		Remove and replace concrete slab with a 2% max. cross slope (1:48).	Existing concrete pad at picnic table is too small to provide required clear floor space.	P	O	1	2	3	LF	\$216
Barrier	522	Where an accessible bench is to be provided, the bench is not 42" long, 20" - 24" deep, with a 17" - 19" high seat and 18" high back (unless affixed to a wall) OR the bench lacks a 30"x48" clear floor adjacent to one end of the bench.	Citation	2010 ADA Stds. 903

ITEM 4: ACCESSIBLE BENCH		Recommendation: Provide level clear floor space (concrete pad) adjacent to one end of the bench.	Although not required under 2010 ADA scoping, E&A recommends for at least 5% of benches - provide a compliant 30"x48" clear floor space to one side of the bench. Existing condition: adjacent to each side of the bench is a lawn area, and no clear floor space is provided.	P	O	7	2	10	SF	\$250
Total for Building: Fruitland Landing									\$8,264

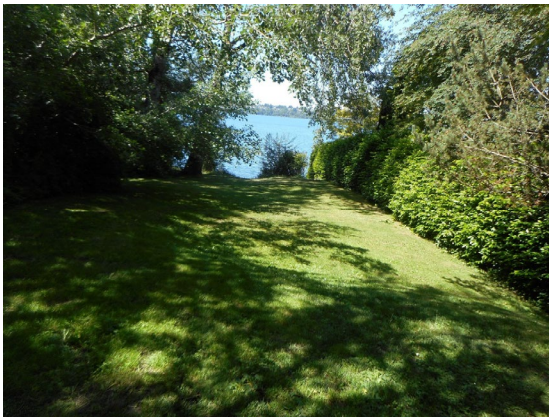
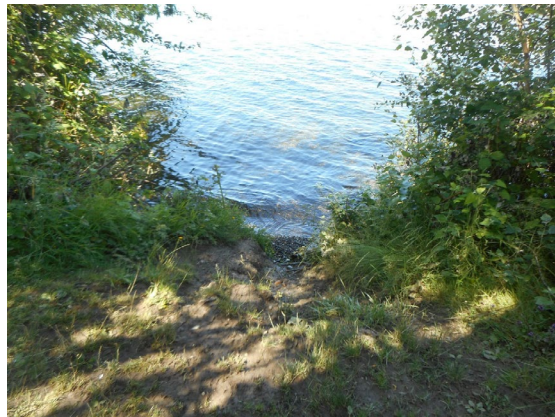
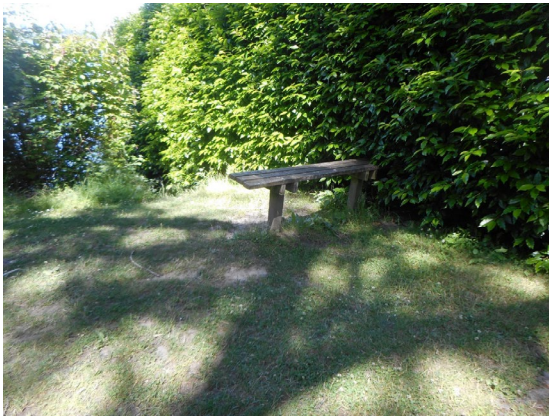
Upper Left: The site has a lawn area only. A paved accessible route is lacking to the bench and water's edge.

ITEM 2: ACCESSIBLE BENCH		Recommendation: Provide level clear floor space (concrete pad) adjacent to one end of the bench.	Although not required under 2010 ADA scoping, E&A recommends for at least 5% of benches provide compliant 30"x48" clear floor space to one side of the bench. Existing condition: Bench is in a lawn area, and no clear floor space is provided.	P	O	7	2 10 SF	\$250
Total for Building: Garfield Landing								\$8,727

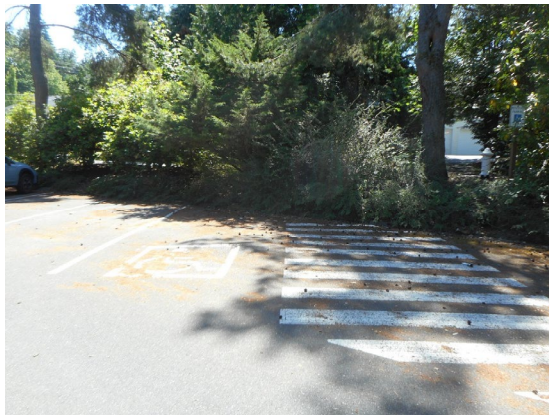
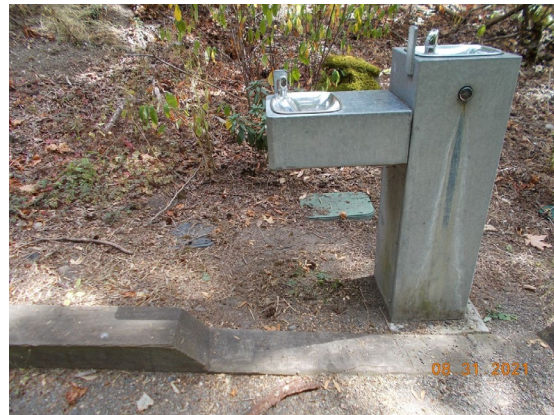
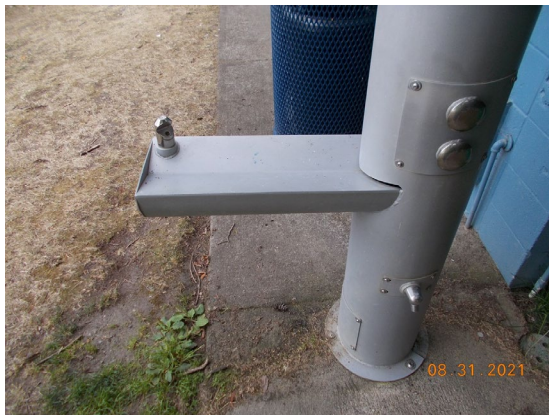
Groveland Beach Park

- Upper Left: Accessible parking stall lacks signage.
- Upper Right: Curb obstructs toe space and a clear floor space is lacking at the lower fountain.
- Lower Left: Drinking fountain by restrooms lacks a clear floor space and an accessible route.

LOCATION	RECOMMENDATION	COMMENTS	TYPE	RESP CODE	PRI	QTY	UNITS	BUDGET
Accessible Parking								
Barrier	540	The accessible stall lacks compliant accessible parking signage, or existing signage is not 60" min. high measured to the bottom of sign.	Citation	2010 ADA Stds. 502.6, 703.7.2.1, 216.5				
ITEM 1: PARKING LOT - ACCESSIBLE PARKING	Add new sign displaying the International Symbol of Accessibility at one existing accessible stall.	Signs shall be 60" min. AFF or ground surface, measured to bottom of the sign. Existing condition: No sign is provided at one accessible parking space (other accessible space has sign).	P	O	1	1	EA	\$290

ITEM 3: DRINKING FOUNTAIN AT RESTROOMS		Retain low level drinking fountain (integral with rinse shower and foot rinse nozzles) and add a high level drinking fountain for standing persons.		P	O	1	4	1 EA \$5,590
		Where provided, min. 2 water fountains are required. 1 is required to meet 602.1 - 602.6 for clear floor space, height, operable parts, and water flow, and 1 is required to meet 602.7 which is height for standing persons. Spout outlets of drinking fountains for standing persons shall be 38" min. and 43" max. AFF. Existing condition: Compliant low level drinking fountain is provided for wheelchair users integral with exterior rinse shower nozzle and low level foot rinse nozzle.						
Barrier	754	The drinking fountain lacks a 30"x48" clear floor space for a front approach OR the clear floor space slope exceeds 2% in all directions.	Citation	2010 ADA Stds. 602.2

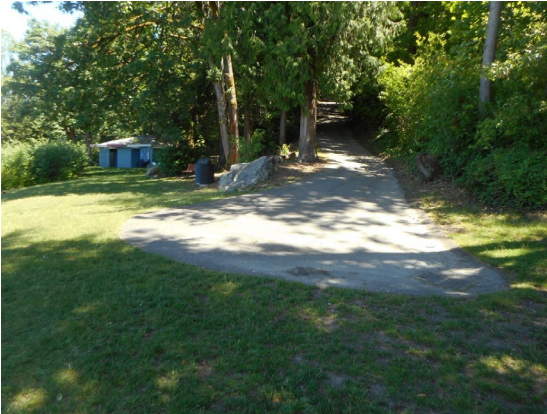
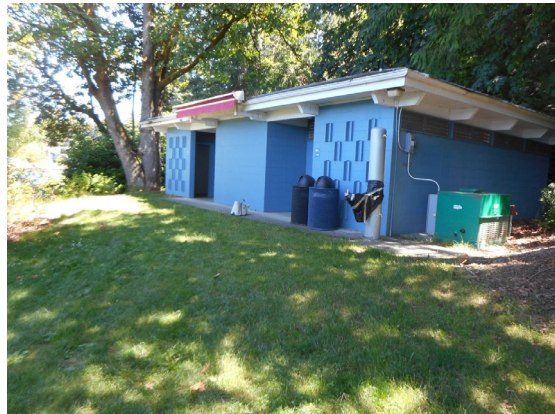
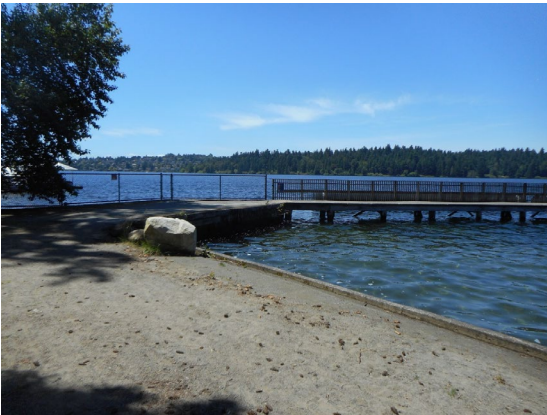
Groveland Beach Park

- Upper Left: Paved road ends. No accessible route is provided to beach, restrooms, volleyball court, or pier.
- Upper Right: No accessible route is provided through the lawn to the restrooms.
- Lower Left: No accessible route is provided to the beach or pier.

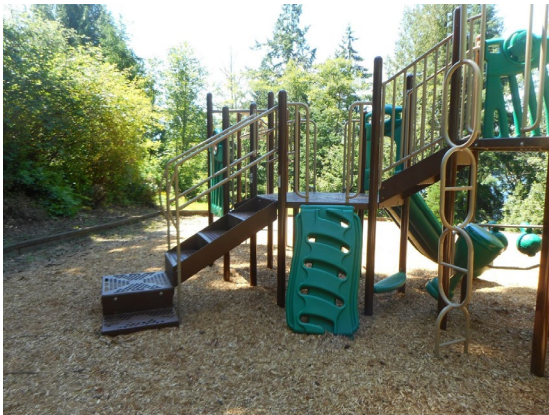
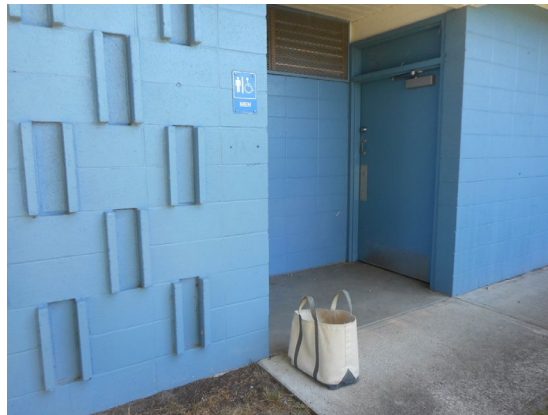
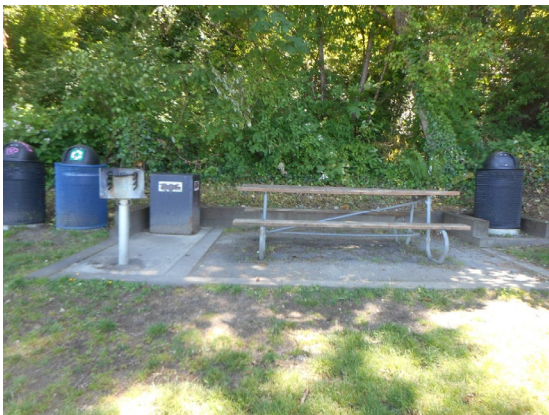
Groveland Beach Park

Upper Left: Play area requires compliant ground surfaces, which must be periodically inspected and maintained.

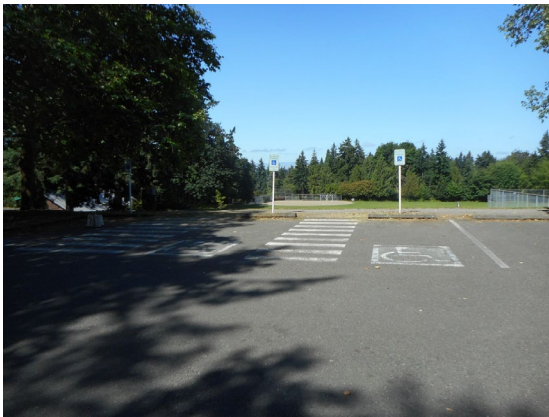
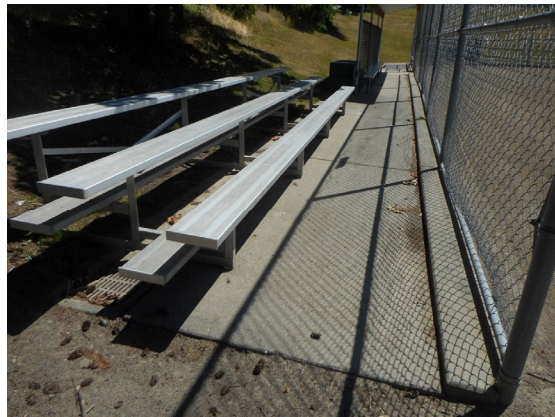
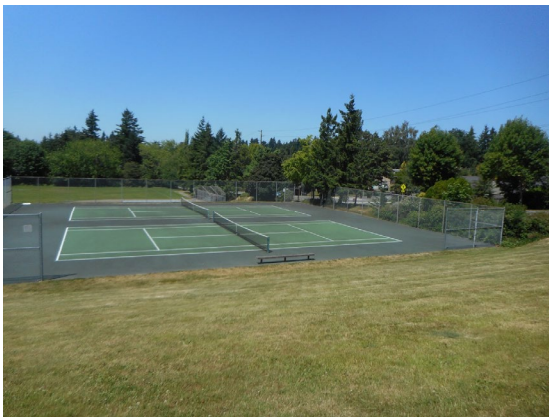
Homestead Park

Upper Left: Parking signs are mounted too low. Bottom to be 60" min. above paving.

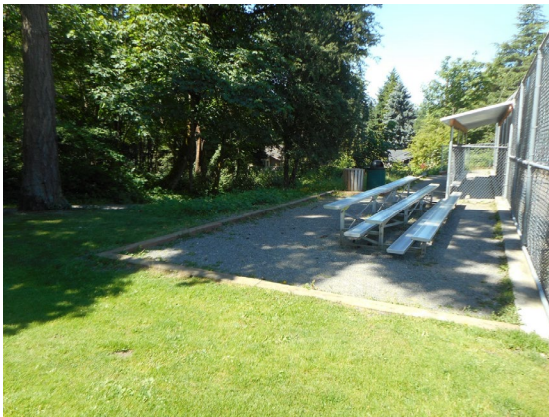
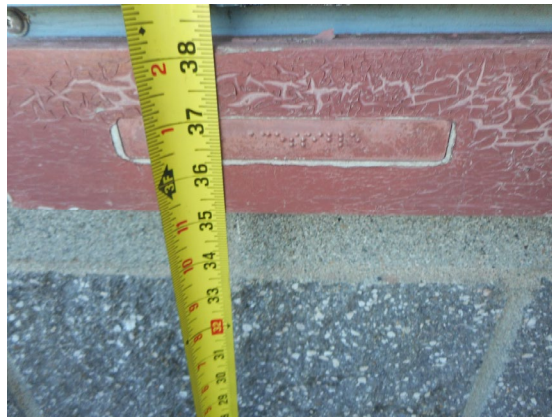
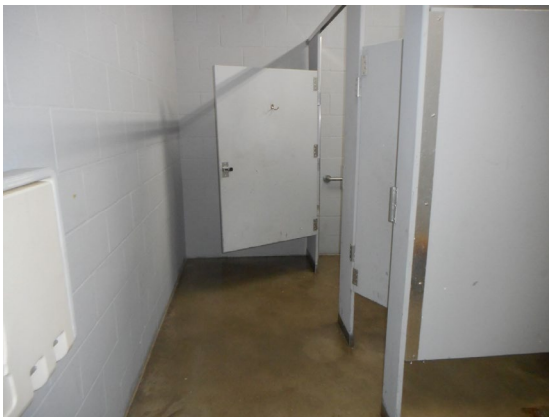
Homestead Park

- Upper Left: Ballfields lack an accessible route.
- Upper Right: Restroom signage is mounted too low.
- Lower Left: Accessible toilet stall doors are required to be self-closing, have a pull on the inside surface, and have coat hooks at 48" max. AFF.

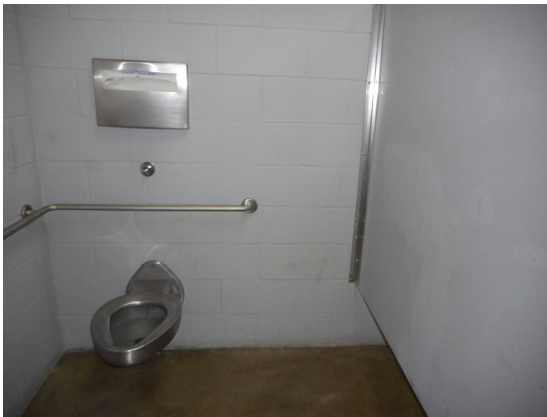
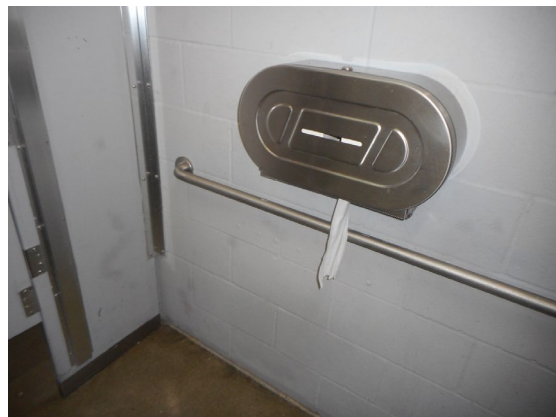
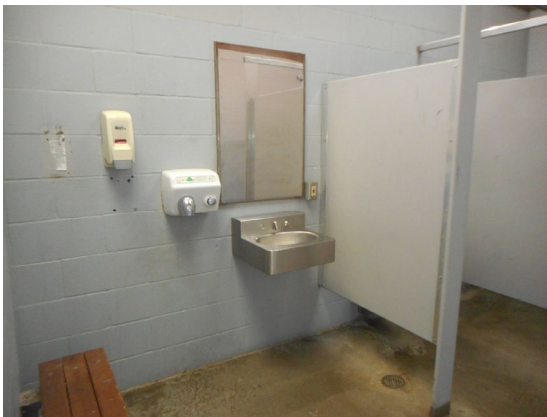
Homestead Park

- Upper Left: Grab bars in accessible toilet stalls are not compliant in length and mounting height. Seat cover dispensers mounted behind toilet are not accessible. Toilets are too far from wall (should be located 16" min. - 18" max. from side wall).
- Upper Right: Toilet paper dispensers are mounted within the required 12" clearance space above the grab bar.
- Lower Left: Men's lavatory does not provide compliant knee clearance. Soap dispenser is mounted too high.

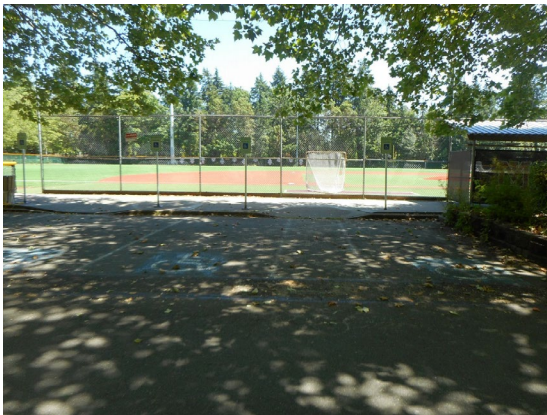
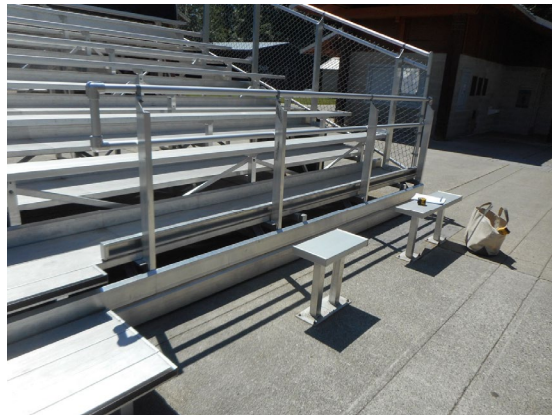
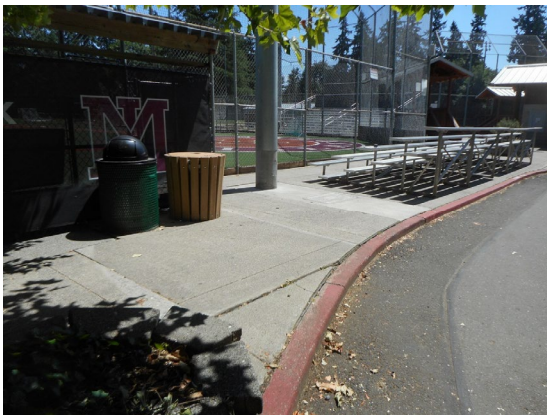
Island Crest Park

- Upper Left: Van accessible parking space is insufficient in width. Relocation of signage is required due to restriping.
- Upper Right: Ballfield #1 Home Team bleachers — companion seats do not provide the required width for adjacent wheelchair seating.
- Lower Left: Ballfield #1 Visitor Team bleachers — space is not sufficient for wheelchair seating, including accessible route.

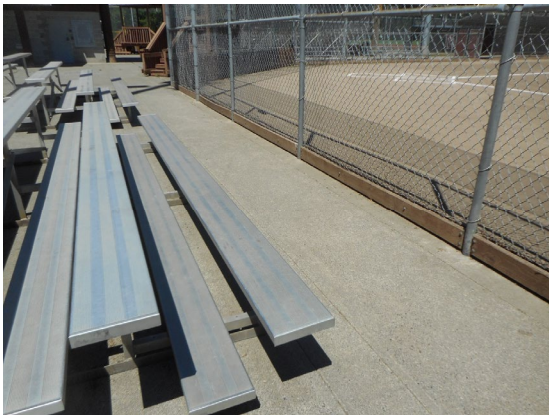
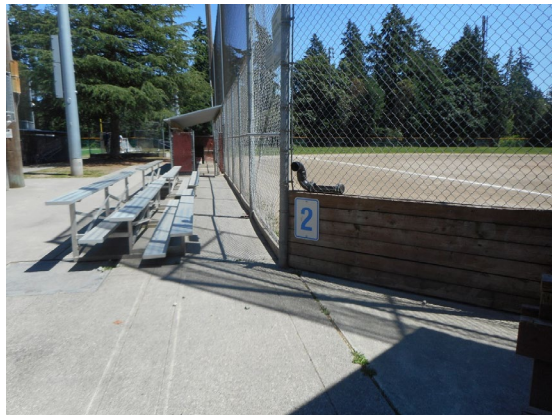
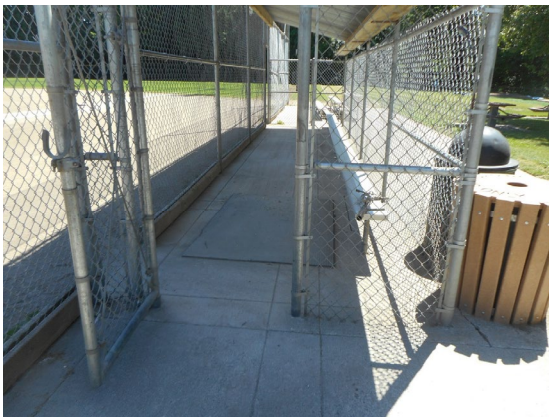
Island Crest Park

Upper Left: Ballfield #2 Home Team bleachers are too close to fencing to provide an accessible route in front of the required wheelchair spaces.

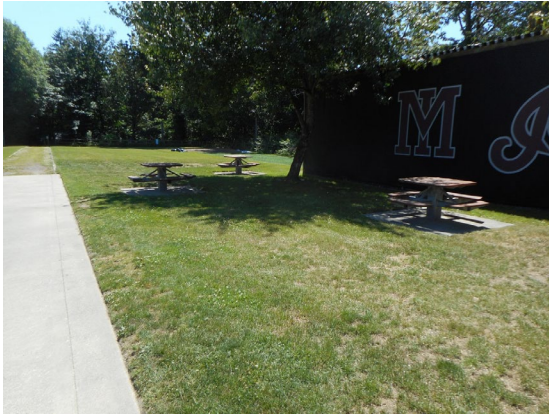
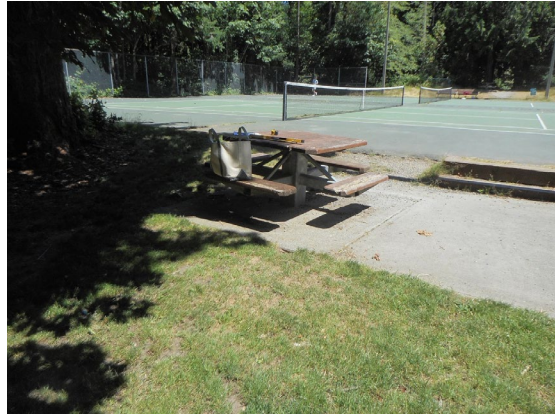
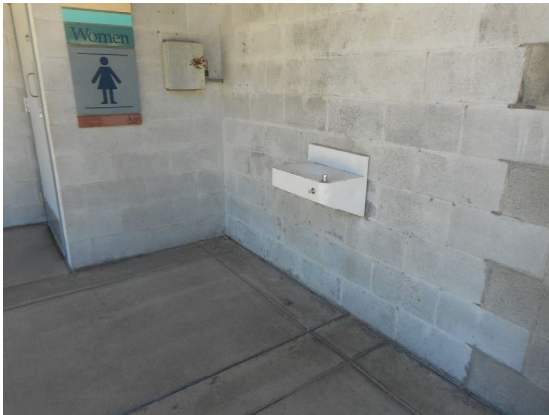
Island Crest Park

Upper Left: 1 picnic table is required to provide an accessible seat. An accessible route is required to table.

Lower Left: A single low drinking fountain is provided outside of each restroom, with insufficient knee space. Hi-low drinking fountains are required.

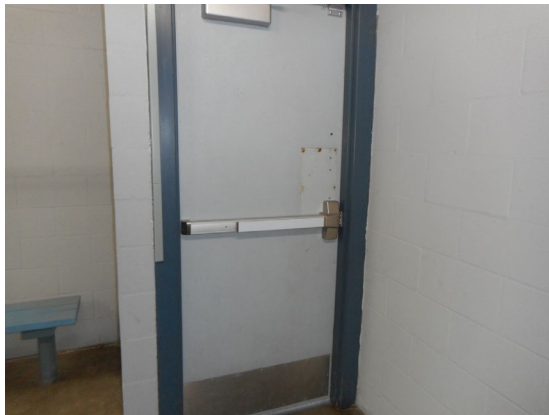
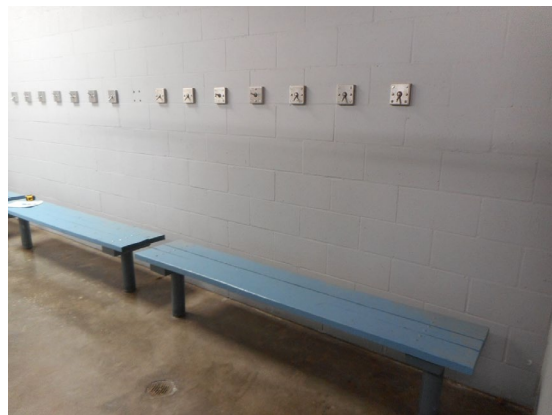
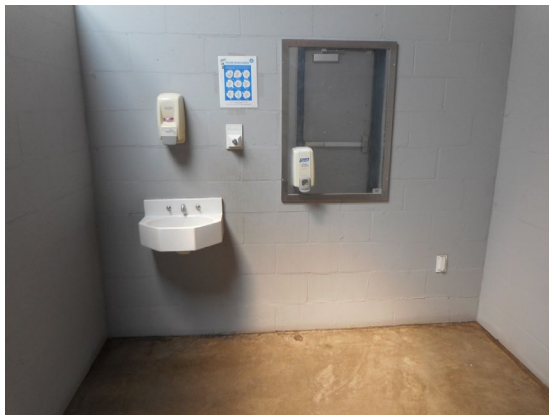
Island Crest Park

- Upper Left: Restroom doors have a latch and a closer, requiring 12" min. width on the push side.
- Upper Right: Dressing room benches are non-compliant, an additional bench is required in each dressing room. Clothes hooks are mounted too high, one in each room must be lowered or provide a new hook at 48" max. AFF.
- Lower Left: Each restroom has 2 lavatories. Neither has an accessible knee space clearance. 1 in each restroom must be compliant. Soap dispenser mounted too high.

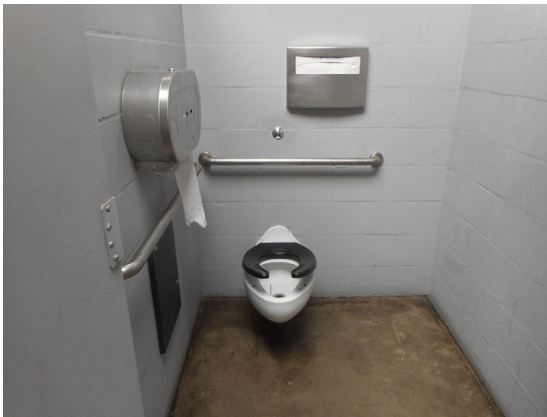
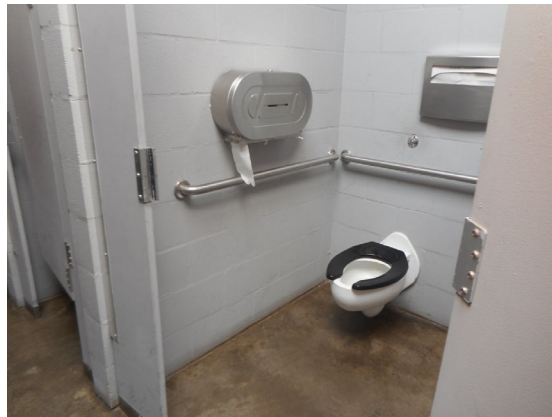
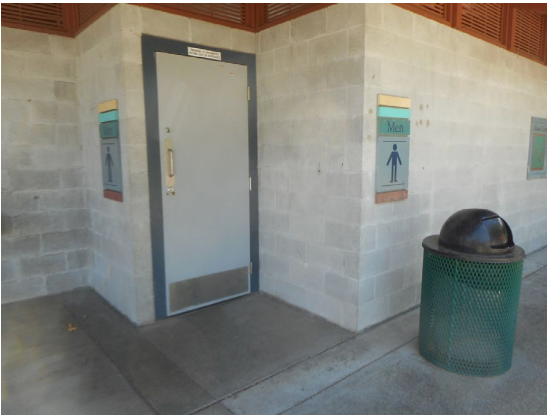
Island Crest Park

- Upper Left: Accessible toilet stall in each restroom is insufficient in width. Seat heights are too low. Grab bars require relocation. Flush control in Men's accessible stall is incorrectly located. Photo is Men's restroom.
- Upper Right: The accessible toilet stall in each restroom requires toilet paper & seat cover dispensers to be relocated. Photo is Women's restroom.
- Lower Left: Restroom signage is non-compliant (requires raised lettering and braille), and is non-compliant in location.

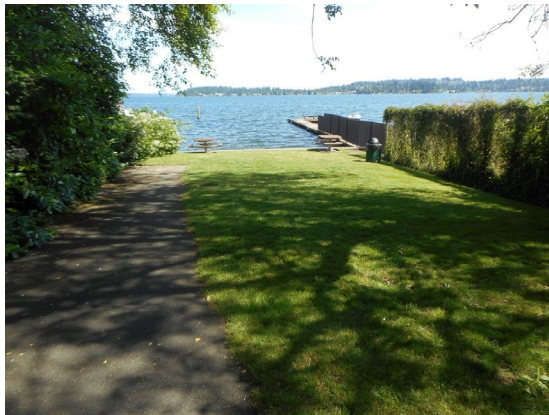
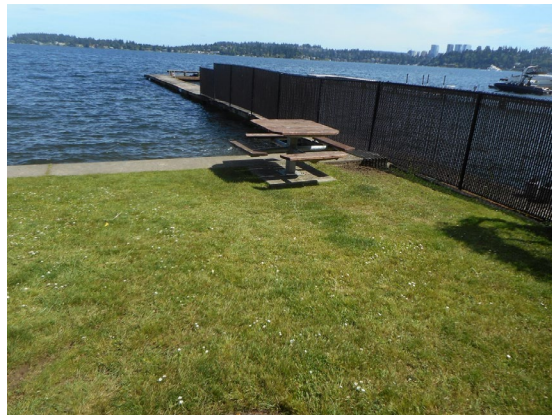
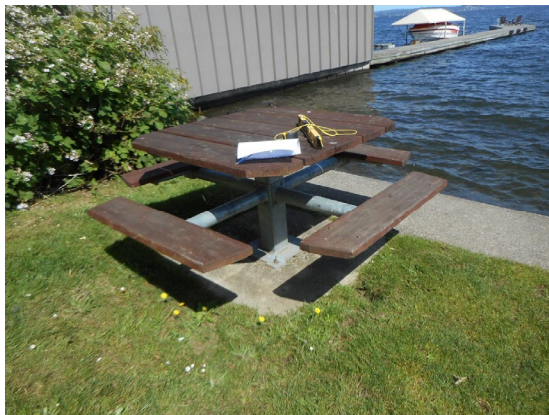
Lincoln Landing

- Upper Left: No accessible route is provided to picnic tables.
- Upper Right: Neither of the 2 picnic tables provides an accessible seat with the required knee and toe clearance. 1 accessible picnic table must be provided.
- Lower Left: The accessible picnic table requires a paved clear floor space at the accessible seat, and an accessible route to it.

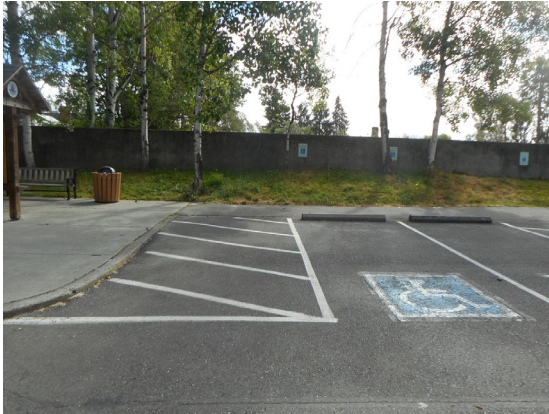
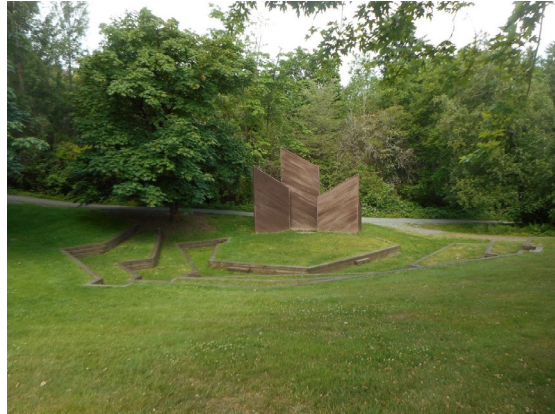
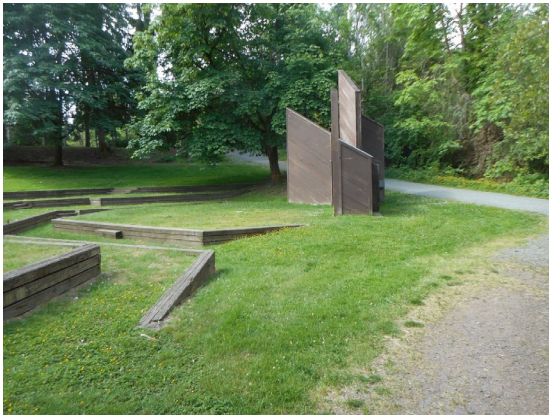
Luther Burbank Park

Upper Left: Accessible parking signs are mounted too low (and too far from stall). Provide pole mounted signs at head of stalls.

Lower Left: There are no accessible seating areas in the Amphitheatre. Wheelchair accessible area next to a companion seat could be accommodated near paths on both sides of stage.

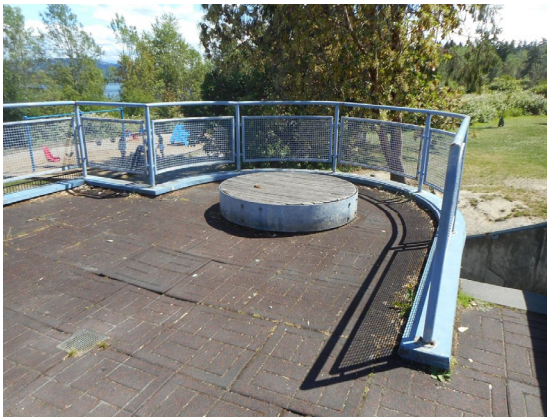
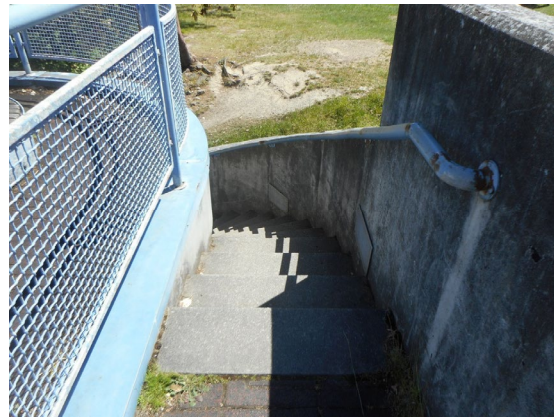
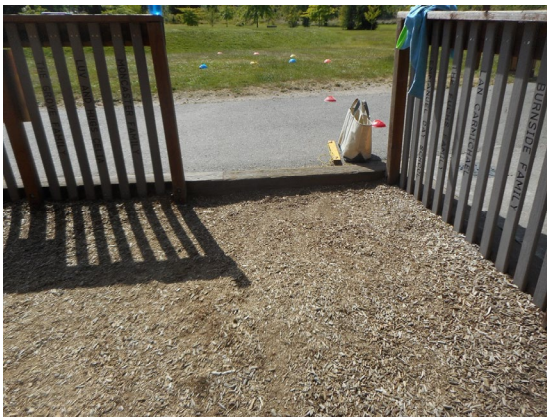
Luther Burbank Park

- Upper Left: Rooftop viewing platform is provided above the restrooms near the tennis courts.
- Upper Right: Rooftop platform lacks an accessible route.
- Lower Left: Entry into the play area near Picnic Area C includes a step down and no accessible ramp is provided.

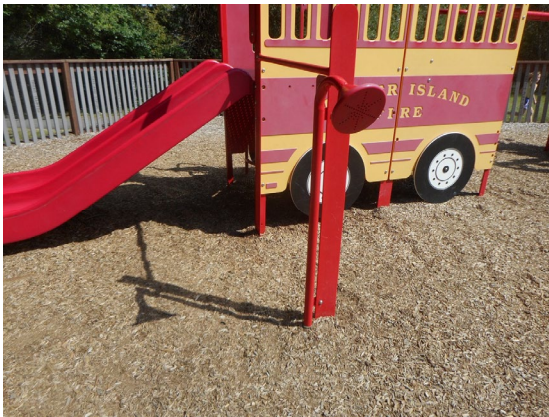
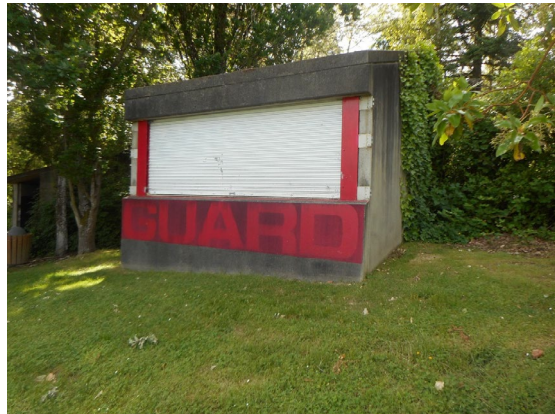
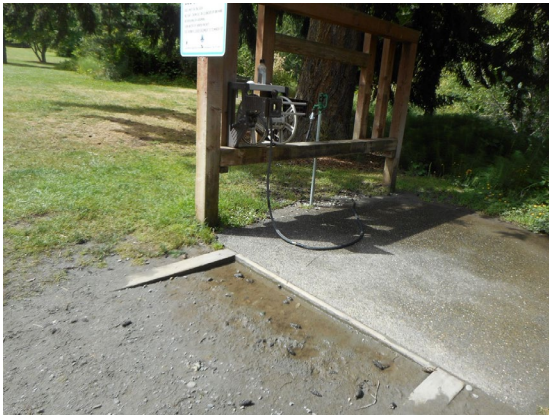
Luther Burbank Park

Upper Left: Ground surfaces of all play areas must be compliant and require periodic inspections & maintenance.

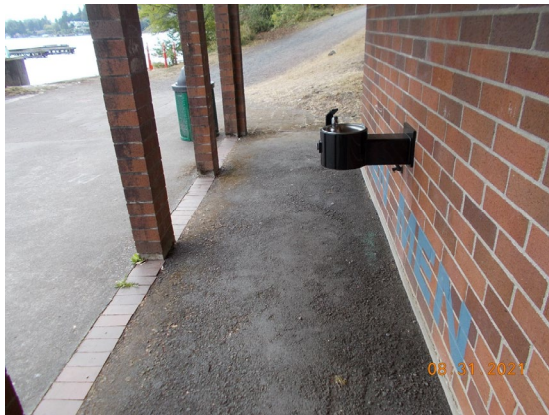
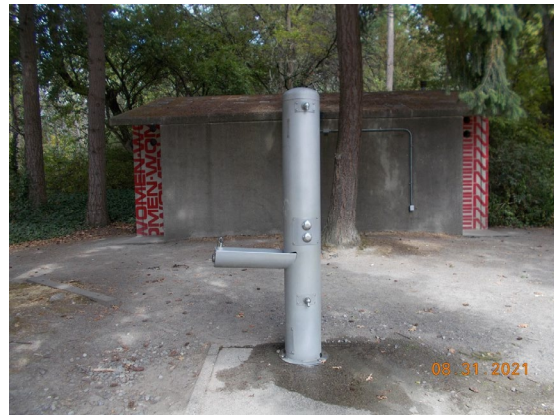
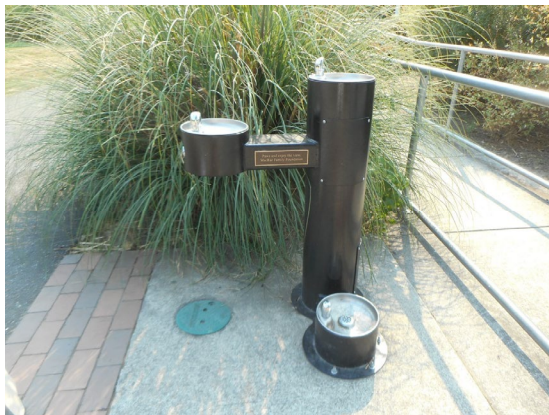
Luther Burbank Park

- Upper Left: Only low level drinking fountain is provided near old boiler room. Hi-low drinking fountain required.
- Upper Right: Drinking fountain with foot rinse and shower lacks a high level drinking fountain.
- Lower Left: The hi-low fountain near the tennis courts has a clear floor space with excessive slope that affects the height of the fountain, resulting in a protruding object hazard.

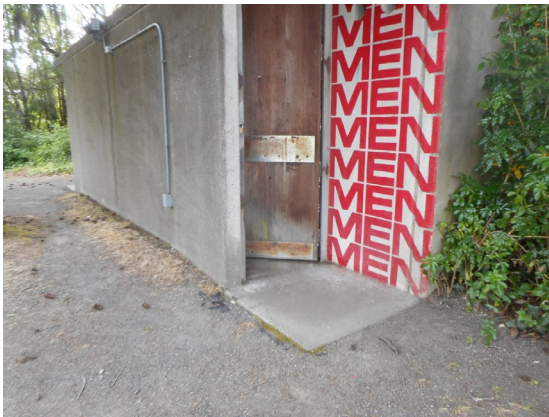
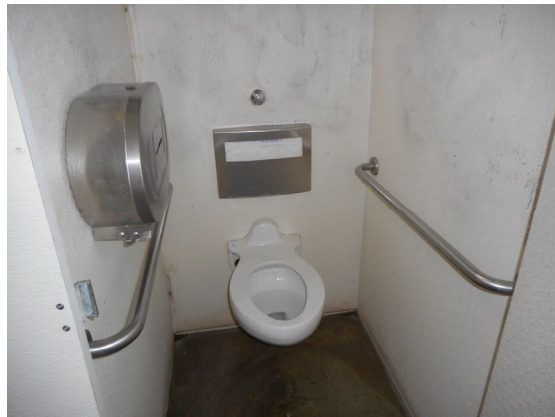
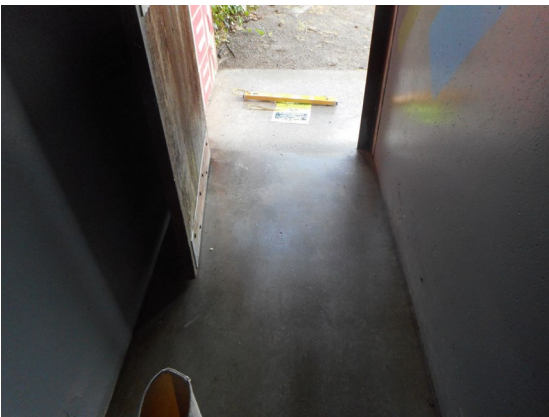
Luther Burbank Park

Upper Left: Restrooms near Picnic Area C are substantially non-accessible.

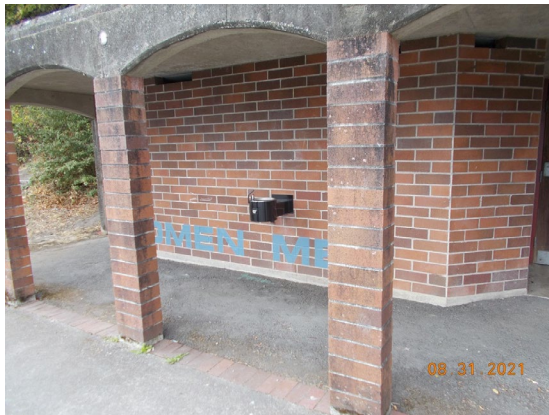
Upper Left: Restrooms near the old boiler room are substantially non-accessible.
