CITY OF MERCER ISLAND **REVISED**

CITY COUNCIL REGULAR VIDEO MEETING

TITLE:	AB 6002: Draft ADA Transition Plan	<input checked="" type="checkbox"/> Discussion Only <input type="checkbox"/> Action Needed: <input type="checkbox"/> Motion <input type="checkbox"/> Ordinance <input type="checkbox"/> Resolution
RECOMMENDED ACTION:	Receive report. No formal action required.

City of Mercer Island ADA Transition Plan

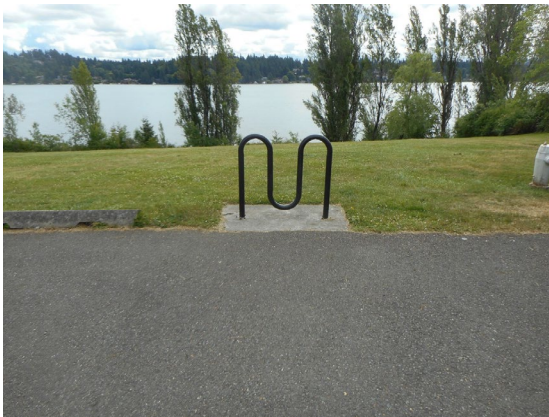
Upper Left: Bike rack lacks a paved clear floor space at one end.

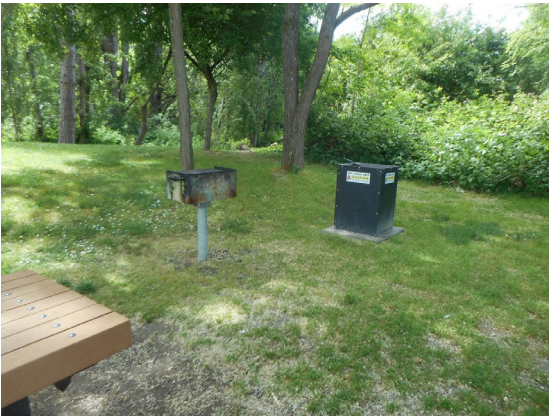
Lower Left: BBQ grill and hot coal disposal unit lack an accessible route and paved clear floor space directly adjacent.

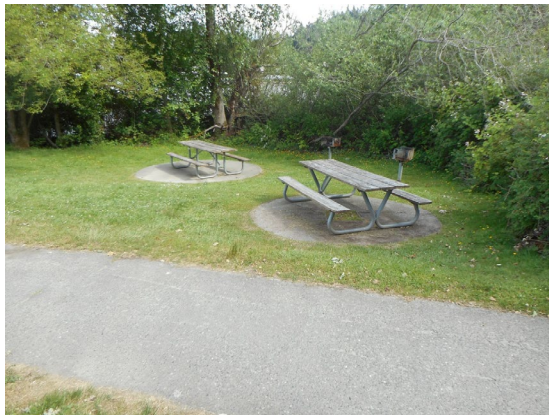
Upper Left: An accessible picnic table in each area requires a paved accessible route and an accessible seat.

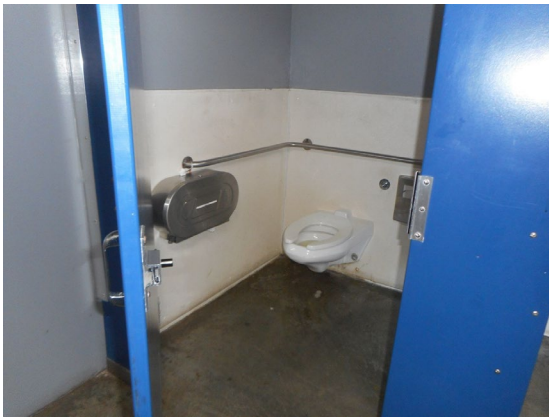
Upper Left: Grab bars in restrooms near tennis courts are too short. Toilet paper dispenser is too close to grab bar and toilet in Men's restroom is too far from wall.

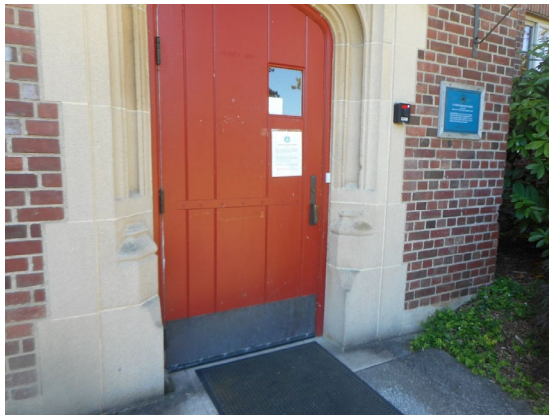
Upper Left: North entry door is recessed 12" from brick façade. To preserve historic doorway, power operator would be required.

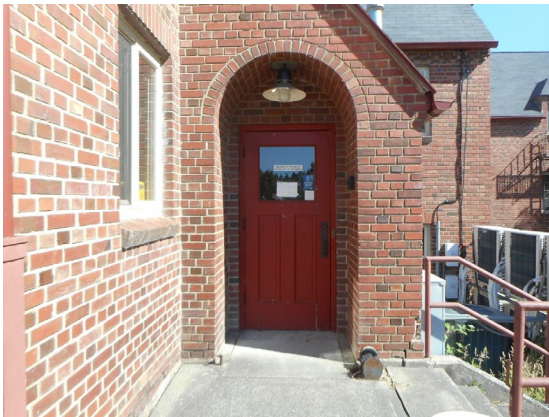
Upper Left: South entry is designated as accessible entry, but door is recessed 34" (8" max. allowed) into required door maneuvering space. Consider abandoning entry.

LOCATION	RECOMMENDATION	COMMENTS	TYPE	RESP CODE	PRI	QTY	UNITS	BUDGET
Doors								
ITEM 6: SOUTH ACCESSIBLE ENTRY	Consider abandoning this entry and designate as emergency exit only.	Door maneuvering spaces at latch are required to be min. 18" at pull side and min. 12" at push side (if equipped with latch & closer). Existing condition: On exterior - door is recessed 34" and does not provide the 18" width on the pull side (6" exists). On the interior - door has both a closer and a latch, therefore 12" width on the latch / push side is required - 2" exists.	P	O	1	2	1 LEAF	\$0

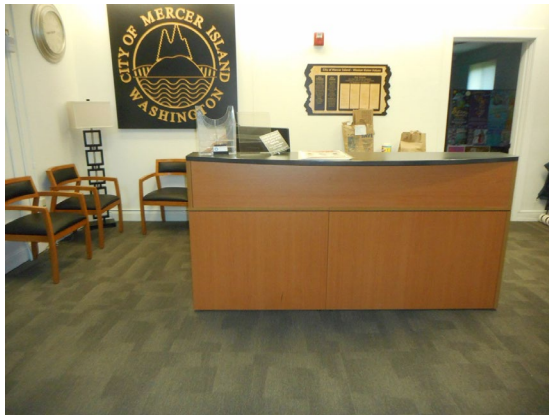
LOCATION	RECOMMENDATION	COMMENTS	CITATION	TYPE	RESP CODE	PRI	QTY	UNITS	BUDGET
Built In Elements									
Barrier	481	The sales or service counter lacks a 36" long lowered portion of counter that is max. 36" high for a 48" parallel approach or is not 30" long min. with knee space for a forward approach or does not extend the same depth as the sales or service countertop.	2010 ADA Stds. 227.3, 904.4.2, 902.3						
ITEM 1: RECEPTION DESK - FIRST FLOOR		Provide an accessible counter with a 36" AFF countertop height (min. 36" length).	Existing reception desk is 42" AFF.	P	O	1	2	1	EA \$650

- Upper Left: First floor reception desk does not provide an accessible height counter.
- Upper Right: Office door is too narrow. Remove door and provide 32" min. wide framed opening (otherwise door opening needs to be widened).
- Lower Left: Doors have knob type hardware. Lever-type is required for accessibility.

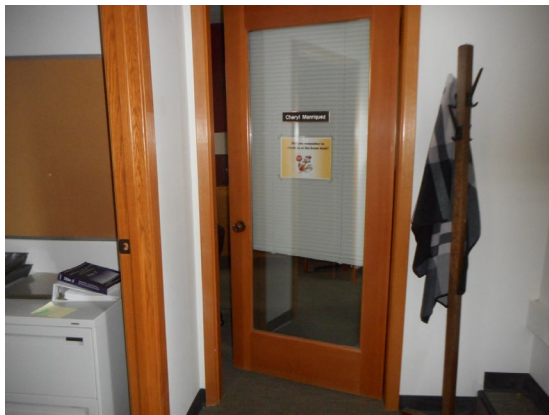
LOCATION	RECOMMENDATION	COMMENTS	TYPE	RESP CODE	PRI	QTY	UNITS	BUDGET
Doors								
Barrier	616	The door hardware requires pinching, gripping, or twisting to operate.						
			Citation	2010 ADA Stds. 404.2.7

ITEM 9: INTERIOR DOORS	Replace existing hardware with new accessible lever-type (or U-shaped) interior hardware.	Hardware is required to be mounted 34" min. and 48" max. AFF. Existing interior doors have knob type hardware.	P	O	1	2	8 EA	\$7,040
Barrier	618	The existing swing or sliding door threshold exceeds 3/4" and/or does not have a 1:2 bevel, or threshold measures between 1/4" and 3/4" but lacks a 1:2 beveled transition.						
			Citation	2010 ADA Stds. 404.2.5, 302, 303

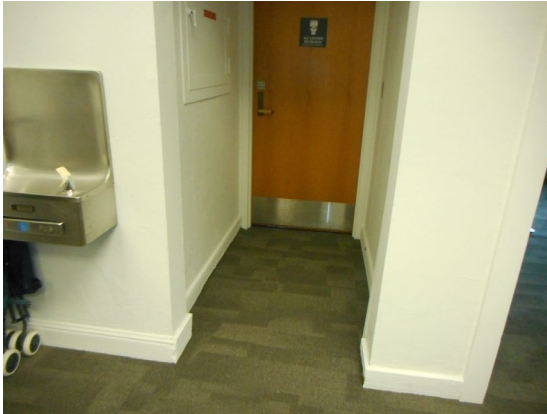
LOCATION	RECOMMENDATION	COMMENTS	TYPE	RESP CODE	PRI	QTY	UNITS	BUDGET
Signage								
Barrier	716	The accessible building entry or restroom sign lacks signage displaying the International Symbol of Accessibility OR the Pictogram is not 6" high min.	Citation	2010 ADA Stds. 703.7.2.1, 216.6, 216.8				
ITEM 24: RESTROOM - FIRST FLOOR	Provide a sign with the International Symbol of Accessibility.	Sign to be mounted 48" high min. measured from finished floor to bottom of the visual characters to 60" max. to the bottom of the visual characters. Existing condition: No compliant signage.	P	O	1	2	1 EA	\$180
Total for Building: Luther Burbank Park Administration Building & Caretaking Facility								\$30,363

- Upper Left: Restroom signage is non-compliant. The International Symbol of Accessibility is required.
- Upper Right: Grab bar encroaches on door maneuvering space; should be 1-1/2" from the side wall behind. Revised side wall (and door opening) is required. Toilet requires seat height between 17" - 19" AFF and flush control shall be on open side of toilet.
- Lower Left: Pipes below lavatory are not insulated.

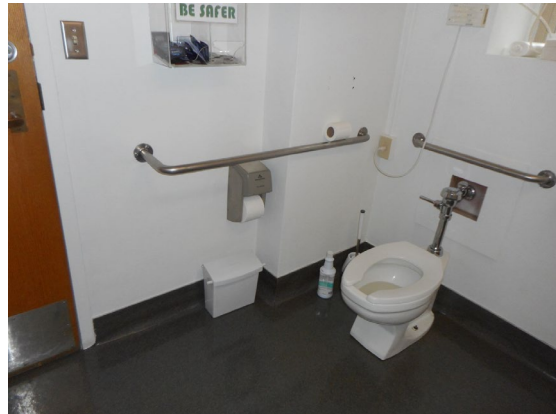
LOCATION	RECOMMENDATION	COMMENTS	TYPE	RESP CODE	PRI	QTY	UNITS	BUDGET
Restrooms / Bathrooms								
Barrier	679	The toilet seat height is not between 17" and 19" high.	Citation	2010 ADA Stds. 604.4, 604.9

ITEM 20: RESTROOM - FIRST FLOOR	Replace with new grab bars. Install new wall surface at side wall to provide 1-1/2" between grab bar and wall.	Grab bars should be 1-1/4" - 2" in diameter, 33" - 36" AFF, with 1-1/2" min. between the wall and the grab bar. Circular cross section - outside diameter 1-1/4" min. - 2" max. Non-circular cross section - perimeter of 4" min. - 4.8" max. Horizontal projections shall be 1-1/2" min. below bottom of rail. [2010 Standards: Rear grab bar min. 24" long from centerline of toilet at transfer side; allows 1-1/4" to 2" cross section and non-circular shapes; allows alternate children's use height.]. Existing condition: Both grab bars are not compliant in length. Grab bars are required to provide 1-1/2" space between bar and the wall; wall jogs back 8" at 27" from corner.	P	O	1	3	1 EA	\$2,300
Barrier	682	The flush controls are not located at open side of toilet, or controls require gripping, twisting, or pinching to operate.	Citation	2010 ADA Stds. 604.6

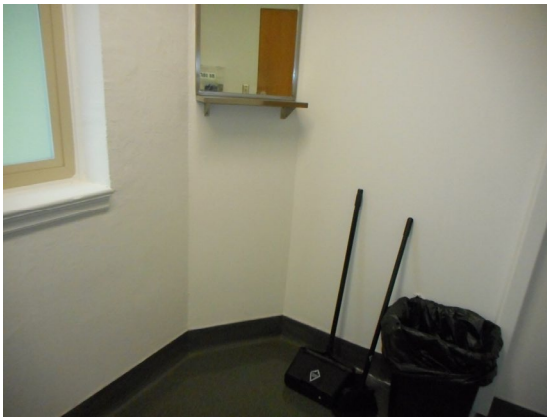
LOCATION	RECOMMENDATION	COMMENTS	TYPE	RESP CODE	PRI	QTY	UNITS	BUDGET
Restrooms / Bathrooms								
Barrier	692	The mirror exceeds max. 40" high measured from the bottom of the reflecting surface OR mirrors not located above countertops exceed 35" high.	Citation	2010 ADA Stds. 603.3				
ITEM 23: RESTROOM - FIRST FLOOR	Provide a tall mirror mounted from 35" - 74" AFF.	Wall mounted mirrors are required to be 35" max. and 74" min. to the reflected surface (tall mirrors). Existing mirror / shelf unit is 52" AFF.	P	O	1	3	1 EA	\$710

- Upper Left: Existing shelf/mirror unit is mounted too high. Shelf to be 40" - 48" AFF. An additional tall mirror is required.
- Upper Right: Coat hook is mounted above the required 48" max. height.

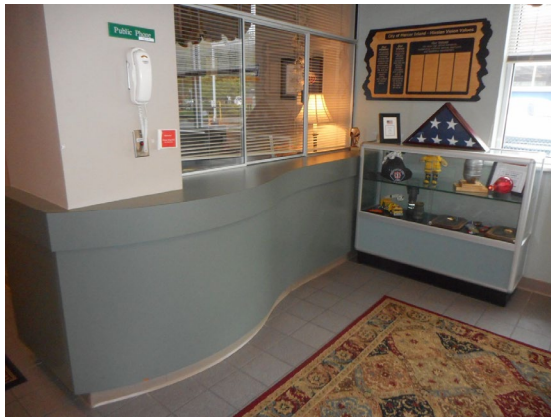
LOCATION	RECOMMENDATION	COMMENTS	TYPE	RESP CODE	PRI	QTY	UNITS	BUDGET
Built In Elements								
Barrier	481	The sales or service counter lacks a 36" long lowered portion of counter that is max. 36" high for a 48" parallel approach or is not 30" long min. with knee space for a forward approach or does not extend the same depth as the sales or service countertop.	Citation	2010 ADA Stds. 227.3, 904.4.2, 902.3				
ITEM 1: COUNTERTOP AT RECEPTION WINDOW	Recommend no change. The counter provided meets the 1991 Standard for sales and service counters.	Existing countertop is 36" AFF, and has clear floor space adjacent, but (due to the curved configuration) clear floor space is not parallel to the countertop. 1991 Standard does not address the parallel approach directly.	P	O	8	2	1	EA \$0

- Upper Left: Service counter accommodates clear floor space, but curved configuration prevents a parallel approach.
- Upper Right: Meeting room has a movable partition divider, separating it into 2 rooms. Each of these rooms has a wet bar with a sink at 36" AFF. Sinks are required to be 34" max. AFF.
- Lower Left: See above.

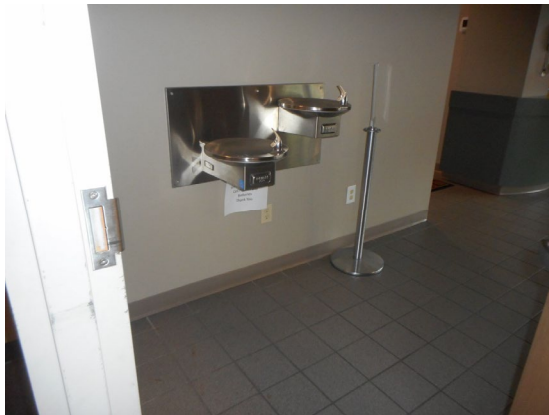
Upper Left: The high level drinking fountain protrudes into the path of travel, with the bottom surface at 34-1/2" AFF.

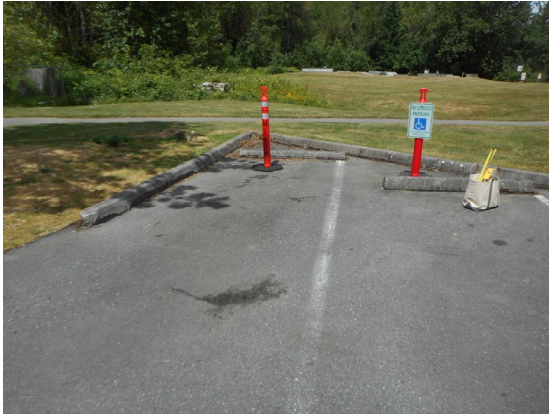
Upper Left: Accessible parking sign is required to be 60" min. above paving to bottom of sign.

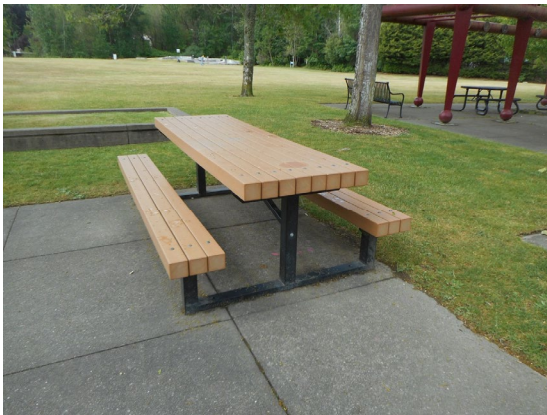
Upper Left: Picnic table does not provide an accessible seat with knee & toe space.

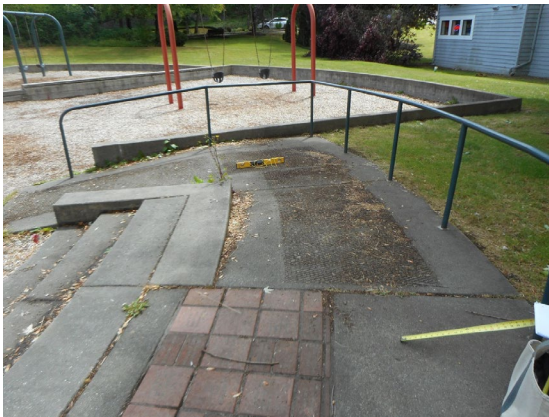
Mercerdale Park

Upper Left: Ramp and top landing have excessive slopes and lacks compliant handrails on both sides.

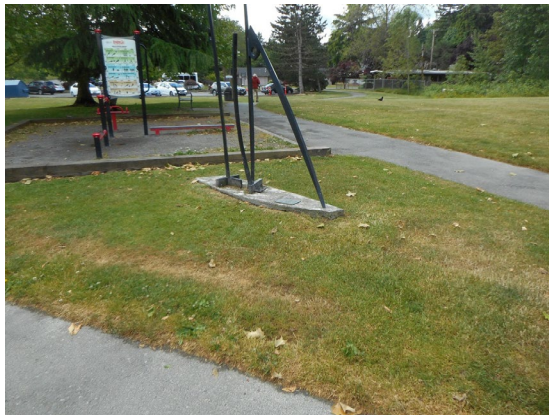
Mercerdale Park

Upper Left: Sculpture lacks a clear floor space and accessible route to the information plaque.

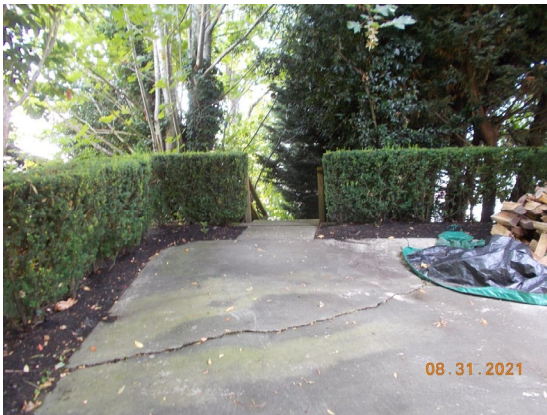
Miller Landing

Upper Left: This landing is not accessible, as change in level is substantial and property is narrow. Provide signage indicating that landing is not accessible.

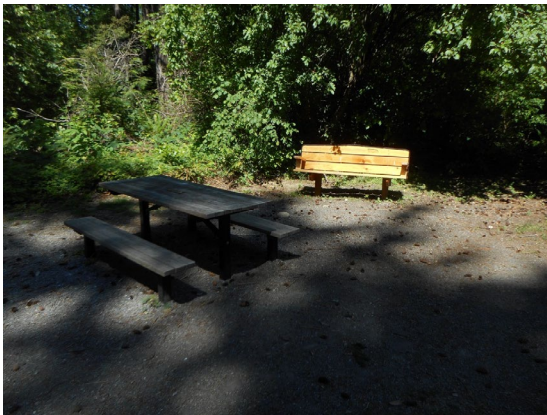
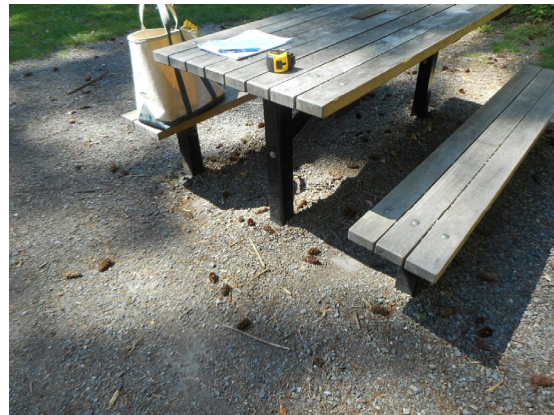
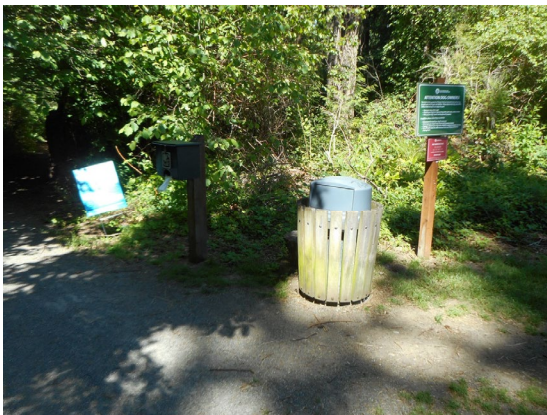
Pioneer Park

- Upper Left: Accessible routes are required to accessible picnic tables and benches.
- Upper Right: Picnic tables do not provide an accessible seat and clear floor space.
- Lower Left: Clear floor space and accessible route is required at min. 5% of dog waste and trash receptacles.

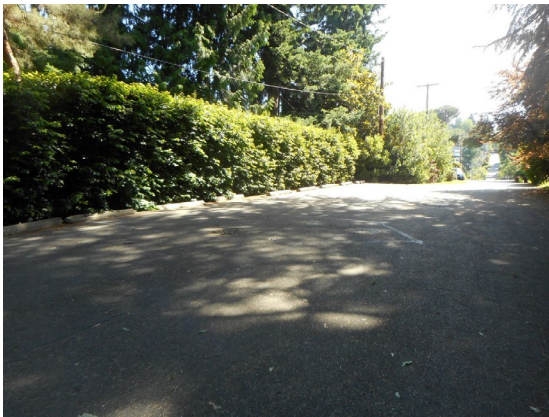
Proctor Landing

Upper Left: 12 parking spaces; no accessible parking is provided.

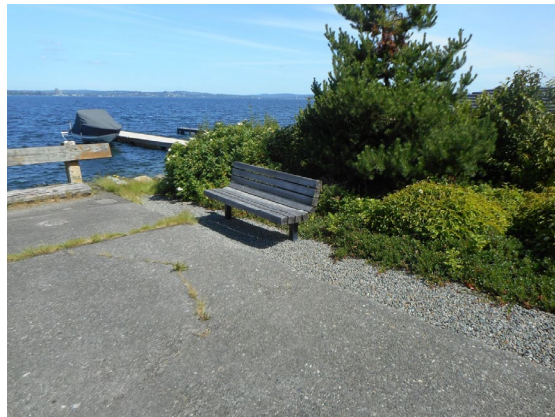
Roanoke Landing

- Upper Left: Roanoke Landing. I
- Upper Right: The bench requires an adjacent clear floor space (concrete pad) at one end. Loose gravel is adjacent to each side of the bench.

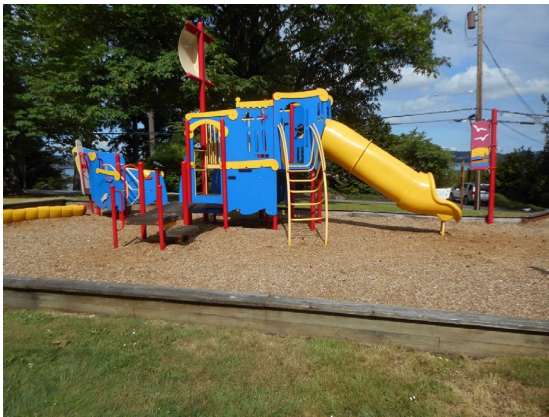
Roanoke Park

Upper Left: Play area requires compliant ground surfaces, which must be periodically inspected and maintained

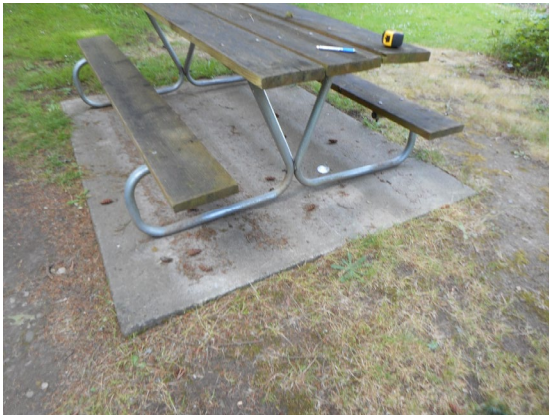
Lower Left: Picnic table does not provide an accessible seat and clear floor space.

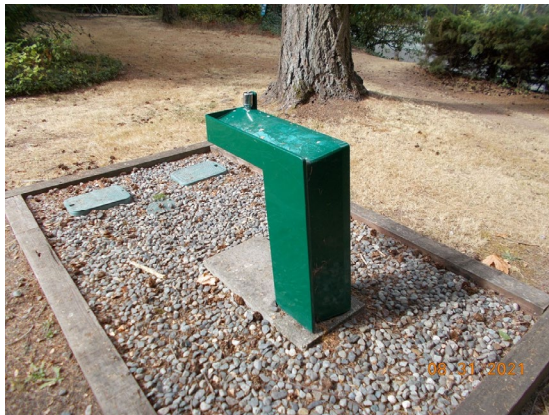
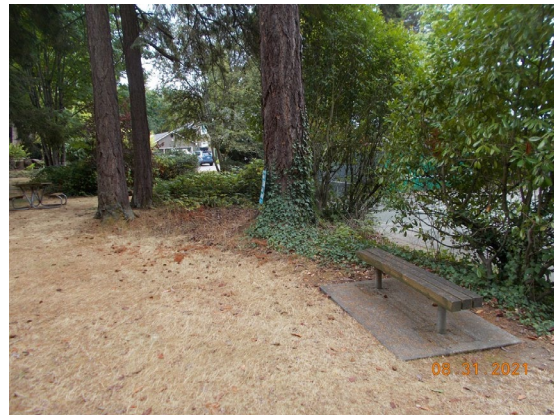
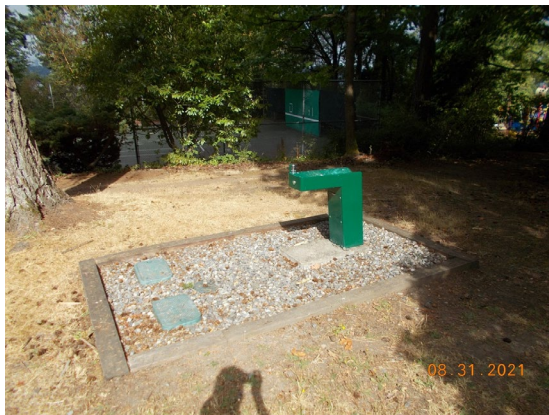
Roanoke Park

- Upper Left: Low level only fountain is provided. Drinking fountain requires a hi-low model for both wheelchair users and standing persons.
- Upper Right: Clear floor space and accessible route is required to bench and picnic tables.
- Lower Left: Clear floor space and accessible route is required to drinking fountain.

ITEM 6: EAST OF TENNIS COURT	Replace the fountain with a hi-low model.	Where provided, min. 2 water fountains are required. 1 is required to meet 602.1 - 602.6 for clear floor space, height, operable parts, and water flow, and 1 is required to meet 602.7 which is height for standing persons. If a water fountain is provided that meets both requirements, it may be substituted for 2 fountains. Spout outlets shall be 36" max. AFF or ground. Drinking fountains for standing persons: Spout outlets of drinking fountains for standing persons shall be 38" min. and 43" max. AFF. Existing condition: Only low level drinking fountain is provided.	P	O	1	4	1	EA	\$4,400
-------------------------------------	---	--	---	---	---	---	---	----	---------

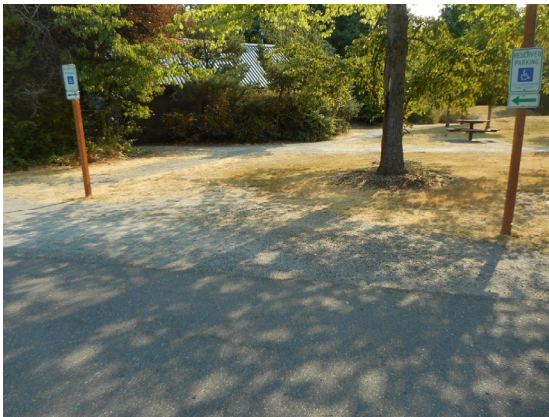
Rotary Park

Upper Left: Accessible parking space is not paved, and has no access aisle.

ITEM 1: ACCESSIBLE PARKING	Assuming new paving for accessible space and access aisle (not included in this report), relocate one sign and add new van sign panel to existing sign.	Existing condition: roadside gravel shoulder has space designated for accessible parking between 2 existing signs. This area is not paved, has a 2" level change at edge of asphalt road, and no access aisle. Signs shall be 60" min. AFF or ground surface, measured to bottom of the sign. Note: Where a total of four or fewer parking spaces, including accessible parking are provided on site, signs not required.	P	O	1	1	1	EA	\$92
-----------------------------------	---	--	---	---	---	---	---	----	------

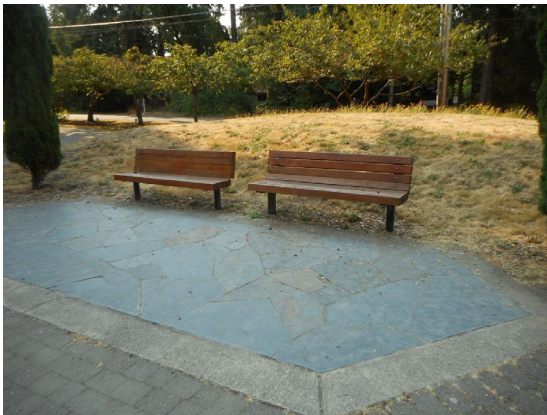
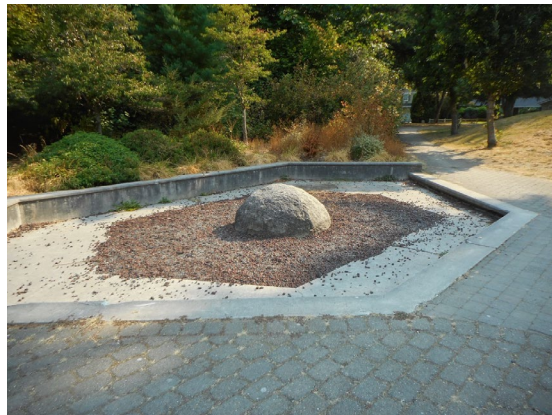
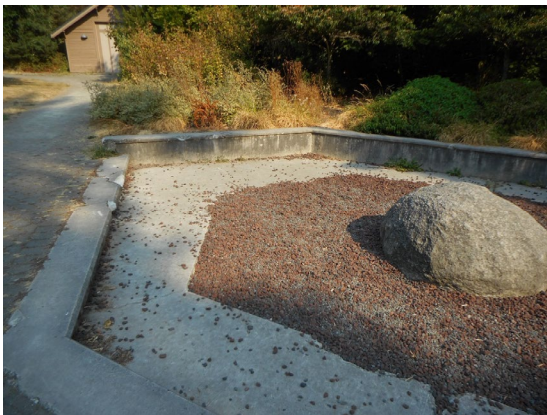
Rotary Park

- Upper Left: Benches do not have a paved clear floor space on one end.
- Upper Right: Play area has a step, and requires an accessible ramp.
- Lower Left: Play area has lava rock for a ground surface. Ground surface must be one that complies with ASTM F 1951.

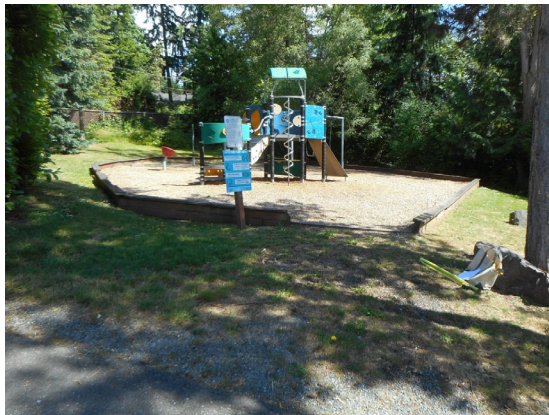
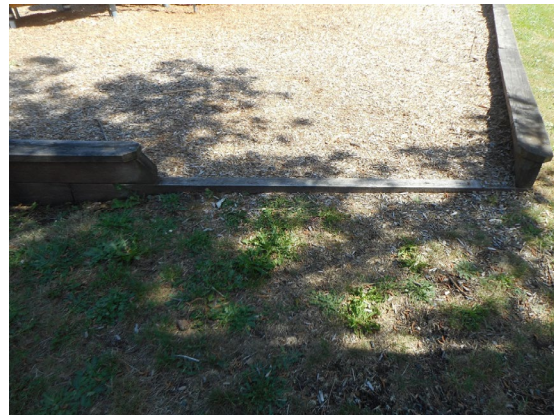
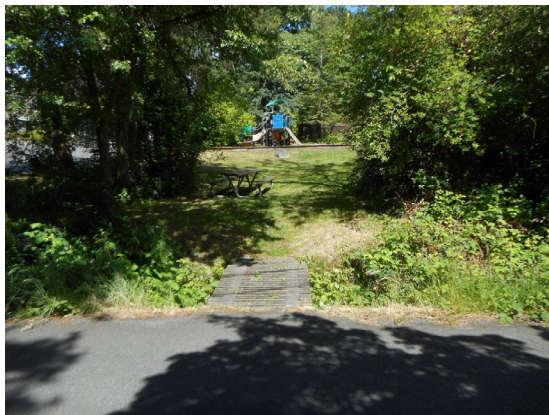
Secret Park

- Upper Left: Play area requires compliant ground surfaces, which must be periodically inspected and maintained.
- Upper Right: Play area requires an accessible route and a ramp down to play area.
- Lower Left: Picnic table does not provide an accessible seat and clear floor space. An accessible route is required to trash can, picnic table, and play area.

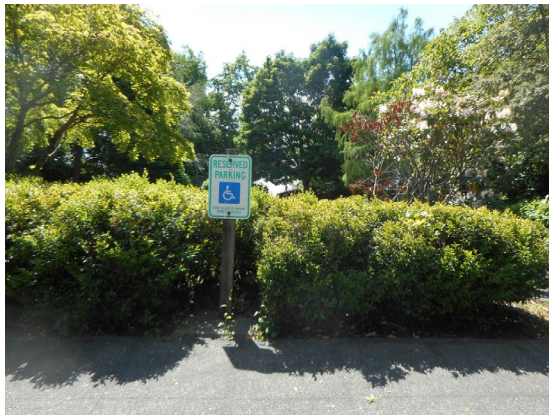
Slater Park

Upper Left: Accessible parking sign is too low and should be raised to 60" min. AFF.

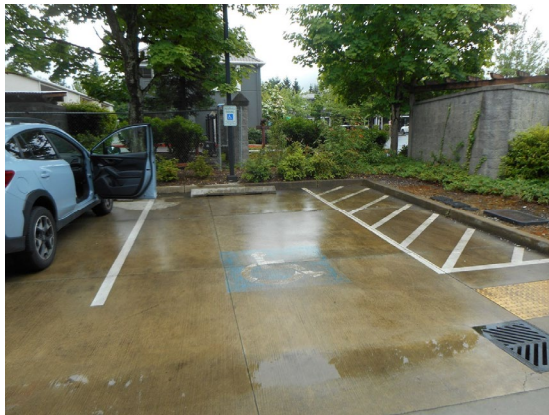
South Fire Station #92

Upper Left: Accessible parking sign is mounted too low.

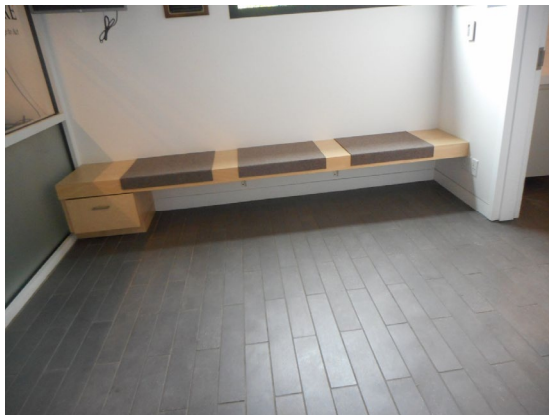
Lower Left: Bench does not have an accessible clear floor space at one end.

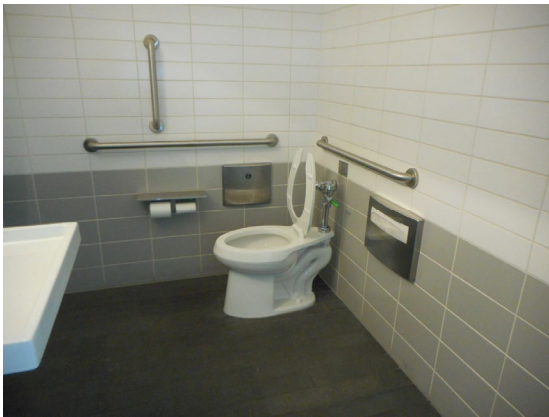
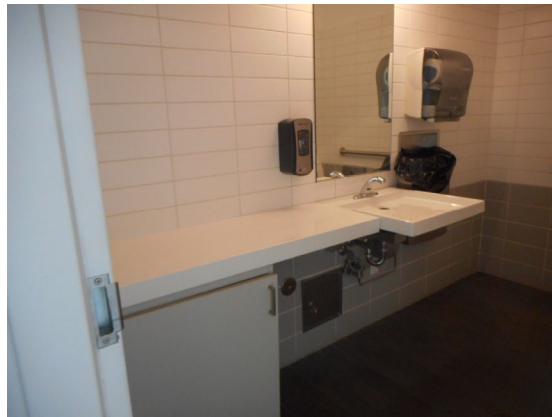
South Fire Station #92

- Upper Left: Toilet is installed at a skewed angle, and located too far from side wall. Grab bars are mounted too high.
- Upper Right: Lavatory encroaches on toilet clearance and door maneuvering space. Also, lavatory rim is too high.

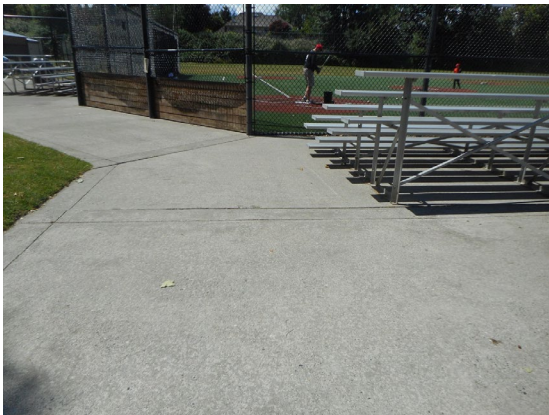
Upper Left: Bleachers require wheelchair seating (with signage).

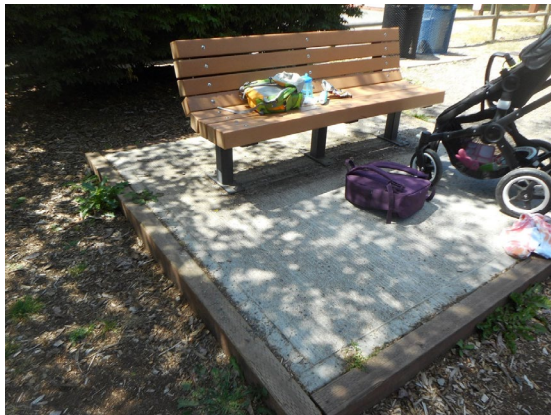
Upper Left: 30"x48" clear floor space is required on one side of bench, and an accessible route to bench is required.

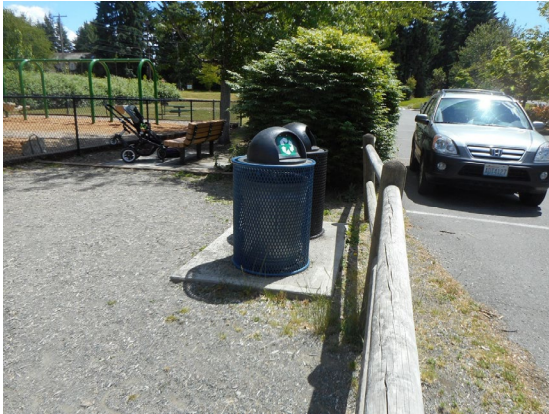
Upper Left: Accessible route and clear floor space is required at trash receptacles.

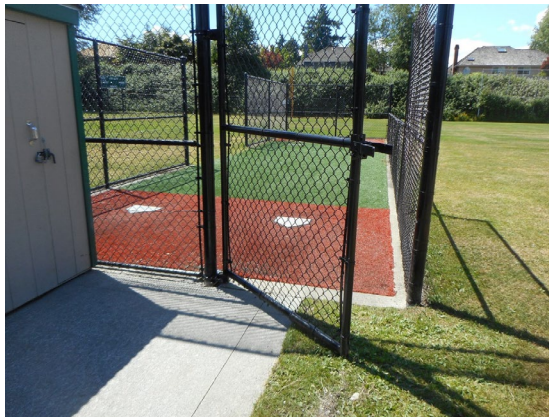
Upper Left: Accessible route and door maneuvering space is required at practice area.

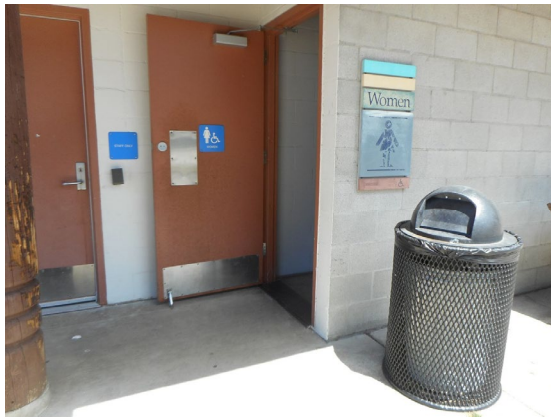
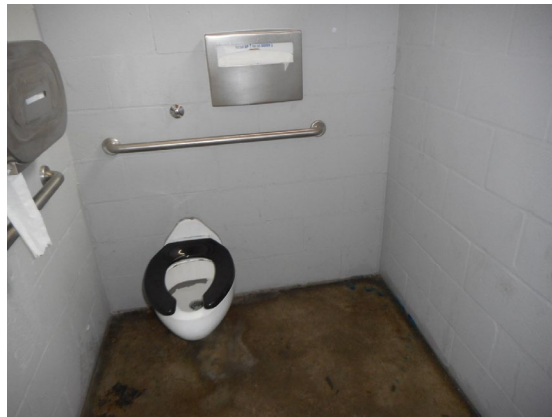
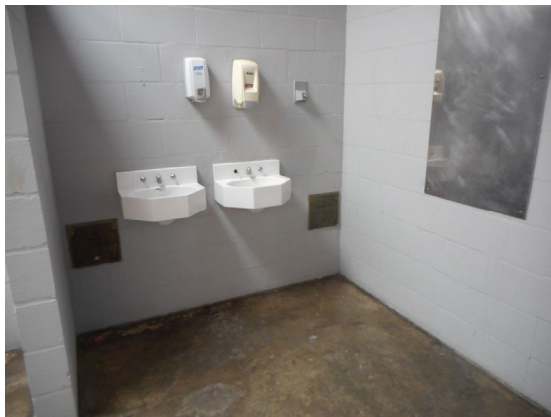
- Upper Left: Restroom signage should be compliant.
- Upper Right: Accessible stall size is non-compliant. Dispensers require relocation.
- Lower Left: Soap dispenser and hand drying operation button are mounted too high.

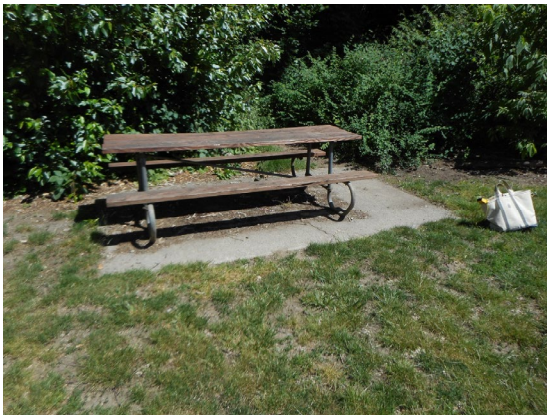
Upper Left: Picnic table does not provide an accessible seat and clear floor space.

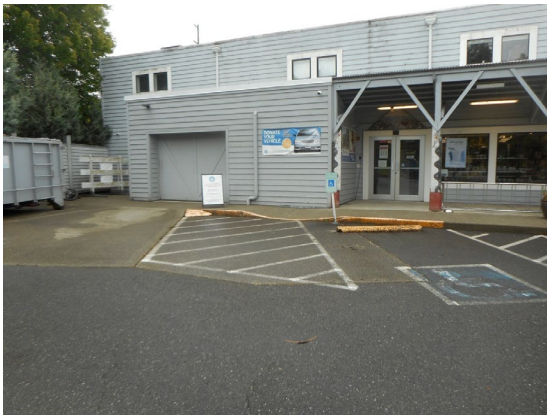
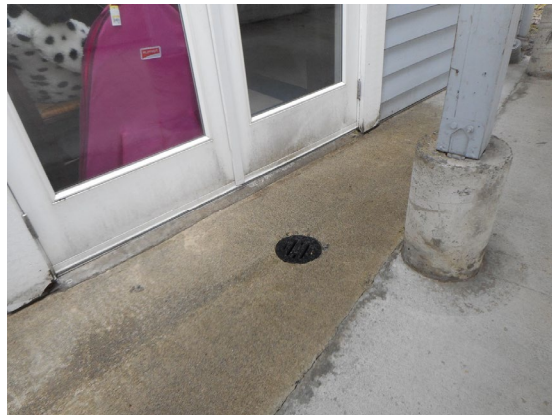
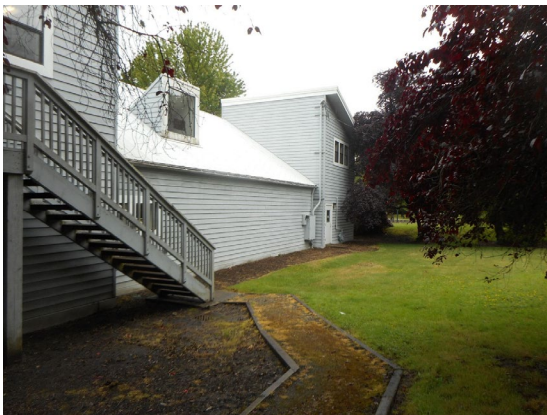
- Upper Left: Accessible parking sign is mounted too low. Bottom edge of sign to be 60" min. above pavement.
- Upper Right: Exit door has a column blocking the required door clearance and maneuvering space.
- Lower Left: Exit door from first floor lacks a paved clear floor space on exterior side.

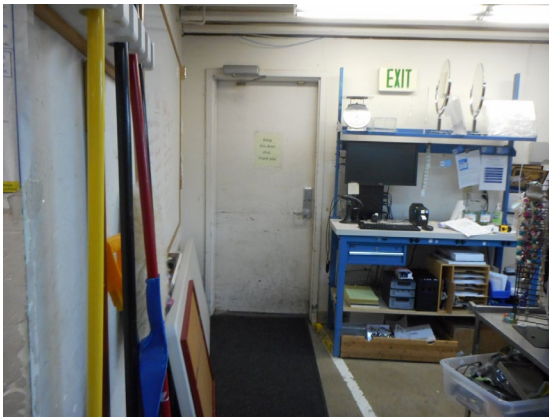
Upper Left: Countertop blocks the 12" min. required maneuvering space on the latch/push side.

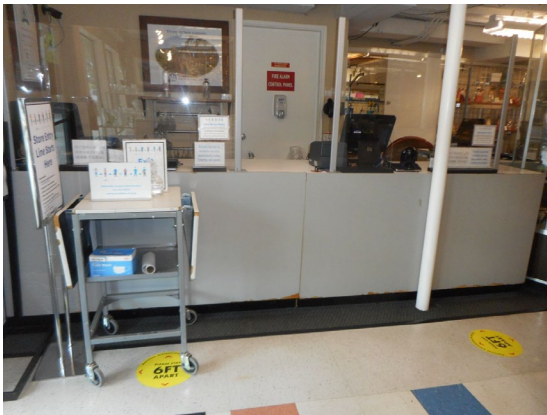
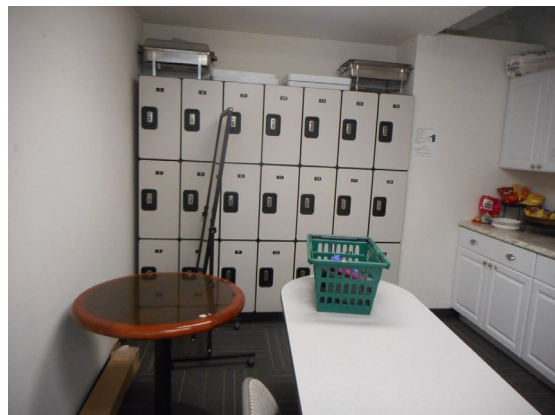
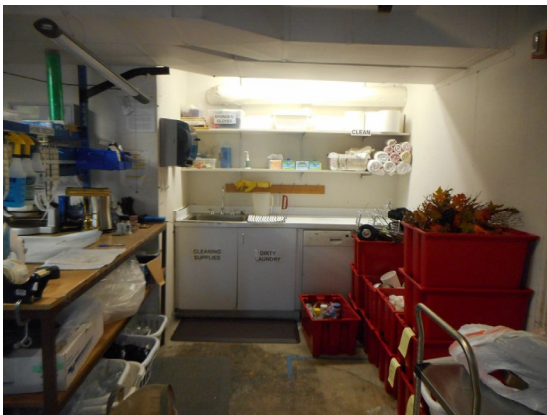
- Upper Left: Check-out counter lacks a 36" high max. x 36" min. in length accessible counterspace.
- Upper Right: Lockers do not provide the min. 5% required to be accessible, due to height of hooks & bottom shelf.
- Lower Left: Sink is 36" AFF (should be 34" max.) and lacks knee clearance for a forward approach. Above countertop outlets are out of accessible reach. Paper towel dispenser is mounted too high.

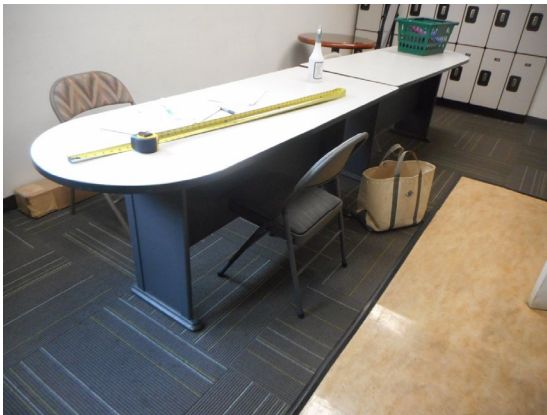
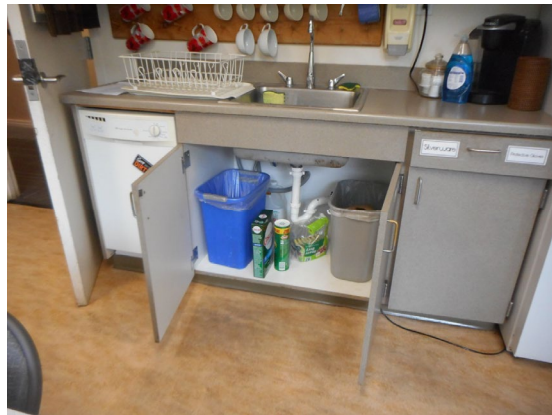
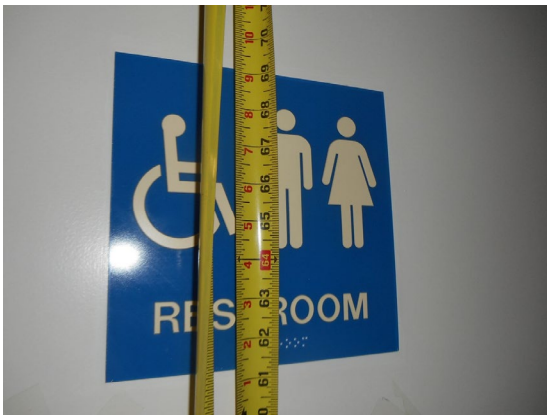
- Upper Left: Dining table does not provide the required knee clearance space.
- Upper Right: Countertop and sink are too high. Must be 34" AFF max. for sink height and for accessible reach to above countertop mounted outlets. Also, kitchen lacks 50% of storage at accessible height.
- Lower Left: Second level accessible restroom signage is mounted too high.

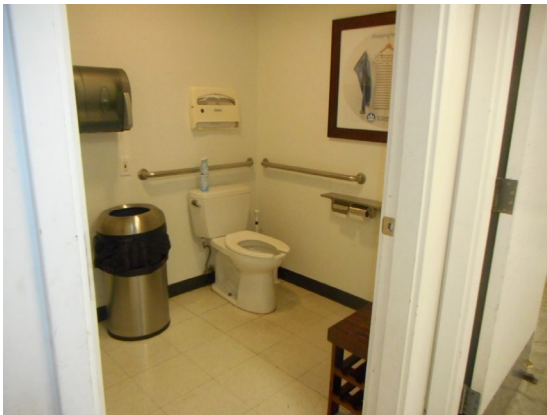
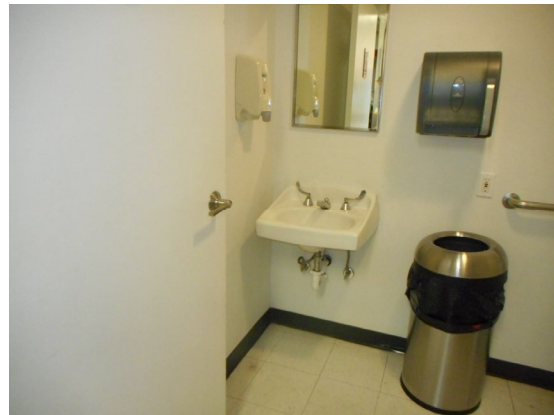
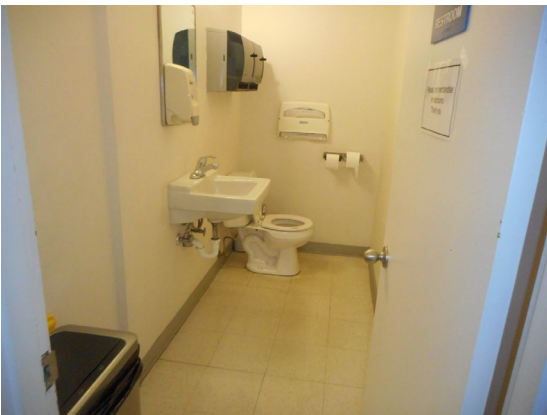
- Upper Left: Ground floor restroom grab bars are too short and incorrectly located. Seat cover dispenser is not accessible above the toilet.
- Upper Right: Ground floor restroom lavatory does not provide the required knee space clearance. Pipes require insulation. Mirror and towel dispenser are too high.
- Lower Left: 2nd floor restroom adjacent the kitchen is inaccessible. Provide directional signage to accessible restroom.

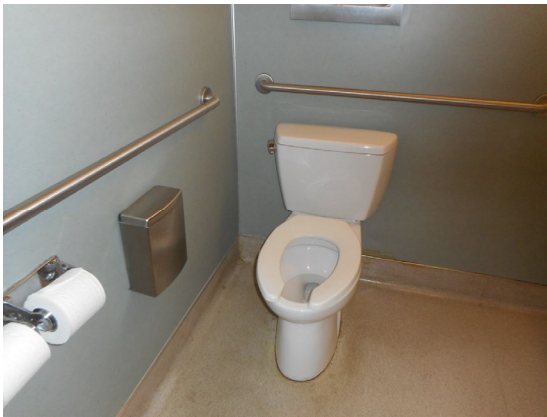
Upper Left: Second floor accessible restroom: grab bars are mounted too high, flush control is required on the open side, seat cover dispenser is not accessible above the toilet.
