AGENDA
Historic Preservation Commission Meeting
Tuesday, June 18, 2024
Town Hall / Council Chambers - 302 Pine St Minturn, CO

- A.** Ordinance 16 - Series 2024 An Ordinance Amending the Town's Historic Register to Add 478 Eagle River Street - Harris

Review the landmark designation nomination of 478 Eagle River Street based on the criteria outlined in the Minturn Municipal Code Sec. 19-3-20, citing findings of fact, and forwarding a recommendation of approval, approval with conditions, or denial to the Minturn Town Council.

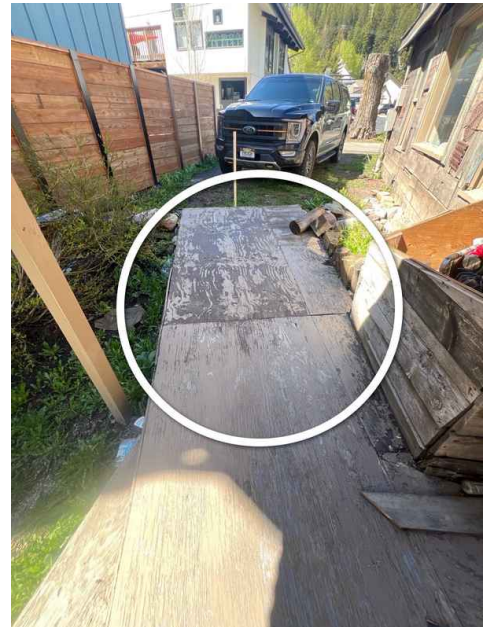
The deck(s) surfaces were weathered and in need of general maintenance. We suggest refinishing to restore UV and moisture protection as well as to restore aesthetics

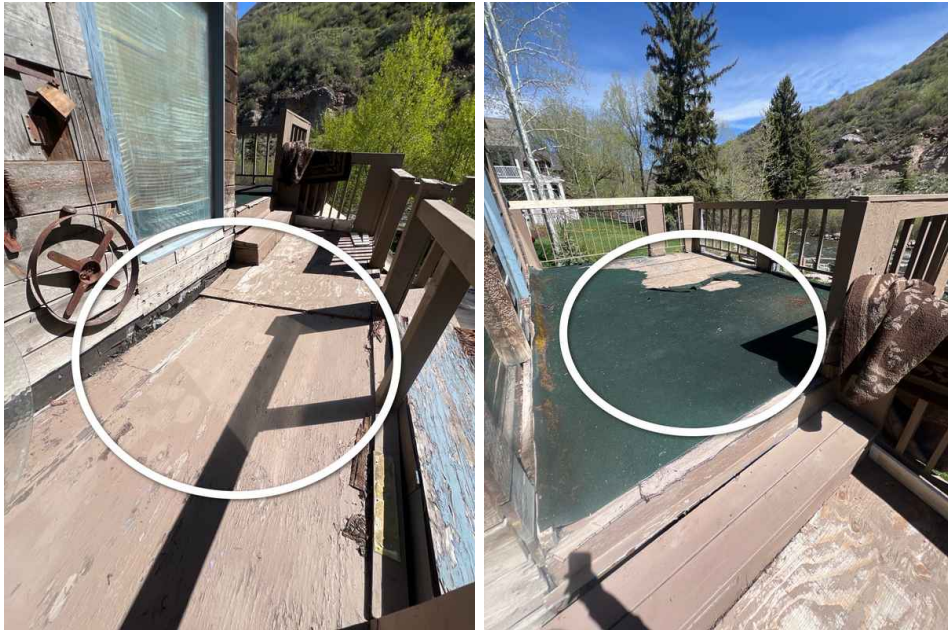
6.6.2 Deck surface

OUT OF LEVEL

The deck surface was not level from apparent structural settlement. We suggest a further review with repair or replacement as needed.

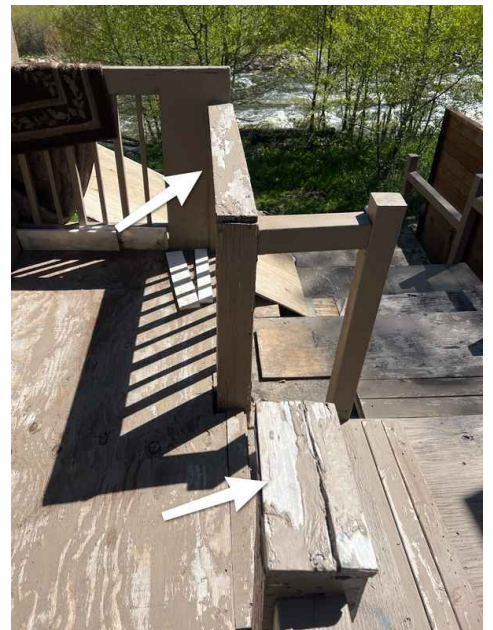
6.7.1 Guard rails

DETERIORATED FINISH

The guard rail exhibited deteriorated finish and needs maintenance and refinishing.

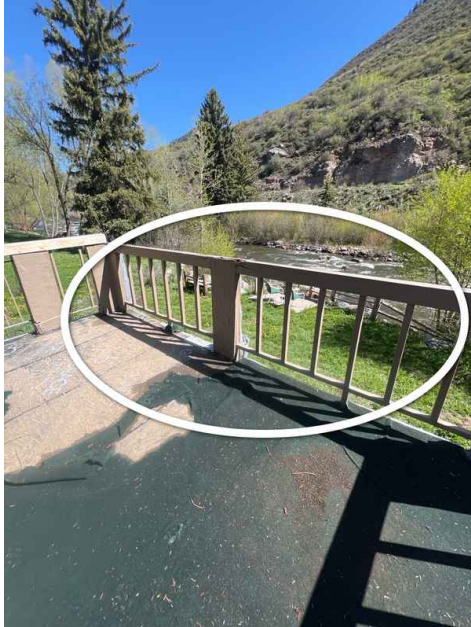
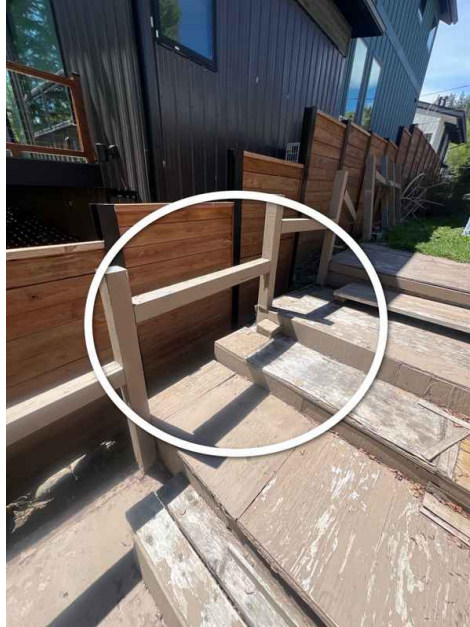
6.7.2 Guard rails

BALUSTER SPACING GREATER THAN 4"

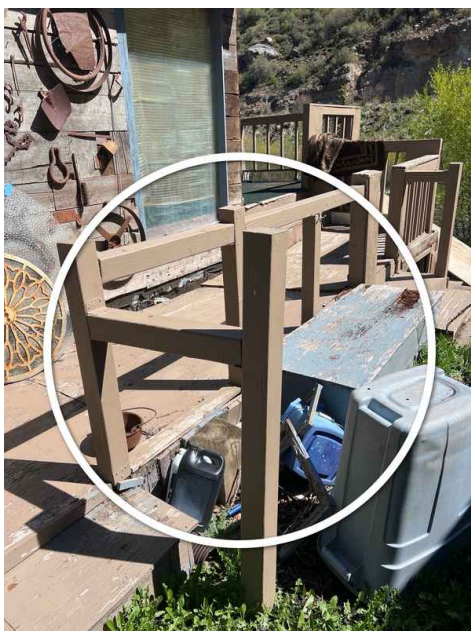
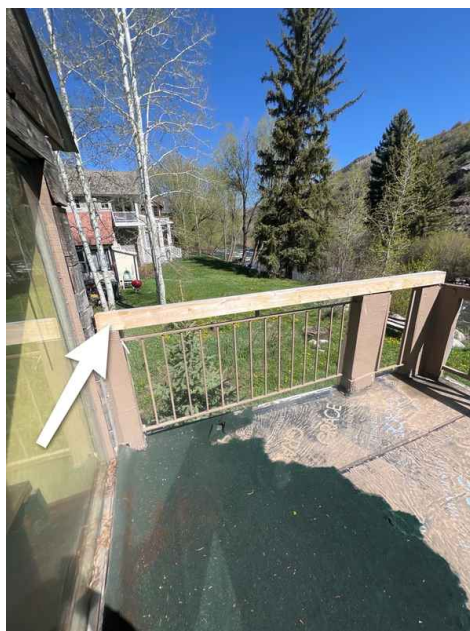
6.7.3 Guard rails

LOOSE GUARD RAIL

The deck guardrail assemblies were loose and should be secured to prevent possible safety concerns.

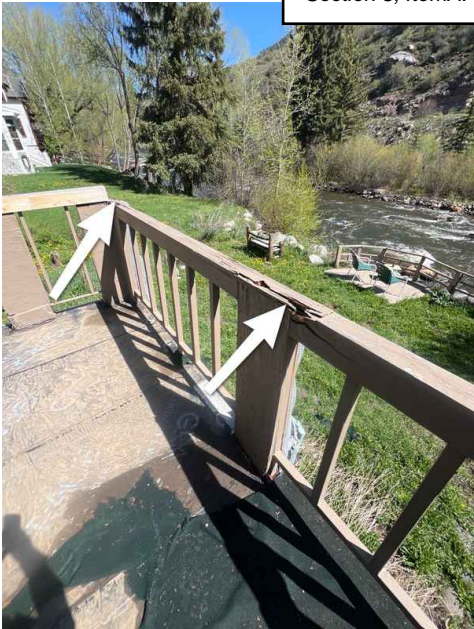
6.7.4 Guard rails
DETERIORATED

The deck guardrail assemblies exhibited deterioration. Photographs are examples only. We suggest a review of the complete rail system by a qualified contractor and repairs made as needed.

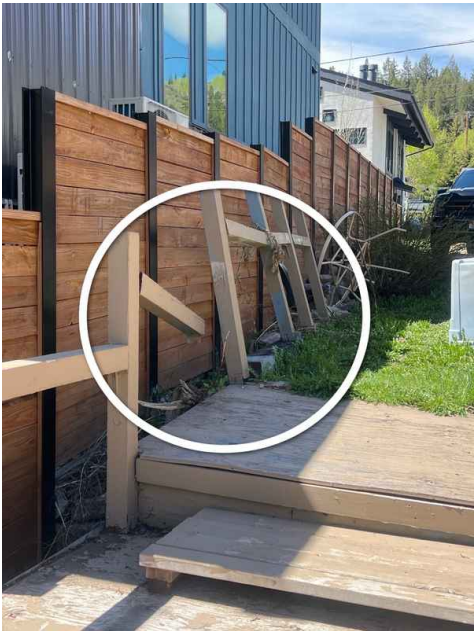
6.7.5 Guard rails
DAMAGED RAILINGS

Damaged railings were noted. We suggest repair for safe deck usage.

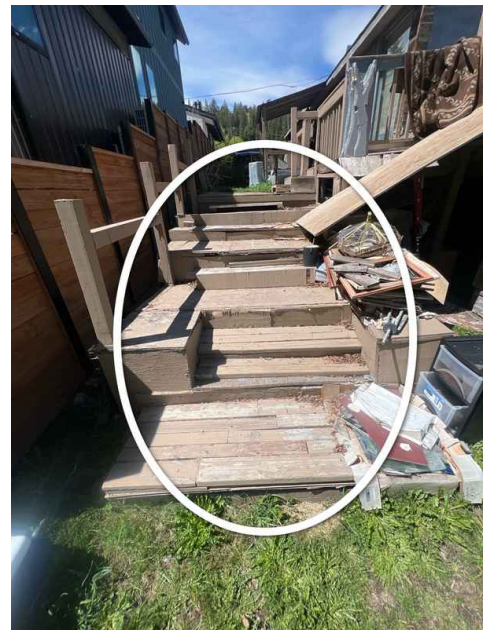
DAMAGED OR DETERIORATED**SEVERAL**

The steps were generally deteriorated and/or structurally damaged, making them potentially hazardous to a person who might use them. We recommend further review for a better understanding of replacement costs/repairs and present condition.

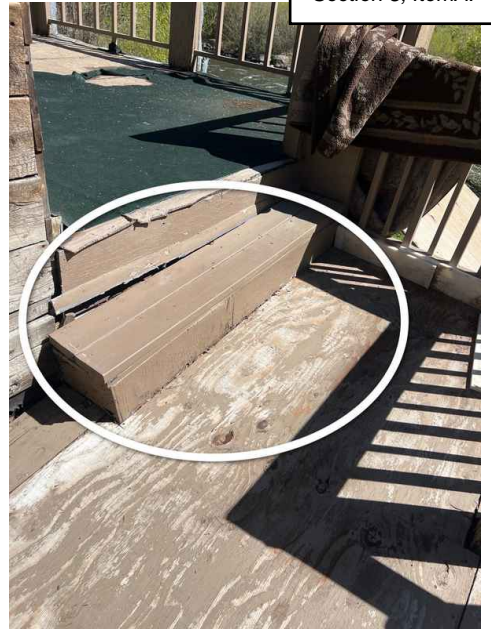
6.8.3 Deck steps

OUT OF LEVEL

The stairs are out of level from an apparent structural settlement. We suggest repair or replacement as needed for safe usage.

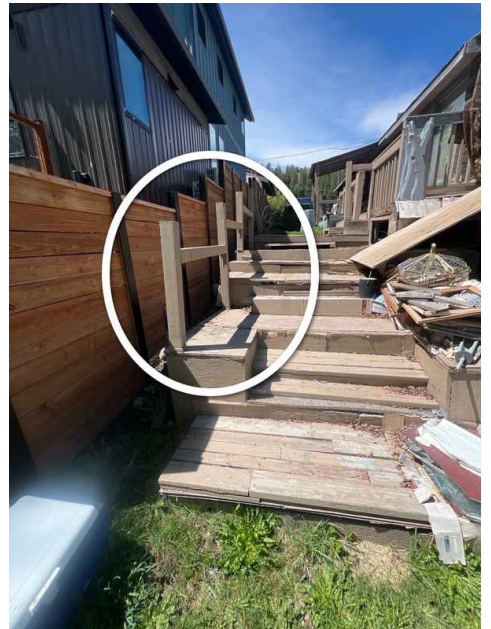
6.9.1 Handrails

NO HANDRAIL

The handrail is missing. While the home may have complied with the building code when it was built, upgrading for safety should be considered.

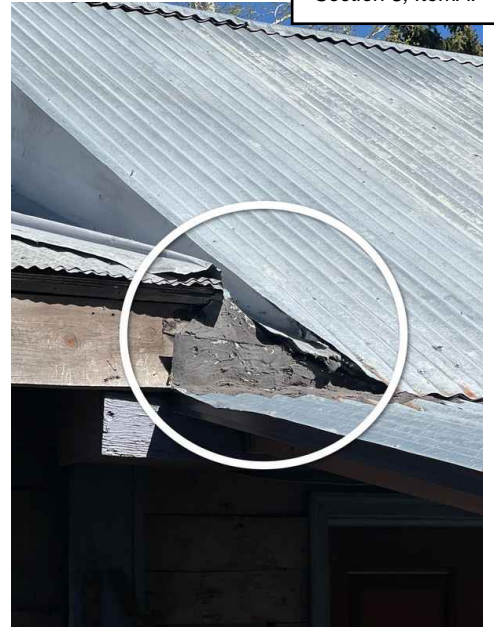
7.7.1 Flashings

POOR DETAIL

A poor flashing detail was noted with heavy use of sealant. We suggest further review with repairs made as deemed necessary to prevent moisture damage.

Contact a qualified professional.

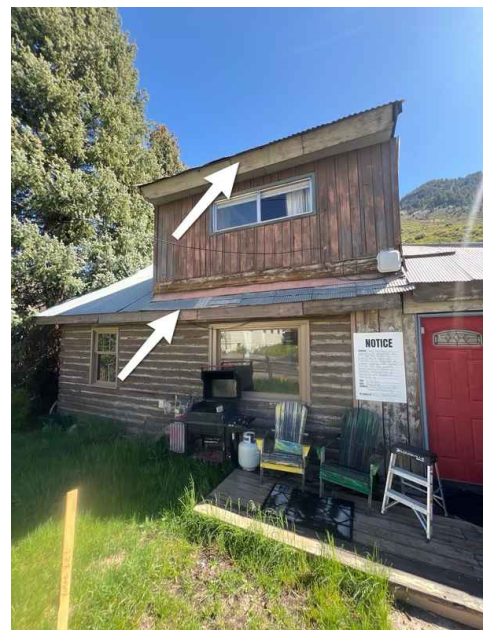
IMPROVE- ADD GUTTERS

There are no gutters present on the structure or on certain areas of the structure. Gutters are recommended because they collect rainwater from the roof and direct it away from the building.

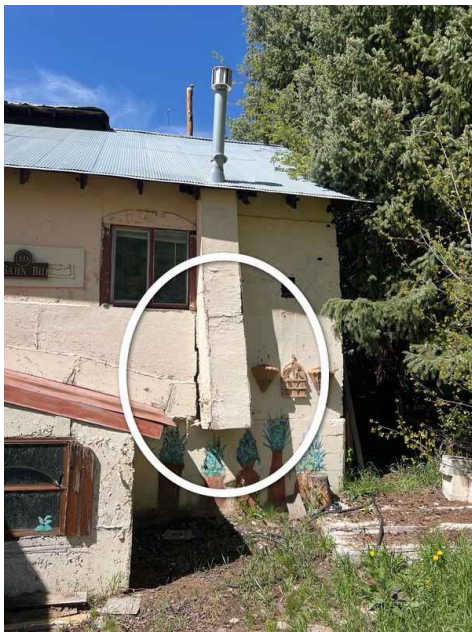
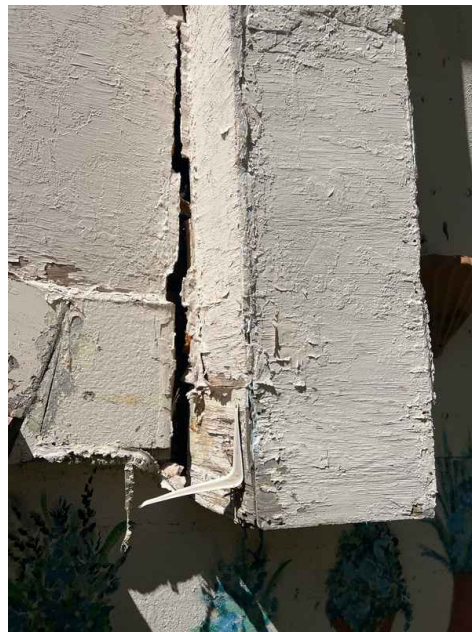
8.3.1 Finish conditions

DETERIORATED/DAMAGED

The exterior chimney has deteriorated and is badly damaged. Repair or replacement is required to keep functioning as designed as well as to prevent fire danger

Contact a qualified painting contractor.

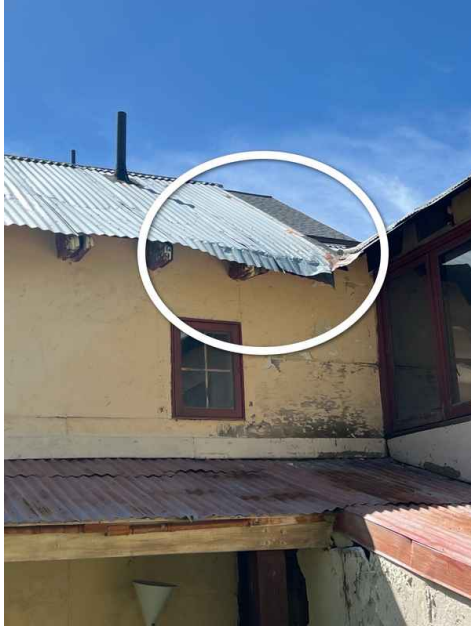
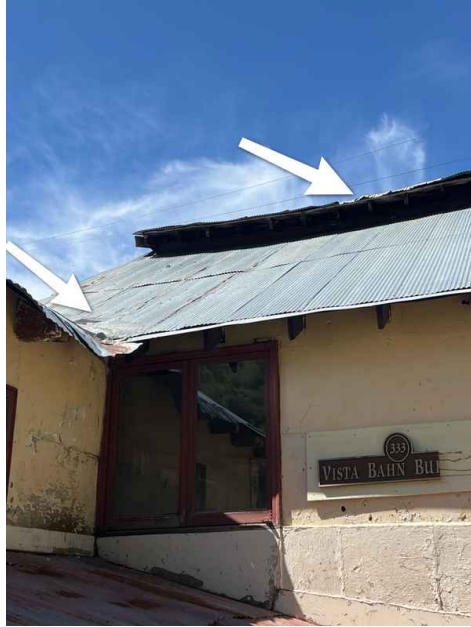
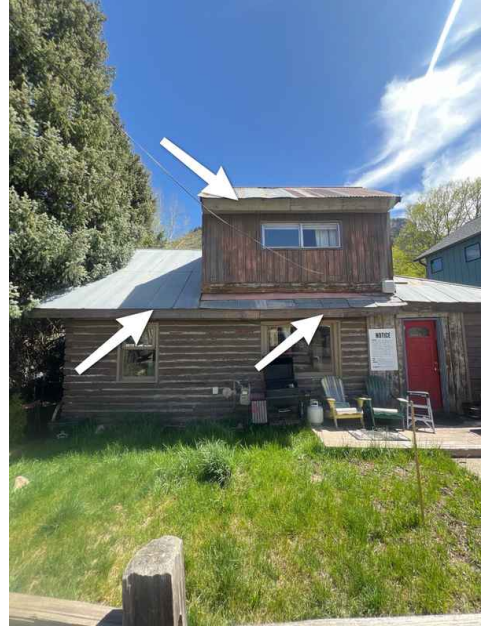
9.4.1 Metal roofing material condition

DAMAGED ROOF PANELS

The metal panels are damaged. This damage should be repaired to avoid the possibility of damage to the home structure or materials from roof leakage. All corrections should be made by a qualified contractor.

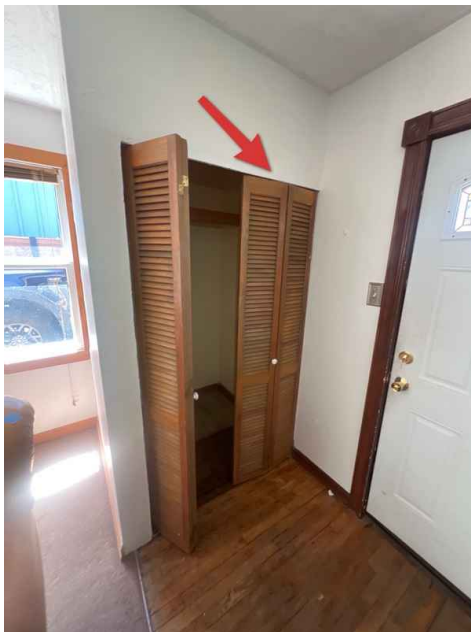
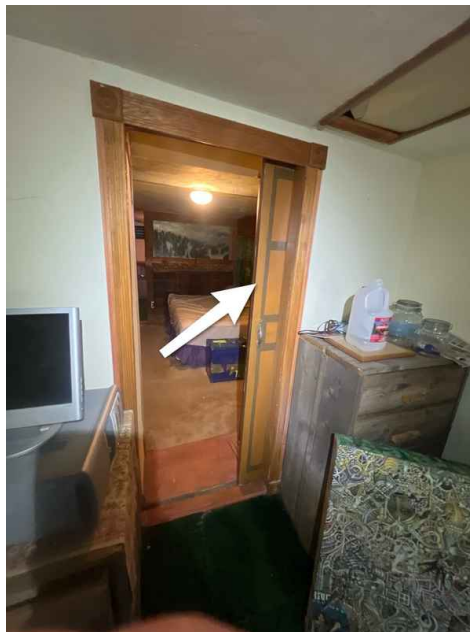
The door was off its track or had a restrictive movement. Hardware may be missing, damaged, or in need of adjustment at the track or door rollers. We recommend repair as required for the full operation of the door.

Contact a qualified handyman.

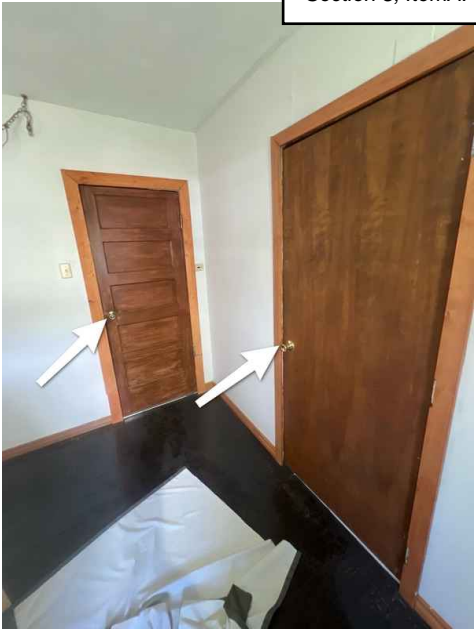
10.3.1 Door hardware
HARDWARE MISSING

The door(s) were observed to be missing hardware for the proper operation of the door(s). We recommend correction as necessary to return the door(s) to its original functional design.

Recommendation
Contact a handyman or DIY project

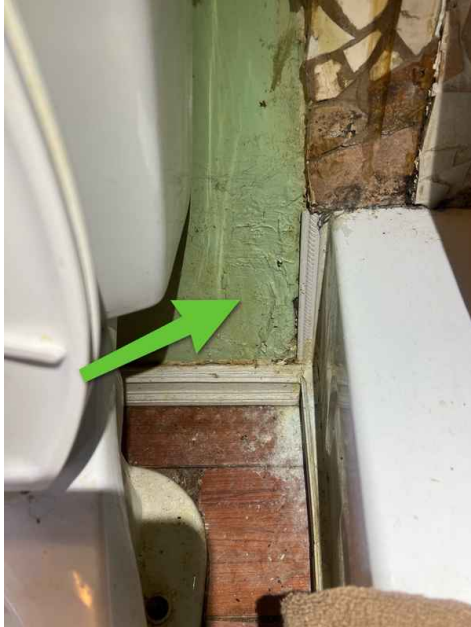
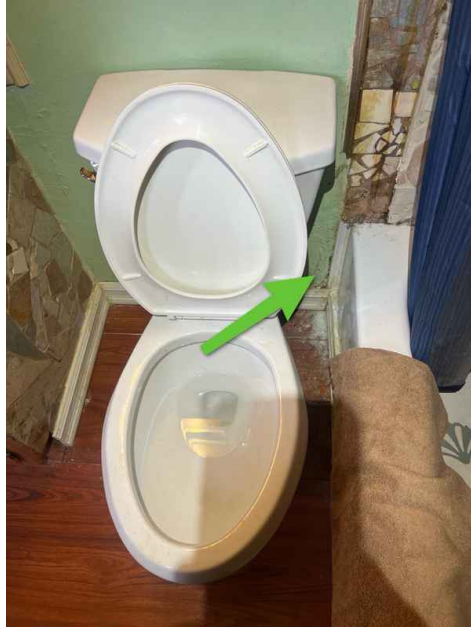
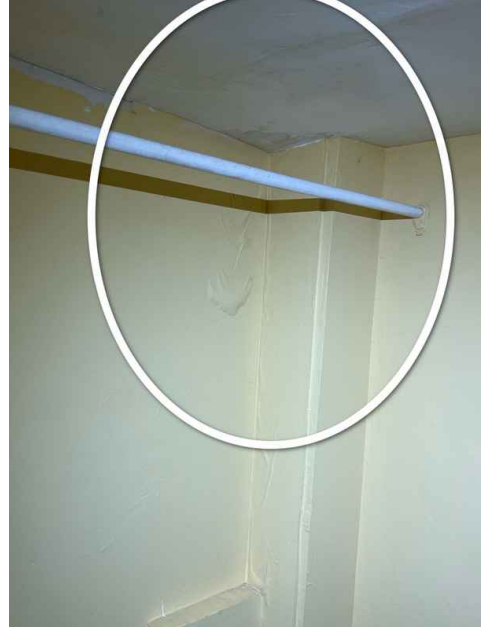
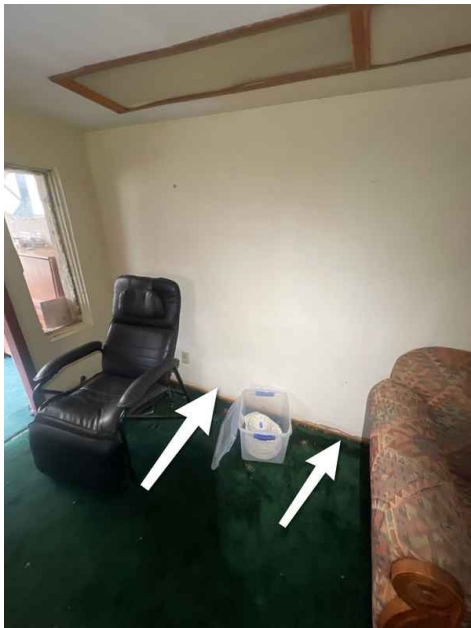
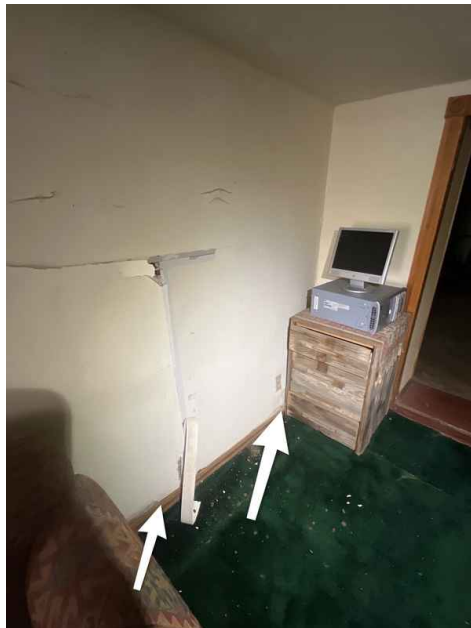
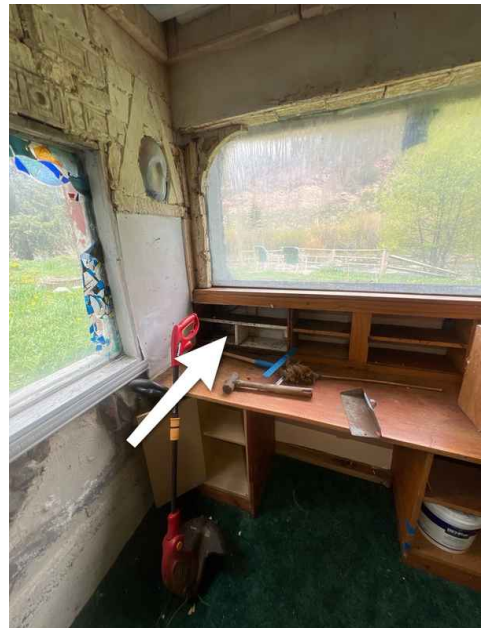
10.4.1 Walls

EVIDENCE OF MOISTURE - DRY

Stains or drip marks on the walls visible at the time of the inspection appeared to be the result of moisture intrusion. The source of moisture may have been corrected. We suggest asking the owners for more information about this condition. If no information is available, we recommend a further examination by a qualified contractor to better understand the situation.

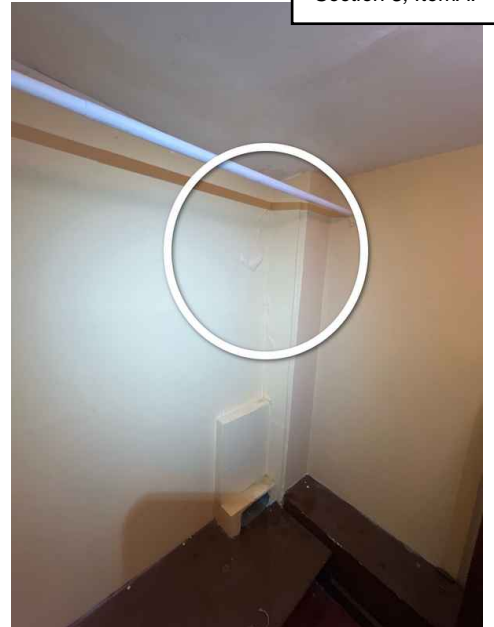
10.4.2 Walls

ACTIVE LEAK PRESENT

Active leaking was noted, and the wall was wet at the time of inspection. We suggest further investigation of the moisture source, correction with proper drying techniques to prevent microbial growth.

Contact a qualified professional.

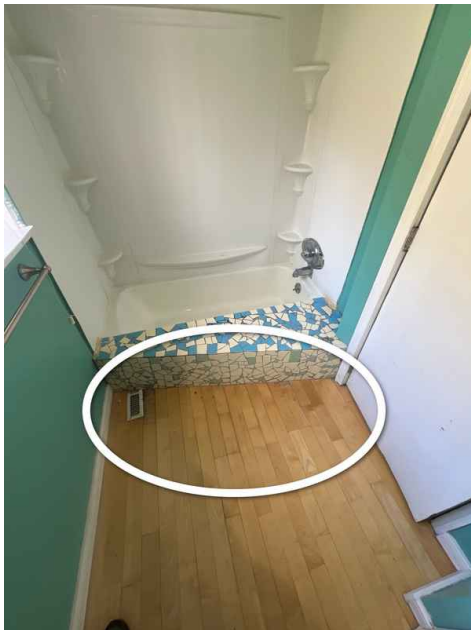
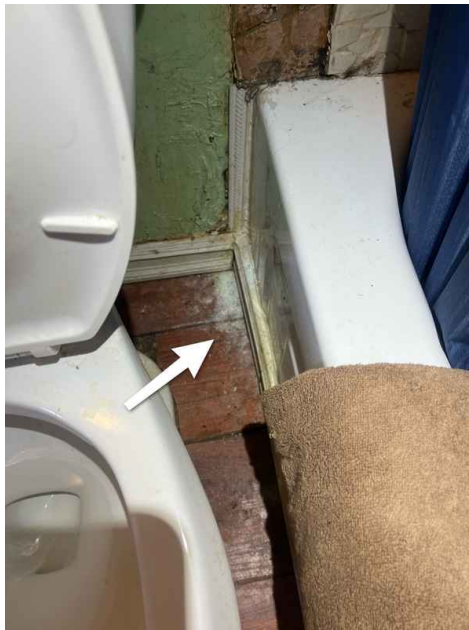
10.7.1 Floors

WATER DAMAGED WOOD FLOOR

Bowing and cupping was noted on the wood floor. This is possible evidence of a water intrusion event and we suggest asking the seller for more information. We recommend that all floor damage be repaired.

Contact a qualified flooring contractor

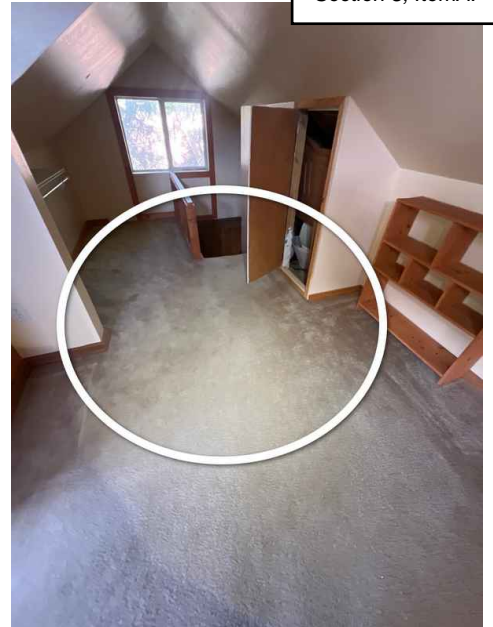
10.7.2 Floors

SQUEAKY OR LOOSE FLOOR

The floor was observed to be squeaky or loose. Squeaky or loose flooring may indicate non-visible structural or attachment issues. We recommend further review for a better understanding of replacement costs/repairs and present condition.

Contact your builder.

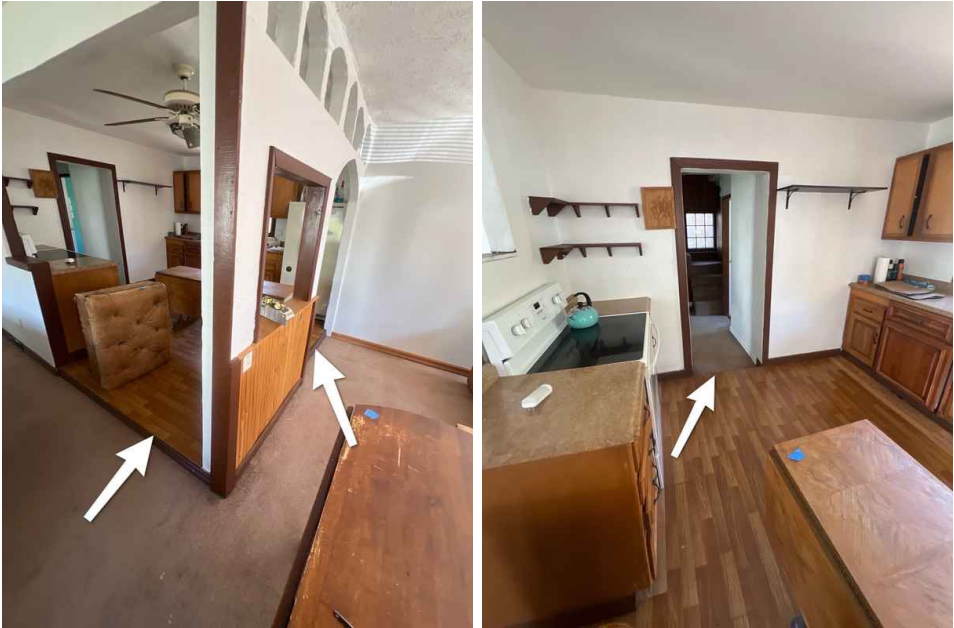
TRIP HAZARD

An elevation change of fewer than 4 inches was observed. This creates a trip hazard and should be corrected before personal injury results. We recommend that the lip be corrected as necessary.

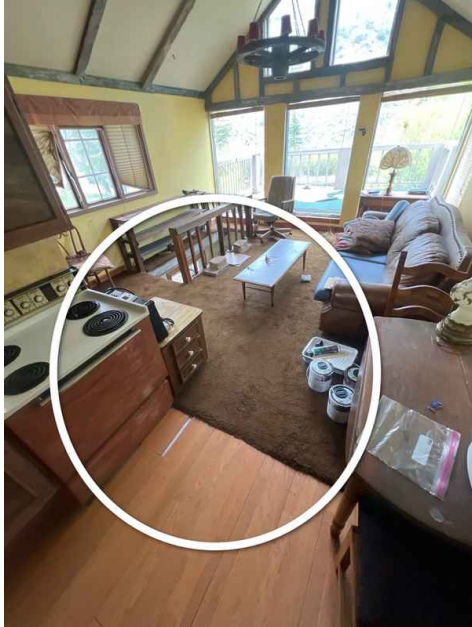
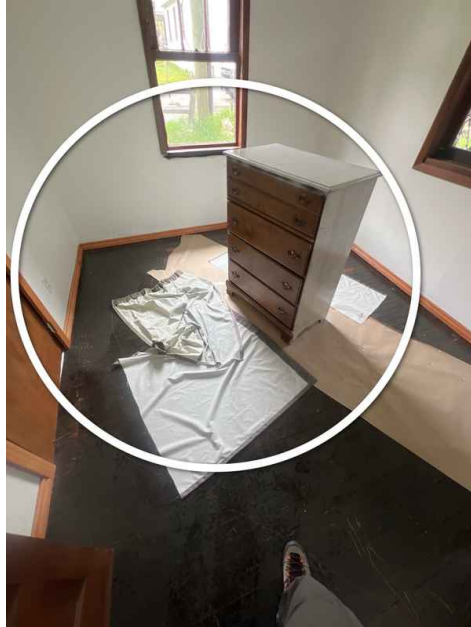
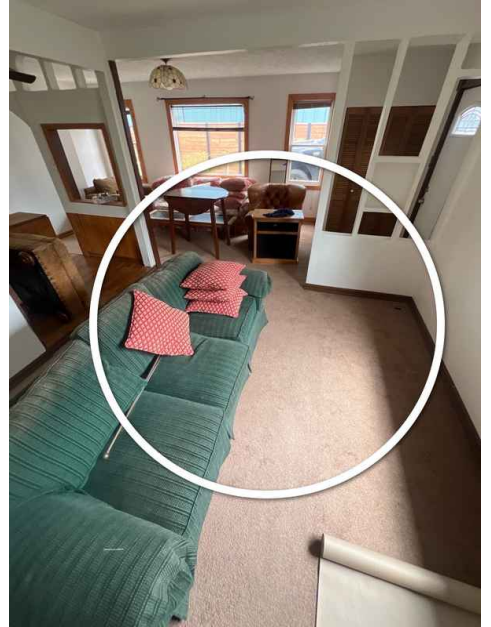
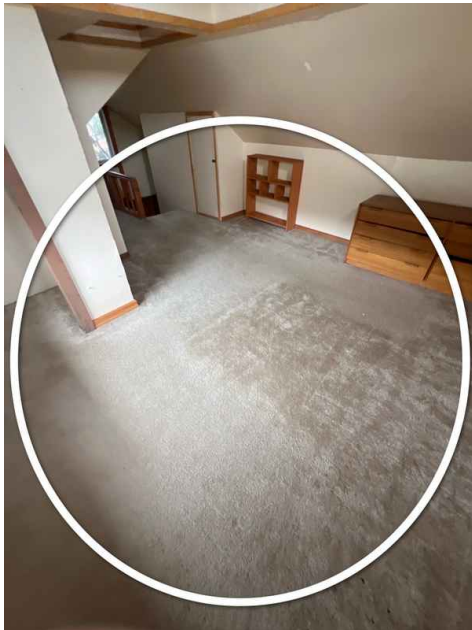
10.7.5 Floors

AREA(S) NOT LEVEL

Several areas of the floors in the home were not level with either low or high spots noted. This is most likely caused by settlement or old building practices and materials.

Contact a qualified professional.

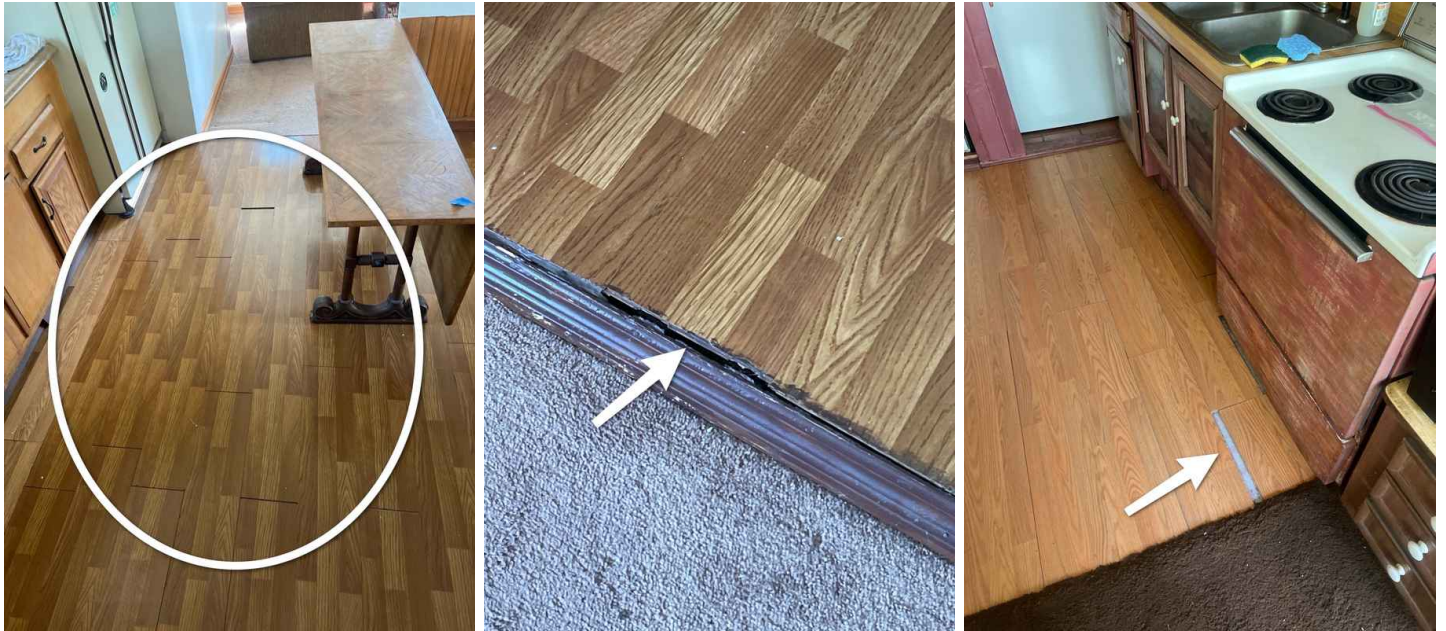
10.7.6 Floors

GAPS IN THE FLOOR

Several areas of flooring have wide gaps from poor installation. We suggest repairs.

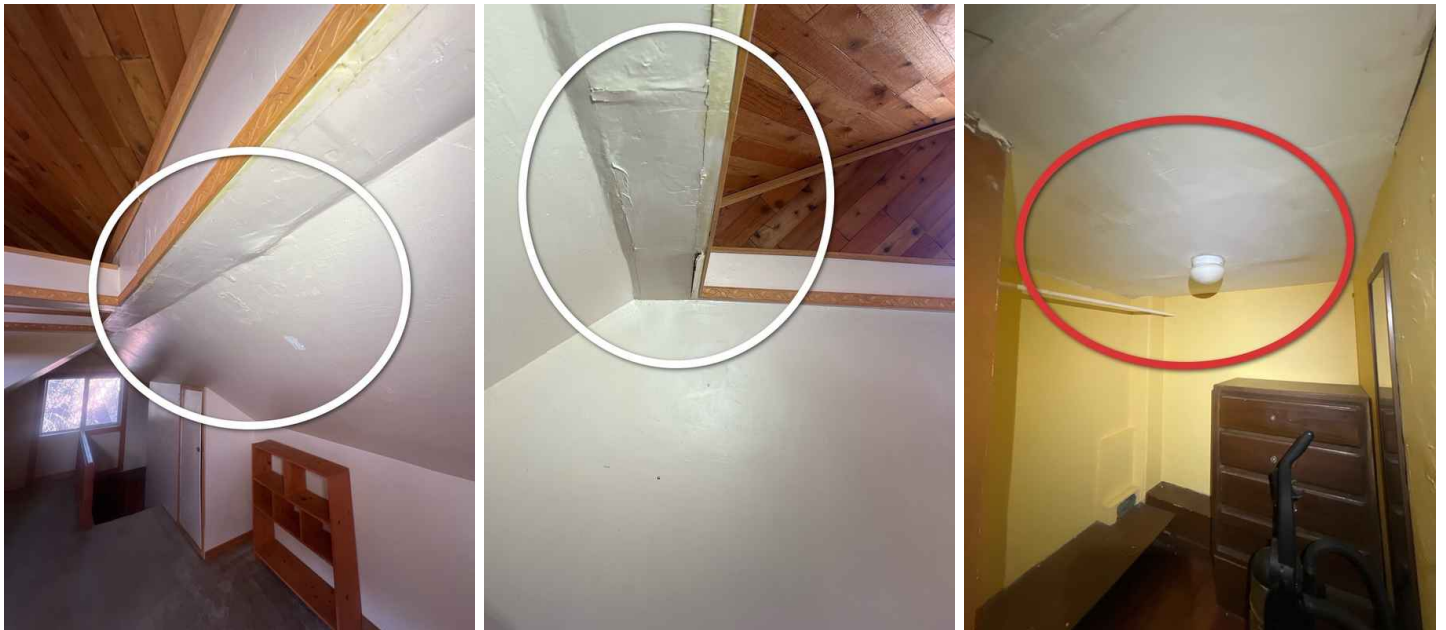
10.8.1 Ceilings

STAIN(S) ON CEILINGS/WALLS- DRY

Water stains were observed indicating a past or present leak. The area was dry at the time of inspection. Monitoring the stained area(s) is recommended if repairs have been made. We recommend further review to understand repair costs and present conditions better.

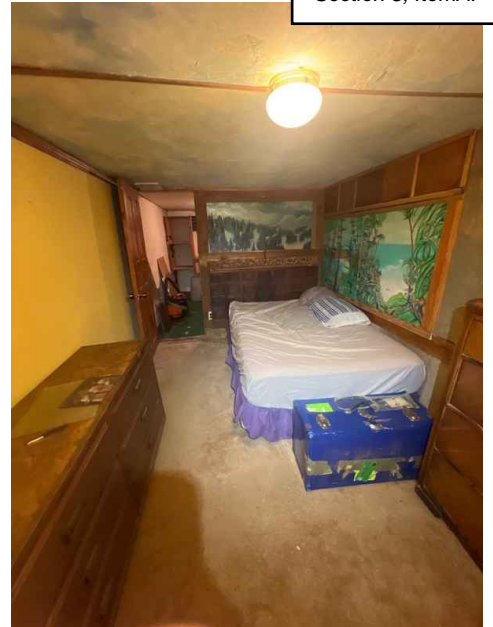
10.13.1 Egress

ROOMS SHOULD NOT BE USED AS SLEEPING AREA-NO EGRESS

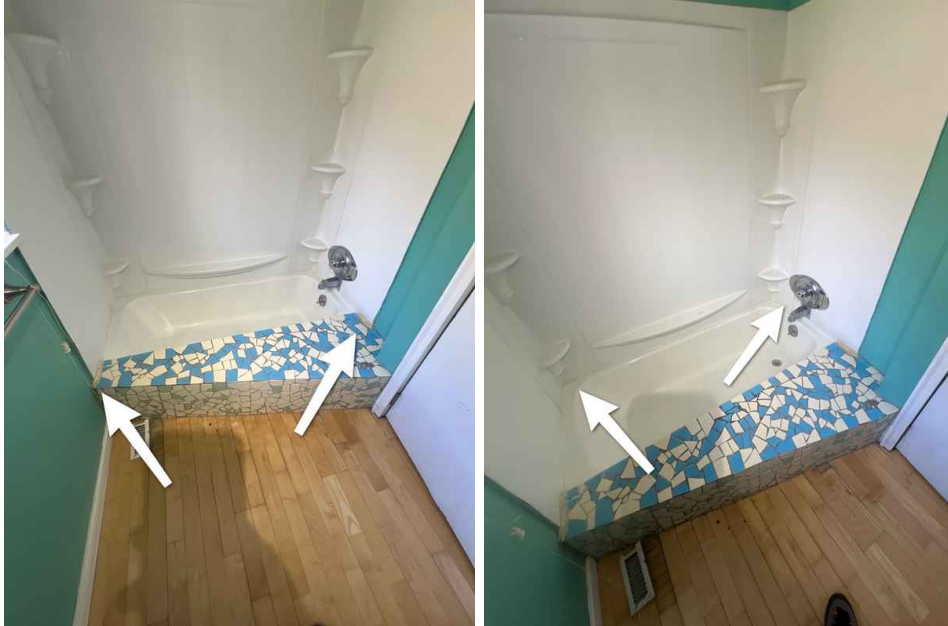
12.5.2 Tile

CRACKED TILES

Cracked tiles were observed in the bath(s) shower/tub wall area. We recommend that all cracked tiles be repaired or replaced to reduce water penetration and possible damage to the surrounding areas.

Contact a qualified tile contractor

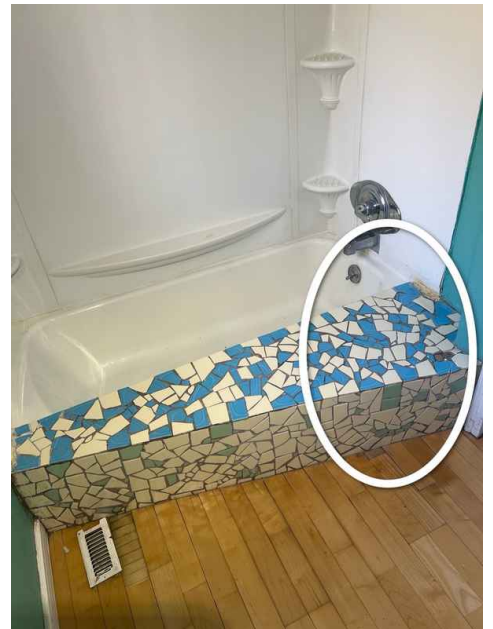
12.5.3 Tile

LOOSE OR DAMAGED TILES

Loose or damaged tiles were observed in the bath(s) shower/tub area. We recommend that all loose and damaged tiles be repaired or replaced to reduce water penetration, health concerns and possible damage to the surrounding areas.

Contact a qualified tile contractor

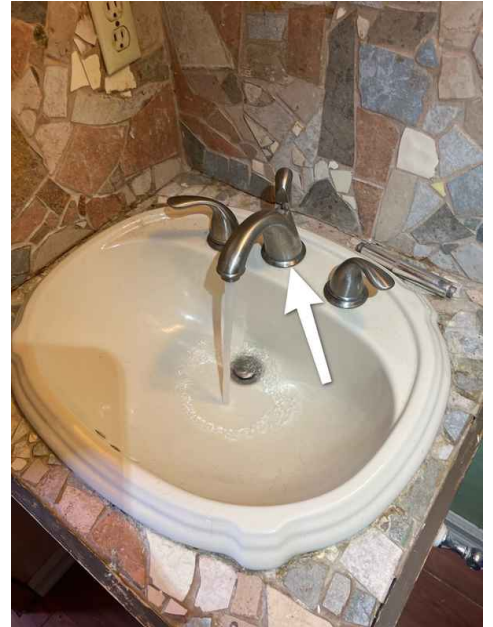
13.2.1 Sink drains

PAST LEAKS

Evidence of past leakage was noted under the bath sink(s). We recommend that the sink(s) be reviewed and repaired as necessary.

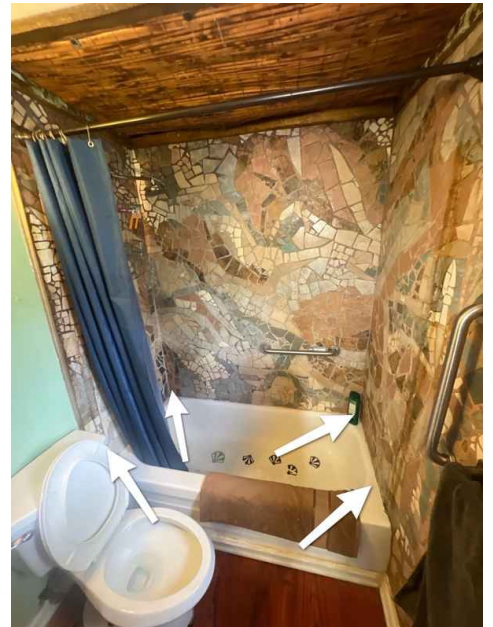
13.9.1 Drain

DRAIN STOPPER

The drain stop was missing or defective in the bathtub(s). We recommend that all missing, damaged or non-functioning drain stops be repaired or replaced.

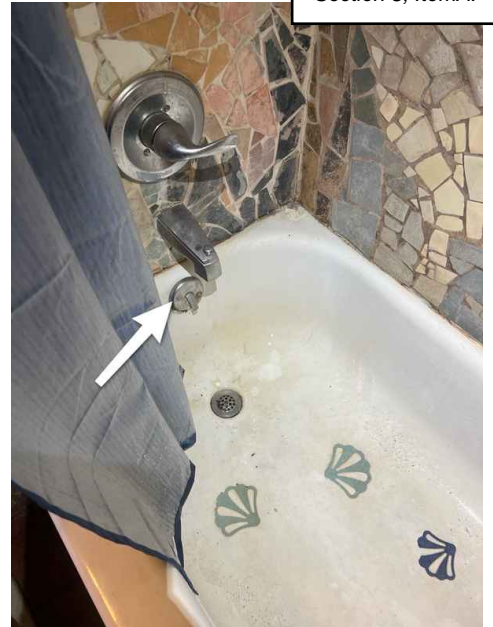
13.10.1 Bathtub

DAMAGED TUB

Damage was noted to the bathtub.

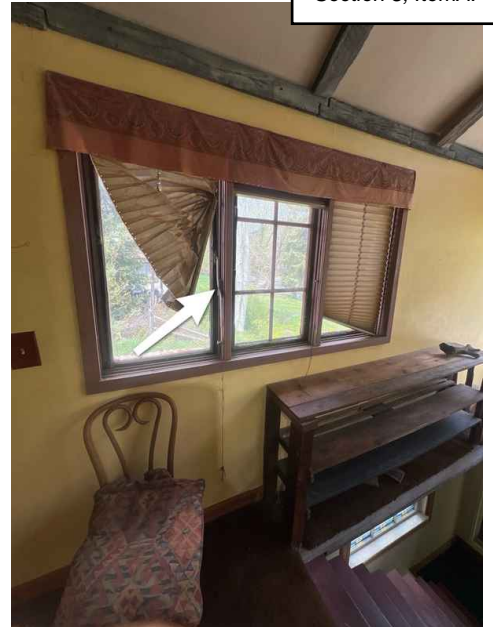
14.5.2 Window condition

DETERIORATED FINISH

Deteriorated finish was noted on the windows. We suggest repair to restore proper aesthetics.

Contact a qualified professional.

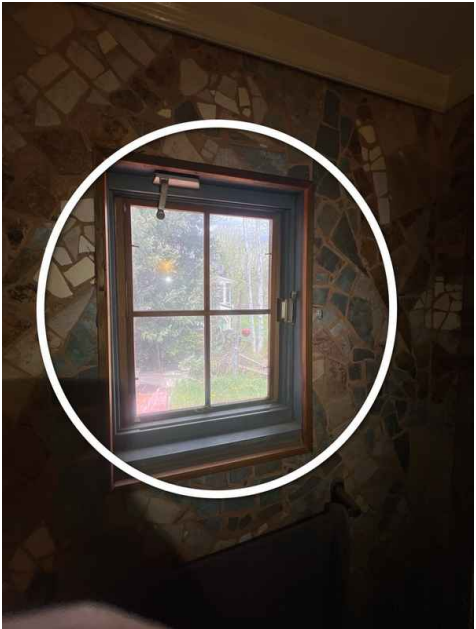
14.6.1 Window Screens

DAMAGED SCREENS

Window screens at one or more areas were worn or damaged. We recommend that all worn or damaged screens be repaired or replaced to restore proper function.

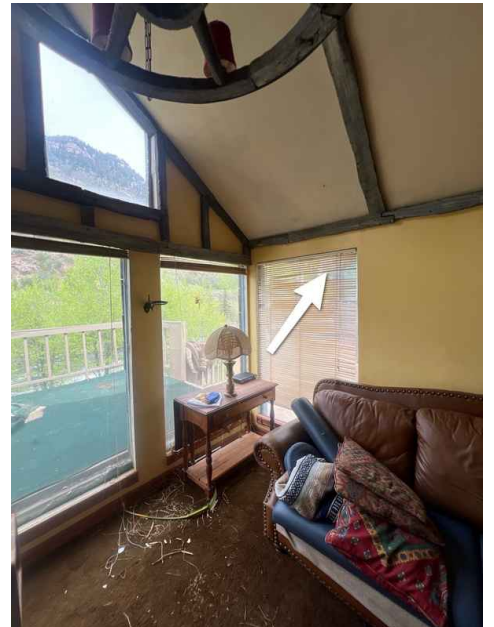
14.8.2 Windows - Glass

CRACKED OR BROKEN GLASS

Cracked or broken glass was observed. We recommend an immediate replacement for all cracked or broken windows. This is a safety concern and should be addressed.

Contact a qualified window repair/installation contractor.

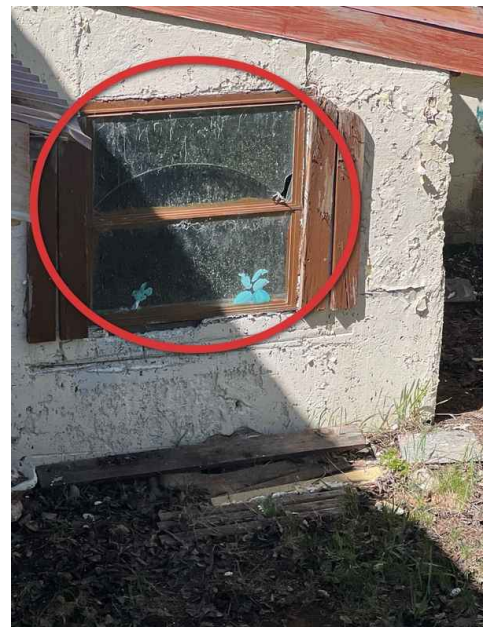
14.8.3 Windows - Glass

MISSING TEMPERED GLASS

Tempered glass was not found or could not be verified in currently recommended locations. This building may have been built before this feature was required. Upgrading is not required in a pre-1960's building but should be considered for glass in the more vulnerable locations.

Contact a qualified window repair/installation contractor.

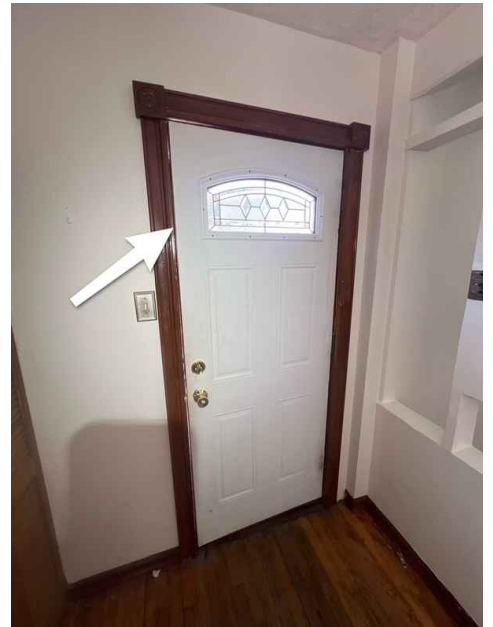
15.1.2 Exterior doors

BAD LATCH

The exterior door(s) did not latch properly. We recommend repair to return the door to proper operation.

Contact a handyman or DIY project

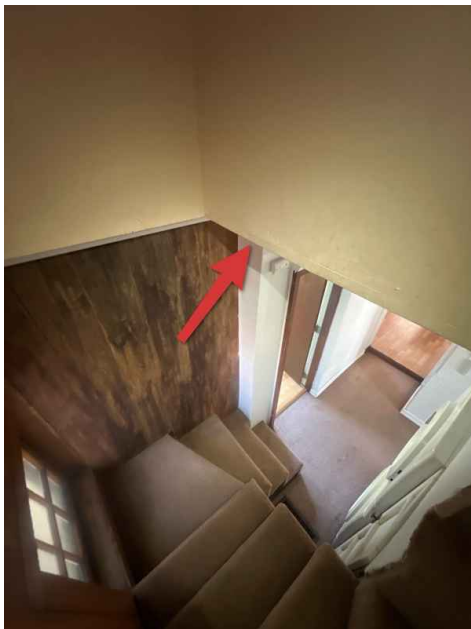
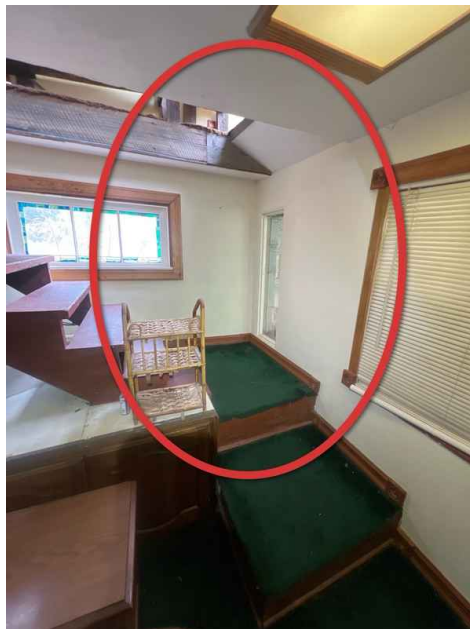
16.1.2 Stairways

TOO NARROW

This staircase did not have a minimum clear width of 31 inches, measured at and just below the handrail. This condition is not uncommon in older homes built to standards that were accepted practice at the time of original construction.

Contact a qualified professional.

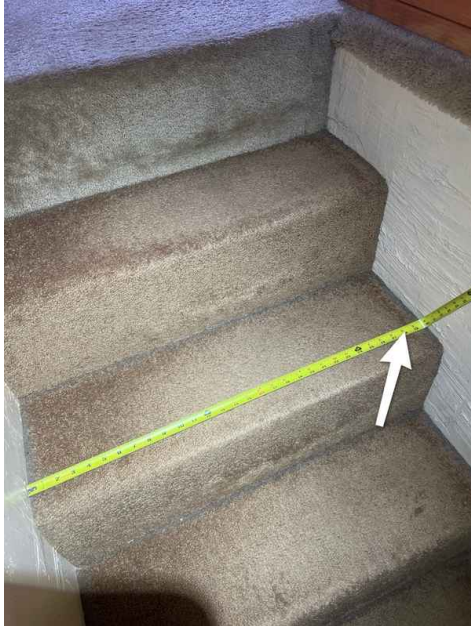
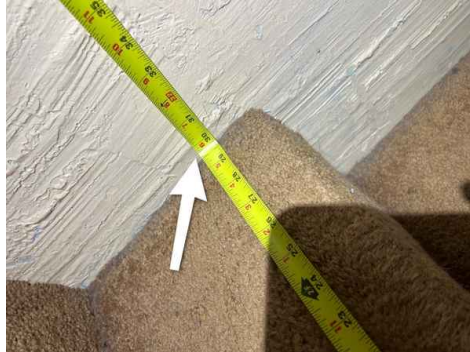
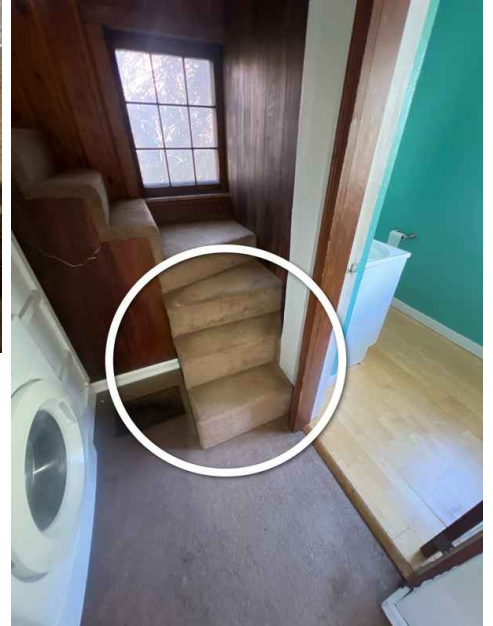
16.2.1 Staircase illumination

NO STAIRCASE LIGHT

No lighting was provided to illuminate this staircase. Modern safety standards require that all staircases with 6 risers or more, such as this one, have lights installed that illuminate the stairs, including landings and treads. The lights illuminating the stairs must be controlled by switches installed at and operable from both the top and bottom of the staircase. For safety reasons, the Inspector recommends that lighting and switches be installed by a qualified electrical contractor.

Contact a qualified electrical contractor.

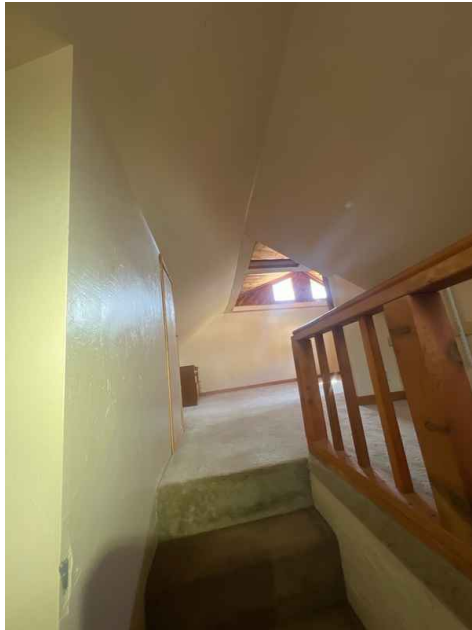
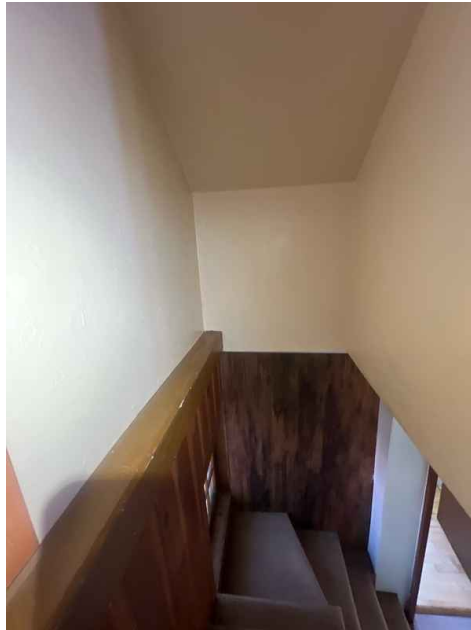
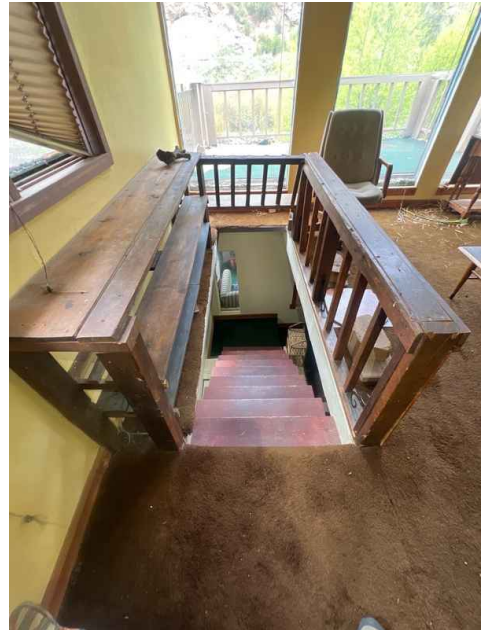
16.3.1 Stair Risers

OPEN RISERS GREATER THAN 4"

This condition is not uncommon in older homes built to standards that may have been the generally-accepted practice at the time of original construction, but which differ from generally-accepted current standards.

Contact your builder.

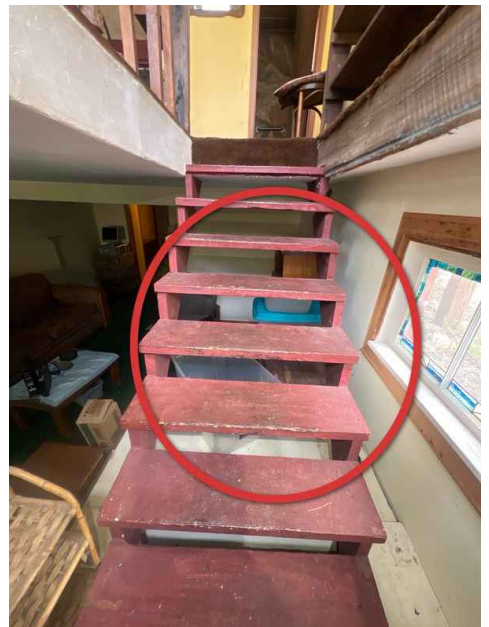
16.3.2 Stair Risers

RISERS TOO TALL- OLDER HOME

Risers at this staircase exceeded 7 3/4 inches (19.6cm) in height. Although this condition is now considered a potential trip/fall hazard, it is not uncommon in older homes such as this one, built during a time period during which safety standards were different from generally-accepted current safety standards. Current standards mandate a minimum height of 4 inches minimum and maximum height of 7 3/4 inches.

Contact your builder.

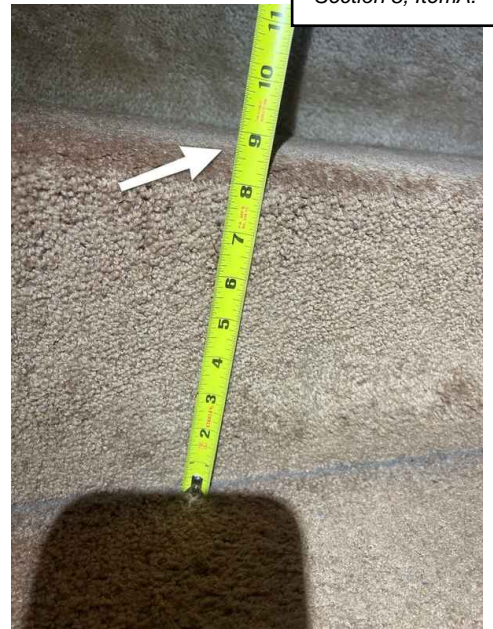
16.4.1 Stair Treads

TREADS TOO NARROW

Treads at this staircase were less than 10 inches in depth measured from riser to nosing. This condition is a potential trip/fall hazard. A 10-inch minimum and 10 3/8-inch maximum are the generally-accepted current standard tread depths.

Contact your builder.
