AGENDA
Historic Preservation Commission Meeting
Tuesday, June 18, 2024
Town Hall / Council Chambers - 302 Pine St Minturn, CO

- A.** Ordinance 16 - Series 2024 An Ordinance Amending the Town's Historic Register to Add 478 Eagle River Street - Harris

Review the landmark designation nomination of 478 Eagle River Street based on the criteria outlined in the Minturn Municipal Code Sec. 19-3-20, citing findings of fact, and forwarding a recommendation of approval, approval with conditions, or denial to the Minturn Town Council.

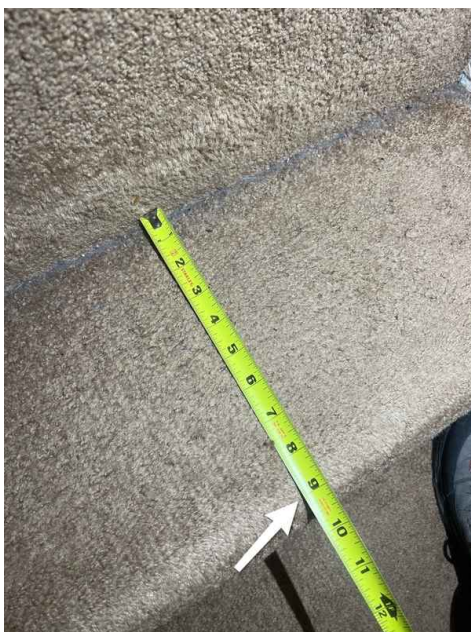
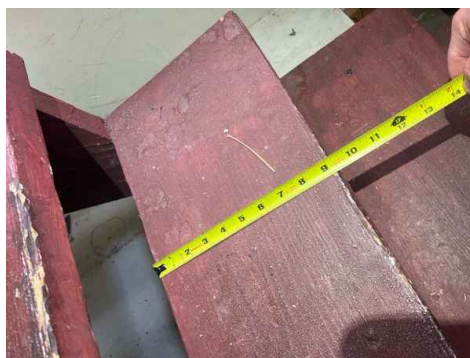
16.5.1 Railings

BALLUSTER SPACING

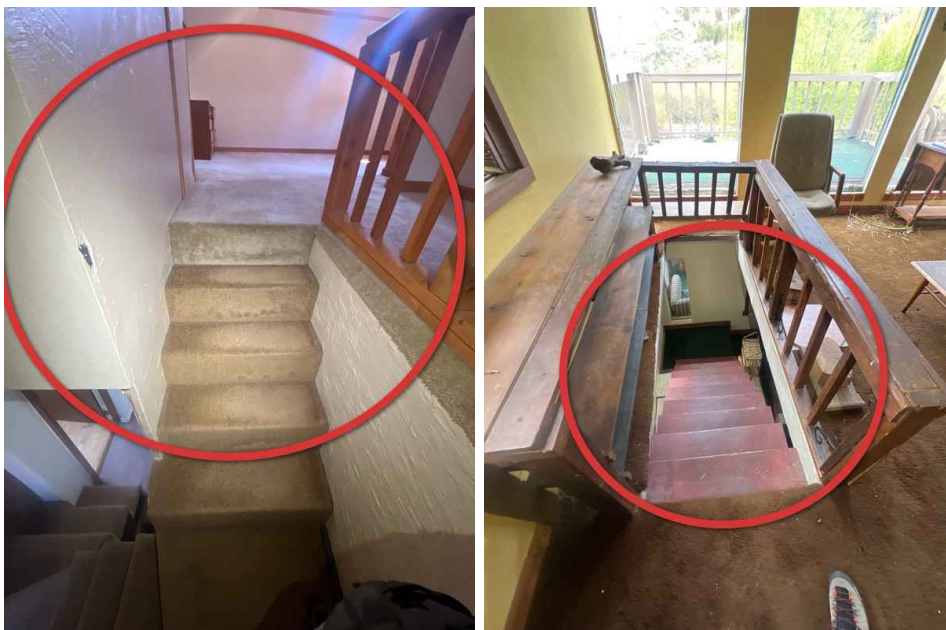
16.6.1 Handrails

NO HANDRAIL

Contact a qualified carpenter.

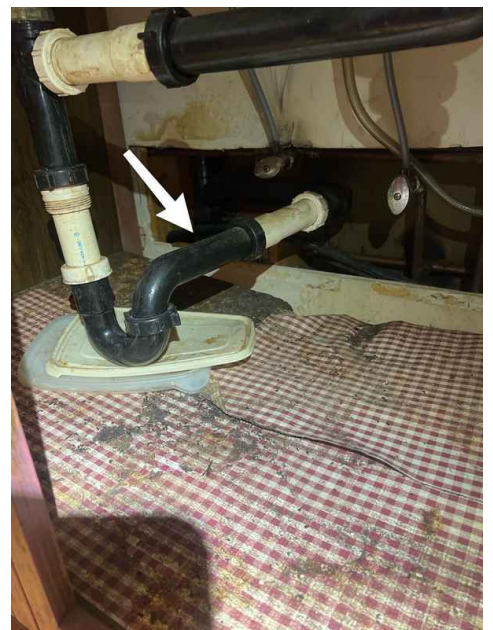
17.2.2 Sink Drain

LEAKING DRAIN

The drain trap or drain of the kitchen sink appeared to be leaking. We recommend repair of the drain trap or drain.

Contact a qualified plumbing contractor.

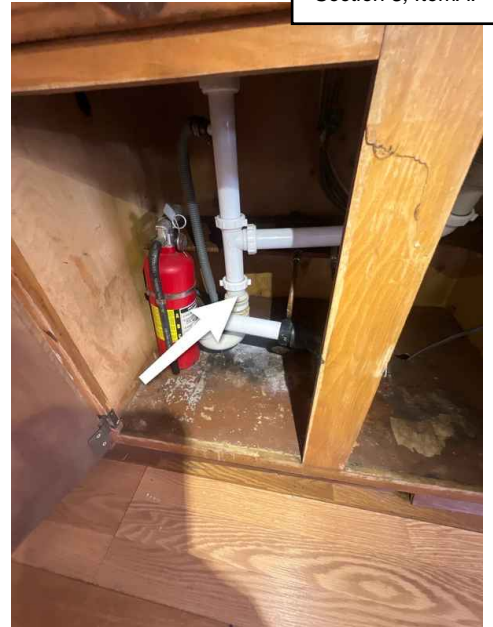
17.2.3 Sink Drain

FLEXIBLE DRAIN PIPE

A flexible drain pipe was noted under the kitchen sink, this is not recommended and suggests a nonprofessional installation. These types of pipes can become easily clogged by collecting dirt and grime in the accordion corrugations that impede flow. We recommend further review by a qualified plumbing contractor.

Contact a qualified plumbing contractor.

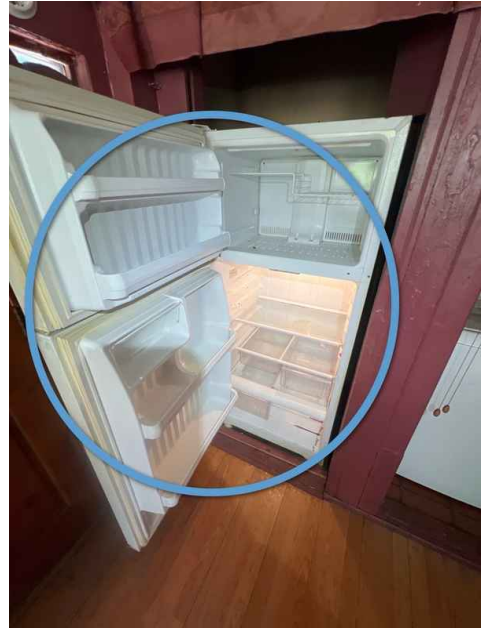
17.13.2 Refrigerator

DAMAGED OR MISSING SHELVES

The shelving in the refrigerator or freezer was damaged or missing.

Contact a qualified appliance repair professional.

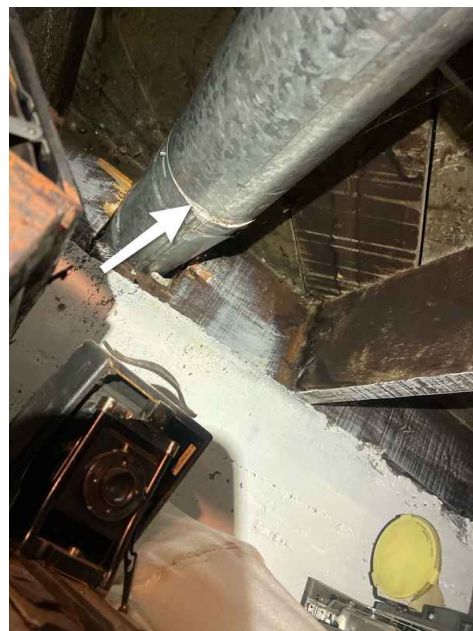
19.8.2 Exhaust flue

TO CLOSE TO COMBUSTIBLES

The combustion exhaust flue had improper clearance from combustible materials. The minimum clearance is 1 inch. This condition is a potential fire hazard and should be corrected by a qualified contractor.

Contact a qualified HVAC professional.

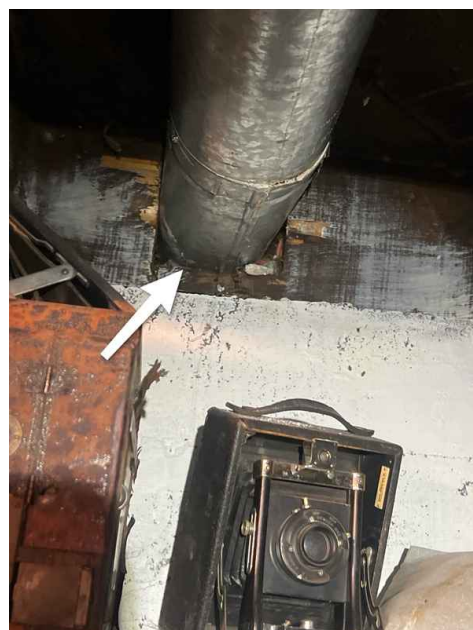
19.8.3 Exhaust flue

CORROSION BASE OF VENT

Corrosion visible at the base of the combustion exhaust vent of the furnace indicated the presence of excessive amounts of moisture, typically related to condensation formed by improper furnace exhaust vent conditions. This condition may result in premature failure of furnace components. The Inspector recommends that the furnace be serviced by a qualified HVAC contractor.

Contact a qualified heating and cooling contractor

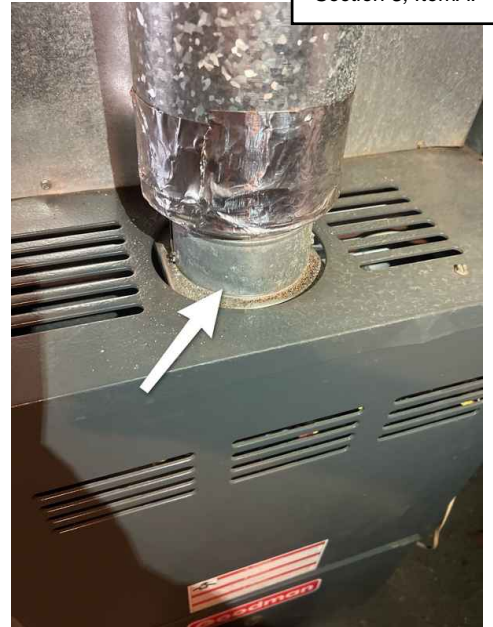
19.10.1 Combustion air

COMBUSTION AIR NOT SUFFICIENT (FORMULA)

Combustion air supply appeared to be insufficient at the time of the inspection. Combustion appliances require 50 cubic feet per 1000 BTU/h aggregate input. "Aggregate" means that if two combustion appliances such as a gas-fired boiler and a gas-fired water heater are installed in the same room, each of their input ratings in BTU/h must be included when calculating adequate combustion air. Insufficient combustion air can cause a combustion appliance to operate inefficiently, increasing heating costs and may cause the furnace to produce unacceptably high levels of toxic gases such as carbon monoxide. The Inspector recommends correction by a qualified HVAC or plumbing contractor.

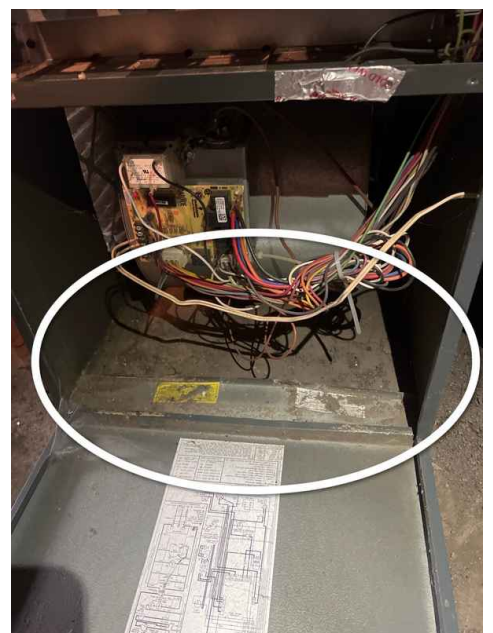
19.11.2 Furnace interior

CORROSION

Corrosion was noted on the interior of the heating system. We suggest further reviewing the heating system with repairs made as deemed necessary by a qualified heating contractor.

Contact a qualified professional.

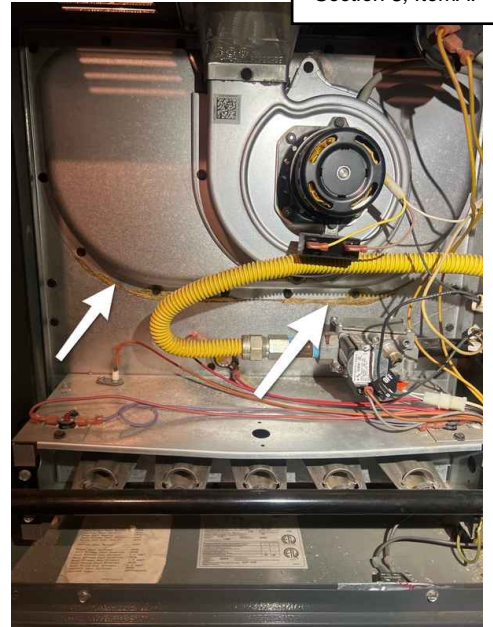
19.12.1 Fuel pipe

NO DRIP LEG / SEDIMENT TRAP

No sediment trap or drip leg was installed at this heating unit. Sediment traps and drip legs are installed to keep particulates and moisture out of the gas valve. Particulates or moisture in the gas valve can interfere with burner operation. The Inspector recommends the installation of a sediment trap/drip leg by a qualified plumbing contractor.

Contact a qualified HVAC professional.

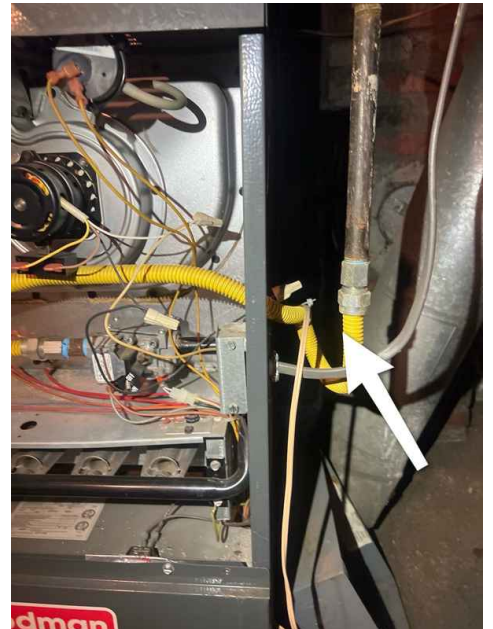
19.12.2 Fuel pipe

FLEXIBLE TUBING THROUGH CABINET

Flexible tubing used to provide gas fuel to the furnace penetrated the furnace cabinet. This condition is improper. Gas should enter the cabinet through a solid pipe. The Inspector recommends the installation of a proper gas supply pipe by a qualified HVAC contractor.

Contact a qualified heating and cooling contractor

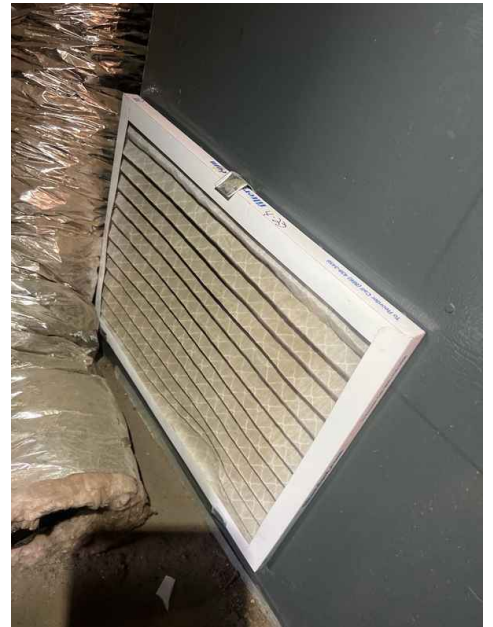
19.16.2 Air filter

RETURN AIR DUCT DISCONNECTED

We suggest repairs for proper function.

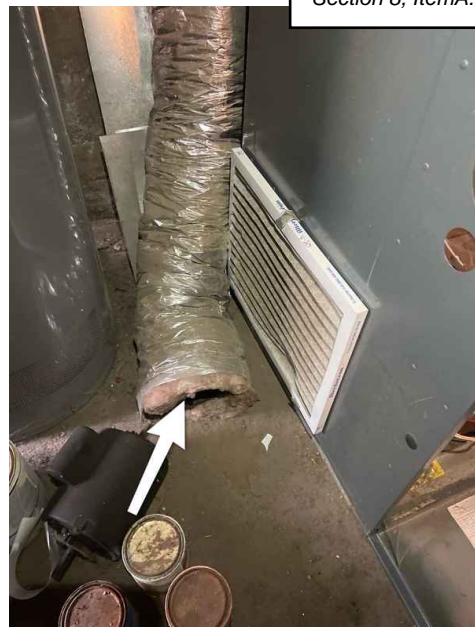
19.18.1 Distribution Systems

DUCTS NOT SEALED

Air supply ducts were not properly sealed. Recommend a qualified HVAC contractor to seal supply and return ducts for maximum efficiency.

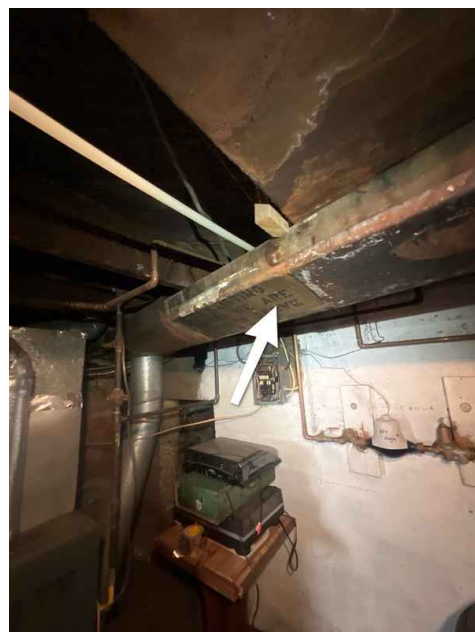
19.18.2 Distribution Systems

DUCTS IN UNHEATED SPACE

The Inspector recommends that heat supply ducts routed through unheated space be sealed and insulated by a qualified heating, ventilation, and air-conditioning (HVAC) contractor for significant savings on heating costs.

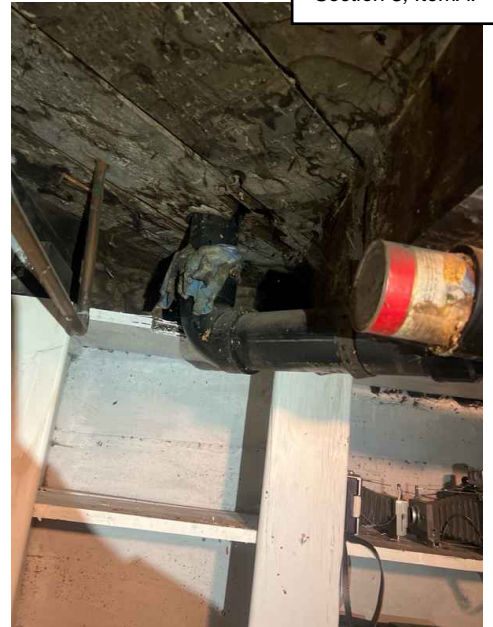
20.14.2 Drain, Waste, & Vent Systems

MISSING SEWER CAP

An improper cap (soup can) was noted on the sewer line, this may allow sewer gas to enter the home.

Contact a qualified professional.

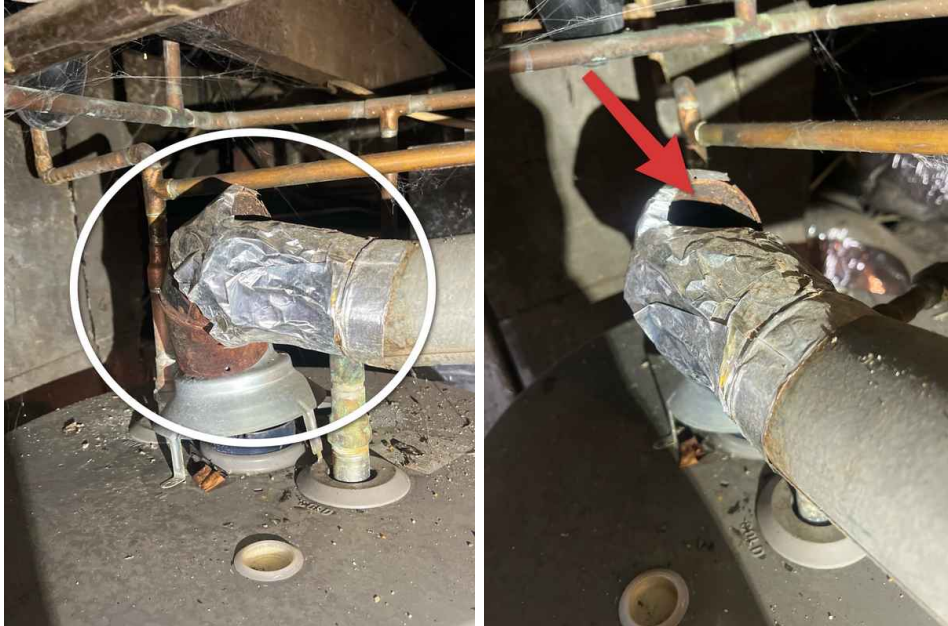
21.13.1 Combustion air

INADEQUATE COMBUSTION AIR

The combustion air supply for this water heater appeared to be insufficient at the time of the inspection. Insufficient combustion air may cause incomplete combustion that can produce excessive amounts of invisible, odorless, tasteless, toxic gases like carbon monoxide. The inspector recommends additional air be provided to allow for proper combustion.

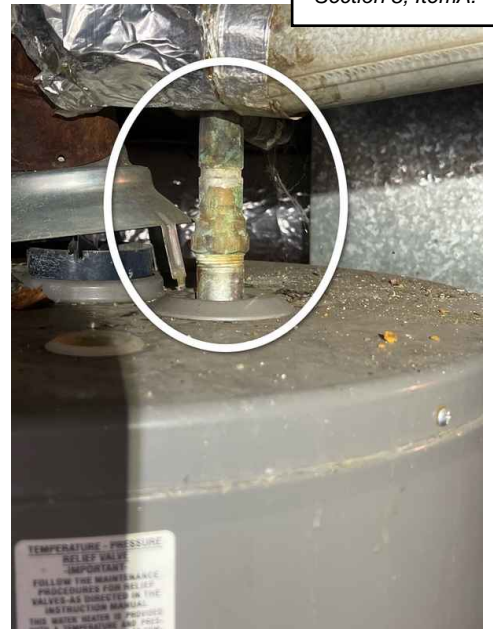
21.17.1 Fuel supply

NO DRIP LEG (SEDIMENT TRAP)

Contact a qualified plumbing contractor.

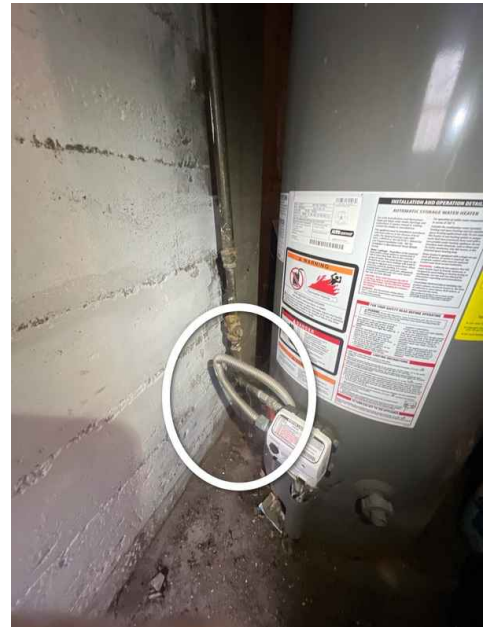
21.20.1 Temperature relief pipe

TPR RELIEF PIPE SHORT OR MISSING

Contact a qualified plumbing contractor.

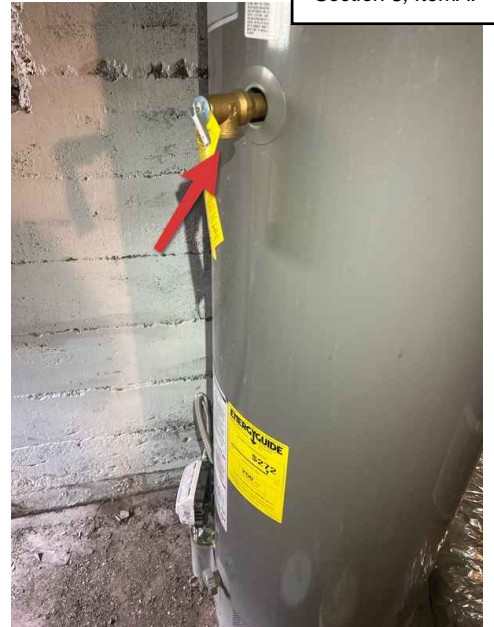
21.21.1 Expansion tank

IMPROVE- CONSIDER ADDING EXPANSION TANK

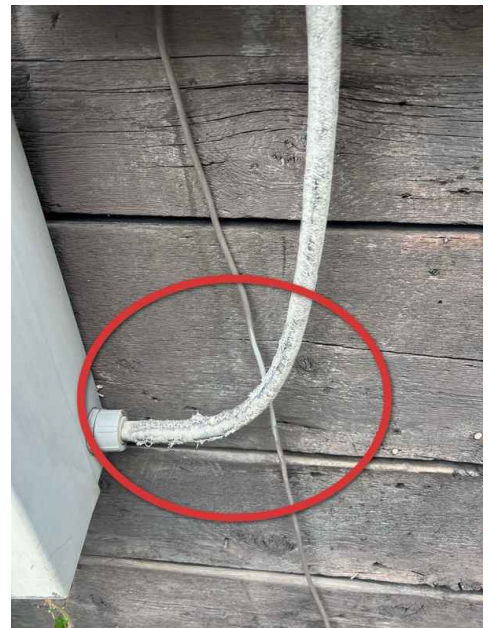
22.9.2 Main service -Condition

SERVICE LESS THAN 10'

Contact a qualified electrical contractor.

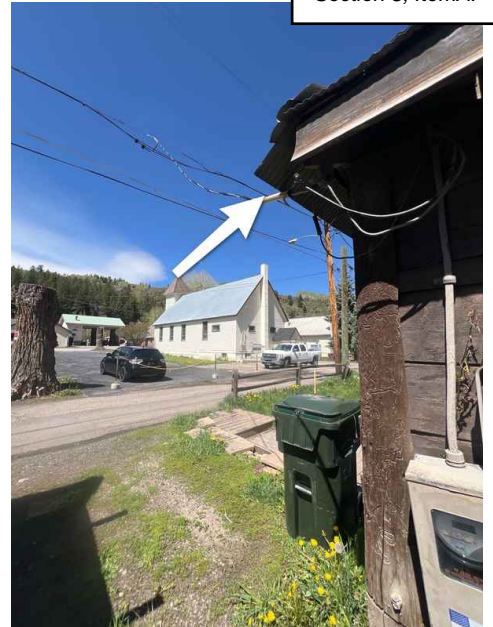
22.9.3 Main service -Condition

LESS THAN 12' OVER DRIVEWAY

Contact a qualified electrical contractor.

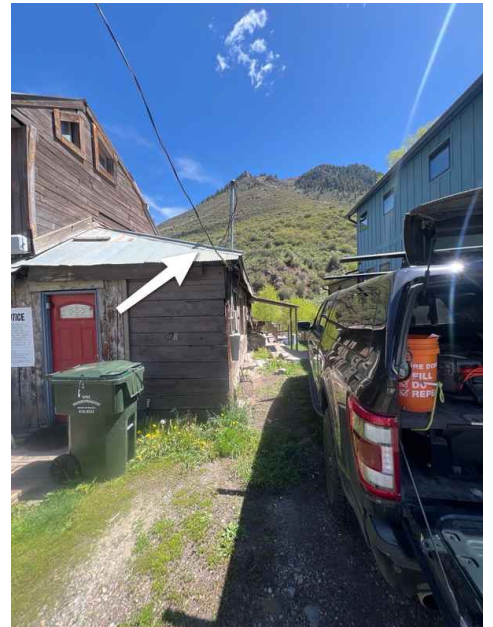
22.9.4 Main service -Condition

LOOSE METER CABINET

Contact a qualified electrical contractor.

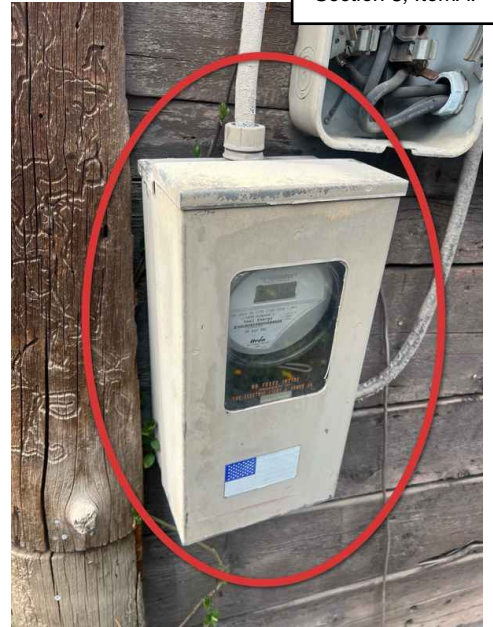
22.10.1 Disconnect -condition

NO MAIN POWER SHUT OFF (MORE THAN 6)

Contact a qualified professional.

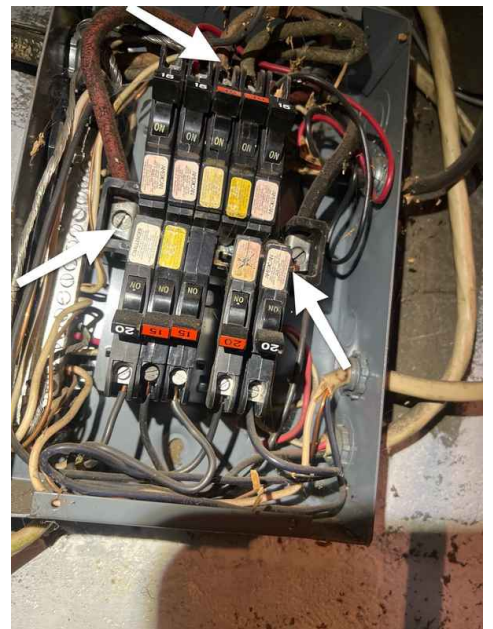
22.19.1 Main & Subpanels- Conditions

DEAD FRONT MISSING

Contact a qualified professional.

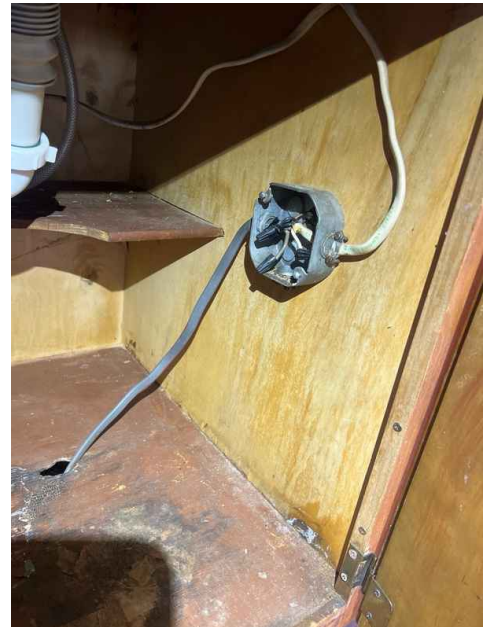
22.21.2 Wiring General

EXPOSED WIRING

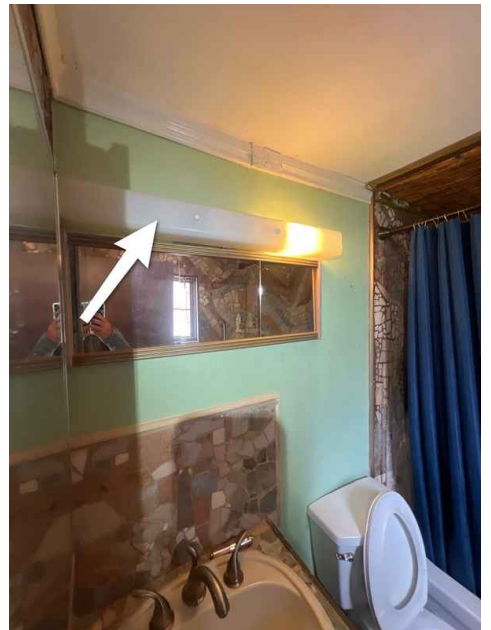
22.23.2 Lights

DAMAGED OR IMPROPERLY INSTALLED

The light fixture was damaged or improperly installed. All damaged or improperly installed fixtures should be repaired or replaced to proper operation by an electrician.

Contact a qualified electrical contractor.

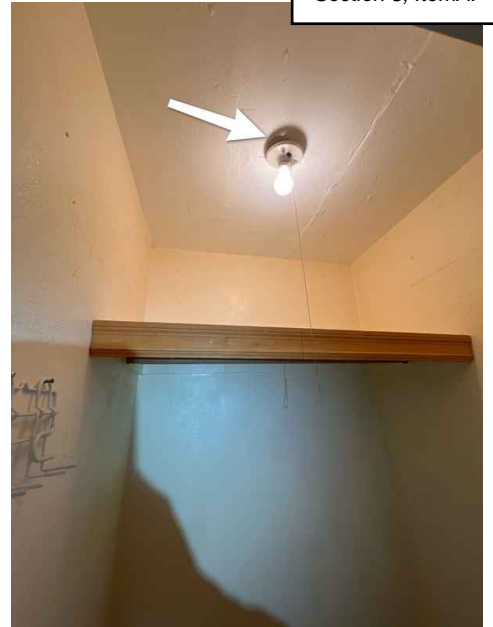
22.23.3 Lights

DAMAGED LIGHT COVER

The light fixture had a damaged cover. We recommend that the fixture cover be replaced.

Contact a qualified electrical contractor.

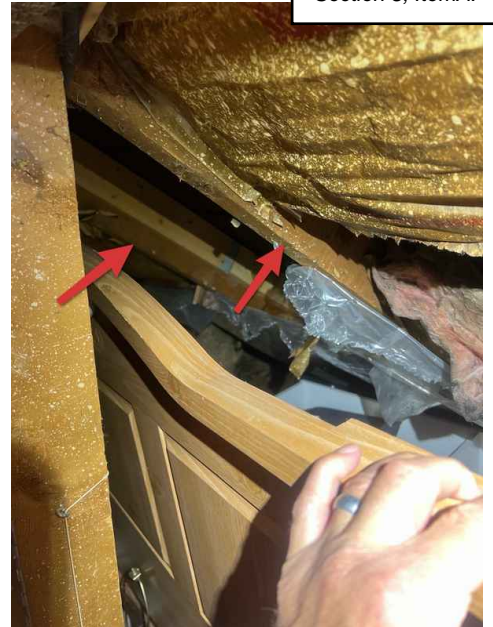
23.6.1 Rafters

RAFTER SAG

The rafters sagged visibly at the time of the inspection. This condition appeared to be due to inadequately sized or overspaced rafters. We suggest you consult with a qualified contractor to understand the options and costs for correcting or stabilizing this condition.

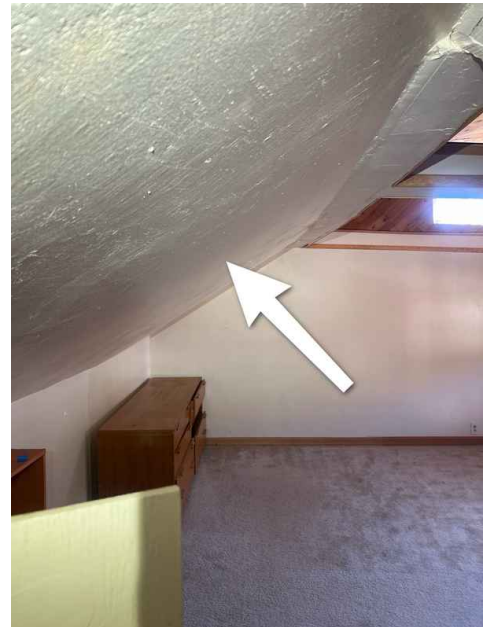
23.6.2 Rafters

SPLICED RAFTERS

Repairs have been made to the rafters in the attic. The inspector recommends evaluation by a structural engineer. Any correction should be made by a qualified contractor.

Contact your builder.

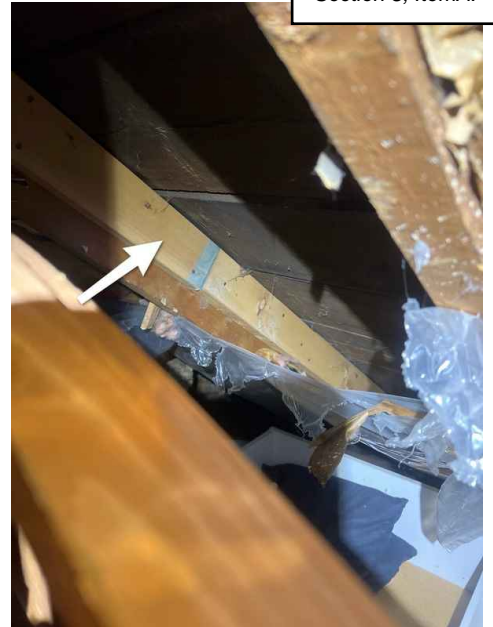
23.6.3 Rafters

UNDERSIZED RAFTERS

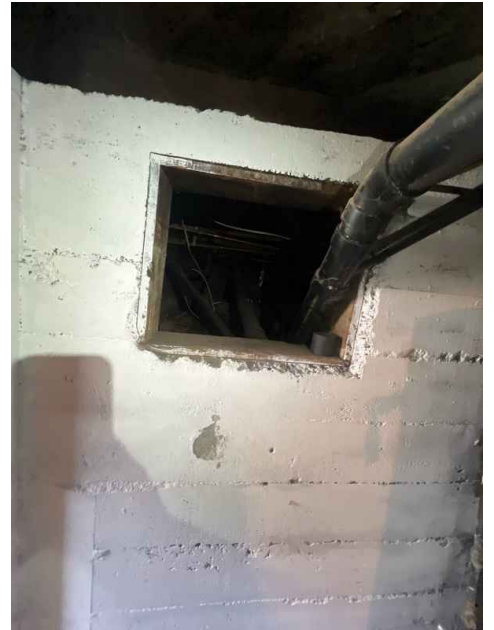
25.4.1 Foundation walls

ALTERED OR CUT FOUNDATION WALLS

The foundation walls were noted to have been cut to accommodate HVAC ducts. We suggest a further review of this condition by a qualified professional.

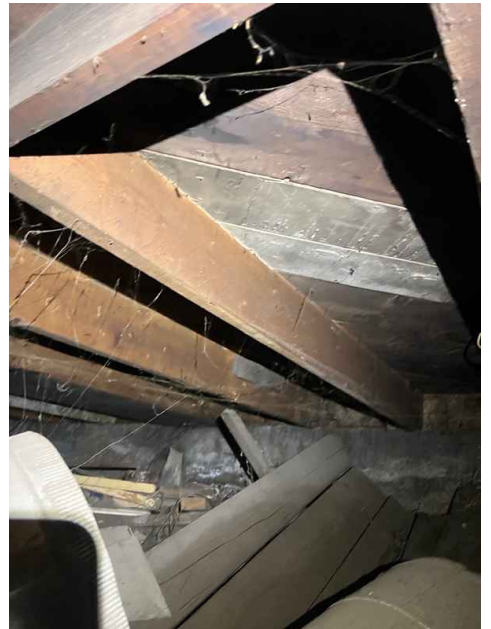
25.10.1 Moisture and leaks

EFFLORESCENCE- WALLS

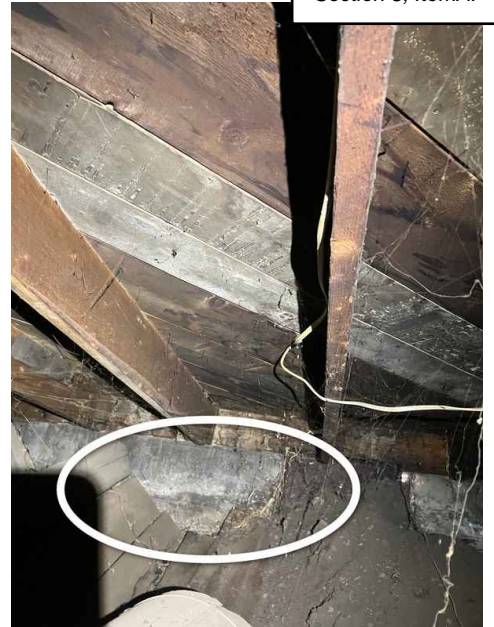
25.10.2 Moisture and leaks

EVIDENCE OF MOISTURE FLOOR FRAMING-DRY

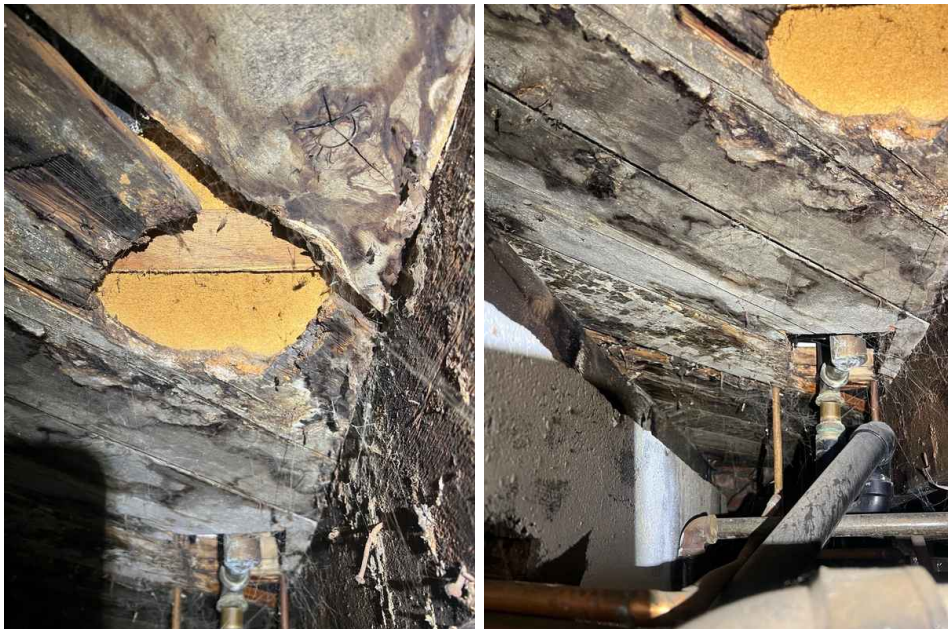
25.11.1 Ventilation

INADEQUATE OR MISSING VENTILATION

Contact a qualified professional.

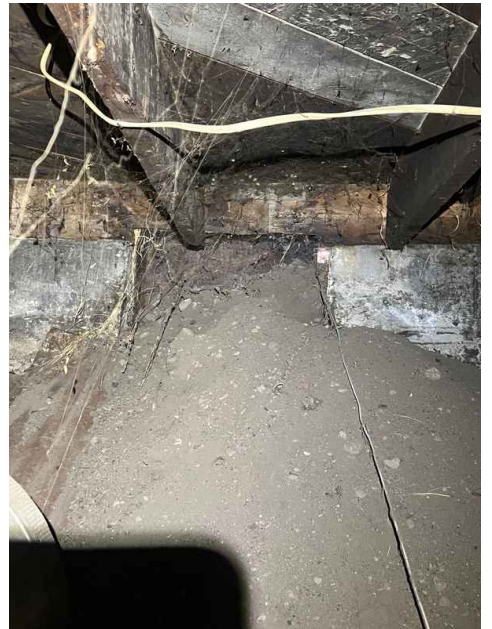
25.13.1 Crawlspace conditions

DEBRIS

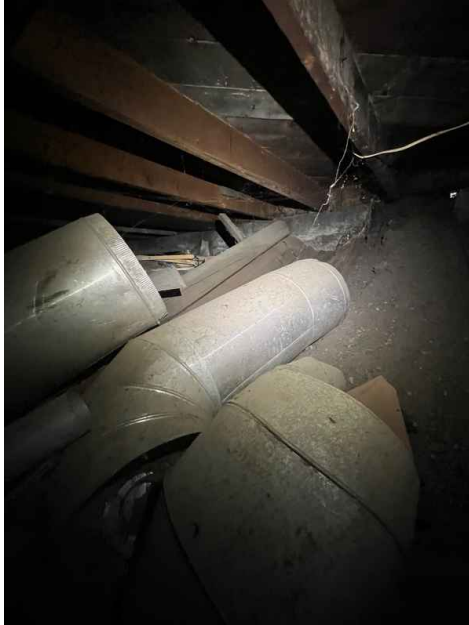
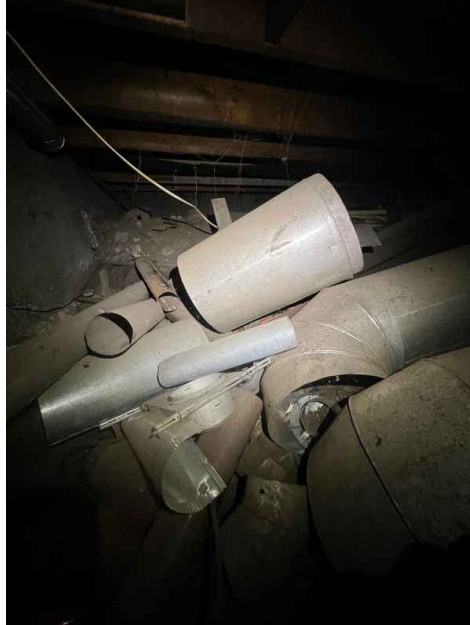
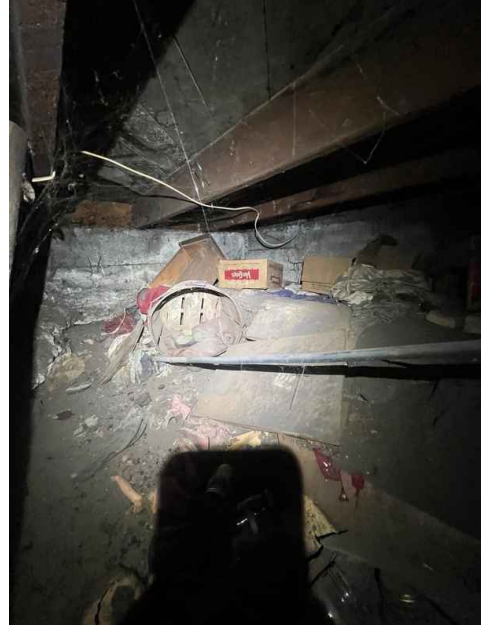
Old construction debris was noted in the crawl space. This type of debris can provide a food source for microbial growth. We suggest removal and cleaning of this material.

Contact a qualified professional.

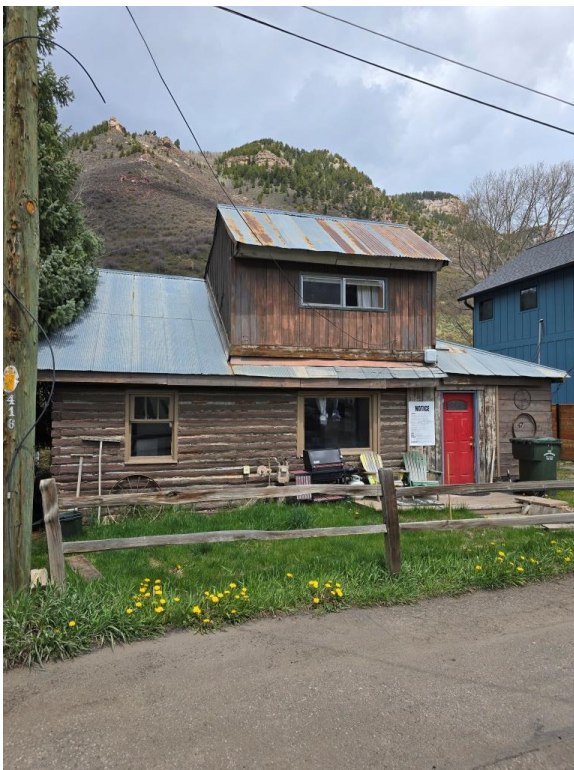
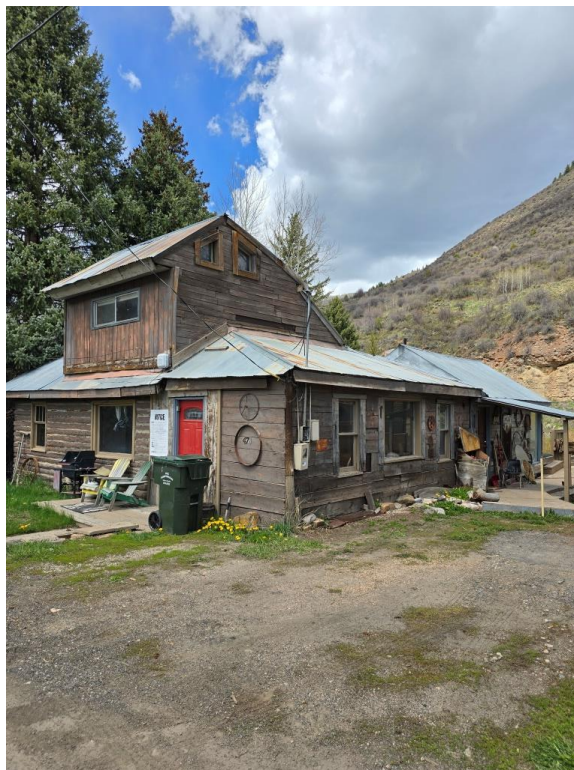
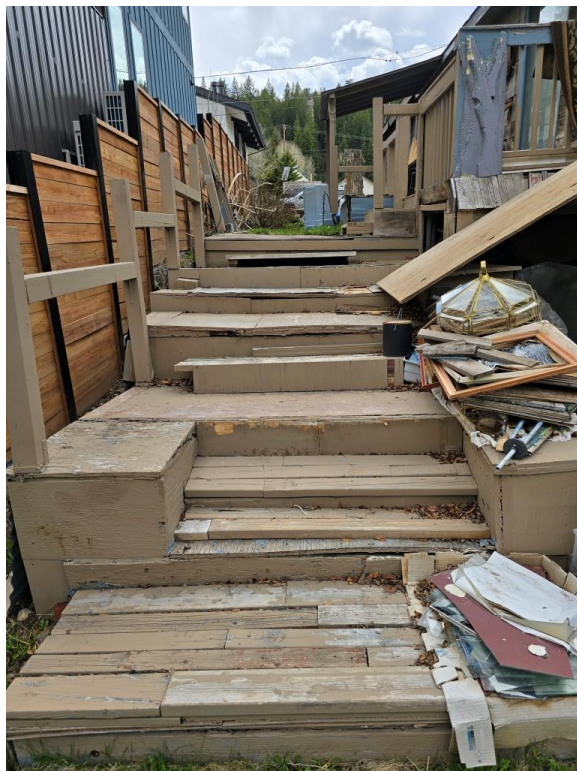
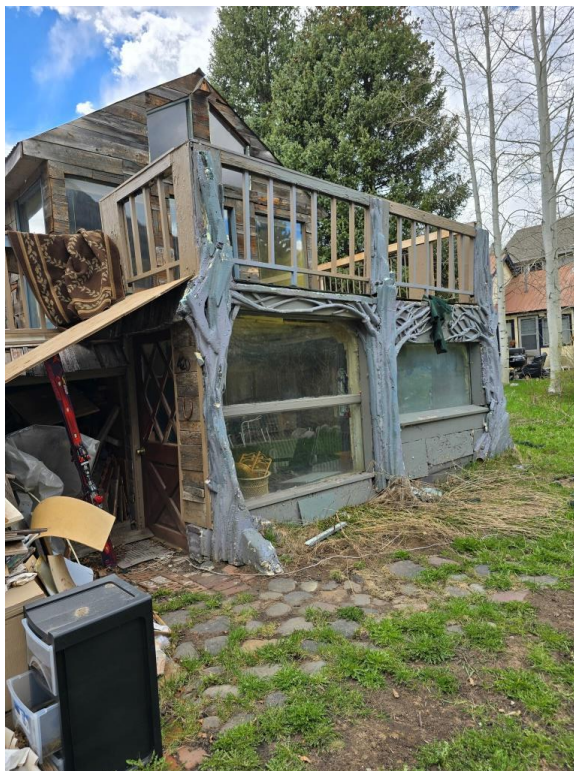
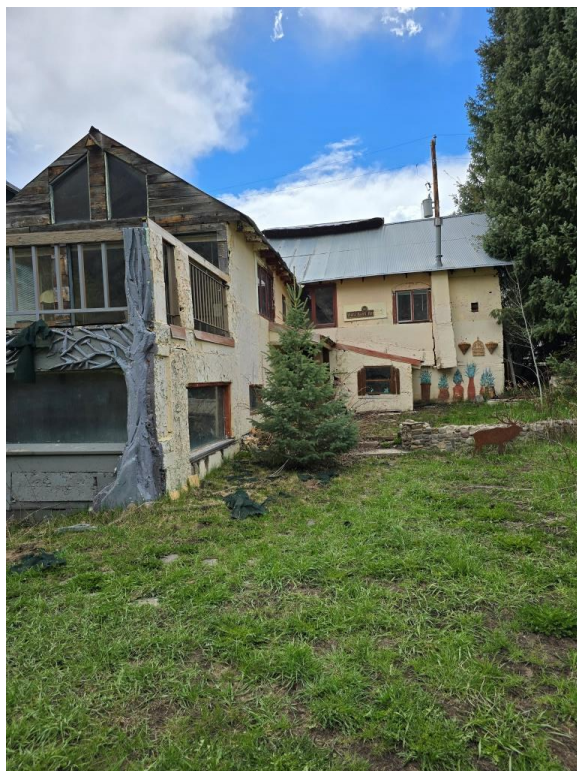
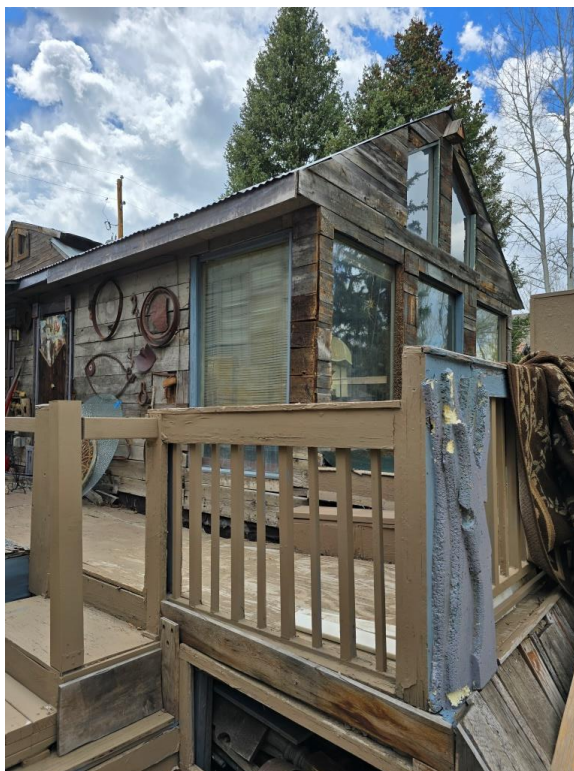
- It is highly likely that the existing buildings and additions are structurally unsound, and therefore unsafe for continued habitation.
- The existing structure has not been regularly maintained over time, and it has fallen into a state of disrepair and negligence. It would not be financially feasible to rehabilitate the existing exterior materials.

The following photographs illustrate the haphazard, disjointed, piecemeal, patched together methods and materials used during the various phases the structure was added on to over time. The materials, design, construction methods are all sub-par and do not represent a Rustic historic style.
