City Council Public Hearing Agenda

1. Public Hearing - Proposed Sale of City Owned Property 401 Virginia Street
 - a. Opening of Public Hearing
 - b. Introduction
 - c. Testimony in Favor
 - d. Neutral Testimony
 - e. Testimony Opposed
 - f. Close the Public Hearing

401 Virginia Street New Meadows, Idaho 83654

Company Information

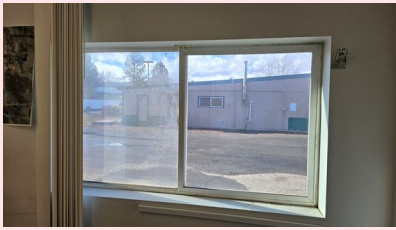
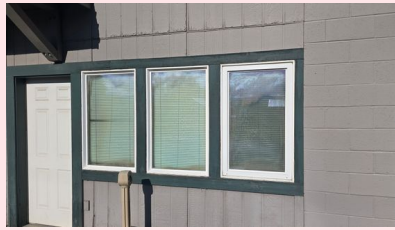
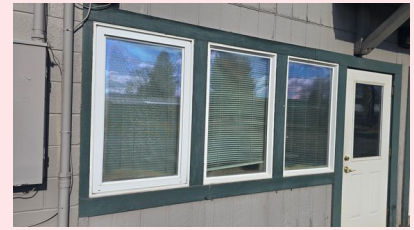
South and west windows have failed vacuum seals. Cracked glass also noted at one of the rear windows. This presents as visual irregularities between the double pane glass which cannot be cleaned without glazing replacement. I list as a major concern due to the cost of replacing multiple windows. Hire a glass replacement company to further evaluate and replace windows with lost seals.

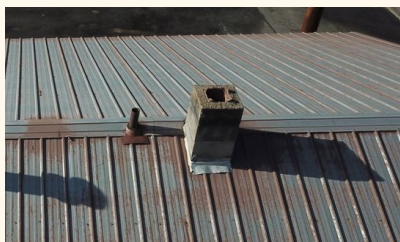
✂ RG-1 Roof & Gutters:

The unused concrete chimney should be capped to prevent water and ice from entering and damaging the masonry. Hire a mason to further evaluate and install a masonry or metal chimney cap.

simple metal cap

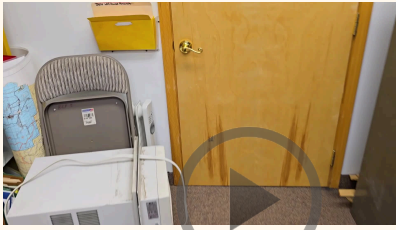
✂ I-2 Interior:

The east office door was not latching correctly and requires the strike height to be adjusted so the door latches closed.

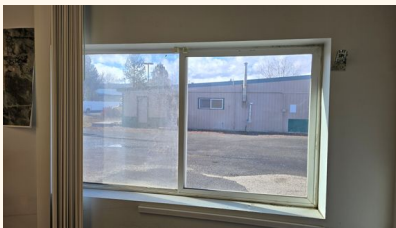
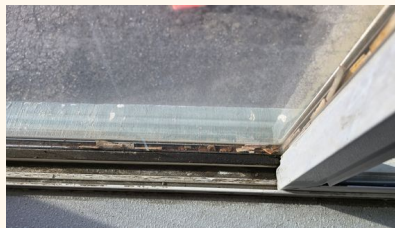
I-3 Interior:

As mentioned above and previously in the exterior chapter, several windows appeared to have failed vacuum seals. Hire a glass replacement company to further evaluate and replace windows with lost seals.

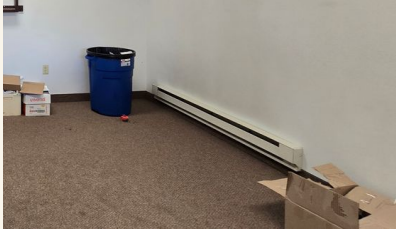
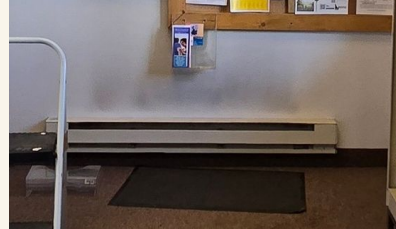
🔍 HCFV-2 Heating, Cooling, Fireplaces & Ventilation:

This building has electric baseboard heaters. These can get very hot during operation. Be sure to keep all drapes, curtains, furniture, electric cords and other flammable items away from these heaters when they are on. Baseboard heaters will need annual cleaning. Best practices are to turn power off to the heater and use compressed air to clean the dust from the heating elements. Also be careful with small children to avoid a burn hazard.

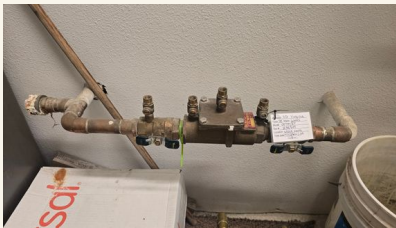
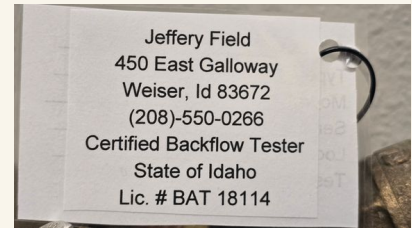
🔍 AP-1 Additional Plumbing:

This building has a backflow prevention device installed. Annual inspection and testing of the backflow devices is required as these perform a critical safety task: keeping the drinking water safe from contamination. A current inspection certificate was noted on this device, I recommend keeping this device on a regular inspection schedule.

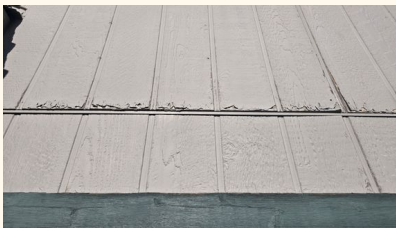
- Failing paint at rear wood siding and along bottom of concrete walls
- Localized minor water damage observed
- Caulking and masonry sealant recommended at localized areas

failed paint & water damage

**(E-1) Recommended Repair:** The wooden portions of the exterior siding and trim needs to be re-painted to preserve and maintain the siding system. Any water damaged siding should be replaced as needed prior to prep and paint. Specialized paint is required for concrete block. Budget for re-painting the exterior in the near term. Examples of specific observations noted during inspection include:

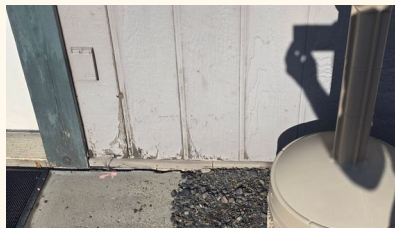
failed paint & water damage

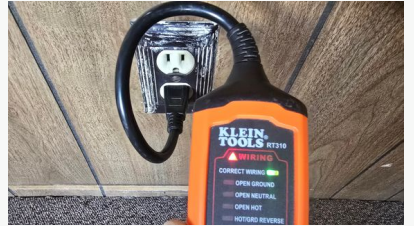
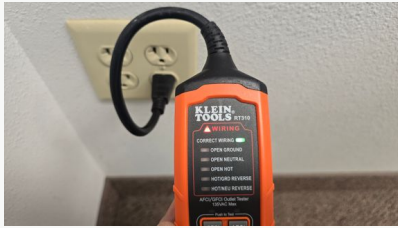
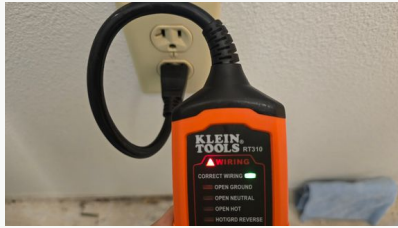
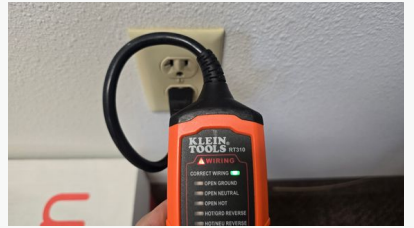
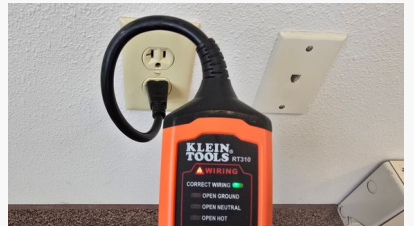
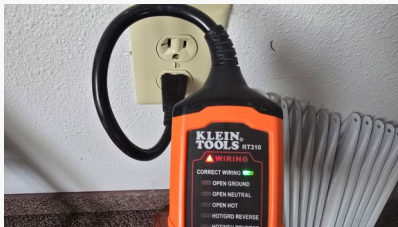
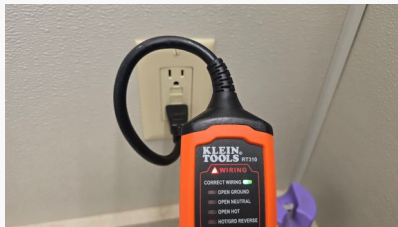
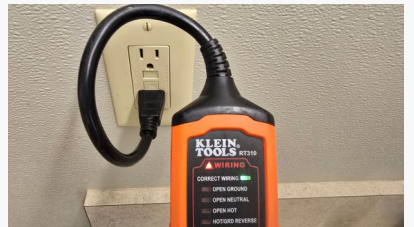
Reverse polarity was noted at the electrical receptacle at the front office wall. This is when the hot and the neutral have been wired backwards. This should be corrected by a licensed electrician.

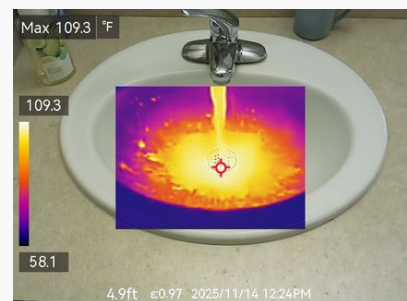
This thermal image shows approximate water temperature at the time of inspection.

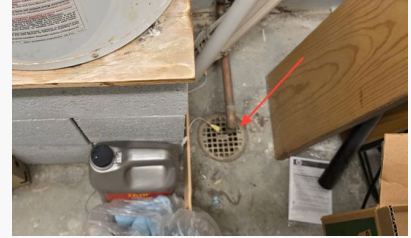
floor drain in storage/utility room

Floor Drain: Floor drain observed (in storage/utility room)

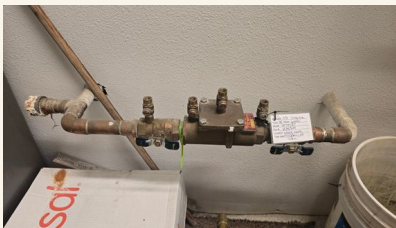
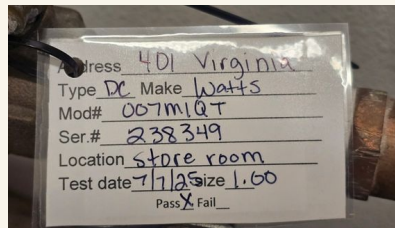
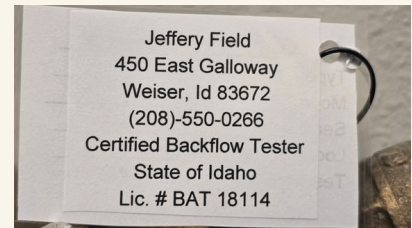
Q (AP-1) Maintenance Reminder: This building has a backflow prevention device installed. Annual inspection and testing of the backflow devices is required as these perform a critical safety task: keeping the drinking water safe from contamination. A current inspection certificate was noted on this device, I recommend keeping this device on a regular inspection schedule.

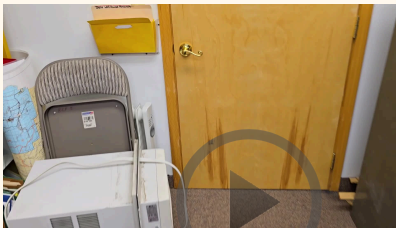
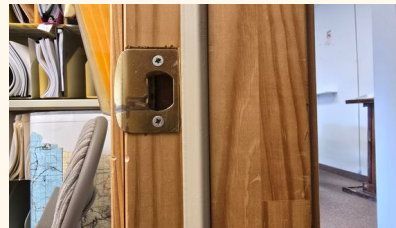
✂ (I-2) Recommended Repair: The east office door was not latching correctly and requires the strike height to be adjusted so the door latches closed.

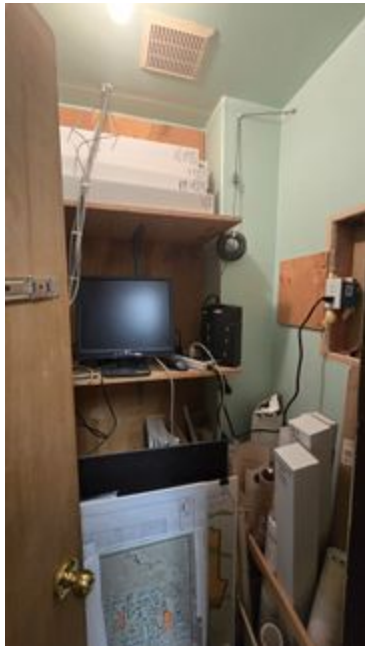
Closet and other storage areas had extensive storage which limited the inspection of these spaces. The front office closet appeared to have been a bathroom at some point.

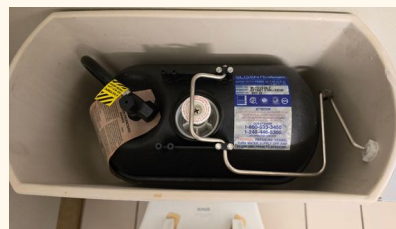
**(WB-1) Recommended Repair:** The Sloan® Pressure Vessel inside the womans bathroom toilet tank was not functioning normally and requires repair or replacement. Hire a licensed plumber to further evaluate and repair as recommended.

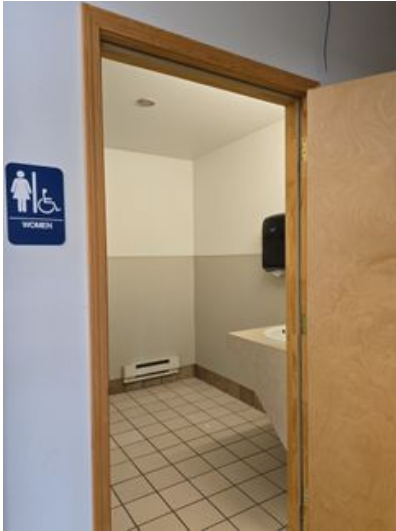
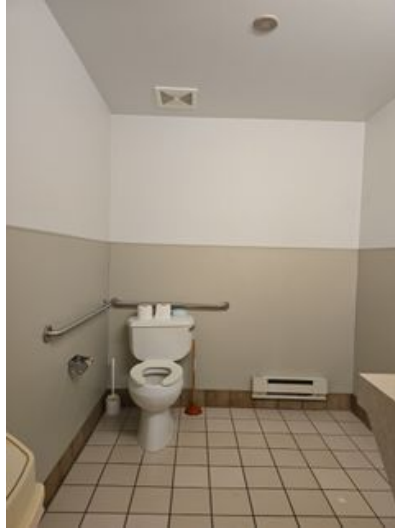
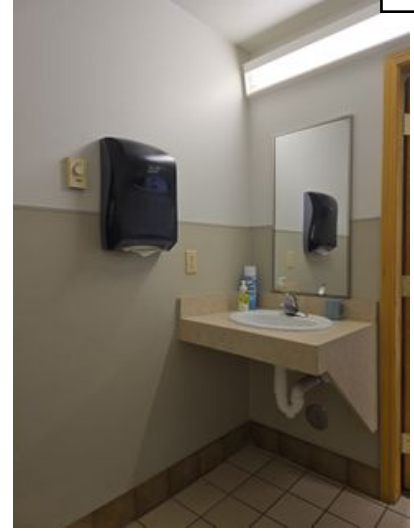
Representative Bathroom Photos

Standard ceiling exhaust fan, Operating normally

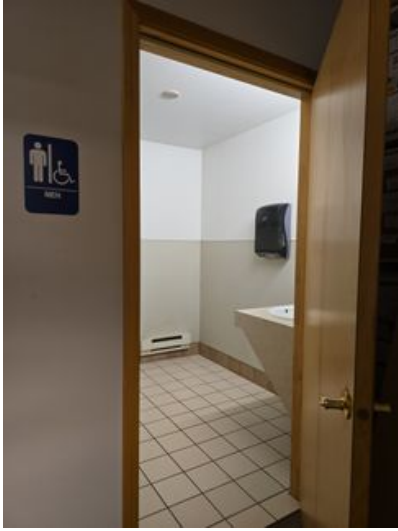
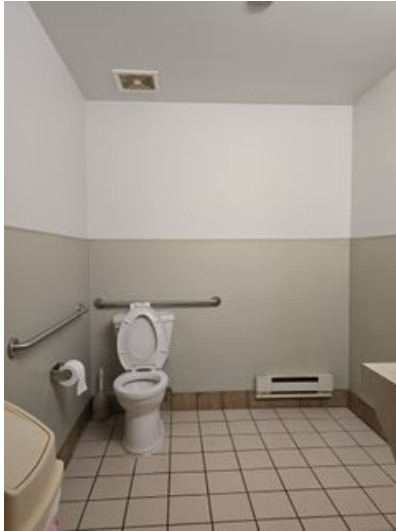
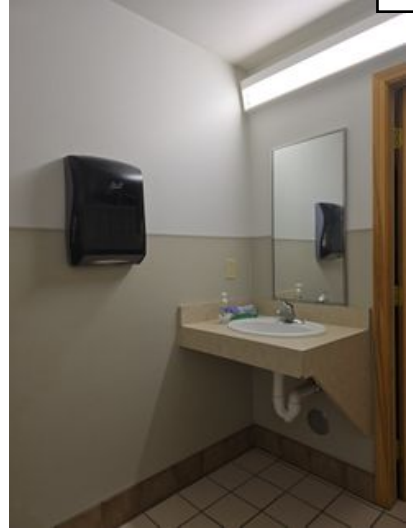
Representative Bathroom Photos

Comments / Observations: Tested, Appearance and function good, No observable plumbing leaks

Standard ceiling exhaust fan, Operating normally
