**CITY OF NOVI**  
**Administrative ePacket**  
**December 05, 2024**

[PCCP Water Main Inspection Results - Croy](#)

# Condition Assessment Report

The City of Novi (Novi) contracted Pure Technologies, a Xylem brand (Pure Technologies), to conduct a condition assessment of the 36-, 30-, and 24-inch Novi Road PCCP Water Transmission Main located in Novi, Michigan. The Novi Road PCCP Water Transmission Main consists of prestressed concrete cylinder pipe (PCCP), specifically lined cylinder pipe (LCP).

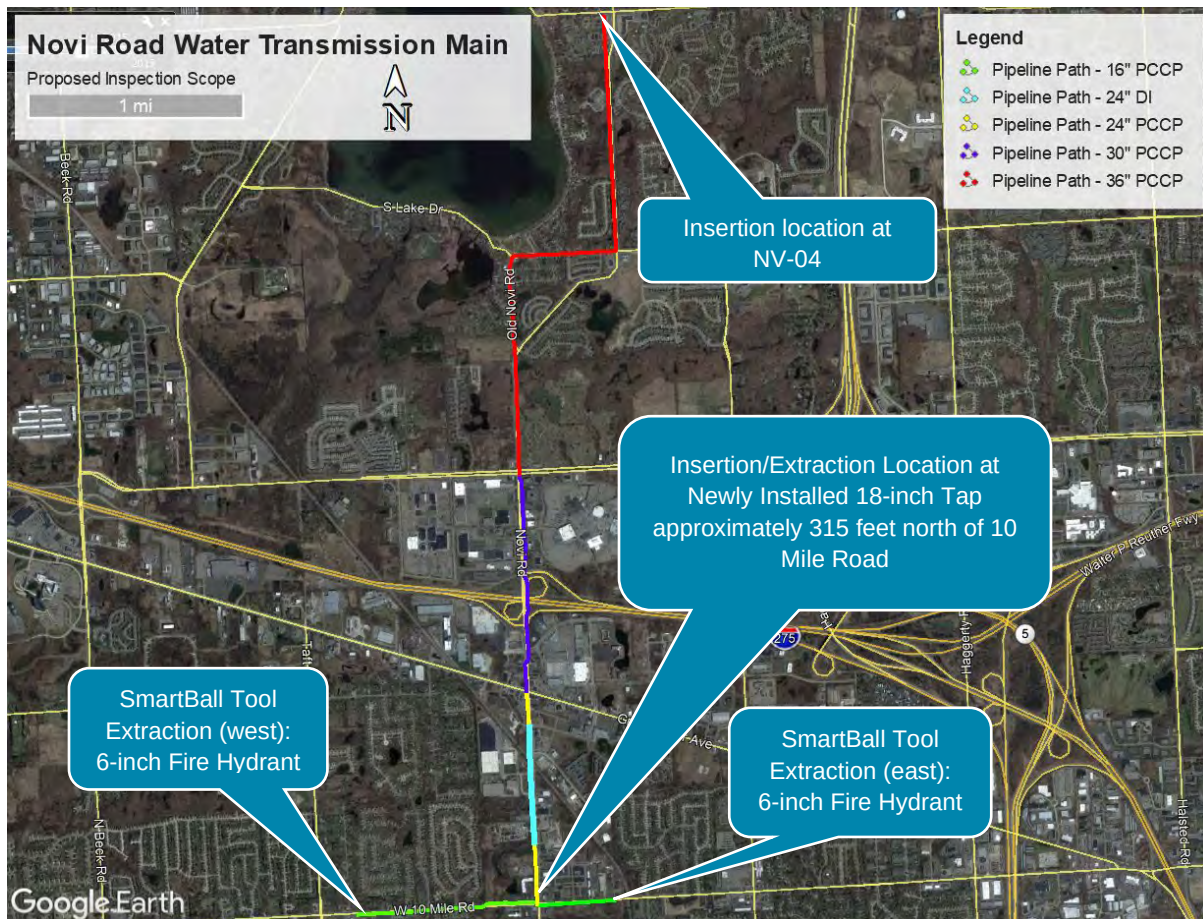
Figure 1.1: 2020 proposed inspected scope. Note: the green section on 10 Mile Road (16-inch PCCP) was planned to be inspected with the SmartBall tool only.

In 2020, Pure Technologies and Novi originally attempted to inspect the transmission main between 14-mile Road and 10-mile Road using the PipeDiver. However, during the inspection the PipeDiver tool became stuck on a broken inline 30-inch butterfly valve in the transmission main. This initial PipeDiver inspection ended with an unplanned recovery of the inspection tool at the butterfly valve, resulting in loss of scope, and cancellation of the remaining portion of contractual scope. The 2020 inspection comprised a cumulative distance of approximately 9,593 feet of 30-inch and 36-inch LCP.

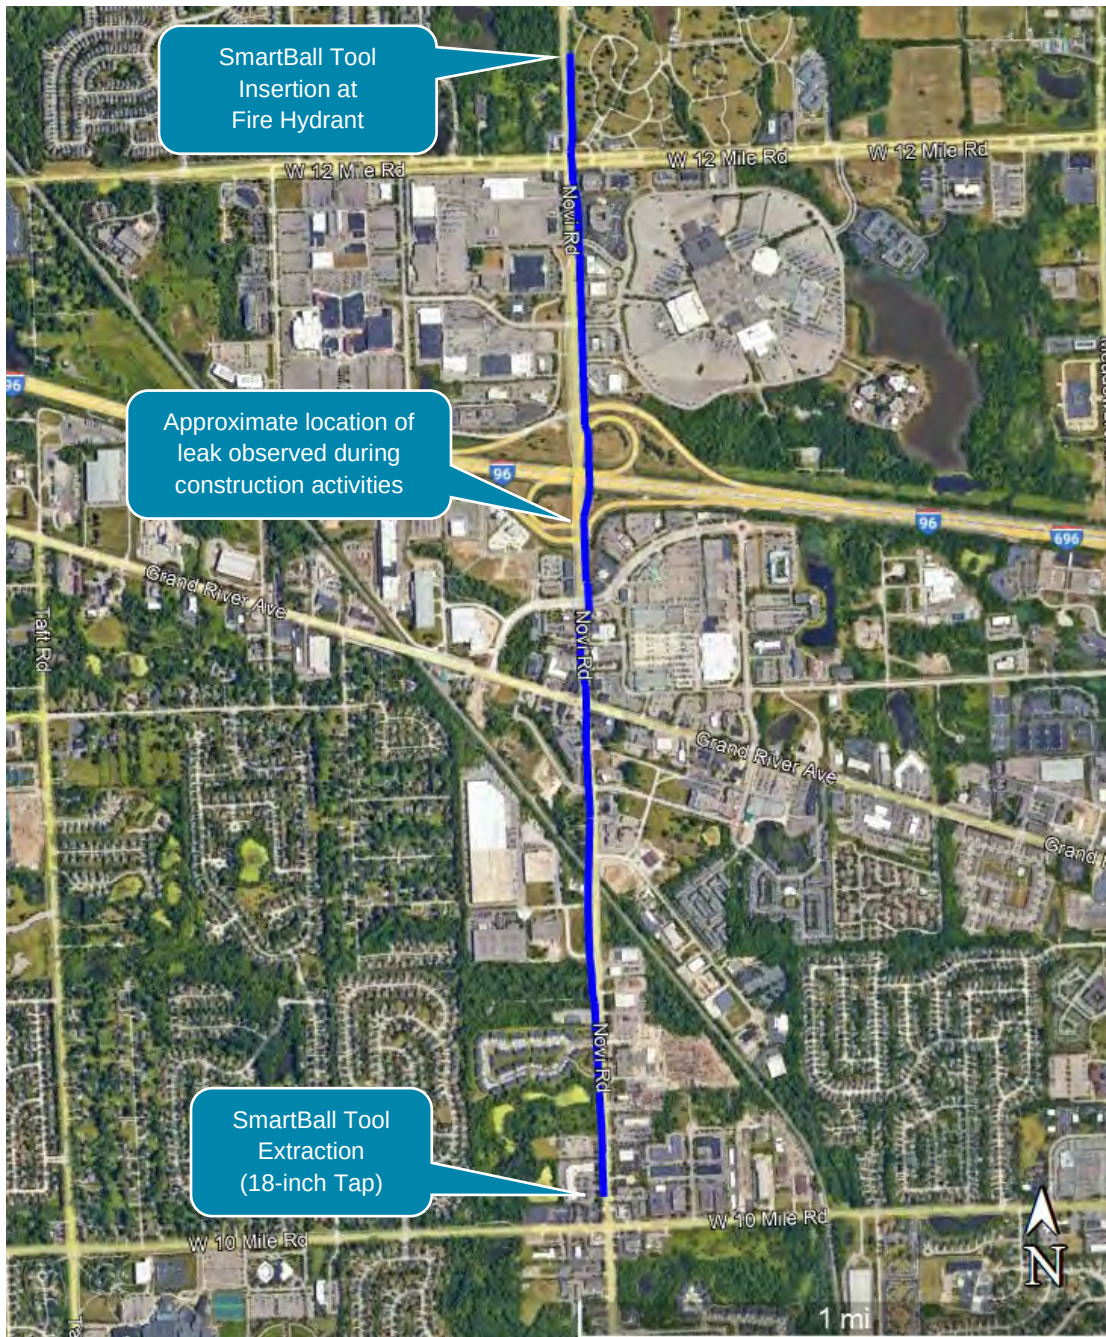
An emergency SmartBall inspection was performed in August 2023 to identify and locate a leak that was observed at a welded joint of an encasement pipe under Interstate 96 during construction activities. Note that this leak was observed for a few days and then the leak appeared to stop as it was no longer observed at the joint. Figure 1.2 highlights the scope of the 2023 inspection.

Figure 1.2: Aerial View of the 36-, 30-, and 24-inch Novi Road PCCP Water Transmission Main 2023 SmartBall Inspection.

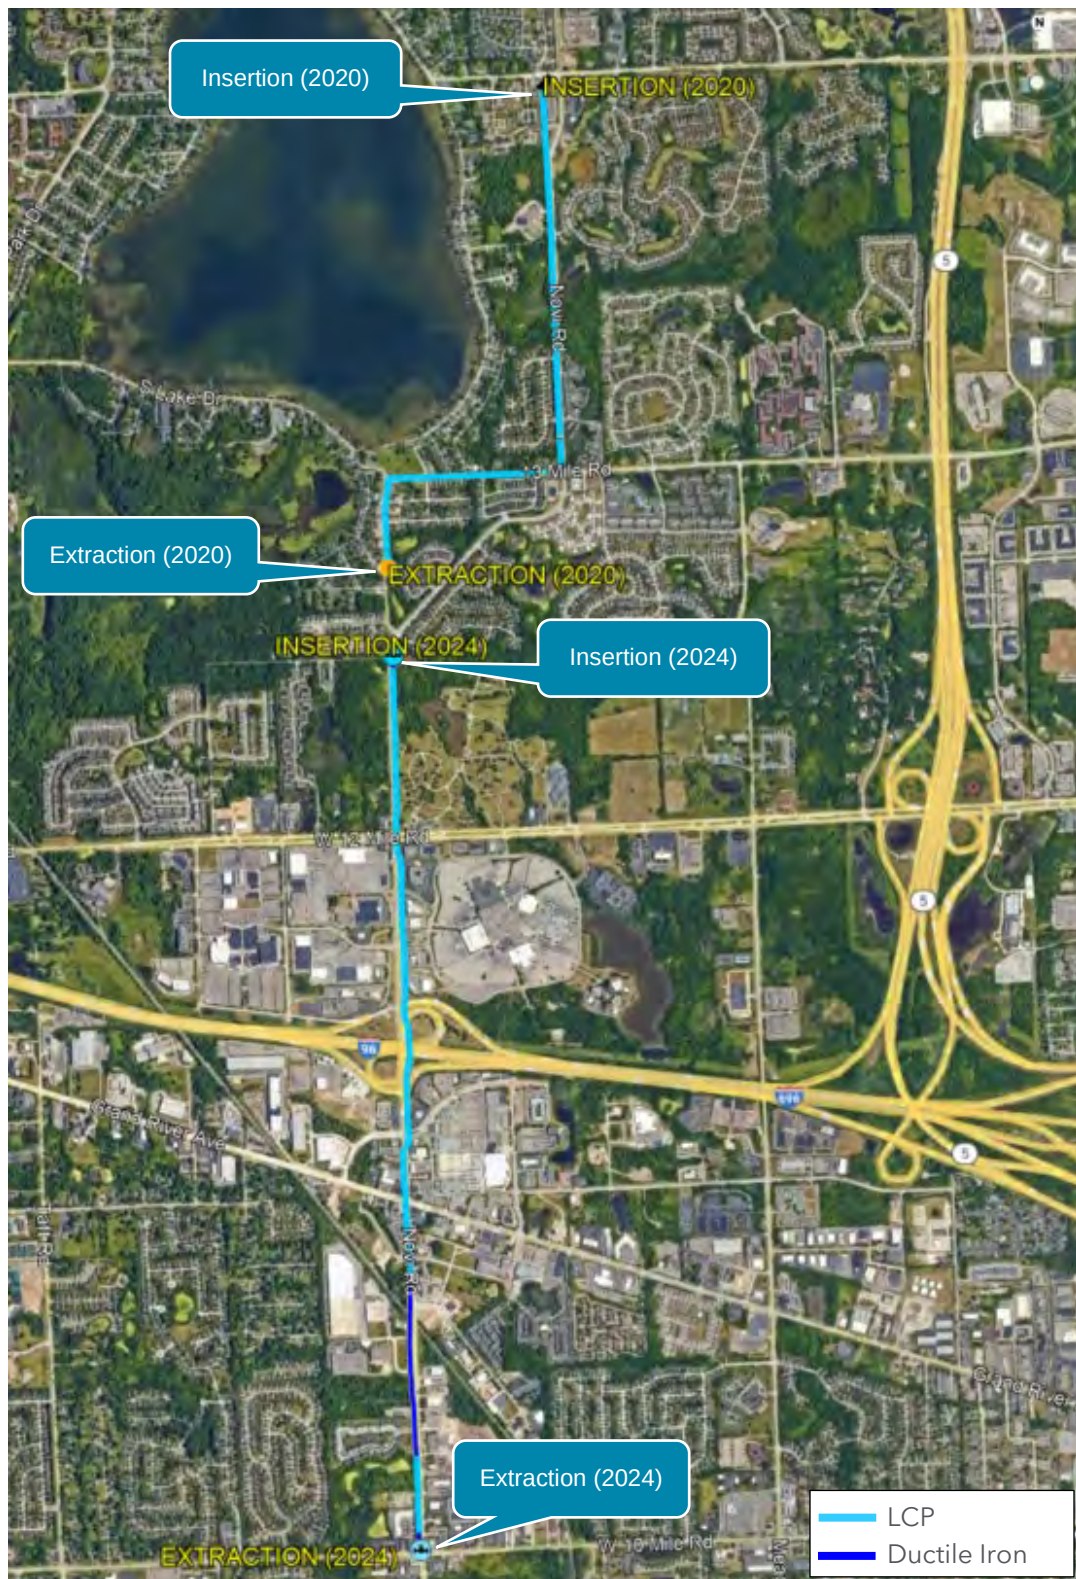
The 2024 PipeDiver inspection scope began at a newly installed 18-inch Tapping Saddle and Valve at Station 31+97, near 12 ½ Mile Road, approximately 1,483-feet downstream of the location the PipeDiver tool was unable to traverse in 2020. The inspection comprised a cumulative distance of approximately 14,776 feet (2.80 miles) of 36-inch, 30-inch, and 24-inch LCP, approximately 2,950 feet (0.56 miles) of which was 24-inch DIP. The electromagnetic data collected for the 24-inch DIP was not analyzable. A map of the inspected sections of the Novi Road PCCP Water Transmission Main is shown in Figure 1.3. This map shows the approximate geographical location of the pipeline.

Figure 1.3: 2020 and 2024 Inspection Limits.

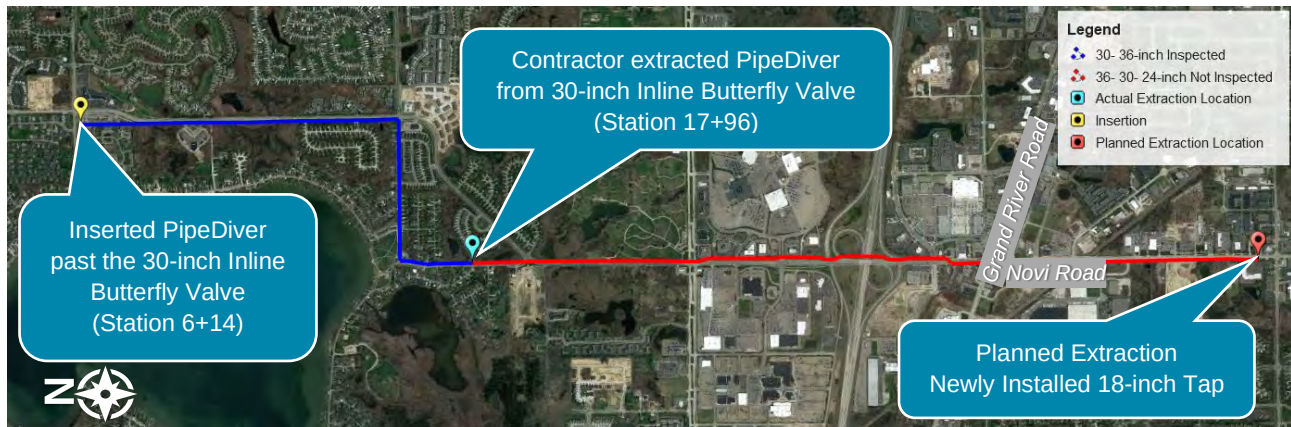
The 2020 inspection took place during a mid-winter break of the elementary school, so that isolation of the insertion locations did not affect normal school operations. During the inspection, the PipeDiver tool was stopped on all but one (1) of the butterfly valves it encountered. Each valve was exercised the help the tool maneuver around the valve. When the tool reached the valve near the intersection of Austin Drive and Old Novi Road, the valve exercising was unsuccessful. It appeared the gears on the valve actuator were worn and turning the key did not move the valve. Flows were adjusted to try and free the tool, but it remained stopped at the valve. The PipeDiver tool was removed from the pipe on Friday April 17, 2020. In total, the 30-inch and 36-inch LCP-PCCP PipeDiver inspection spanned 9,593 feet (1.8 miles) from the 30-inch butterfly valve (Station 6+14) located just downstream of the meter vault, NV-04, to the 30-inch butterfly valve (Station 17+96) near the intersection of Austin Drive and Old Novi Road. An overview of the 2020 PipeDiver inspection is shown in Figure 3.1.

Figure 3.1: Planned PipeDiver electromagnetic inspection scope. Note the red line indicates the part of the planned scope that was not inspected.

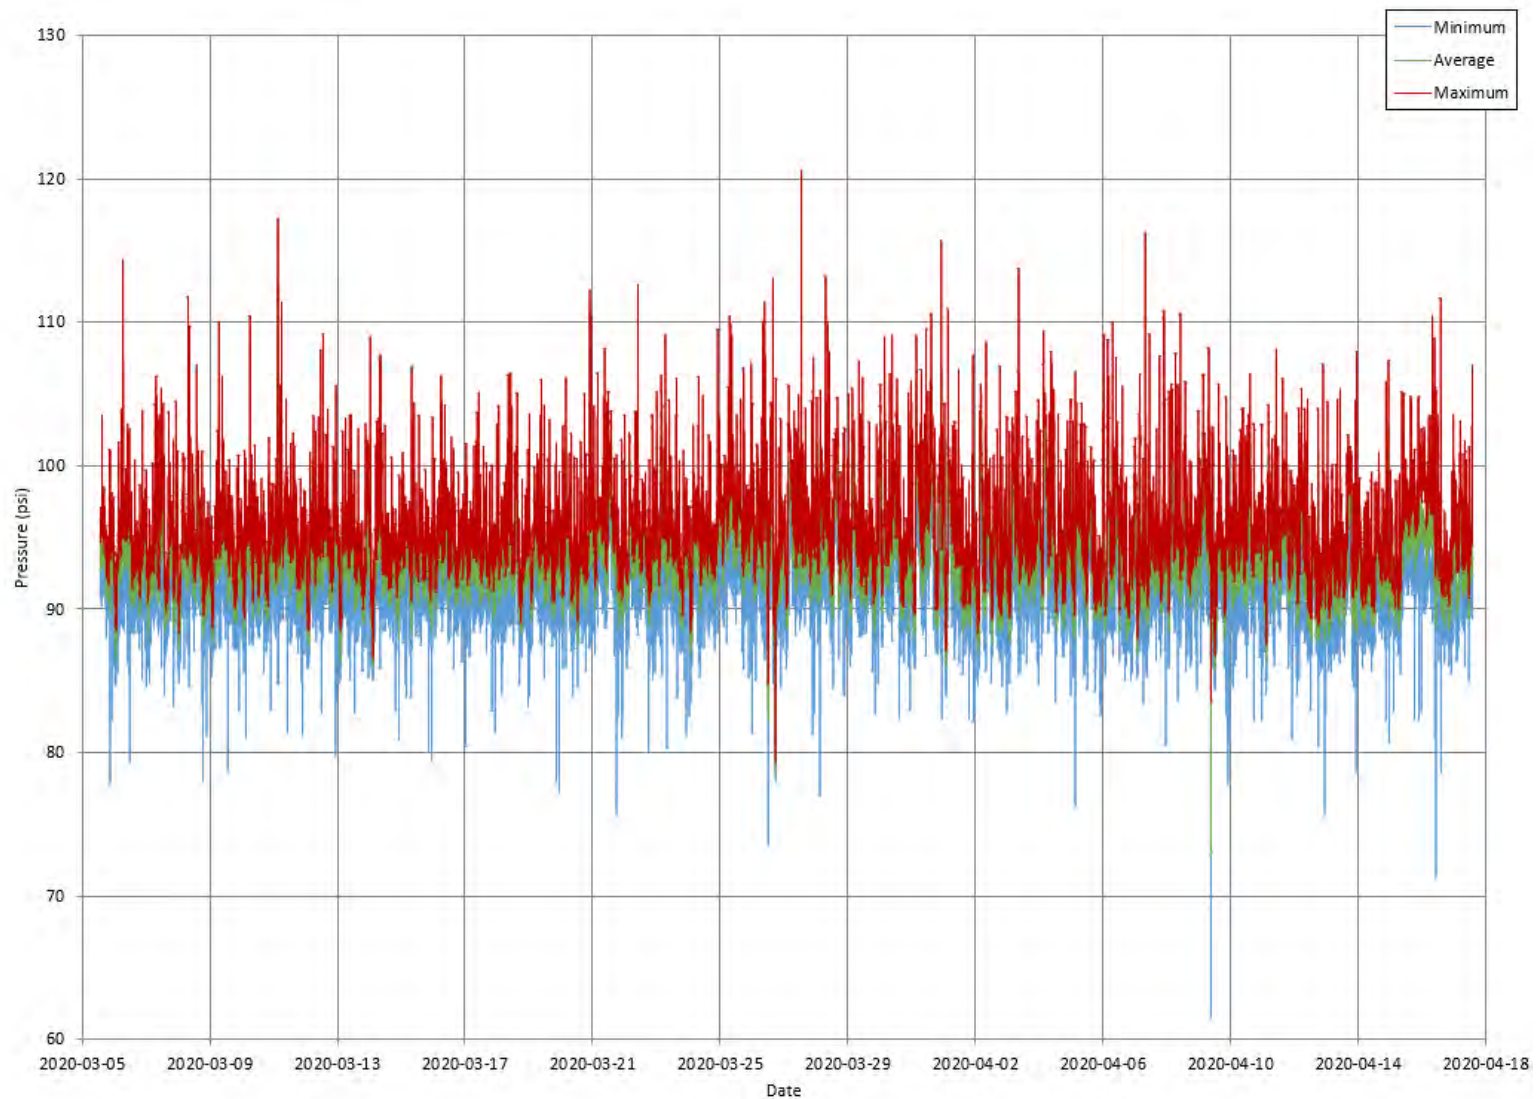
Maximum, minimum, and average pressures were recorded by the pressure logger at four-minute intervals. The maximum pressure recorded during the monitoring period was 120.6 pounds per

square inch (psi), the average pressure was 93.3 psi, and the minimum pressure recorded was 62.3 psi. A chart of the pressures recorded over the full monitoring period is included in Figure 4.3. Maximum pressures in a given four-minute recording interval are plotted along red lines, minimum pressures are plotted along blue lines, and average pressures are plotted along green line.

Figure 4.3: Novi Road Transmission Main (near NV-04) TPM Data - Full Monitoring Period.

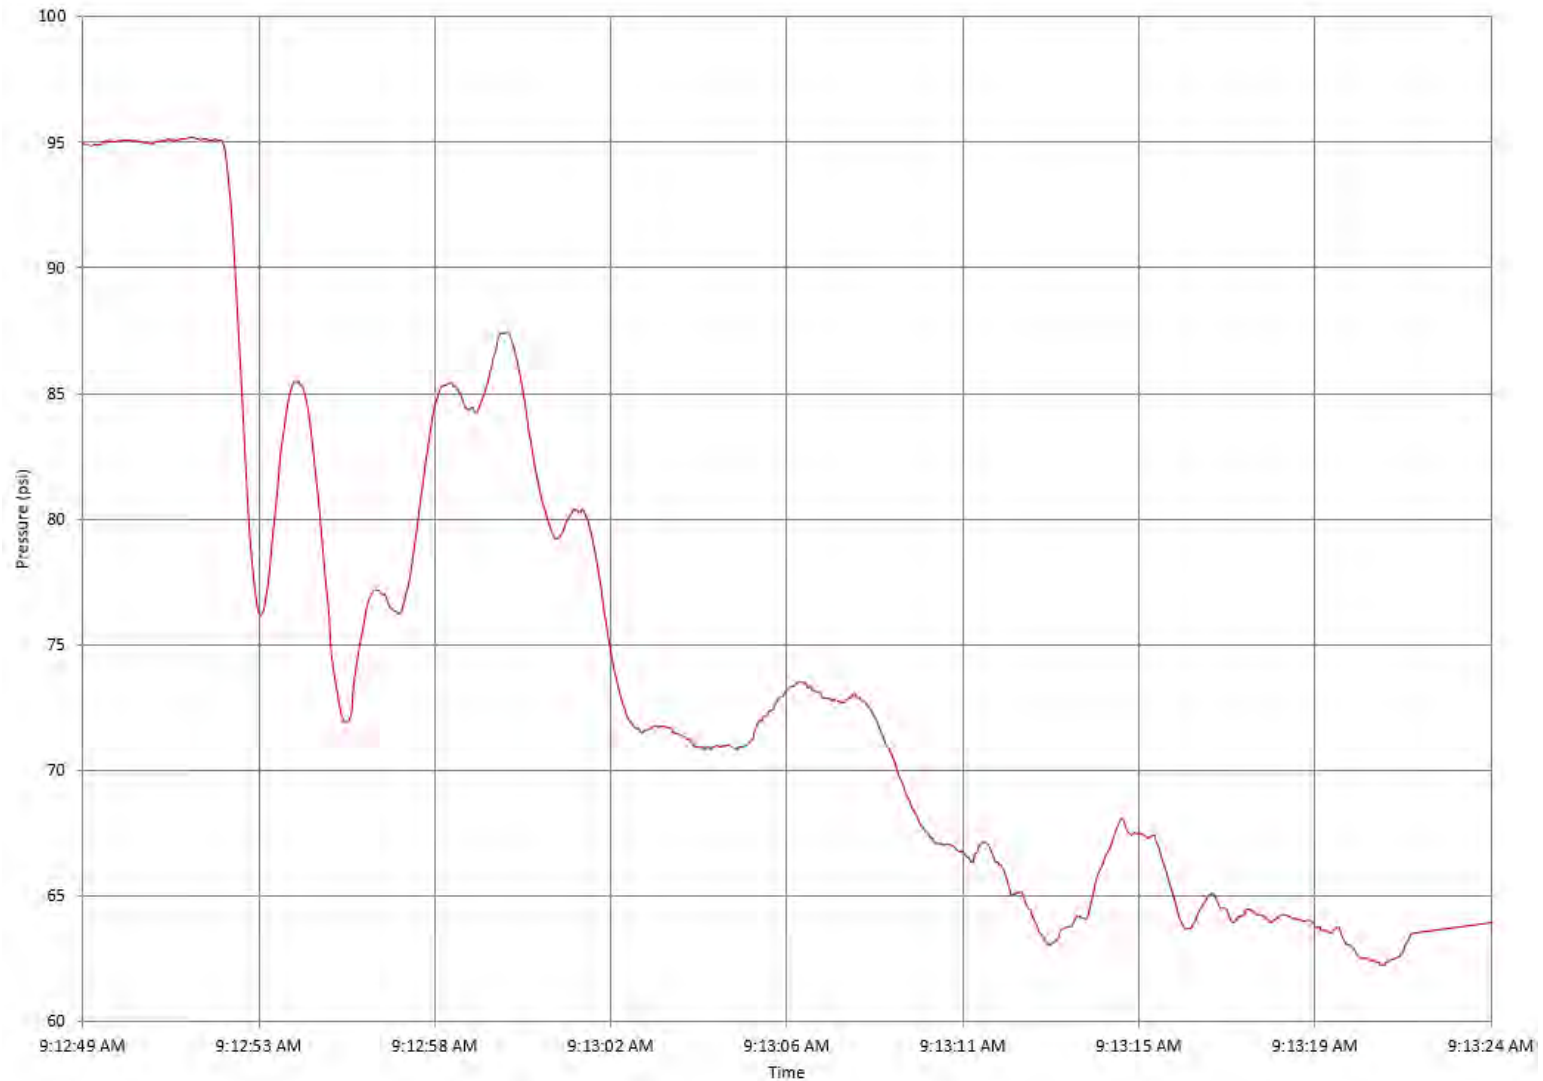
The minimum recorded pressure downstream of meter vault NV-04 monitoring location of 62.3 psi occurred on April 9, 2020. The transient event was observed at this time appears to be associated with a pump being shut off. It is recommended that supervisory control and data acquisition (SCADA) be reviewed to confirm this. The high point of the water main is 954.0 feet above MSL. Therefore, the minimum observed pressure throughout the pipeline, using previously listed assumptions, is approximately 57.9 psi. Further monitoring at different locations would refine this approximation.

Figure 4.6: Novi Road Transmission Main (near NV-04) TPM Data - Minimum Pressure Recording: Apparent Pump Shutoff (4/9/20).

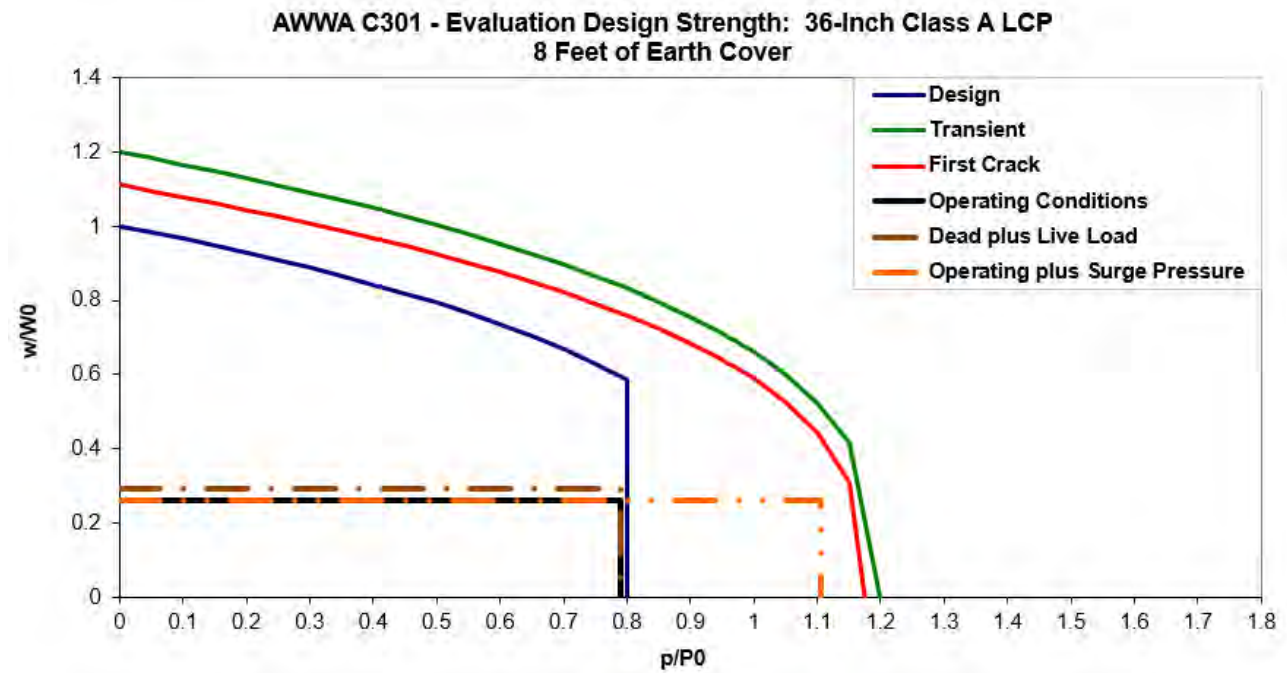
The AWWA C301 analysis was performed for the Novi Road Transmission Main as specified in Table 5.1. The AWWA C301 curves for the Novi Road Transmission Main LCP at a specific depth of six (6) or eight (8) feet earth cover per design are shown in Figures 5.1-5.4. The design operating pressure of 175 psi and the design surge pressure of 70 psi were used in the analysis. The specific depth of cover for Figure 5.1 was based on the depth of cover present for pipes with prestressing wire breaks as indicated in the as-built drawings and designs.

Figure 5.1: AWWA C301-Curve for the 36-inch Class A LCP pipe with 8 feet of Earth Cover.

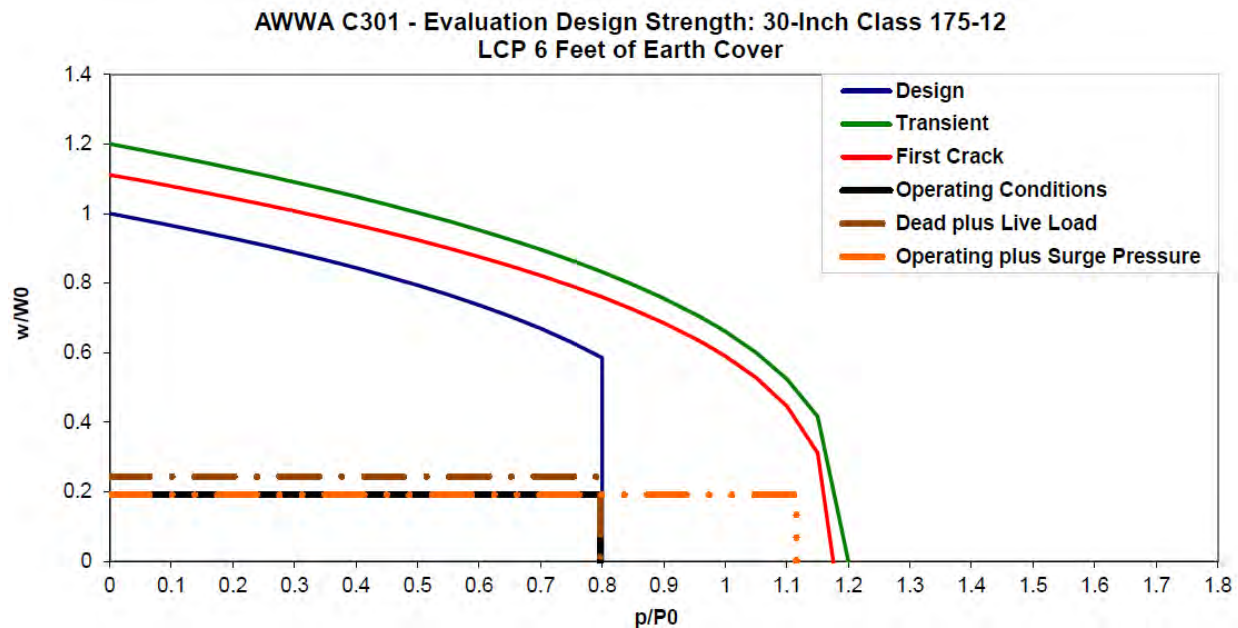
Figure 5.3: AWWA C301-Curve for the 30-inch Class 175-12 LCP pipe with 6 feet of Earth Cover.

Based on the results of the AWWA C304 analyses, all of the criteria for the Elastic Limit and Strength Limit were satisfied. Two (2) Serviceability Limit criteria were above the allowable limits for the 36-inch Class A, 30-inch Class 175-12, and 24-inch Class 175-14 designs- the Core Decompression and the Coating Cracking criteria. One (1) Serviceability Limit criteria was above the allowable limits for the 30-inch Class #184 design - the Core Decompression criteria. See Appendix F for C304 results.

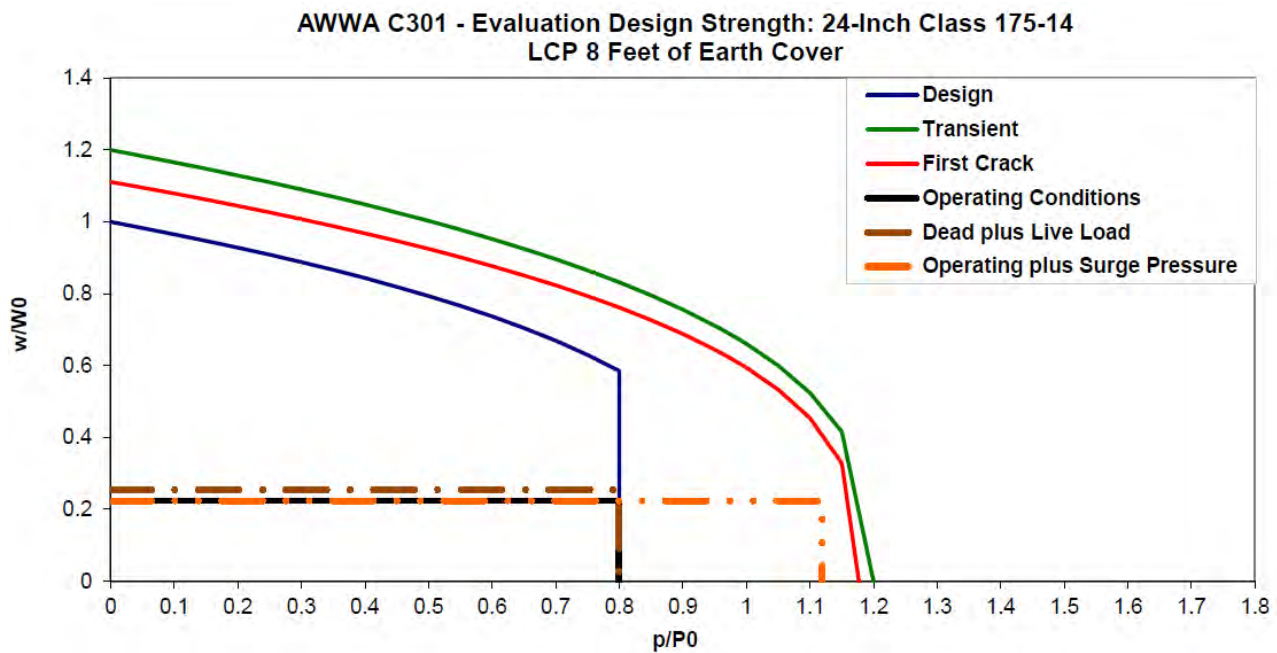
Figure 5.4: AWWA C301-Curve for the 24-inch Class 175-14 LCP pipe with 8 feet of Earth Cover.

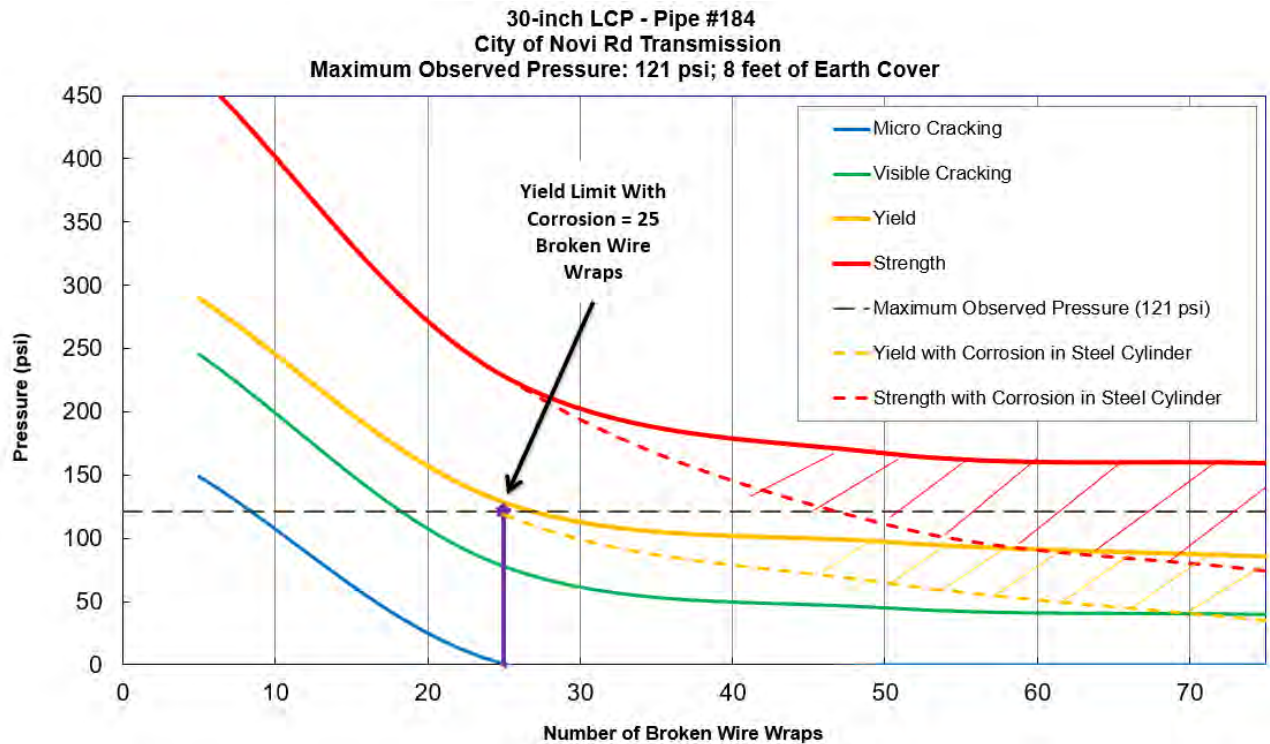
Figure 5.9: Performance curve for the 30-inch Class #184 LCP pipe at maximum observed pressure.

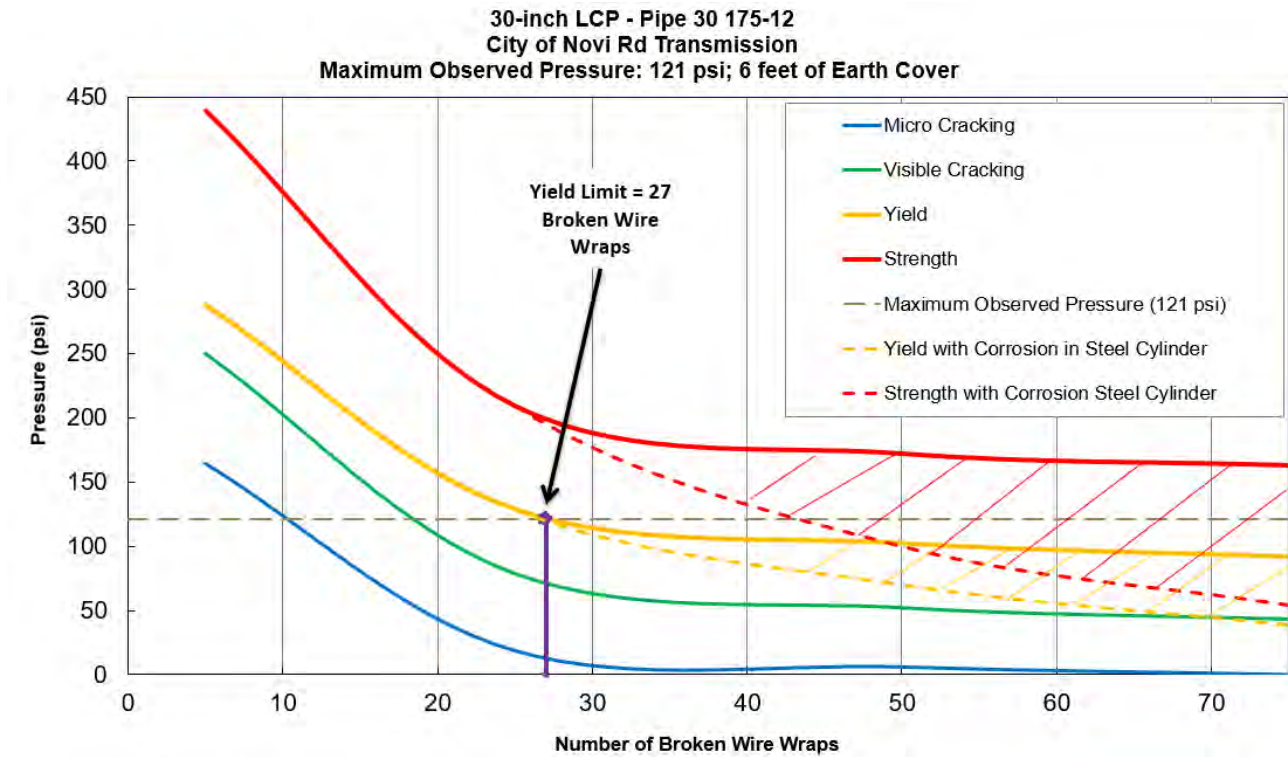
Figure 5.10: Performance curve for the 30-inch Class 175-12 LCP pipe at maximum observed pressure.

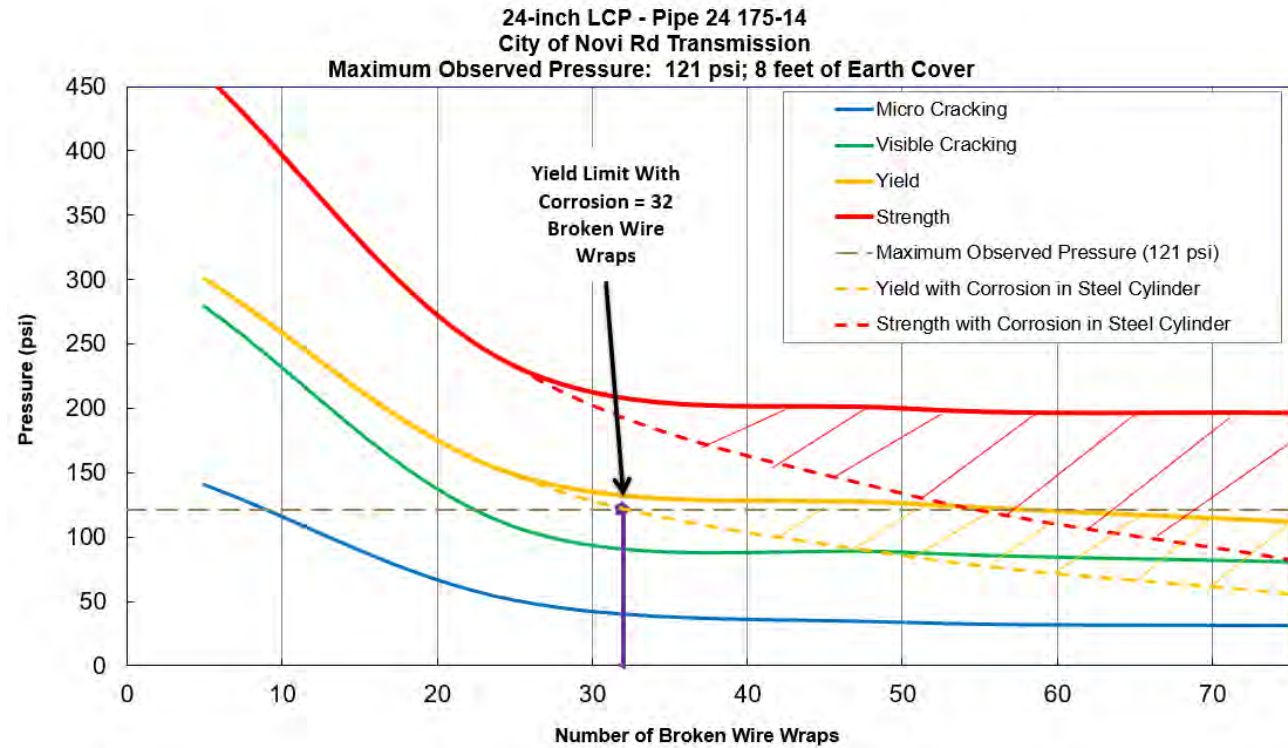
Figure 5.11: Performance curve for the 24-inch Class 175-14 LCP pipe at maximum observed pressure.

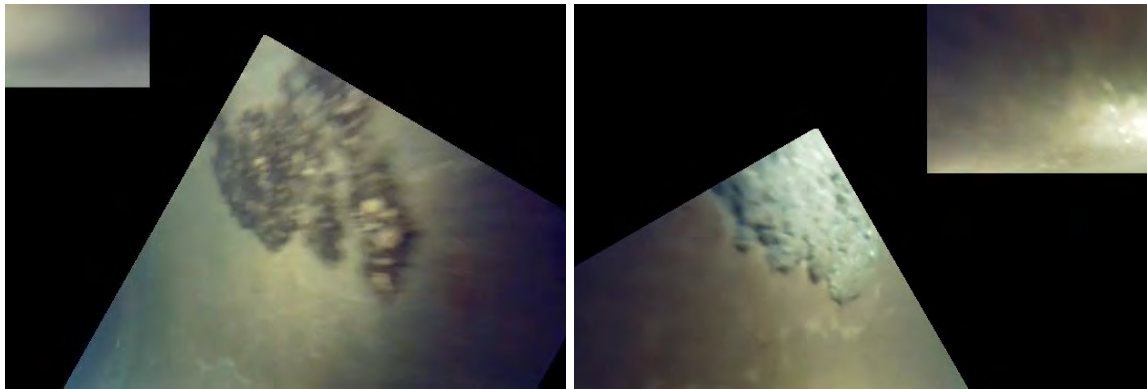
In addition to the leak location, several other observations were reviewed. Discoloration was noted in PRN 11173, as shown in Figure 6.2. Material buildup was observed in PRN 11169, 11289, and 11577, examples of which are shown in Figure 6.3. A possible protrusion into the pipe was observed in PRN 11194, illustrated in Figure 6.4. A visual anomaly was observed in Pure Reference Number 11506, seen in Figure 6.5. Details of video review are included in Appendix H.

Figure 6.3: Material buildup seen on Pure Reference Number 11552 (left) and 11577 (right)

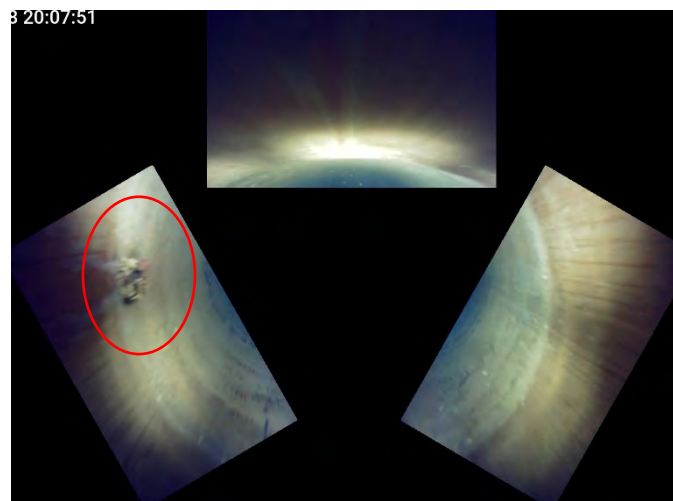
Figure 6.4: Possible protrusion into the pipe in Pure Reference Number 11194

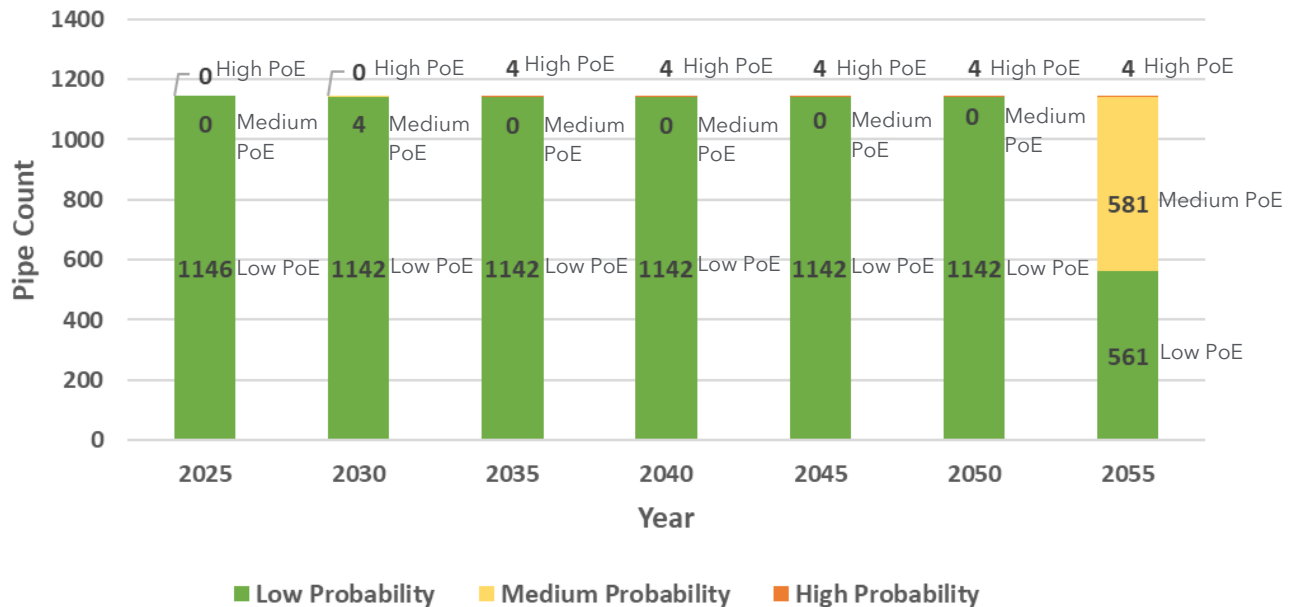
Figure 7.4. Expected Number of Pipes to Exceed Intervention Limit by Probability Categories.

A total of 4 pipes are expected to exceed their specified intervention limits with high PoE (greater than 10 percent), 581 pipes are expected to have a medium PoE (1 percent to 10 percent), and

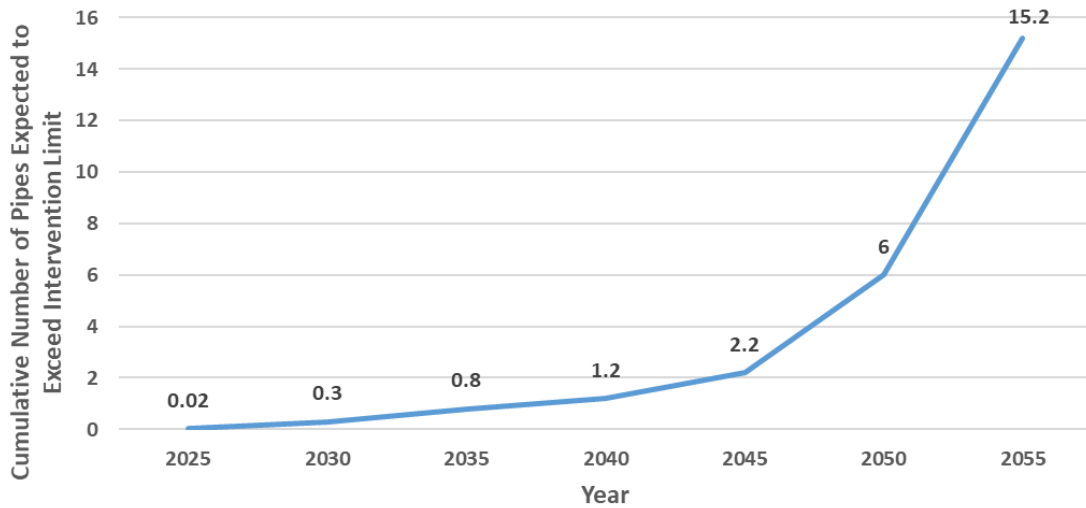
Figure 7.7. Cumulative Number of Pipes Expected to Exceed the Intervention Limit.

The predictive modelling analysis estimates that 15 pipes will reach their Yield Limit at the current maximum operating pressure by the year 2055. The results of the modelling are probabilistic and can be used for long-term capital planning rather than short-term repair decisions.

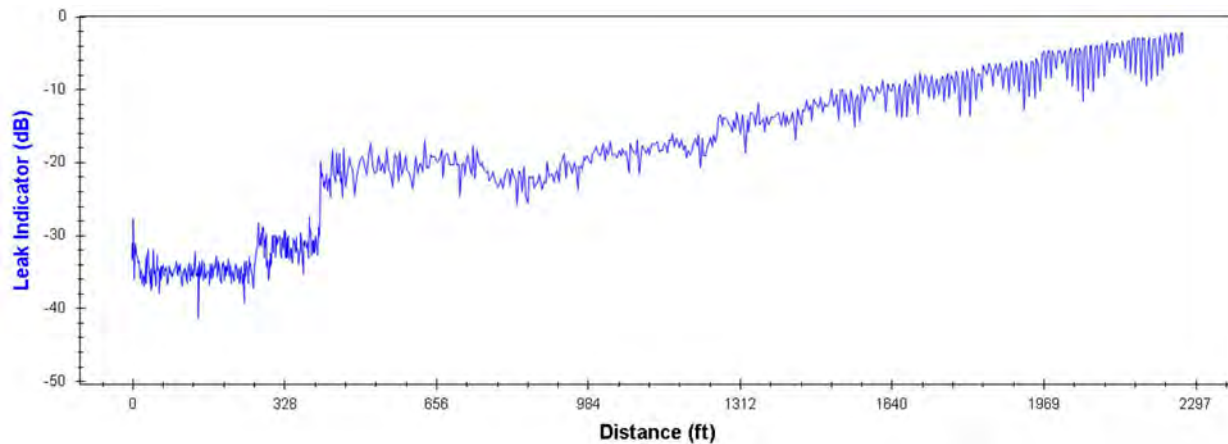
Figure 3.1: Acoustic summary of the SmartBall inspection versus Distance Traveled for the Inspection

The acoustic data recorded by the SmartBall tool was analyzed and cross-referenced with the position data from each SBR to determine a location for each acoustic event. A summary of the leaks identified during the east SmartBall inspection is provided in Table 3.1.

Figure 3.1 shows the acoustic profile of the inspection with respect to the position of the tool within the pipeline, as detected by the SmartBall technology. The magnitude of leaks is estimated by correlating the value of the acoustic signal with historical calibration data.

It is important to note that this overview may contain anomalous spikes in the data. These spikes may have been caused by ambient noise around the pipeline from external sources such as pumps or nearby traffic. These sources of ambient noise are easily distinguishable from leaks or other points of interest upon analysis by trained personnel. Ambient noise generally occurs at a much lower frequency than the frequencies generated by a leak or pockets of trapped gas. The critical findings of the SmartBall inspection are summarized in Table 3.1.

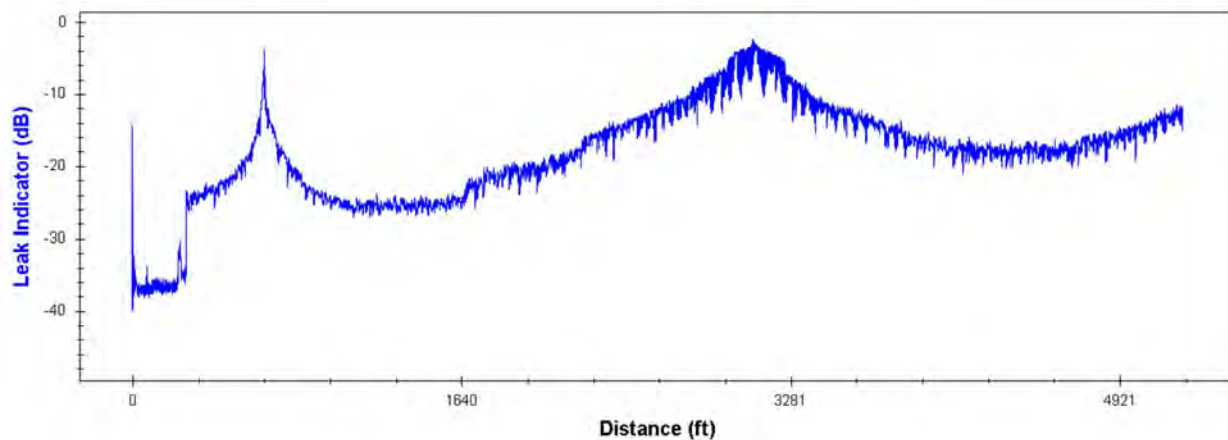
*Figure 3.3: Acoustic summary of the West Inspection versus Distance Traveled*

The acoustic data recorded by the SmartBall tool was analyzed and cross-referenced with the position data from each SBR to determine a location for each acoustic event. A summary of the leaks identified during the SmartBall inspection is provided in Table 3.2.

Figure 3.3 shows the acoustic profile of the inspection with respect to the position of the tool within the pipeline, as detected by the SmartBall technology. The magnitude of leaks is estimated by correlating the value of the acoustic signal with historical calibration data.

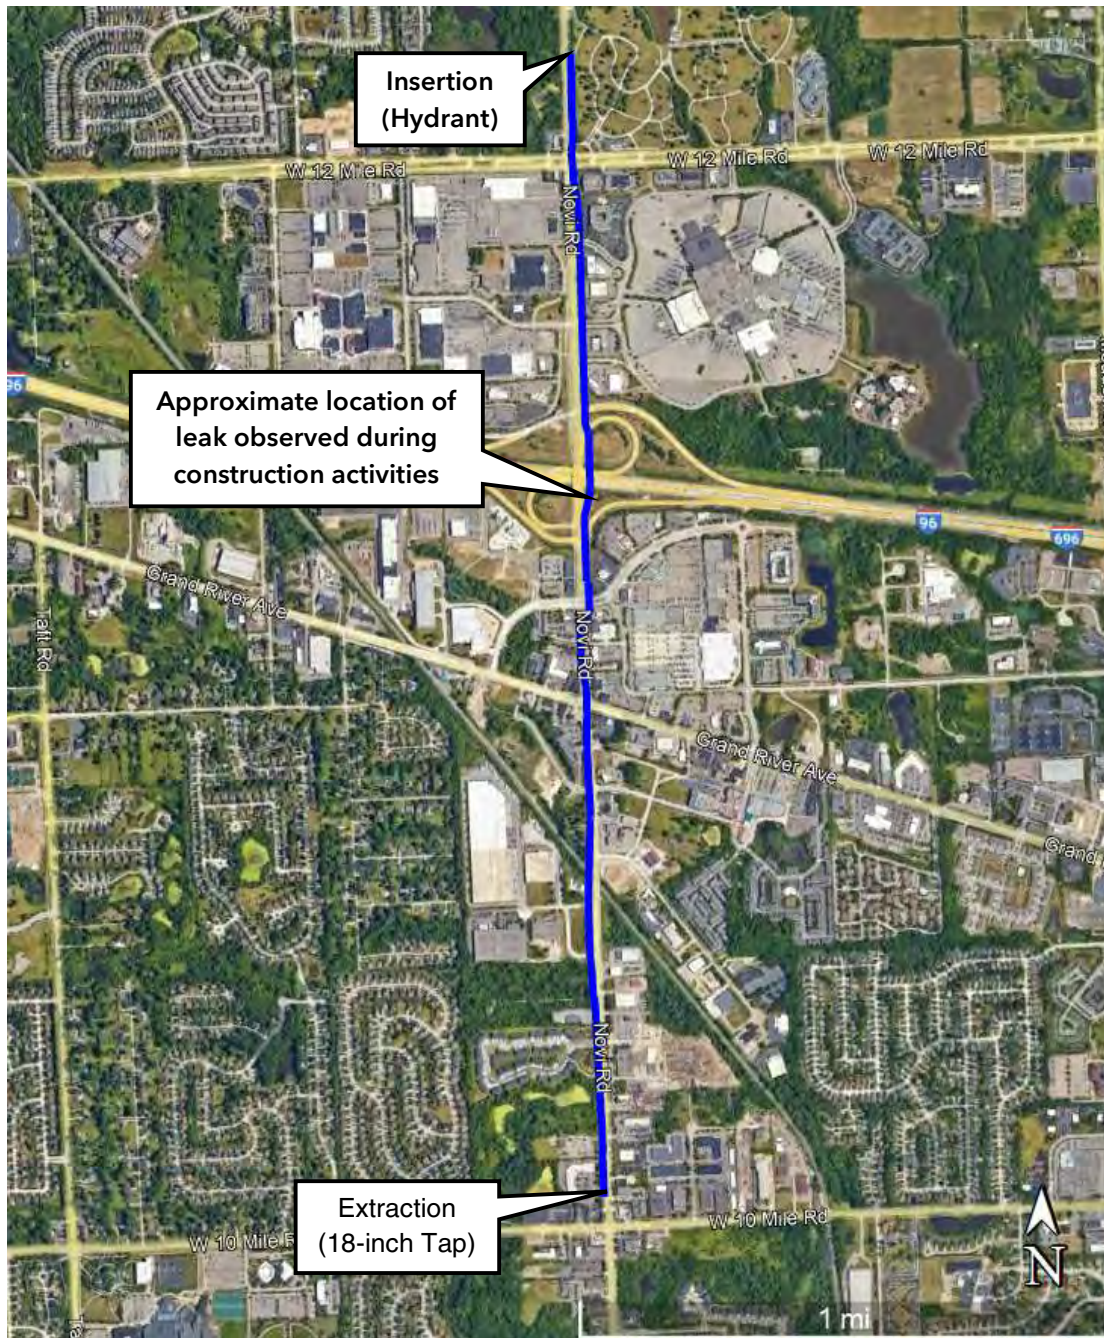
Figure 1.1: Aerial View of the 36-, 30-, and 24-inch Novi Road PCCP Water Transmission Main

The SmartBall inspection was performed to identify and locate a leak that was observed at a welded joint of an encasement pipe under Interstate 96 during construction activities. Note that this leak was observed for a few days and then the leak appeared to stop as it was no longer observed at the joint. The approximate pipeline location is shown in Figure 1.1. Flow proceeds from Insertion to Extraction.
