## PEDESTRIAN AND BICYCLE ADVISORY COMMITTEE MEETING AMENDED AGENDA

May 08, 2025 at 11:30 AM

# DIVISION AVE. RSA • ANNUAL AVERAGE DAILY TRAFFIC (AADT)

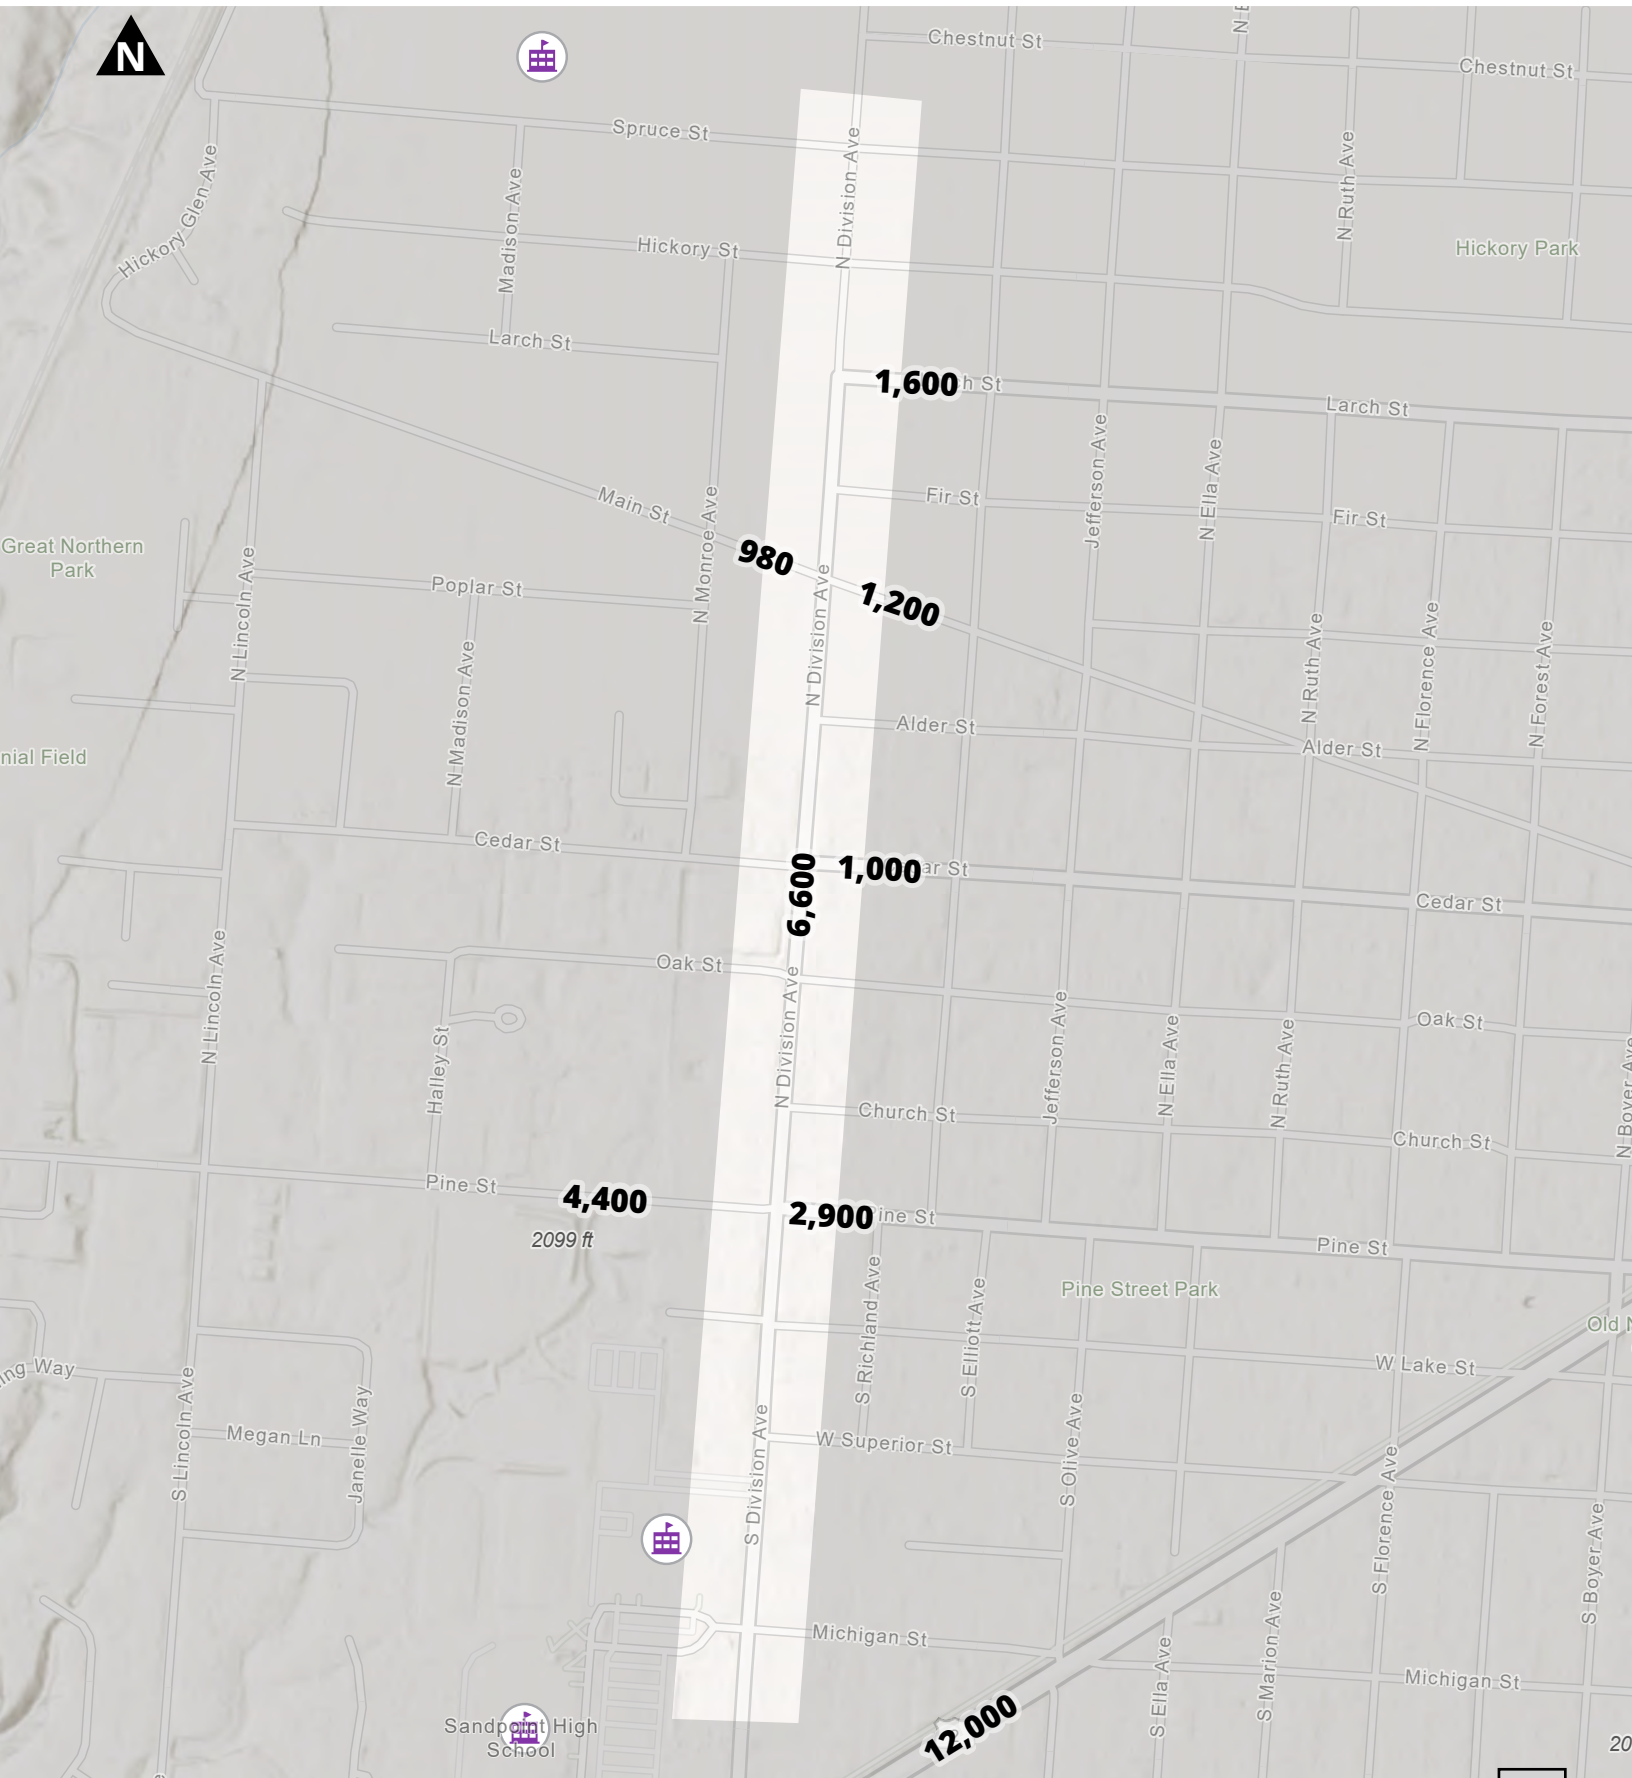
Figure 1

**Figure 1** outlines the 2019 AADT reported by ITD within the RSA study area and **Figure 2** outlines the commercial truck traffic as a percentage that AADT.

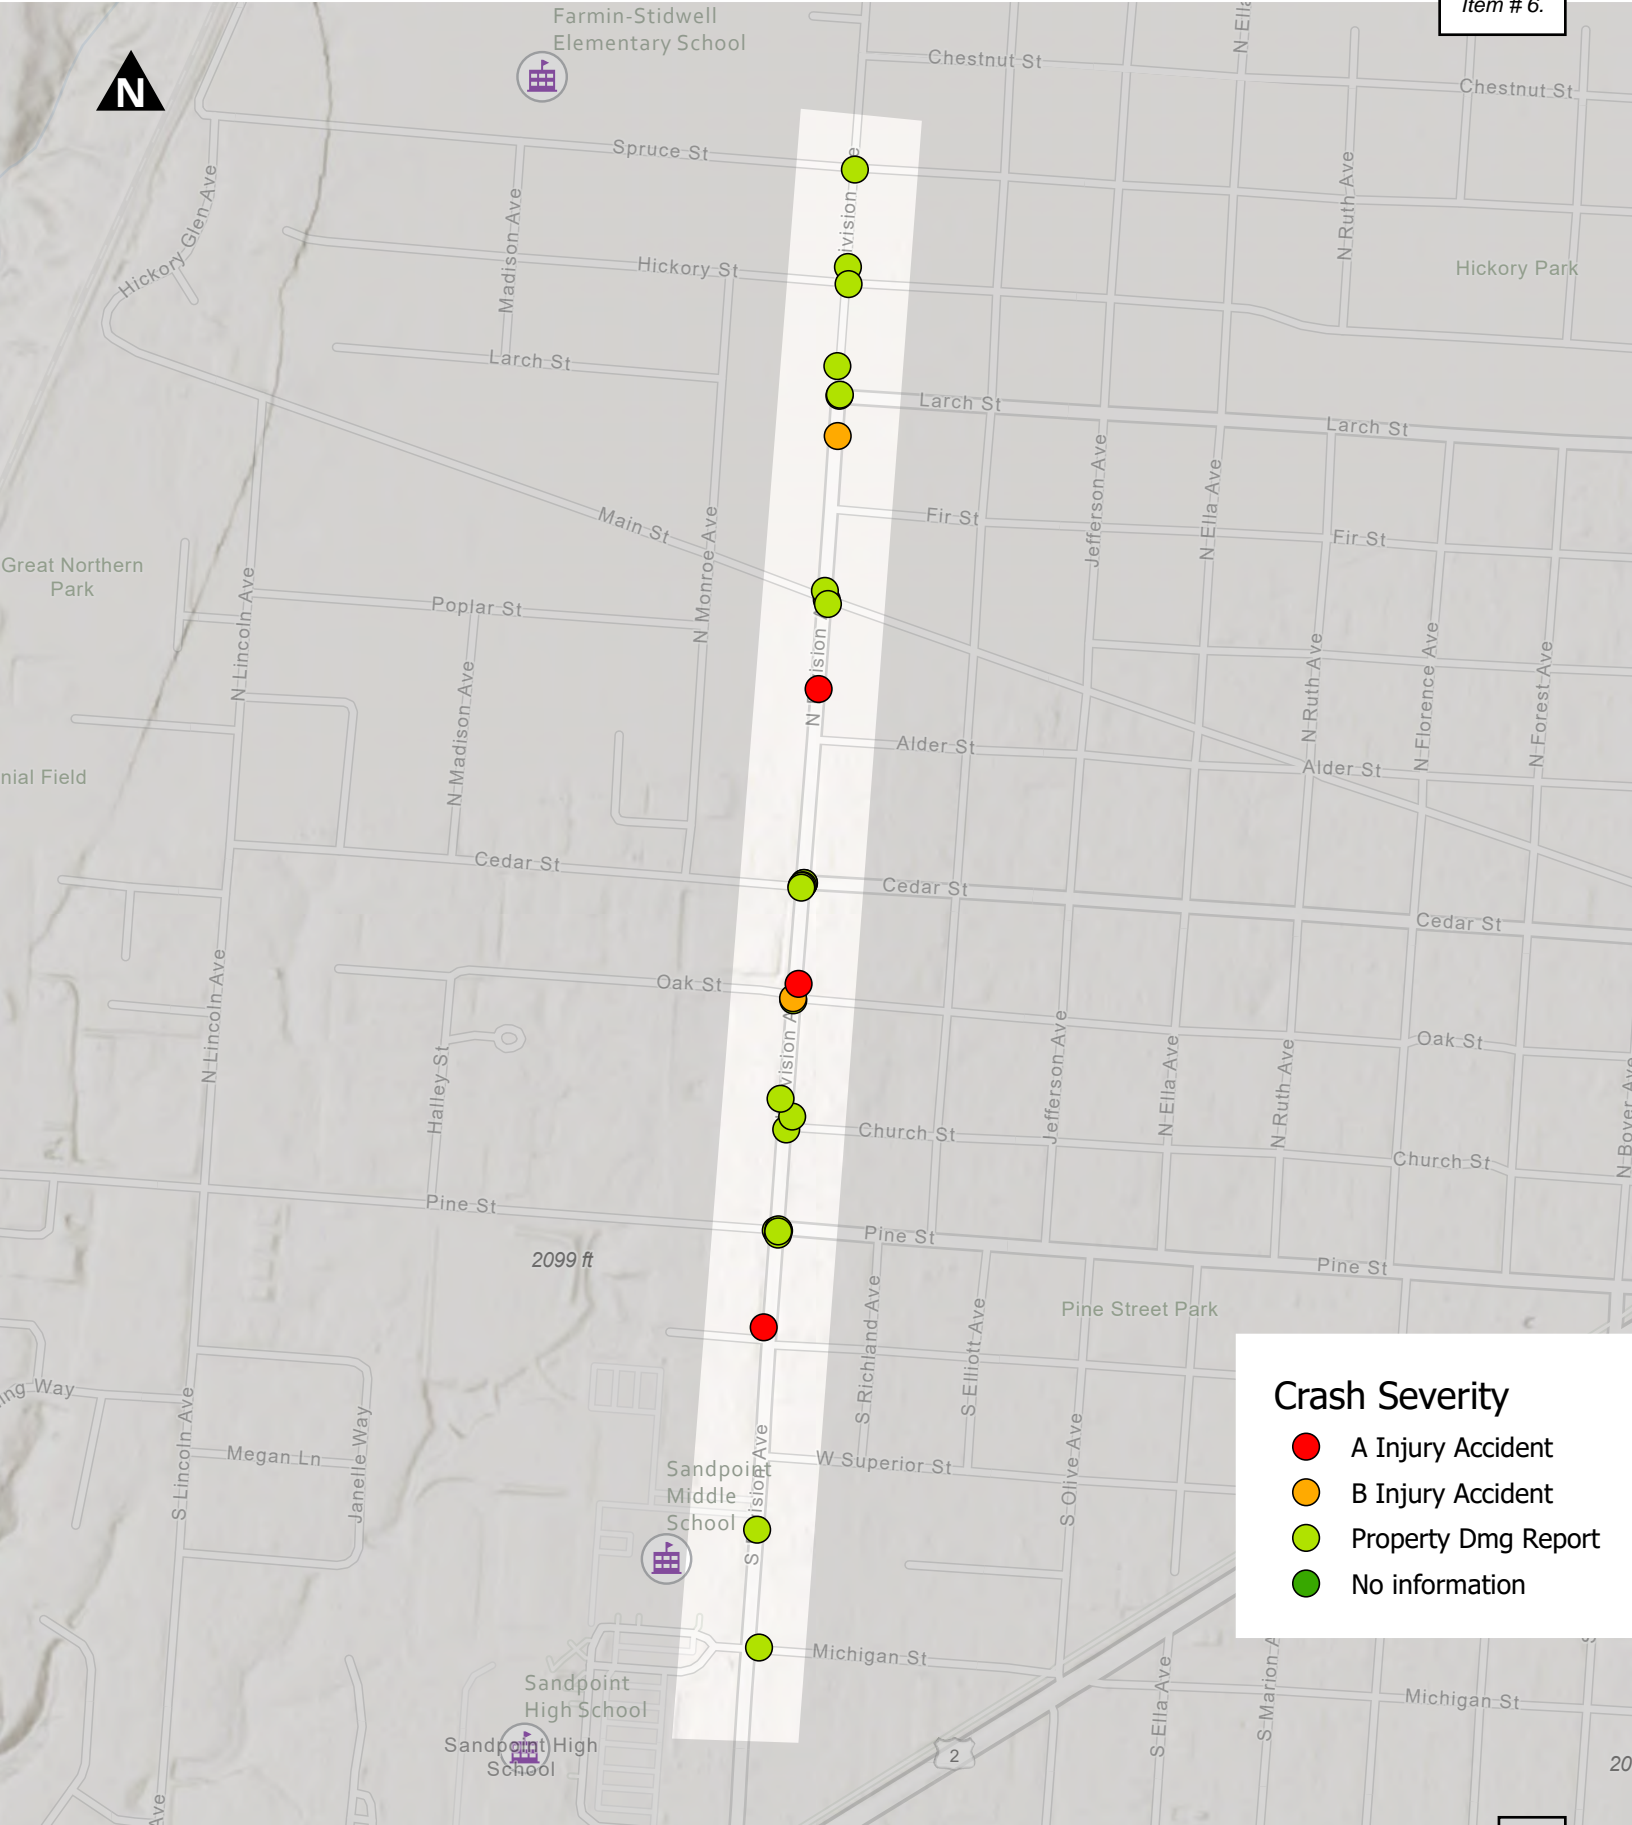
**Figure 3** shows a map of the crashes within the RSA study area by severity, **Figure 4** shows a map of the crashes within the RSA study area by type, and **Figure 5** shows a heatmap of the crashes in the study area to indicate crash density.

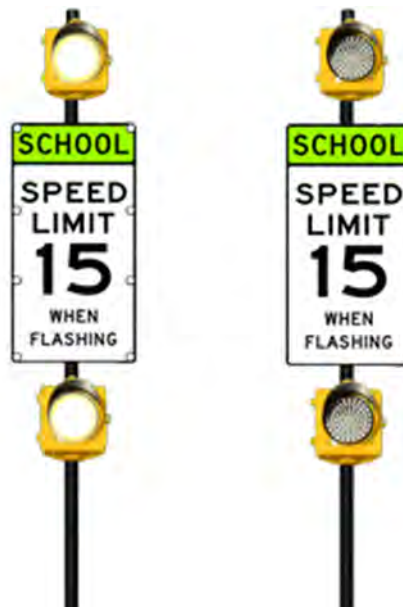
Figure 7: School Speed Limit Signs with Flashing Beacons

The RSA team observed that school zone signs along Division were posted to reduce the speed limit to 20mph. The speed limit along the rest of Division Avenue is 25mph, so the school zone only reduces the speed limit by 5mph. Furthermore, the school zone speed limit is active from 7:30 AM to 3:30 PM, even during periods when the school is not starting or ending. The law enforcement representative on the RSA team noted that the minor reduction in speed limit and broad time that the school speed limit is in effect has resulted in low compliance, but the increased police presence has helped.

The school zone speed limit is 20mph (5mph lower than the normal speed limit on Division Avenue) and active from 7:30 AM to 3:30 PM. To increase compliance with the school zone speed limit, the RSA team

recommends adding flashing lights to the school zone speed reduction signs (see **Figure 7** for example); the flashing lights should be either automatically scheduled, or manually activated by a crossing guard. The RSA team also recommends that the school zone speed limit reduction should only active during school opening and closing peak periods, when students are likely to be present. If speeds continue to be an issue during the school opening and closing peak period, then reducing the school zone speed limit to 15mph (10mph lower than the normal speed limit) would be appropriate. Police presence to enforce the speeds should continue to be a priority.

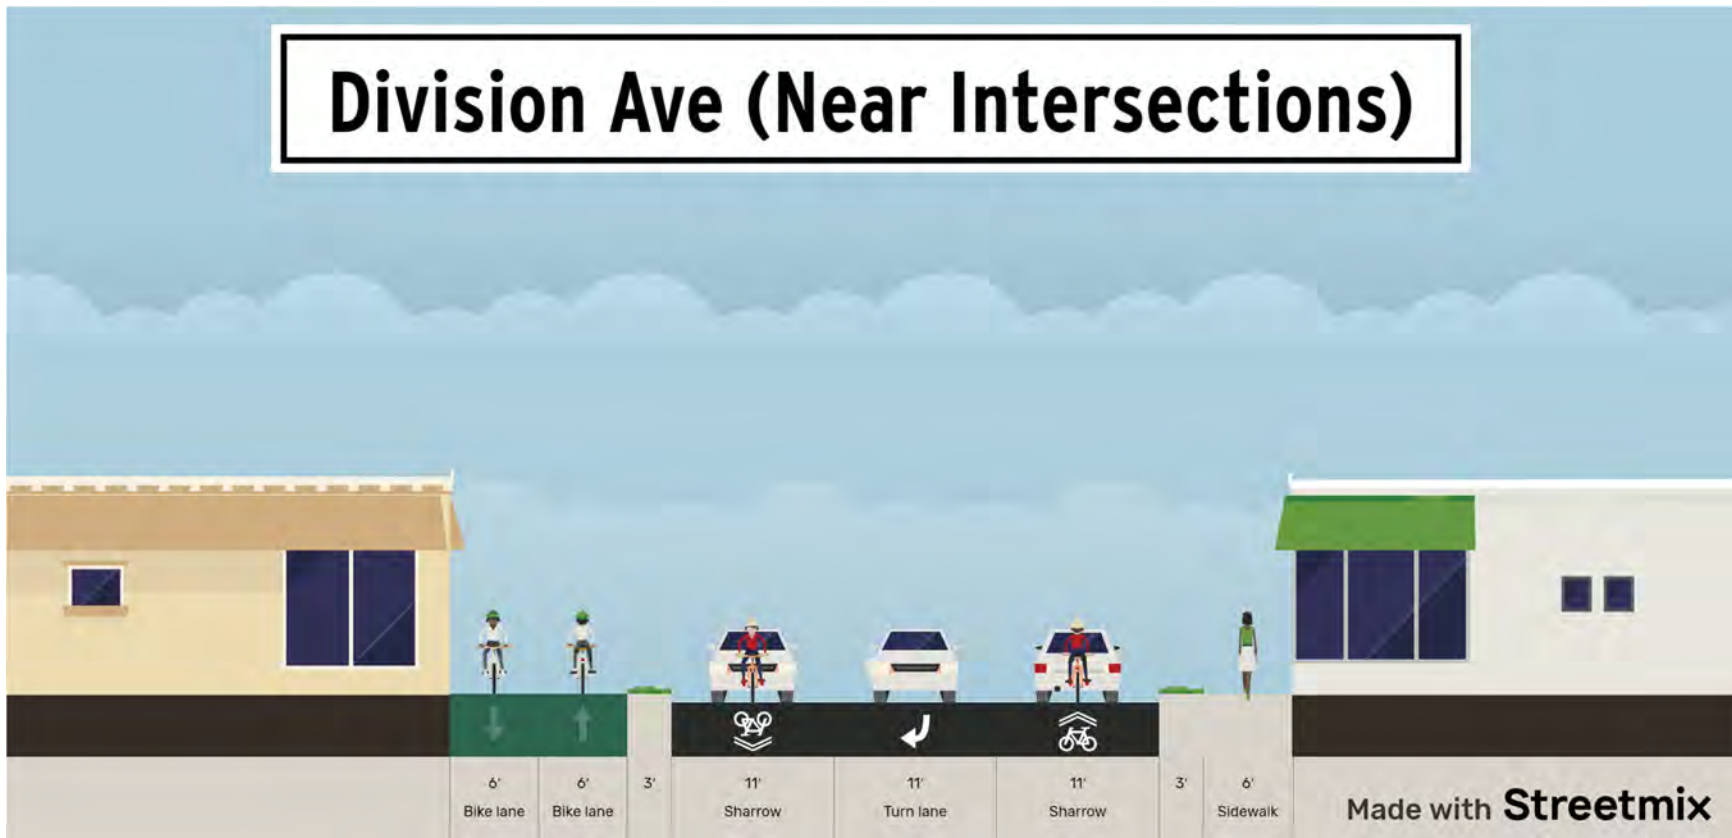
Figure 9: Proposed Division Avenue cross section near intersections.

To better serve cyclists, pedestrians, and vehicle traffic along Division Avenue, Fehr & Peers recommends reconfiguring the full length of Division Avenue. Fehr & Peers measured the cross section of Division Avenue at multiple locations and found the average cross section to be about 57 feet across. Sandpoint Public Works staff indicated that maintaining the multi-use path was essential. For bi-directional travel, the multi-use path should be expanded to be at a minimum 10 feet wide. The Public Works staff also indicated that landscaped buffers should be included in any reconfiguration to provide space for snow storage during the winter and to serve as a buffer between cyclists, pedestrians, and vehicle traffic. Since Division Avenue is a designated truck route, Fehr & Peers also recommends maintaining at least 11 feet lanes throughout the corridor.

**Figure 9** shows the cross section of Division Avenue near intersections where a left-turn lane is required. In these segments, the bike lanes are recommended to be removed and the vehicle lanes are recommended to be narrowed to 11 feet to accommodate the widened multi-use path, planting strips, and sidewalk. Since bike lanes would no longer be provided along Division Avenue, Fehr & Peers recommends adding “Sharrow” pavement markings to indicate to drivers that cyclists may use the vehicle travel lane. The sharrows will provide an area for the commuting cyclists while the multi-use path provides an area for the other users who are less comfortable sharing the road with motor vehicles. With the additional space, Fehr & Peers recommends widening the multi-use path to 12 feet and marking it for bi-directional travel. The east side sidewalk is also recommended to be widened to 6 feet for the length of the corridor. Planting strips are also recommended to be added to provide snow storage. While Sandpoint City staff expressed that planting strips should be 5 feet wide, due to the limited cross-section space, staff also expressed that a minimum planting strip width of 3 feet would be acceptable near intersections with left-turn lanes.

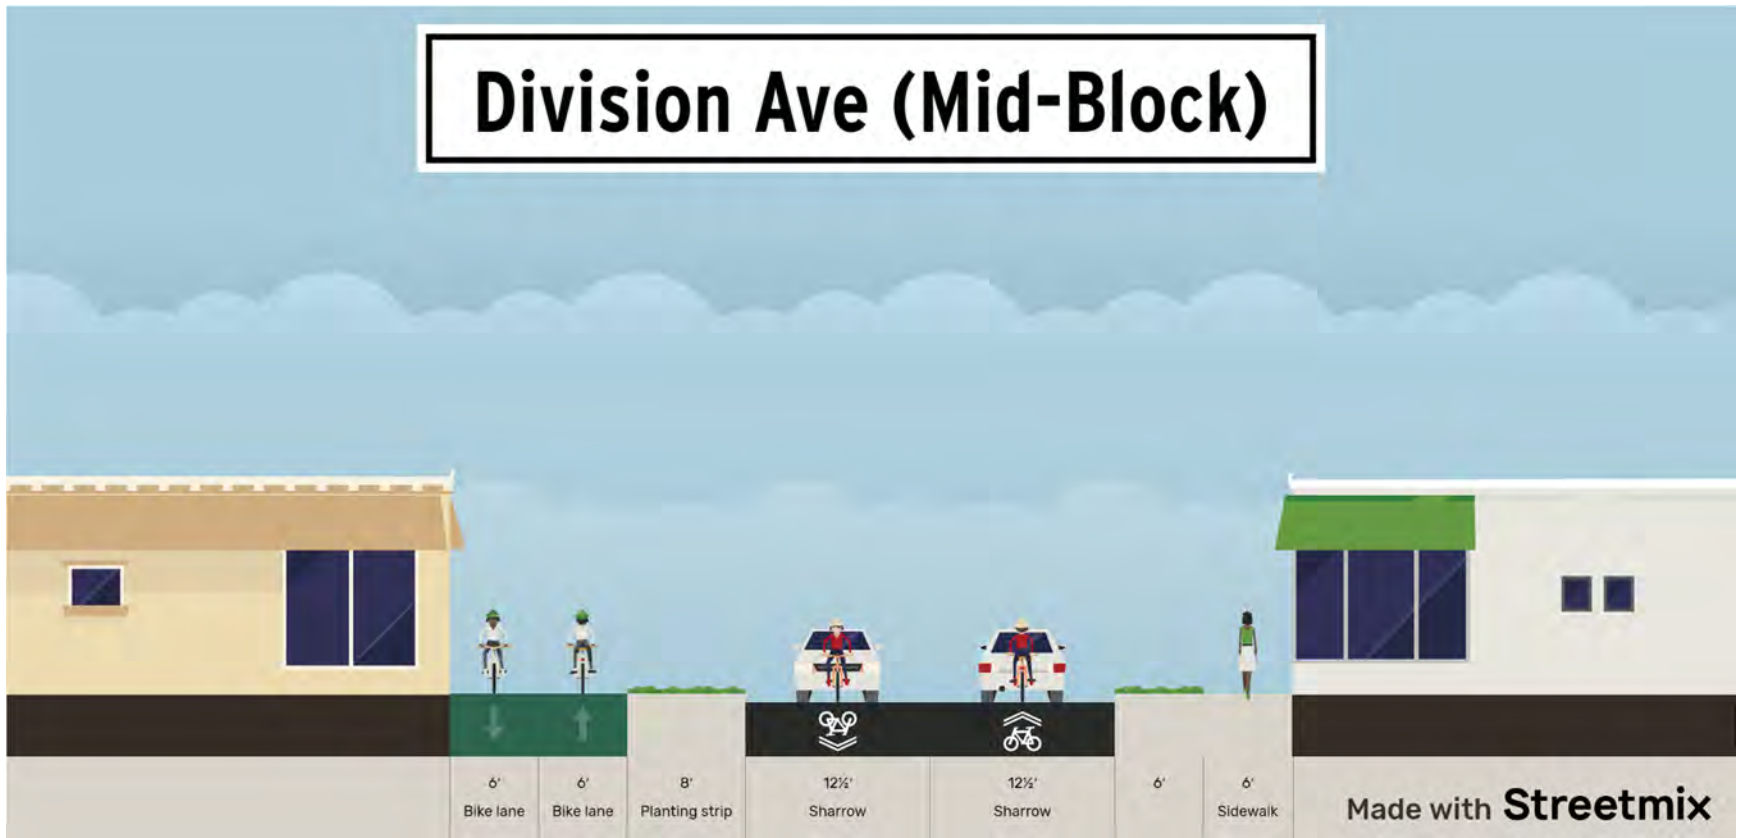
Figure 10: Proposed Division Avenue cross section mid-block (away from intersections).

1. The wider, directionally marked, multi-use path would provide additional space to cyclists and pedestrians.
2. The current 5 feet sidewalk is restrictive for pedestrians with disabilities. Widening to 6 feet provides additional space to make the sidewalk more comfortable.
3. The planting strips between the multi-use path/sidewalk and the vehicle travel lanes serve as snow storage and as additional buffer space between bikes/peds and vehicle traffic.
4. Historically, wide vehicle travel lanes, like the current lanes along Division Avenue encourage speeding. Narrowing the lanes along Division Avenue is recommended to discourage speeding.

**Figure 10** shows the cross section of Division Avenue between intersections where no left-turn lane is required. In these segments, the 11 foot turn lane is removed and the planting strips are recommended to be widened to provide additional snow storage. The travel lanes are also widened to 12 feet with an extra 0.5 foot added to the gutter, also for snow storage. The multi-use path and sidewalk widths are also recommended to be maintained to provide a continuous walking/biking trail.
