URBAN FORESTRY COMMISSION SPECIAL MEETING AGENDA

2. Recommendation to City Council: Existing Trees as they relate to the Downtown Parking Lot Improvement Project - **action item**

CITY PARKING LOT IMPROVEMENTS
218 CHURCH STREET
SANDPOINT, IDAHO

CITY PARKING LOT IMPROVEMENTS 2025

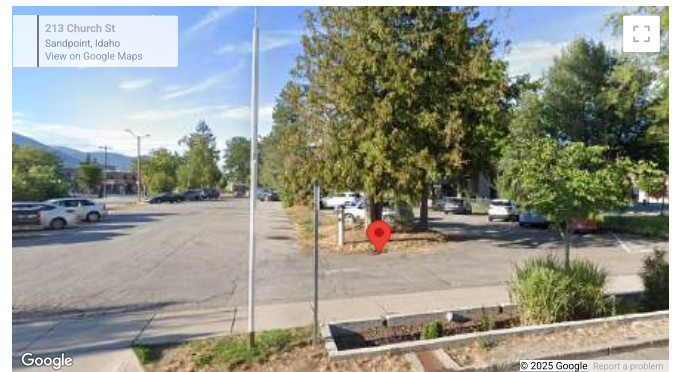
IMG_2707.jpg
 9/29/2018

Tree Information	
Tree Id:	7764
Latin Name:	Thuja plicata
Common Name:	Western Redcedar
Cultivar:	
Genus:	Thuja
Code:	THPL
Status:	Alive
Year Planted:	
DBH:	14
DBH Range:	12-18in
Tree Height:	
Number of Stems:	1
Condition:	Good - No Apparent Problems
Percent Dieback:	None
Crown Class:	Co-Dominant
Clearance Conflicts:	None

Condition:	Good - No Apparent Problems
Percent Dieback:	None
Crown Class:	Co-Dominant
Clearance Conflicts:	None
Observations:	Poor Structure, Double Leader
Stock Type:	
Tree Comments:	Two trunked cedar.
Family:	Cupressaceae
Has Ecobenefits:	Yes
Last Modified:	09/29/2018
Upload ID:	upld_5818ec7cd30a8
User - Upload:	
Last Inspection:	
Next Inspection:	
Inspection Cycle:	
Crown Light Exposure:	
Archived:	No
Tree Protection Zone(TPZ):	
Critical Root Zone(CRZ):	
TPZ Ratio:	
CRZ Ratio:

Management Needs	
Primary Maintenance:	Large Tree (routine)
Secondary Maintenance:	None Needed
Wires:	No Lines
Watch This Tree? :	No
Maintenance Comments:	Consider removing one of the two trunks to prevent future problem. Not high priority.
Organization:	Sandpoint
User:	SP_sdrinkard

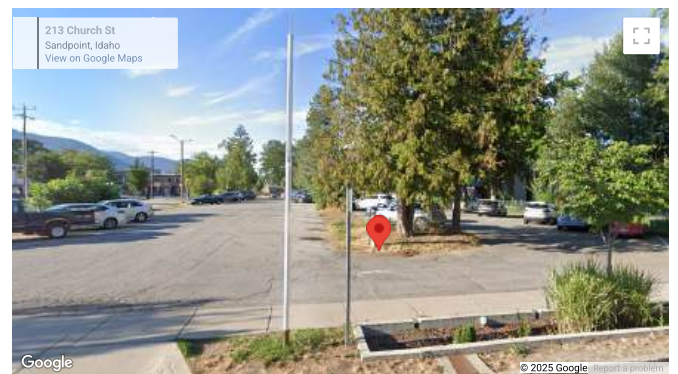
Tree Information	
Tree Id:	7765
Latin Name:	Thuja plicata
Common Name:	Western Redcedar
Cultivar:	
Genus:	Thuja
Code:	THPL
Status:	Alive
Year Planted:	
DBH:	14
DBH Range:	12-18in
Tree Height:	
Number of Stems:	1
Condition:	Good - No Apparent Problems
Percent Dieback:	None
Crown Class:	Co-Dominant
Clearance Conflicts:	None

Management Needs	
Primary Maintenance:	Large Tree (routine)
Secondary Maintenance:	None Needed
Wires:	No Lines
Watch This Tree? :	No
Maintenance Comments:	Consider removing one of the two trunks to prevent future problem. Not high priority.
Organization:	Sandpoint
User:	SP_sdrinkard

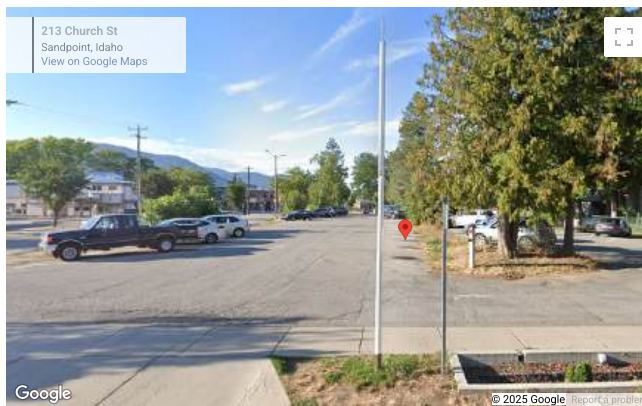
Tree Information	
Tree Id:	7766
Latin Name:	Betula papyrifera
Common Name:	Paper Birch
Cultivar:	
Genus:	Betula
Code:	BEPA
Status:	Alive
Year Planted:	
DBH:	25
DBH Range:	24-30in
Tree Height:	
Number of Stems:	Multiple Stems
Condition:	Dead / Dying

Percent Dieback:	50-75%
Crown Class:	Co-Dominant
Clearance Conflicts:	None
Observations:	Crown Dieback
Stock Type:	
Tree Comments:	Tree in serious decline
Family:	Betulaceae
Has Ecobenefits:	Yes
Last Modified:	09/29/2018
Upload ID:	upld_5818ec7cd30a8
User - Upload:	
Last Inspection:	
Next Inspection:	
Inspection Cycle:	
Crown Light Exposure:	
Archived:	No
Tree Protection Zone(TPZ):	
Critical Root Zone(CRZ):	
TPZ Ratio:	
CRZ Ratio:

Management Needs	
Primary Maintenance:	Large Tree (routine)
Secondary Maintenance:	Remove
Wires:	No Lines
Watch This Tree? :	Yes
Maintenance Comments:	Remove. Serious decline. Not aesthetically pleasing in popular lot.
Organization:	Sandpoint
User:	SP_sdrinkard

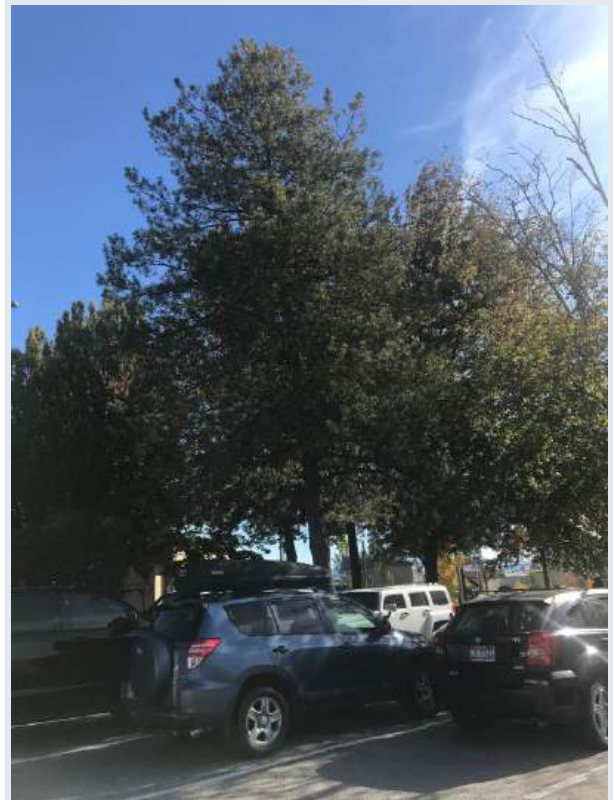
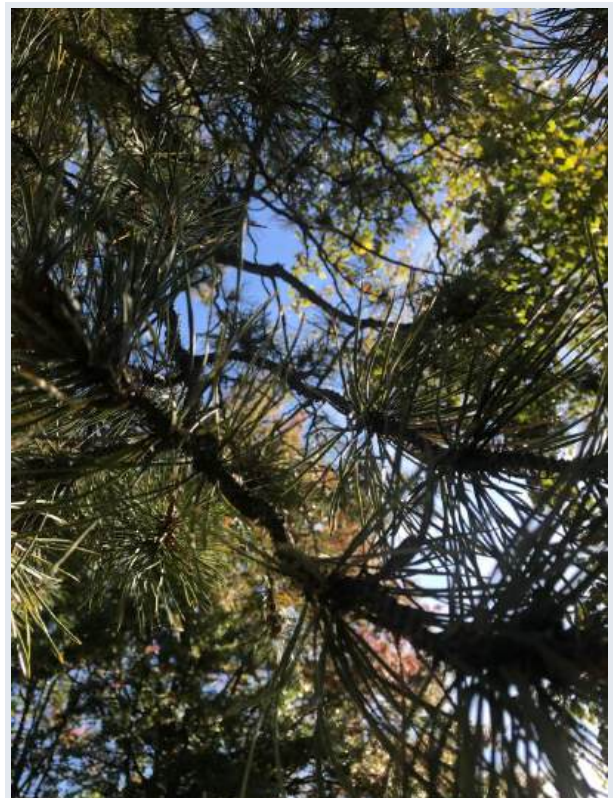
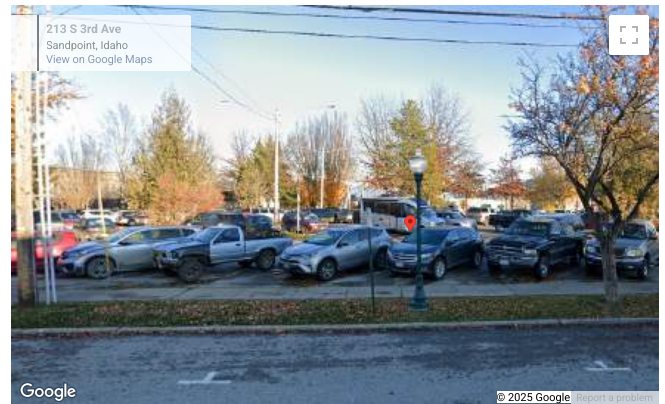
Tree Id:	7767
Latin Name:	Pinus contorta subsp. Latifolia
Common Name:	Lodgepole Pine
Cultivar:	Latifolia
Genus:	Pinus
Code:	PICO
Status:	Alive
Year Planted:	
DBH:	15
DBH Range:	12-18in
Tree Height:	
Number of Stems:	1

Condition:	Good - No Apparent Problems
Percent Dieback:	None
Crown Class:	Dominant
Clearance Conflicts:	None
Observations:	
Stock Type:	
Tree Comments:	
Family:	Pinaceae
Has Ecobenefits:	Yes
Last Modified:	09/29/2018
Upload ID:	upld_5818ec7cd30a8
User - Upload:	
Last Inspection:	
Next Inspection:	
Inspection Cycle:	
Crown Light Exposure:	
Archived:	No
Tree Protection Zone(TPZ):	
Critical Root Zone(CRZ):	
TPZ Ratio:	
CRZ Ratio:

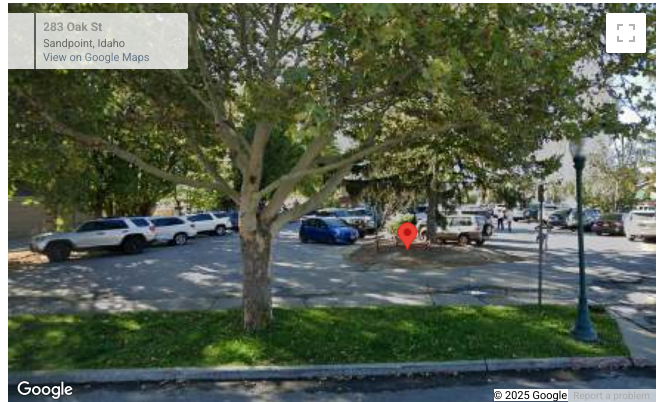
Tree Id:	7770
Latin Name:	Rhus spp
Common Name:	Sumac
Cultivar:	
Genus:	Rhus
Code:	RHSP
Status:	Alive
Year Planted:	
DBH:	3
DBH Range:	3-6in
Tree Height:	
Number of Stems:	Multiple Stems
Condition:	Poor - Major Problems

Percent Dieback:	25-50%
Crown Class:	Overtopped
Clearance Conflicts:	None
Observations:	Nutrient Deficiency, Poor Location, Poor Structure, Serious Decline, Crown Dieback
Stock Type:	
Tree Comments:	There are three "shrub trees" in a row. Perhaps Sumac is species, but in any case there is significant "crown" dieback. Don't really belong if they cannot be trained to be one trunk trees.
Family:	Anacardiaceae
Has Ecobenefits:	Yes
Last Modified:	09/30/2018
Upload ID:	upld_5818ec7cd30a8
User - Upload:	
Last Inspection:	
Next Inspection:	
Inspection Cycle:	
Crown Light Exposure:	
Archived:	No
Tree Protection Zone(TPZ):	
Critical Root Zone(CRZ):	
TPZ Ratio:	
CRZ Ratio:

Management Needs	
Primary Maintenance:	Small Tree (immediate)
Secondary Maintenance:	Remove
Wires:	No Lines
Watch This Tree? :	Yes

Most Recent Changes to this Tree
SP_sdrinkard set Maintenance Comments="Remove and replant with appropriate tree." on Sep 29, 2018 at 4:50pm
SP_sdrinkard set Secondary Maintenance="Remove" on Sep 29, 2018 at 4:49pm
SP_sdrinkard set Secondary Maintenance="Prune-structural, Remove" on Sep 29, 2018 at 4:49pm
SP_sdrinkard set Primary Maintenance="Small Tree (immediate)" on Sep 29, 2018 at 4:49pm
SP_sdrinkard set Tree Comments="There are three "shrub trees" in a row. Perhaps S..." on Sep 29, 2018 at 4:48pm
SP_sdrinkard set Observations="Crown Dieback, Nutrient Deficiency, Poor Location,..." on Sep 29, 2018 at 4:46pm
SP_sdrinkard set Observations="Crown Dieback, Nutrient Deficiency, Poor Location,..." on Sep 29, 2018 at 4:46pm
SP_sdrinkard set Observations="Crown Dieback, Nutrient Deficiency, Poor Structure" on Sep 29, 2018 at 4:46pm
SP_sdrinkard set Observations="Crown Dieback, Poor Structure" on Sep 29, 2018 at 4:46pm

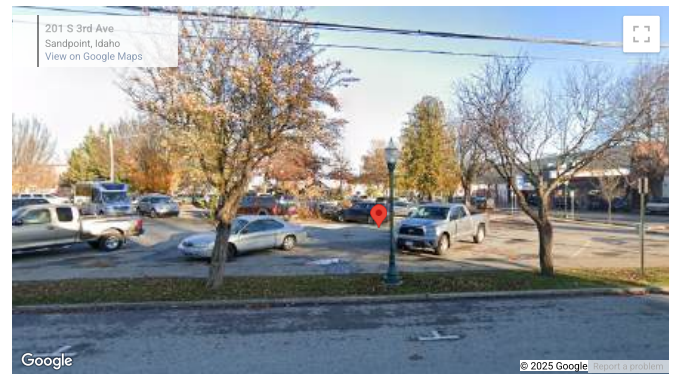
Tree Id:	7763
Latin Name:	Rhus spp
Common Name:	Sumac
Cultivar:	
Genus:	Rhus
Code:	RHSP
Status:	Alive
Year Planted:	
DBH:	3
DBH Range:	3-6in
Tree Height:	
Number of Stems:	Multiple Stems
Condition:	Fair - Minor Problems
Percent Dieback:	25-50%
Crown Class:	Overtopped
Clearance Conflicts:	None

Observations:	Improperly Pruned, Poor Location, Poor Structure
Stock Type:	
Tree Comments:	Not sure that this is a sumac. In any case it needs to be heavily pruned for tree shape or removed.
Family:	Anacardiaceae
Has Ecobenefits:	Yes
Last Modified:	09/29/2018
Upload ID:	
User - Upload:	
Last Inspection:	
Next Inspection:	
Inspection Cycle:	
Crown Light Exposure:	
Archived:	No
Tree Protection Zone(TPZ):	
Critical Root Zone(CRZ):	
TPZ Ratio:	
CRZ Ratio:

Management Needs	
Primary Maintenance:	Small Tree (routine/train)
Secondary Maintenance:	Prune-structural, Remove, Remove Suckers
Wires:	No Lines
Watch This Tree? :	Yes
Maintenance Comments:	Train to be single trunk tree or remove.
Organization:	Sandpoint
User:	SP_sdrinkard

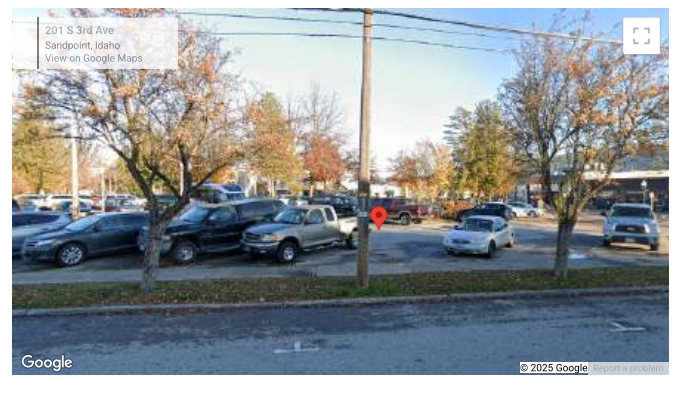
IMG_2702.jpg
 9/29/2018

Tree Information	
Tree Id:	7762
Latin Name:	Amelanchier spp
Common Name:	Serviceberry
Cultivar:	
Genus:	Amelanchier
Code:	AM
Status:	Alive
Year Planted:	
DBH:	3
DBH Range:	3-6in
Tree Height:	
Number of Stems:	Multiple Stems
Condition:	Fair - Minor Problems
Percent Dieback:	25-50%
Crown Class:	Overtopped
Clearance Conflicts:	None

Observations:	Improperly Pruned, Poor Location
Stock Type:	
Tree Comments:	Not sure that this is a service berry. In any case it needs to be heavily pruned for tree shape or removed.
Family:	Rosaceae
Has Ecobenefits:	Yes
Last Modified:	09/29/2018
Upload ID:	
User - Upload:	
Last Inspection:	
Next Inspection:	
Inspection Cycle:	
Crown Light Exposure:	
Archived:	No
Tree Protection Zone(TPZ):	
Critical Root Zone(CRZ):	
TPZ Ratio:	
CRZ Ratio:

Management Needs	
Primary Maintenance:	Small Tree (routine/train)
Secondary Maintenance:	Prune-structural, Remove, Remove Suckers
Wires:	No Lines
Watch This Tree? :	Yes
Maintenance Comments:	
Organization:	Sandpoint
User:	SP_sdrinkard

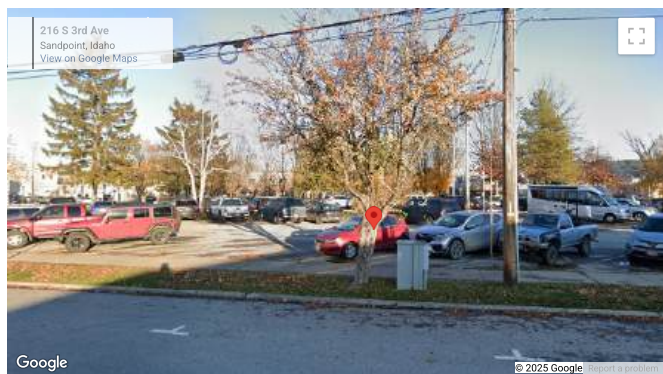
Tree Information	
Tree Id:	7761
Latin Name:	Other
Common Name:	Other
Cultivar:	
Genus:	Other
Code:	
Status:	Alive
Year Planted:	
DBH:	
DBH Range:	
Tree Height:	3
Number of Stems:	Multiple Stems
Condition:	Fair - Minor Problems
Percent Dieback:	25-50%
Crown Class:	Overtopped
Clearance Conflicts:	None

Observations:	Improperly Pruned, Poor Location, Poor Structure
Stock Type:	
Tree Comments:	This is tree turned shrub. Not sure at this time is species.
Family:	
Has Ecobenefits:	No
Last Modified:	12/19/2022
Upload ID:	
User - Upload:	
Last Inspection:	
Next Inspection:	
Inspection Cycle:	
Crown Light Exposure:	Three sides of the crown are exposed to light.
Archived:	No
Tree Protection Zone(TPZ):	
Critical Root Zone(CRZ):	
TPZ Ratio:	
CRZ Ratio:

Management Needs	
Primary Maintenance:	Remove Tree
Secondary Maintenance:	Remove
Wires:	No Lines
Watch This Tree? :	Yes
Maintenance Comments:	Need to replace with a single trunk tree that doesn't "hide" areas of the lot.
Organization:	Sandpoint
User:	SP_sdrinkard

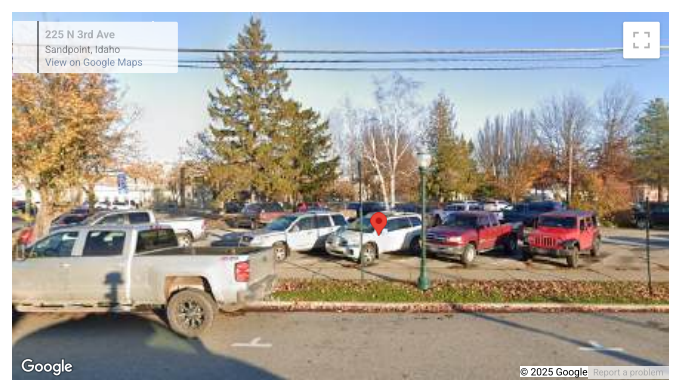
Tree Id:	
Latin Name:	Betula papyrifera
Common Name:	Paper Birch
Cultivar:	
Genus:	Betula
Code:	BEPA
Status:	Alive
Year Planted:	
DBH:	4
DBH Range:	3-6in
Tree Height:	
Number of Stems:	
Condition:	Poor - Major Problems
Percent Dieback:	50-75%
Crown Class:	Overtopped
Clearance Conflicts:	None
Observations:	Poor Location

Management Needs	
Primary Maintenance:	Remove Suckers
Secondary Maintenance:	Remove, Remove Suckers
Wires:	No Lines
Watch This Tree? :	Yes
Maintenance Comments:	
Organization:	Sandpoint
User:

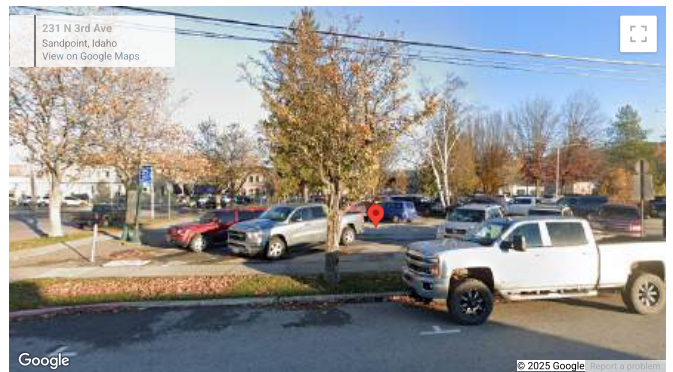
Street View

Tree Information	
Tree Id:	
Latin Name:	Betula papyrifera
Common Name:	Paper Birch
Cultivar:	
Genus:	Betula
Code:	BEPA
Status:	Alive
Year Planted:	
DBH:	20
DBH Range:	18-24in
Tree Height:	
Number of Stems:	Multiple Stems
Condition:	Fair - Minor Problems
Percent Dieback:	25-50%
Crown Class:	Intermediate
Clearance Conflicts:	None

Observations:	Improperly Mulched, Crown Dieback
Stock Type:	
Tree Comments:	
Family:	Betulaceae
Has Ecobenefits:	Yes
Last Modified:	09/29/2018
Upload ID:	upld_5818ec7cd30a8
User - Upload:	
Last Inspection:	
Next Inspection:	
Inspection Cycle:	
Crown Light Exposure:	
Archived:	No
Tree Protection Zone(TPZ):	
Critical Root Zone(CRZ):	
TPZ Ratio:	
CRZ Ratio:

Management Needs	
Primary Maintenance:	Large Tree (routine)
Secondary Maintenance:	Crown Cleaning, Prune-structural, Remove Suckers
Wires:	No Lines
Watch This Tree? :	Yes
Maintenance Comments:	Lots of suckers. Including what may be all the plant material immediately south of this tree.
Organization:	Sandpoint
User:

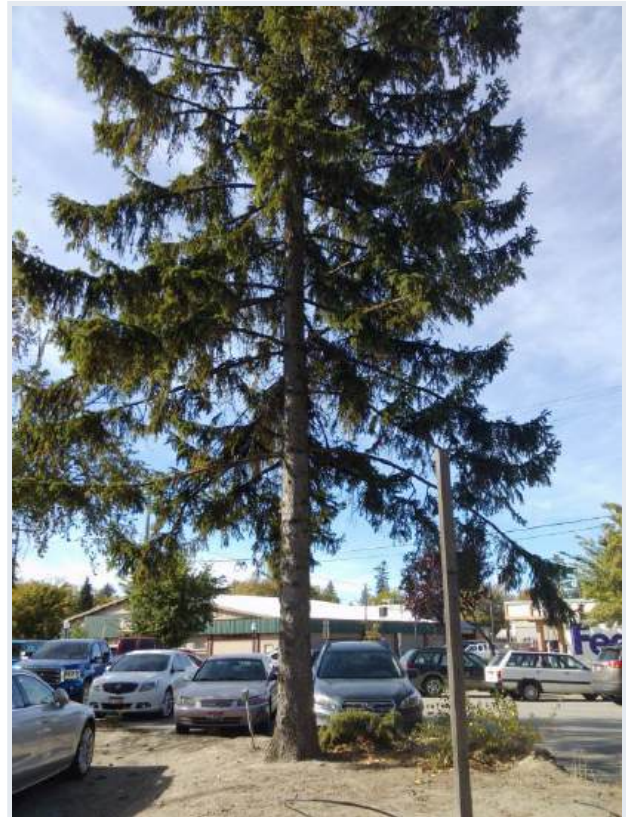
1538155840724929344579.jpg
9/28/2018

Tree Information	
Tree Id:	
Latin Name:	Picea engelmannii
Common Name:	Engelmann Spruce
Cultivar:	
Genus:	Picea
Code:	PIEN
Status:	Alive
Year Planted:	
DBH:	14
DBH Range:	12-18in
Tree Height:	
Number of Stems:	1
Condition:	Good - No Apparent Problems
Percent Dieback:	<25%
Crown Class:	Dominant
Clearance Conflicts:	None

Management Needs	
Primary Maintenance:	Large Tree (routine)
Secondary Maintenance:	None Needed
Wires:	No Lines
Watch This Tree? :	No
Maintenance Comments:	
Organization:	Sandpoint
User:
