CITY OF  
**TUMWATER**

**HISTORIC PRESERVATION COMMISSION  
MEETING AGENDA**

**Thursday, March 12, 2026  
6:30 PM**

### Davis-Meeker Oak

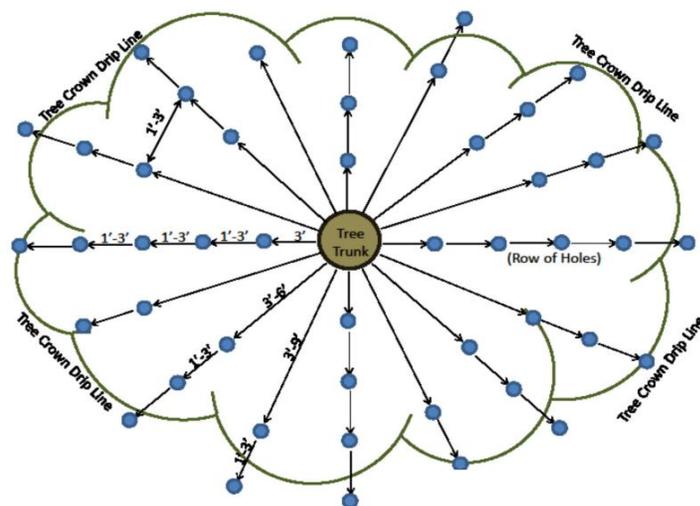
**Figure 1** The above diagram illustrates how holes should extend radially from the trunk to just beyond the dripline. Illustration adapted from Texas A&M Forest Service. See Attachment 2 for proposed root zone management area for the Davis-Meeker Oak and Attachment 3 for a vertical mulching detail.

YEAR 1: VERTICAL MULCHING	
<b>Method</b>	Pneumatic excavation (e.g. Air Spade®)
<b>Time</b>	1 to 3 Days
<b>Site preparation</b>	<ol style="list-style-type: none"> <li>1. Place request for utility locates.</li> <li>2. Coordinate with City of Tumwater and their contract archaeologist for permitting.</li> <li>3. Coordinate with Port of Olympia to potentially reserve and restrict parking.</li> <li>4. Apply water through use of soaker hoses starting 48 hours before pneumatic excavation, regardless of weather predictions. Allow the soaker hose to run for 24 hours. Then turn it off for 24 hours prior to the pneumatic excavation. This will leave the soil as close to field capacity as possible in preparation for the air excavation.</li> </ol>
<b>Procedure</b> Attachment 2 Attachment 3 Figure 1	<ol style="list-style-type: none"> <li>1. Excavate holes radially from the trunk with a pneumatic excavation tool. Each hole is to be excavated pneumatically to a depth of 6 inches to 12-inches, distance between holes 2 to 3 feet, and diameter of 3 inches.<sup>2</sup></li> <li>2. Inspect holes for roots. If woody roots are uncovered, adjust hole location several inches to avoid.</li> <li>3. Excavate hole with handheld drill with 3-inch drill bit, if necessary.</li> <li>4. Backfill hole with a soil amendment (see specification).</li> <li>5. Install a surface application of arborist wood chips 3 to 4 inches thick within the treatment area which encompasses the tree's dripline where not precluded by obstacles such as the roadway. Gently taper arborist wood chips toward the trunk flare so they do not contact the trunk. This is an estimated 20 yards (3-inch depth) to 27 yards (4-inch depth) of arborist wood chips.</li> </ol>

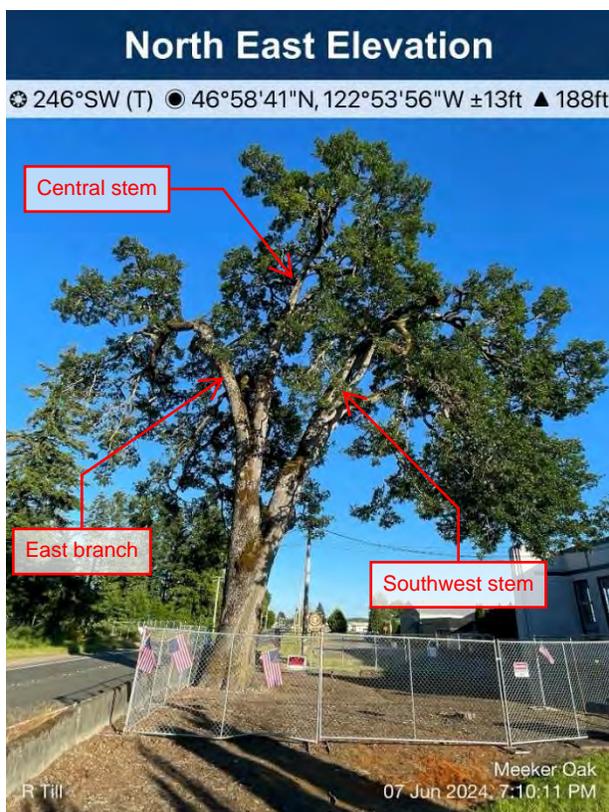
Figure 3 View of tree anatomy and crown shape.

The mass of the crown is to the south or southwest of the central trunk. The crown is split into three stems, which are depicted in Figure 3 and Attachment 3. The approximate outline of the crown and the three primary stems are depicted in the aerial photo in Attachment 4. The main trunk forks at approximately 16 feet into a southwest and northeast stem. The southwest stem arches to the southwest toward the hanger. The northeast stem forks again at approximately 33 feet into a central stem that forms the top of the tree and a second branch system that extends to the east and southeast. The central stem has a historic decay pocket on the south side at approximately 46 feet that is used as a nesting cavity by kestrels (*Falco sparverius*). The cavity is also identifiable from a cascara (*Frangula purshiana*) sapling growing from the cavity. The east/southeast branch system forks into two branches, one extends directly over Old Highway 99 and the second extends to the south/southeast parallel to Old Highway 99.

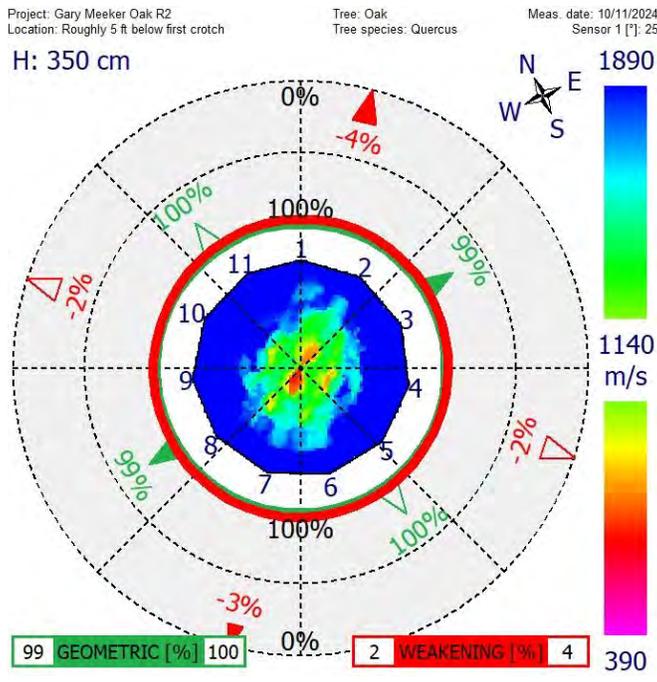
## Oak – Reading 2- 350cm

At this level there is a small amount of compromised wood in the center of the stem. The green indicates where the co-dominant inclusion is causing a weak attachment point.

At this level there is between 2% and 4% strength loss. This is low strength loss.

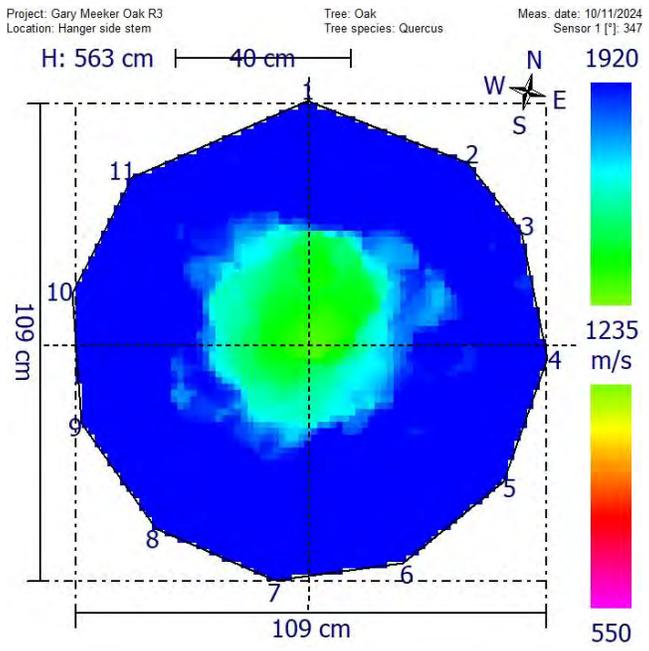
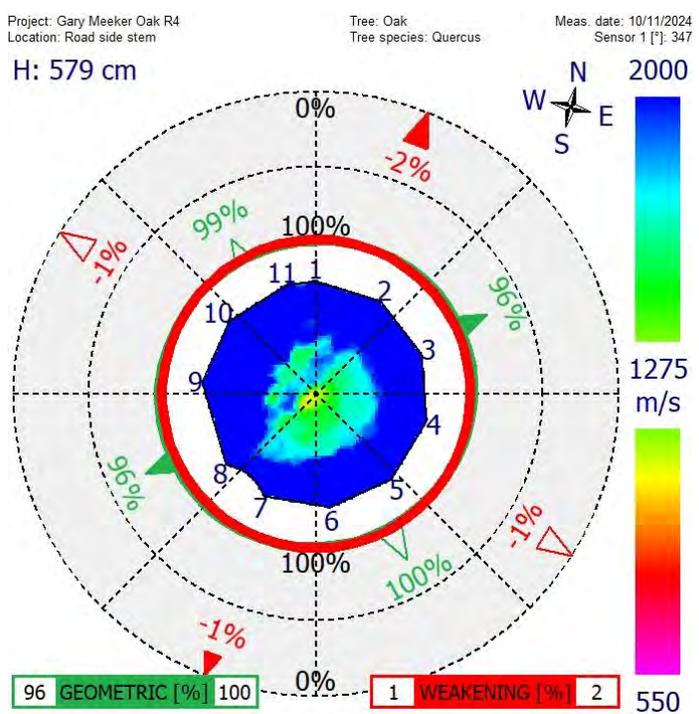
## Oak – Reading 3- 563cm

At this level there is no sign of compromised wood.

At this level there is between 1% and 2% strength loss. This is minimal strength loss.

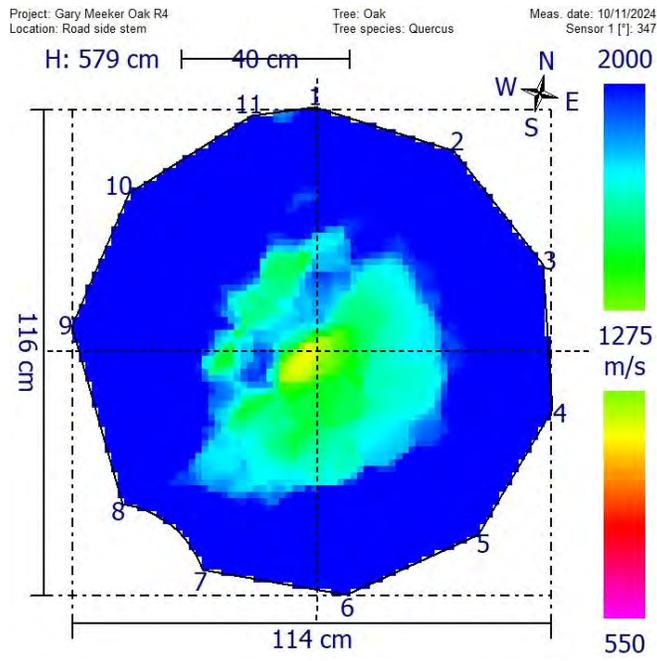
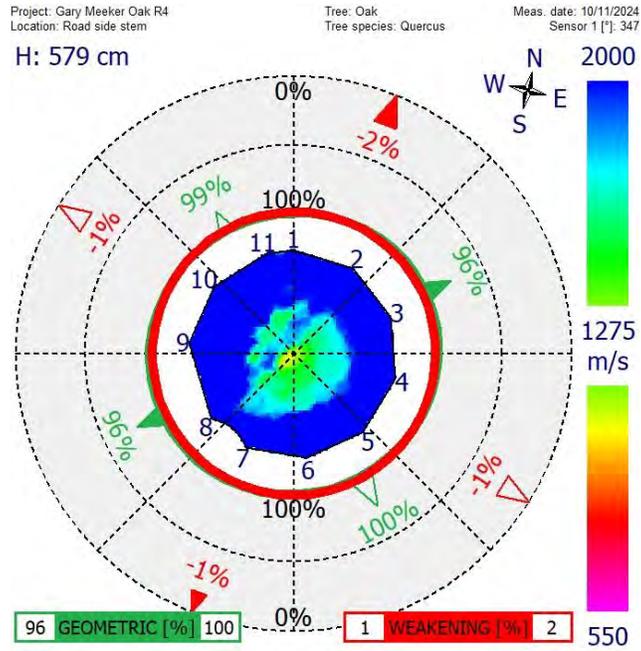
## Oak – Reading 4- 579cm

At this level there is no sign of compromised wood.

At this level there is between 1% and 2% strength loss. This is minimal strength loss.

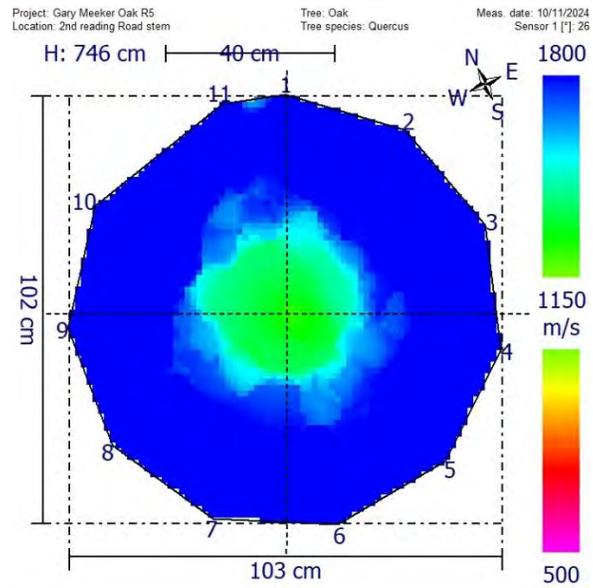
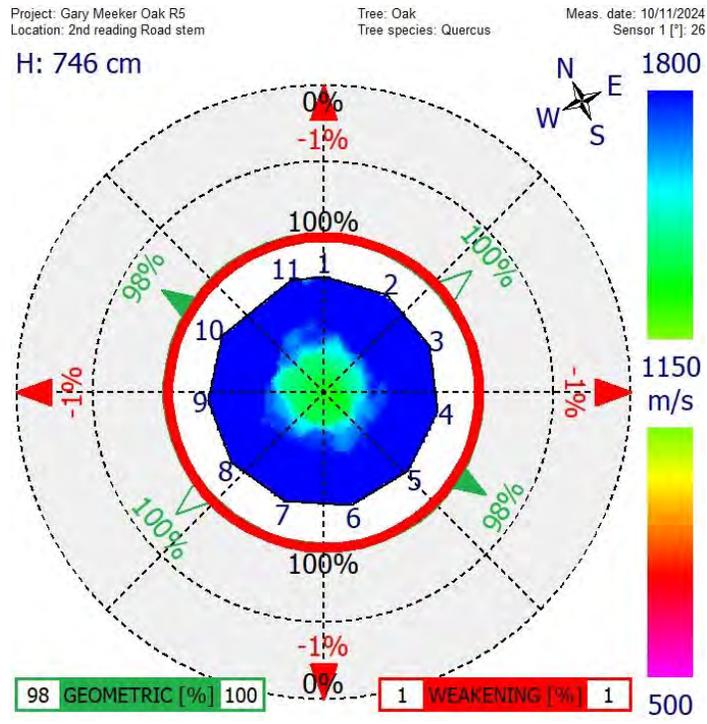
## Oak – Reading 5- 746cm

At this level there are no signs of compromised wood.

At this level there is less than 2% strength loss. This is minimal strength loss.

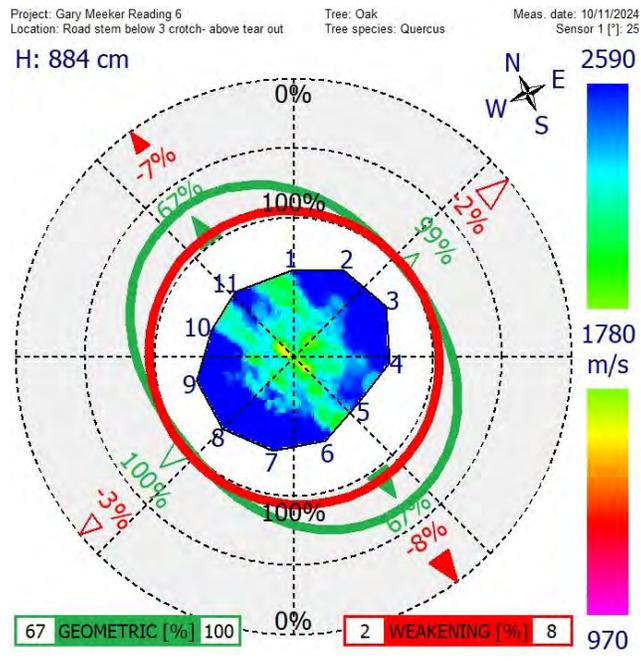
## Oak – Reading 6- 884cm

At this level there is included bark throughout the center of the stem, where the three stems connect.

At this level there is between 2% and 8% strength loss. This is minimal strength loss.

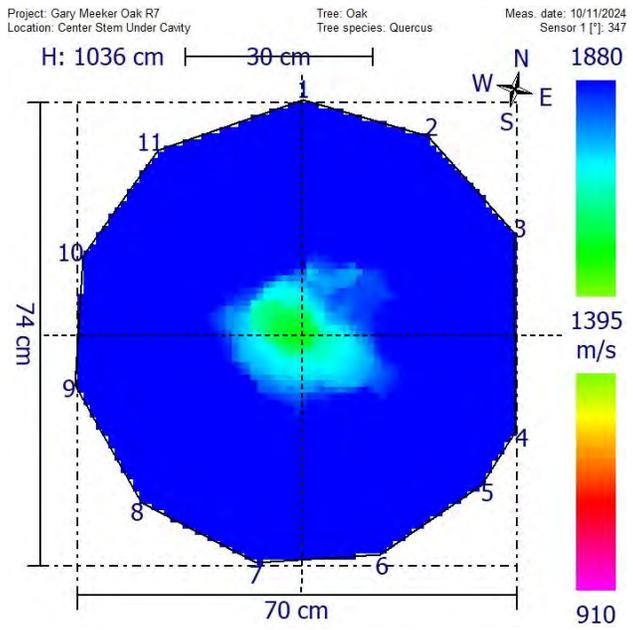
## Oak – Reading 7- 1036cm

At this level there is no sign of compromised wood.

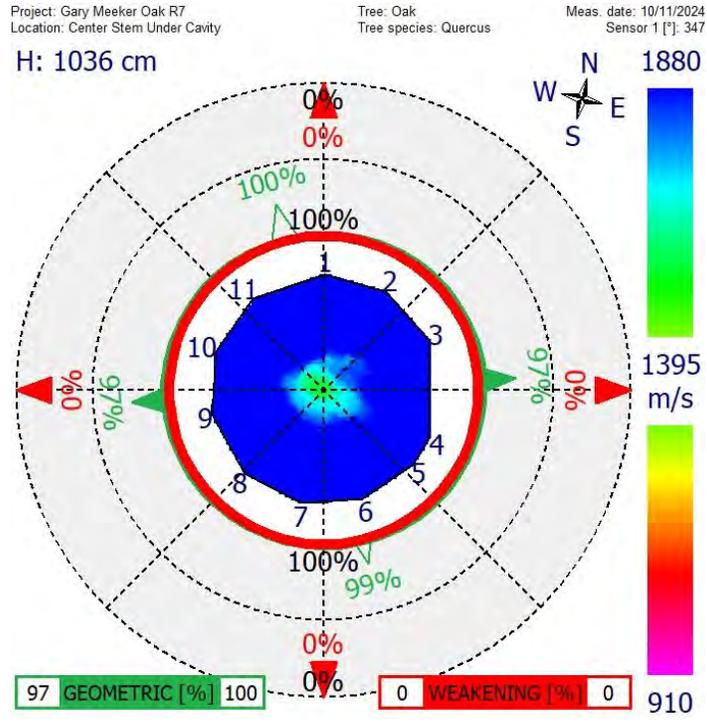
At this level there is no strength loss.

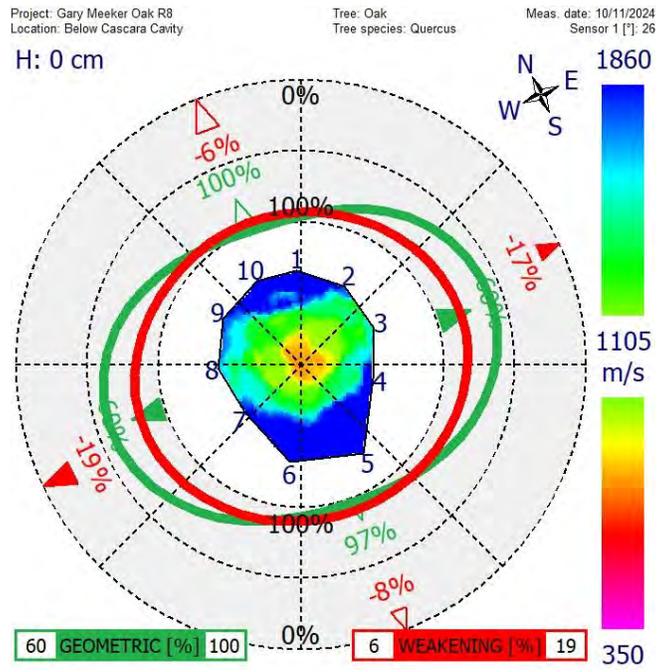
# Oak – Reading 8- 1381cm

At this level there is less dense wood in the center of the stem. The center yellow spot indicates where the cavity above extends too.

At this level there is between 6% and 19% strength loss. This is minimal strength loss.

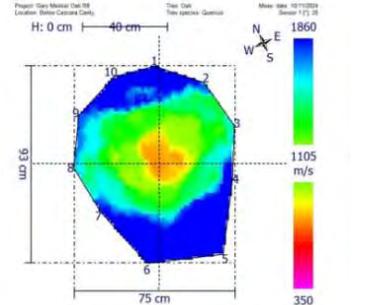
<p>At this level there is less dense wood in the center of the stem. The center yellow spot indicates where the cavity above extends too.</p> <p>At this level there is between 6% and 19% strength loss. This is minimal strength loss.</p>
7	1036 cm/ 33 ft	Stem 1, above 2 <sup>nd</sup> codominant stem.

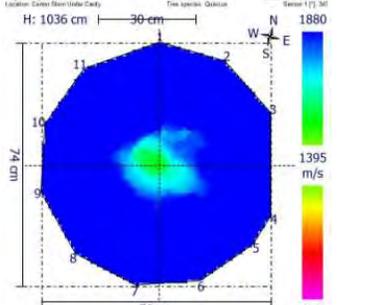
<p>At this level there is no sign of compromised wood.</p> <p>At this level there is no strength loss.</p>
6	884 cm/ 29 ft	Stem 1, below 2 <sup>nd</sup> codominant union, above SE branch failure (Jan. 2012)

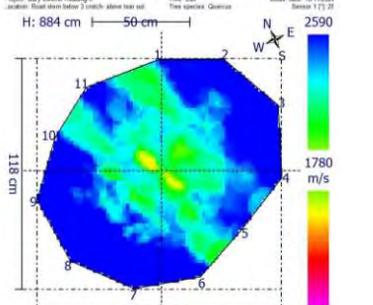
<p>At this level there is likely included bark within the center of the stem, where the codominant stems connect.</p> <p>At this level there is between 2% and 8% strength loss. This is minimal strength loss.</p>

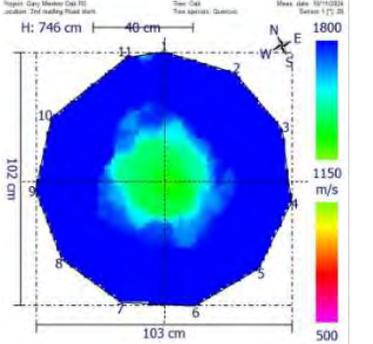
<p>At this level there are no signs of compromised wood.</p> <p>At this level there is less than 2% strength loss. This is minimal strength loss.</p>
<p>4</p>	<p>579 cm/ 19 ft</p>	<p>Stem 1, above 1<sup>st</sup> codominant union.</p>

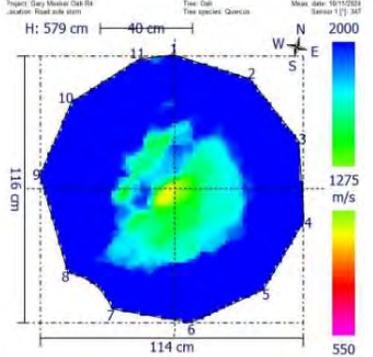
<p>At this level there is no sign of compromised wood.</p> <p>At this level there is between 1% and 2% strength loss. This is minimal strength loss.</p>
<p>3</p>	<p>563 cm/ 18.5 ft</p>	<p>Stem 2, above 1<sup>st</sup> codominant union.</p>

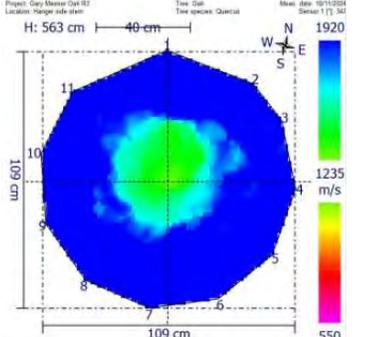
<p>At this level there is no sign of compromised wood.</p> <p>At this level there is between 1% and 2% strength loss. This is minimal strength loss.</p>

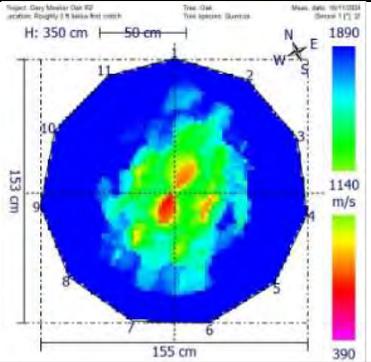
<p>At this level there is a small amount of compromised wood in the center of the stem. The green indicates where the co-dominant inclusion is potentially reducing the strength of the attachment point.</p> <p>At this level there is between 2% and 4% strength loss. This is low strength loss.</p>
<p>1</p> <p>50 cm/ 1.6 ft</p>	<p>Main stem near ground level.</p>

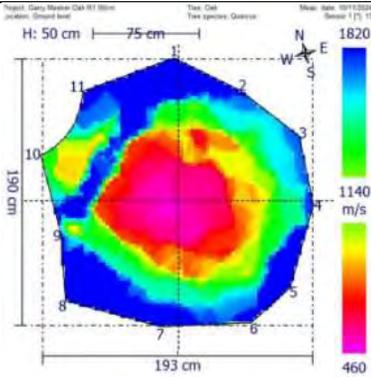
<p>At this level there is significant compromised wood throughout the stem. A wood decay fungi has created a significant amount of compromised wood and hollow trunk.</p> <p>At this level there is between 14% and 21% strength loss depending on direction.</p>
<p>1</p> <p>50 cm/ 1.6 ft</p>	<p>Main stem near ground level.</p>

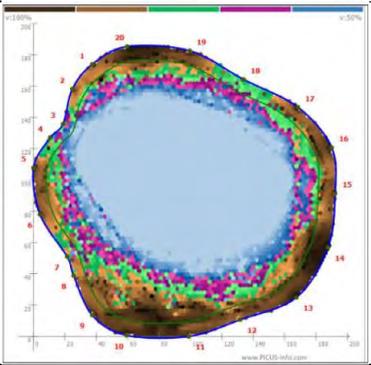
<p>Tree Solutions sonic tomography reading. Conclusion was that there is sufficient wood to support existing tree. The sonic tomography strength limit appears to have been set at approximately 80 percent hollow, or approximately 4-inches (10 cm) of sound wood based on the tree's diameter at the measurement point.</p>

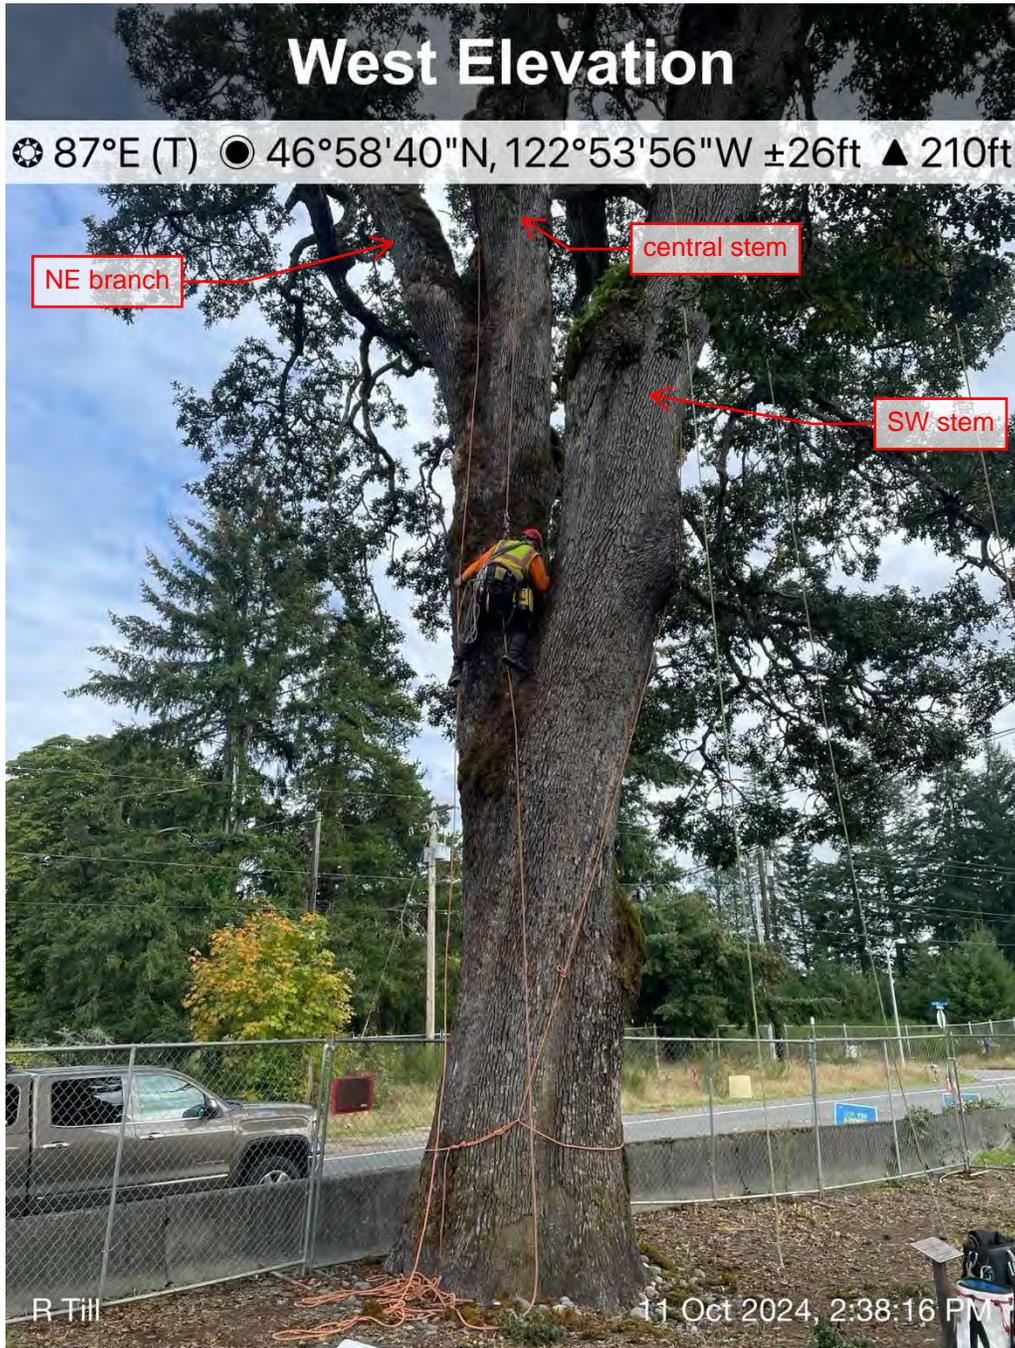
The primary codominant union is located at approximately 16 feet above ground. The union has included bark. This area was inspected with a ¼ inch metal probe and resistance was encountered indicating solid wood in the interior. Spiral grain, indicating adaptive growth, is visible on the southwest trunk.

Figure 1 Inspection of first codominant union. A ¼ inch steel probe was inserted between stems and encountered solid resistance below historic debris collecting between the stems.

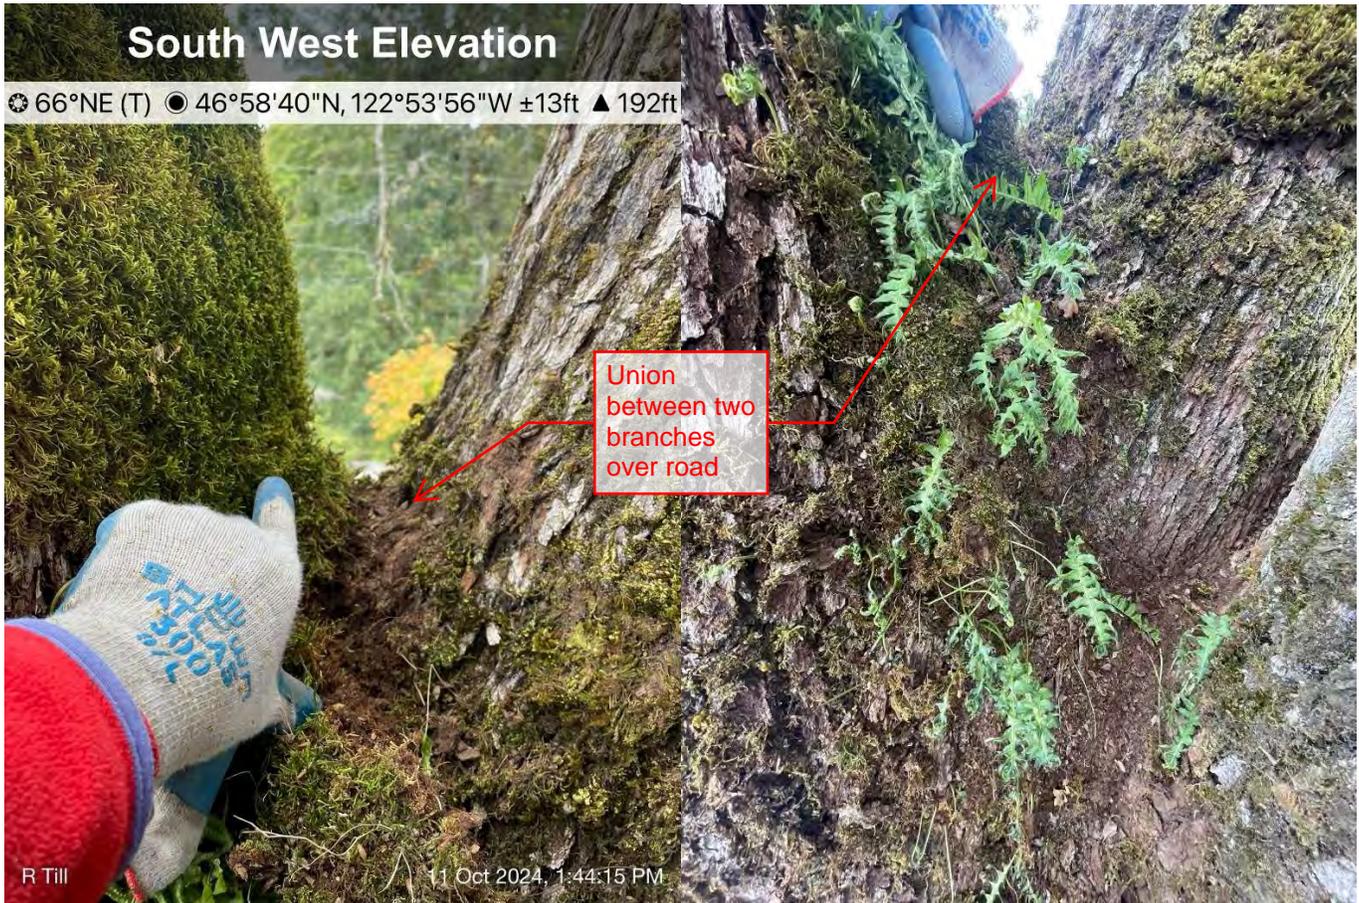
Figures 7 and 8 Southwest view of attachment between two secondary stems extending over the road. Exterior signs indicate a sound union.

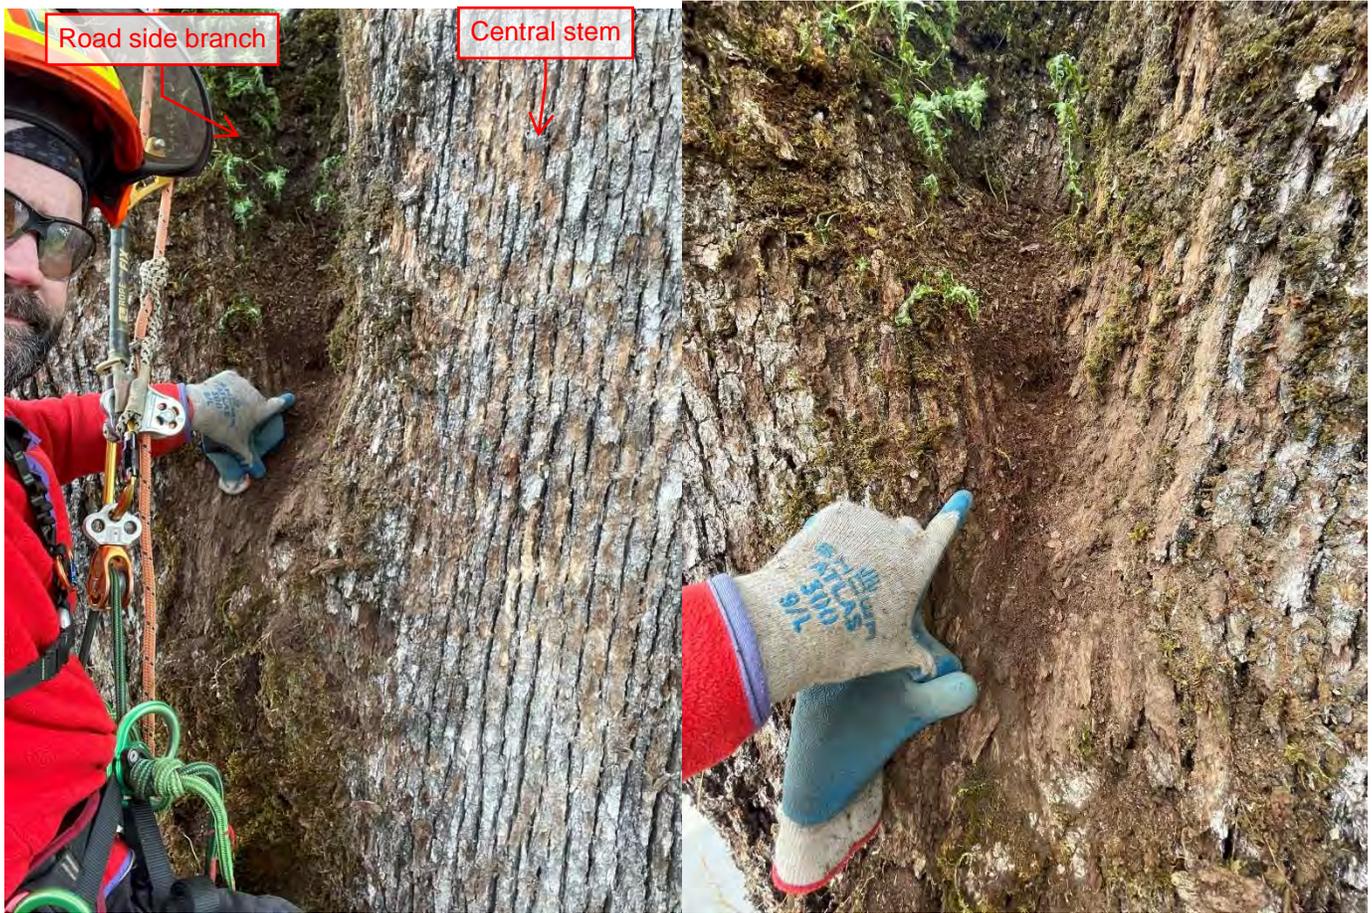
Figures 9 and 10 Northwest view of second codominant union. Included bark transitions into sound wood attachment.

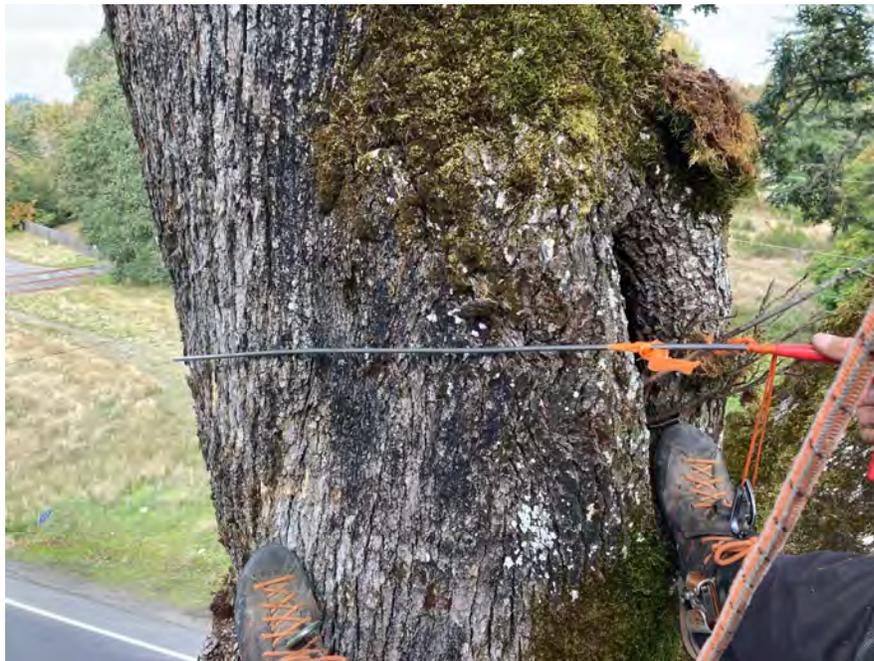
Figure 16 Correlating depth of the cavity, indicating substantial depth.

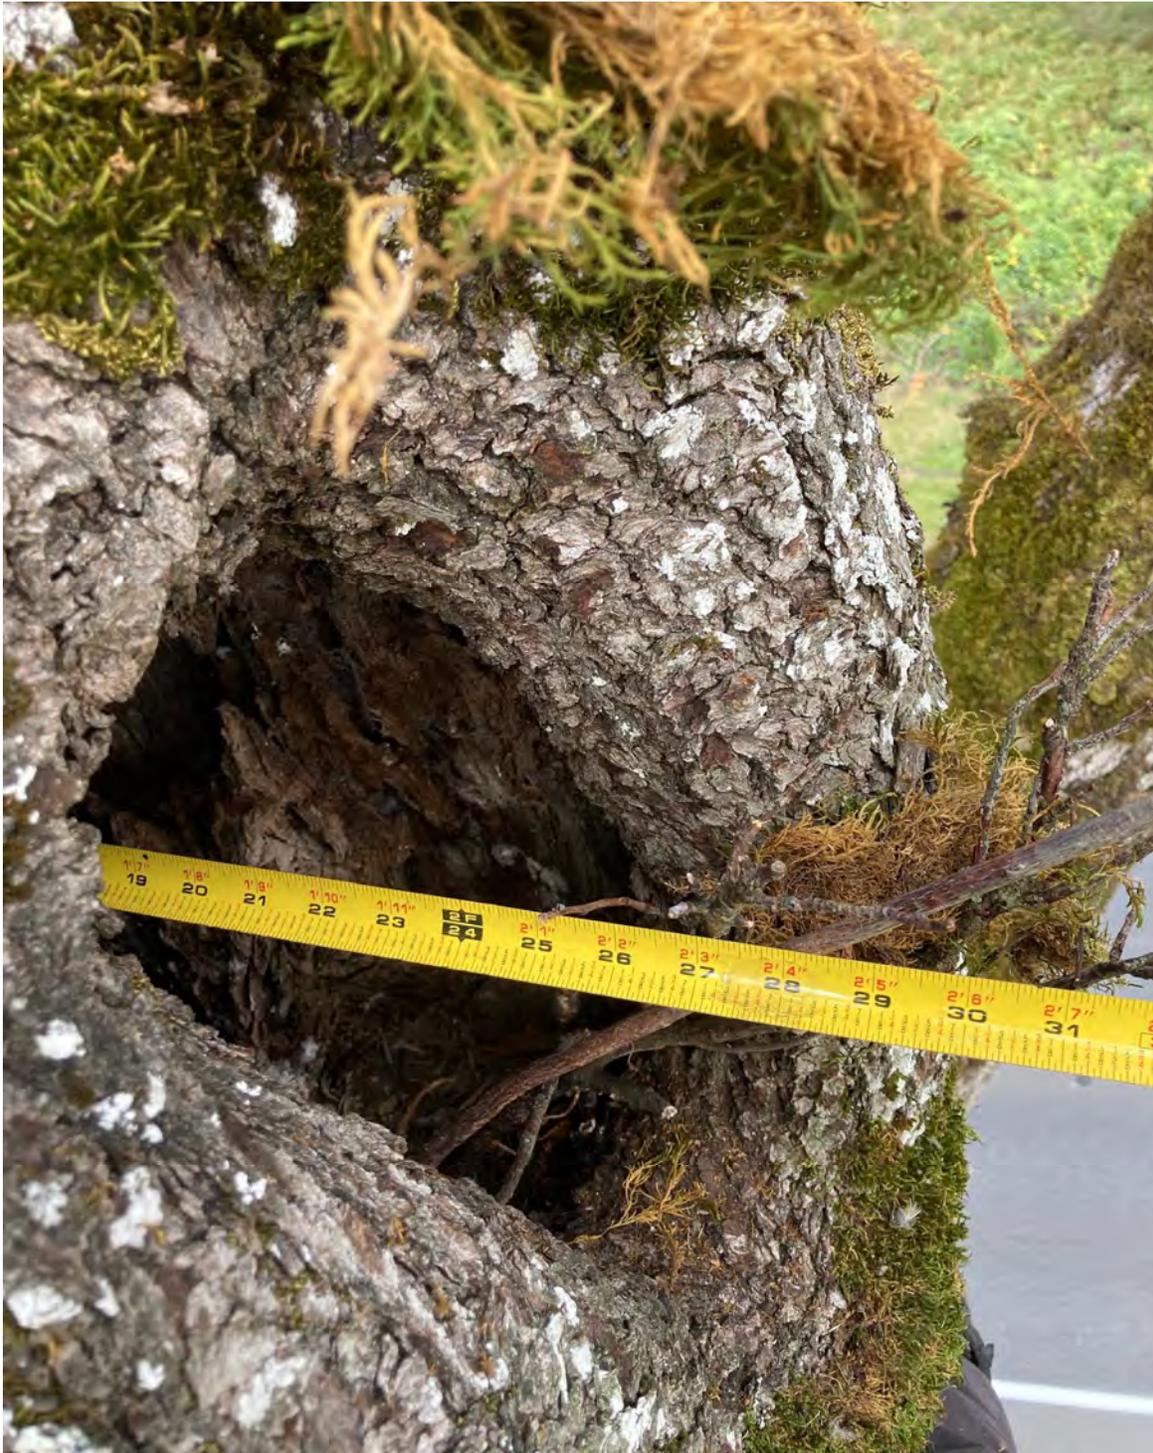
Figure 17 Depth measurement at approximately 25 inches.

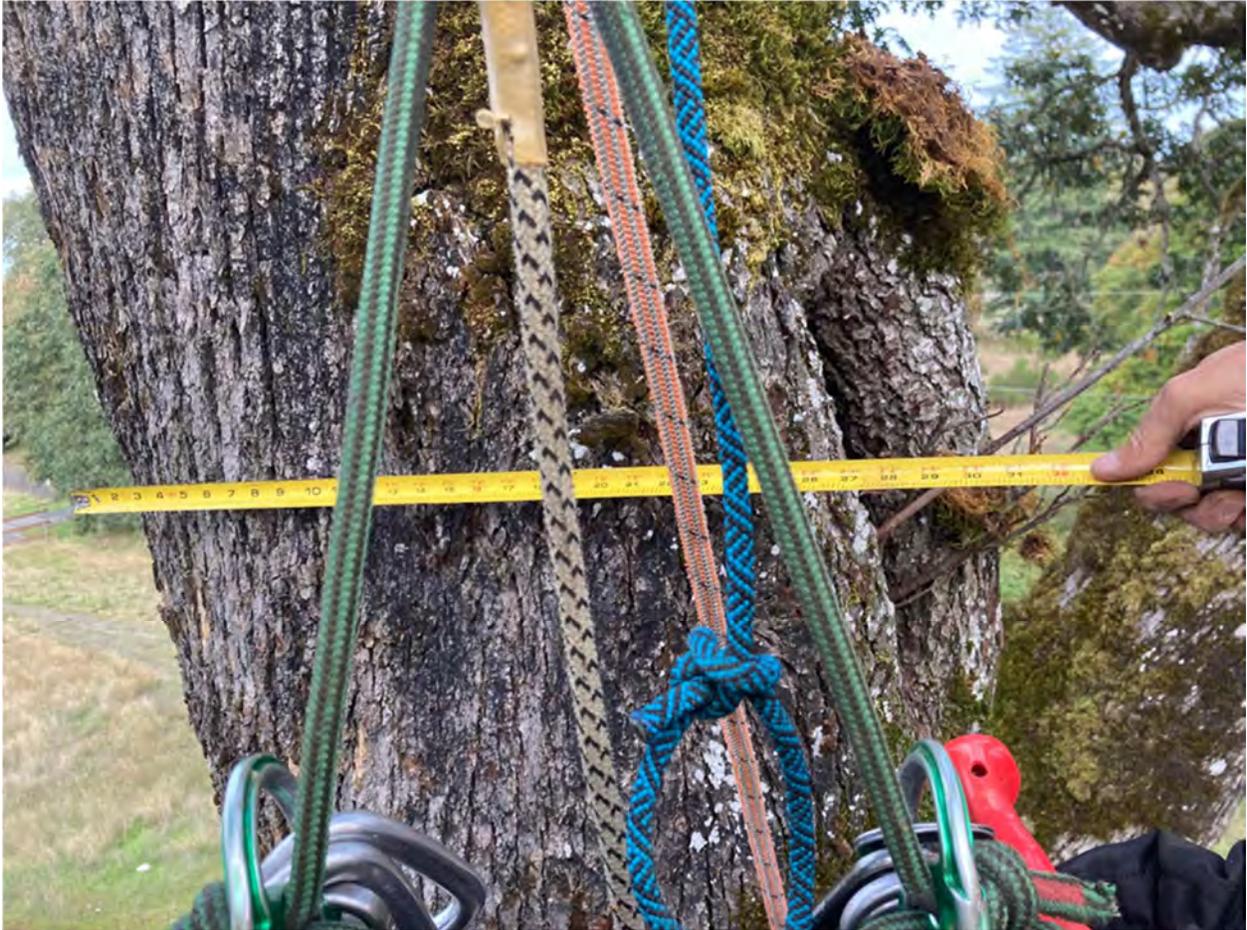
Figure 18 Approximate diameter of tree measured at approximately 27 inches.

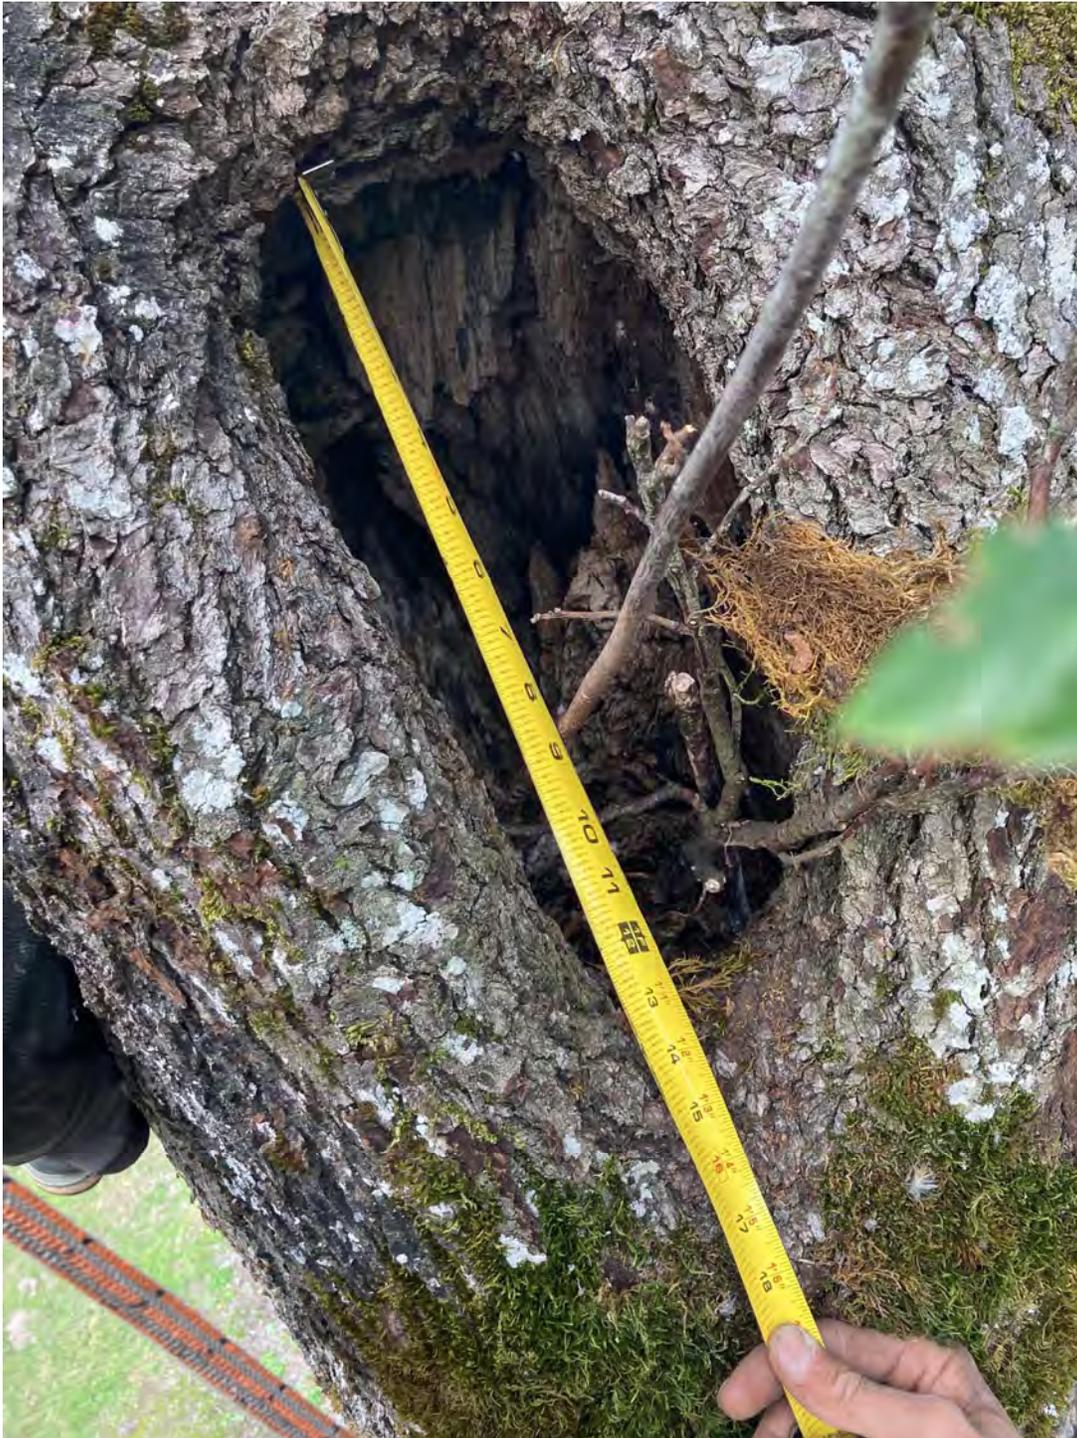
Figure 19 Depth measurement at approximately 24 inches to interior edge of cavity.

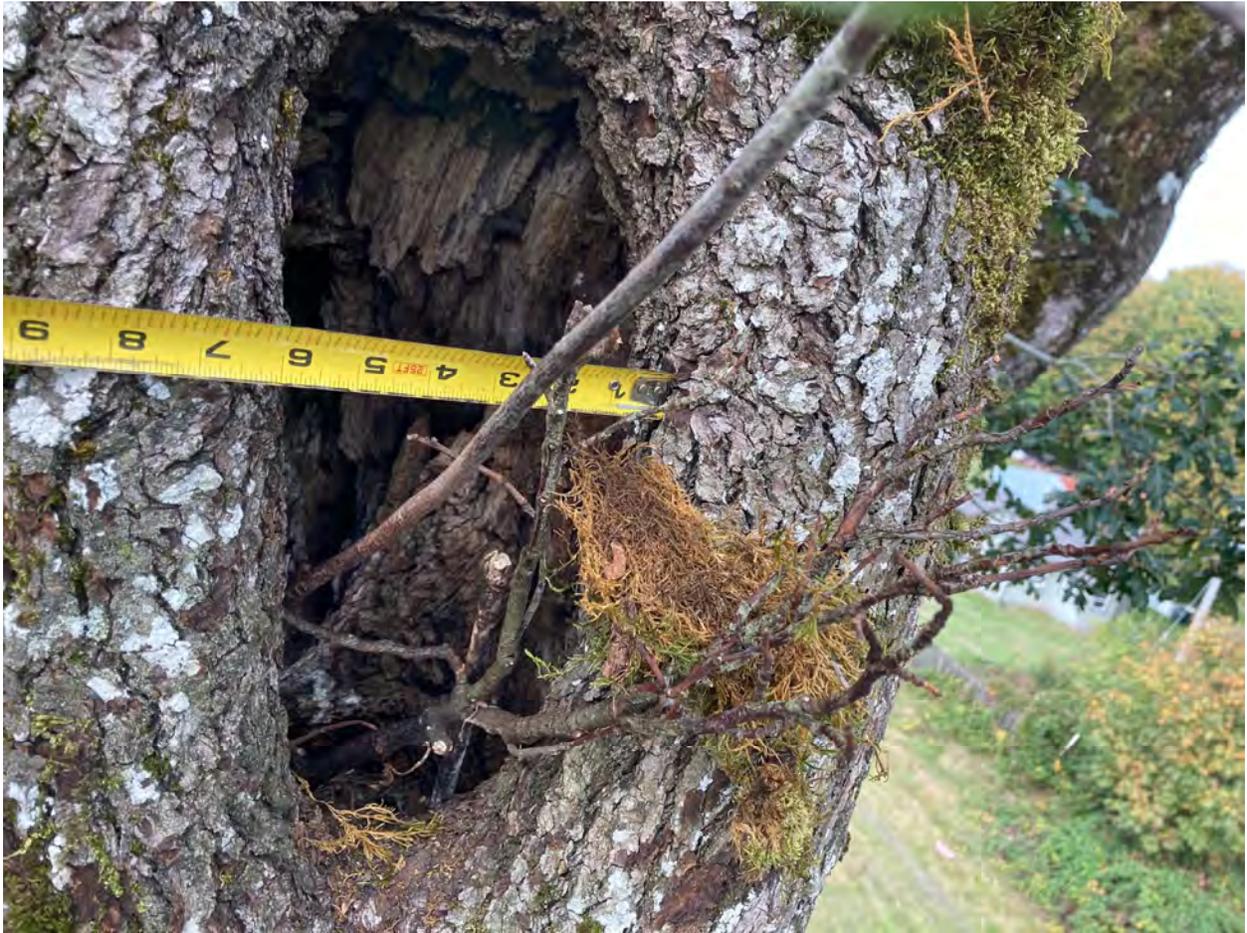
Figure 20 Measurement of diameter of cavity at 6 inches.

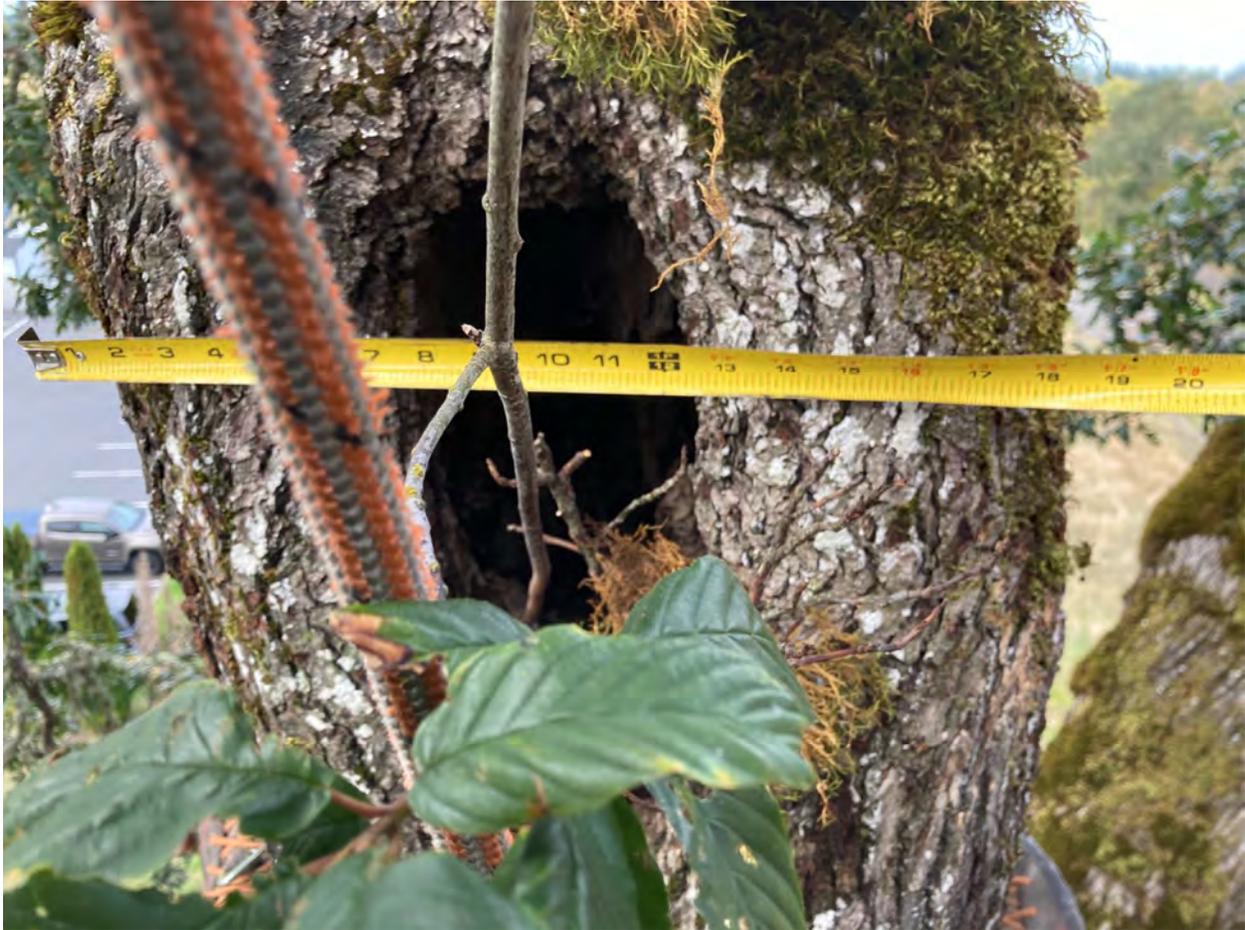
Figure 21 Measurement of diameter perpendicular to cavity opening at approximately 17 inches.

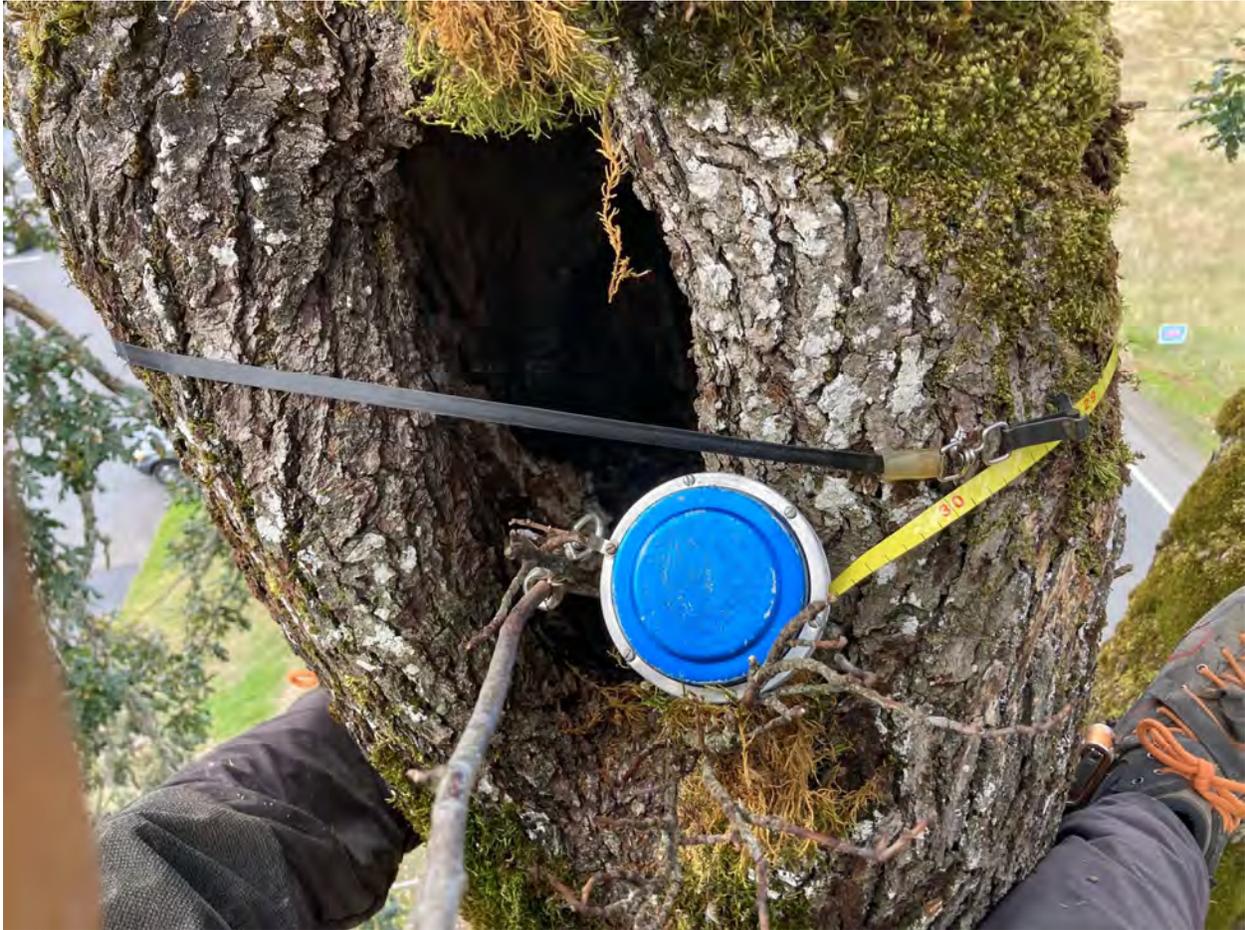
Figure 22 Diameter measurement of approximately 30 inches.

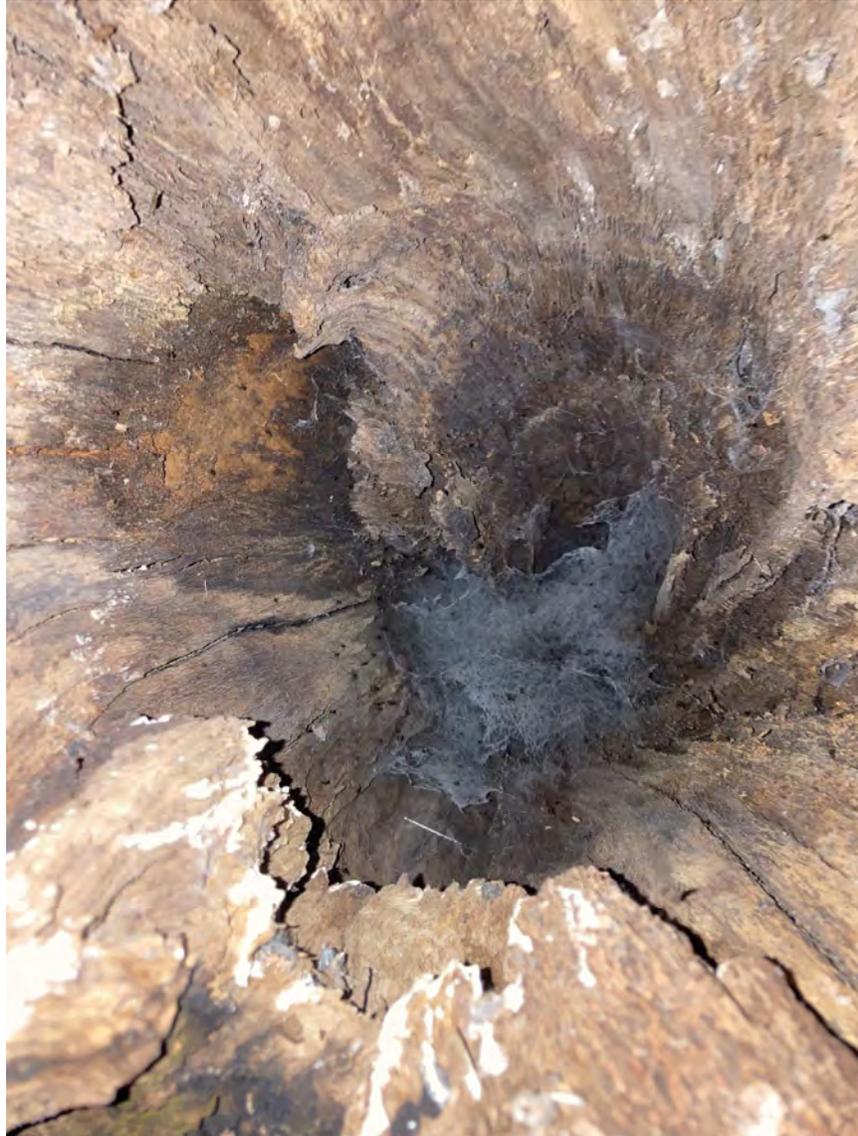
Figure 24 View vertically up the cavity.
