CITY OF  
**TUMWATER**

**HISTORIC PRESERVATION COMMISSION  
MEETING AGENDA**

**Thursday, March 12, 2026  
6:30 PM**

### Davis-Meeker Oak

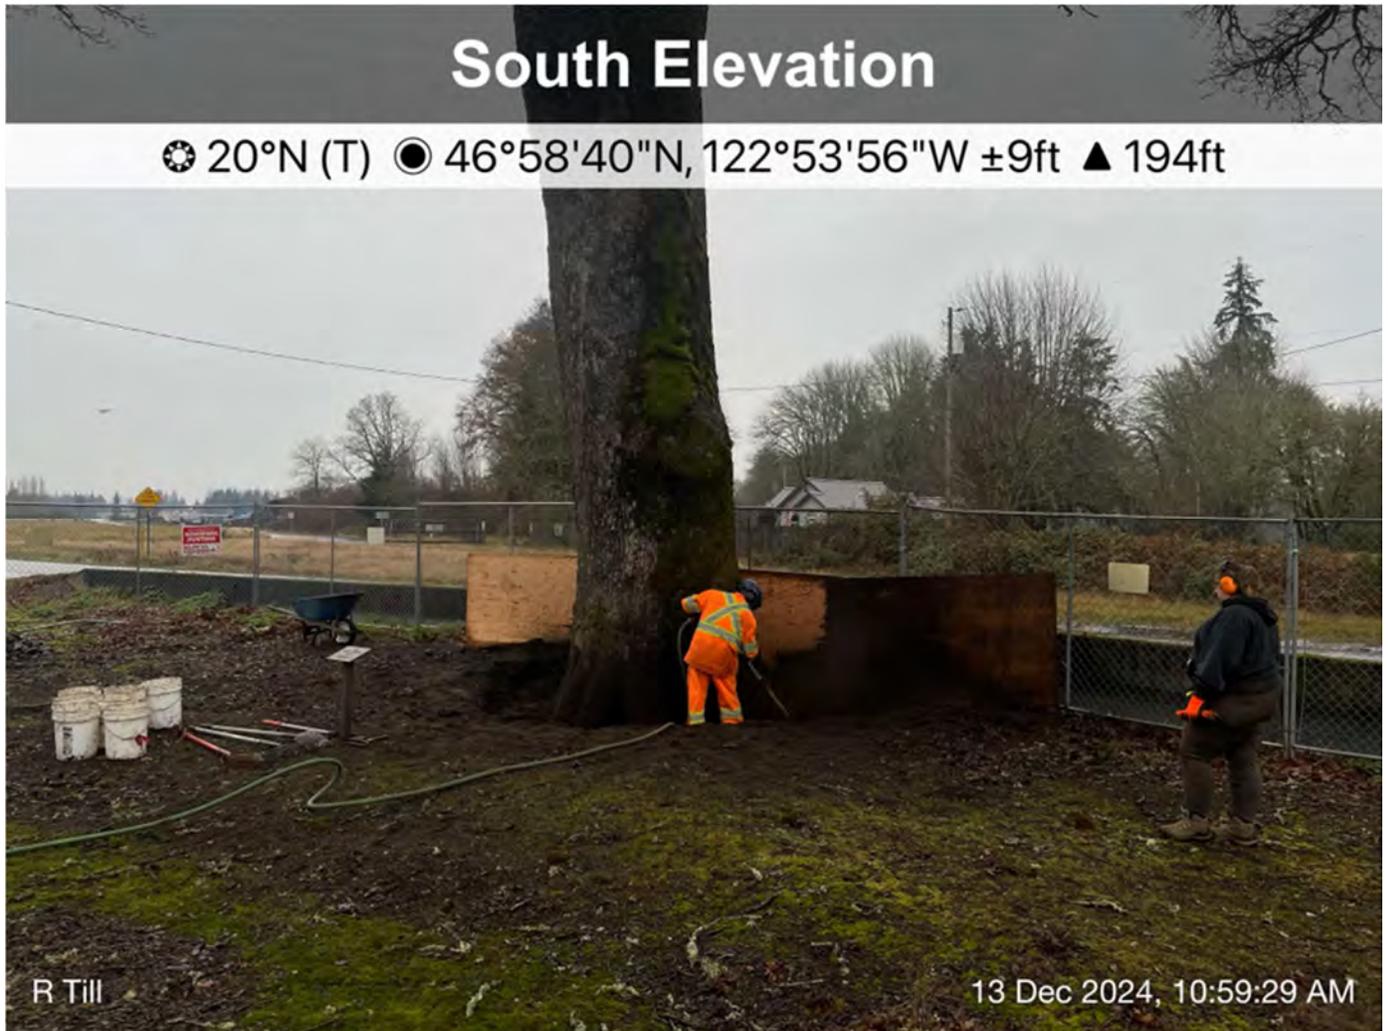
The inspection revealed adequate to robust buttress root growth around the entire tree. One historic decay cavity was revealed to be closing with substantial wound wood growth.

Figure 1 Root crown excavation employed an “air spade” that uses compressed air to remove fine soil. The excavation involved alternating between air spade removal of soil with hand removal of river cobble that was backfilled over the root flare after a prior root crown excavation. The project archaeologist oversaw all work.
