**CITY COUNCIL WORK SESSION  
MEETING AGENDA**

TO: City Council  
FROM: Lisa Parks, City Administrator  
DATE: March 11, 2025  
SUBJECT: Davis Meeker Oak Tree Risk Assessment Final Report Briefing

The City of Tumwater contracted with Todd Prager and Associates LLC to perform a Level 3 Advanced Tree Risk Assessment for the Davis-Meeker Oak, a 66-inch diameter (DBH) Oregon white oak (*Quercus garryana*) and City of Tumwater-designated heritage tree. The advanced assessment included a thorough climbing inspection of the tree, sonic tomography testing at eight locations on the main stems of the tree, and a root crown excavation. The assessment also included a review of historic site conditions. The new information was used to categorize risk using the International Society of Arboriculture's tree risk assessment process. Based on that process, all but one tree part was rated as *low* risk, and one tree part was rated as *moderate* risk during the next three-year timeframe.

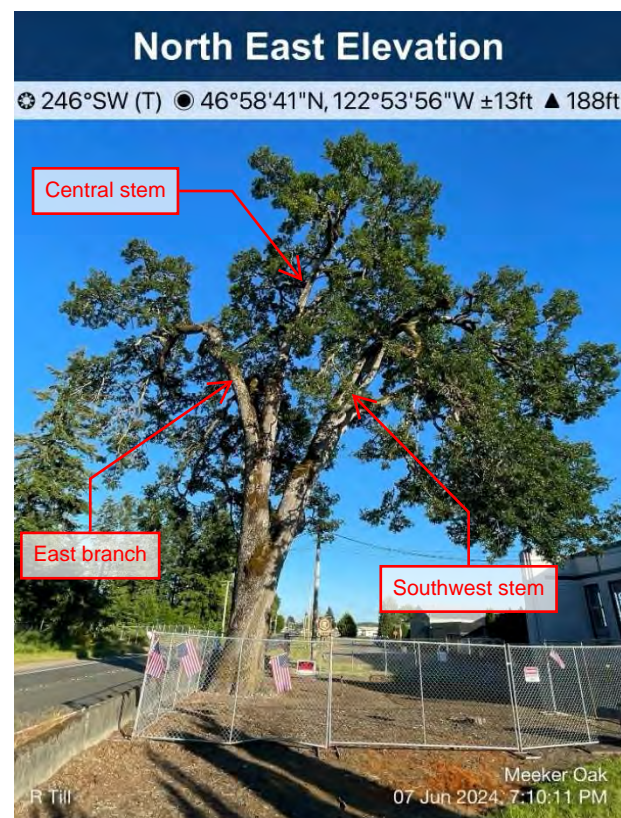
Figure 3 View of tree anatomy and crown shape.

The mass of the crown is to the south or southwest of the central trunk. The crown is split into three stems, which are depicted in Figure 3 and Attachment 3. The approximate outline of the crown and the three primary stems are depicted in the aerial photo in Attachment 4. The main trunk forks at approximately 16 feet into a southwest and northeast stem. The southwest stem arches to the southwest toward the hanger. The northeast stem forks again at approximately 33 feet into a central stem that forms the top of the tree and a second branch system that extends to the east and southeast. The central stem has a historic decay pocket on the south side at approximately 46 feet that is used as a nesting cavity by kestrels (*Falco sparverius*). The cavity is also identifiable from a cascara (*Frangula purshiana*) sapling growing from the cavity. The east/southeast branch system forks into two branches, one extends directly over Old Highway 99 and the second extends to the south/southeast parallel to Old Highway 99.

In agreement with the City's prior contract arborist, the Davis-Meeker Oak visually appears to be in good health, with healthy crown density, leaf color, leave size, and internode growth. The tree visually has a fair structural condition rating based on the codominant unions with included bark and history of failures.

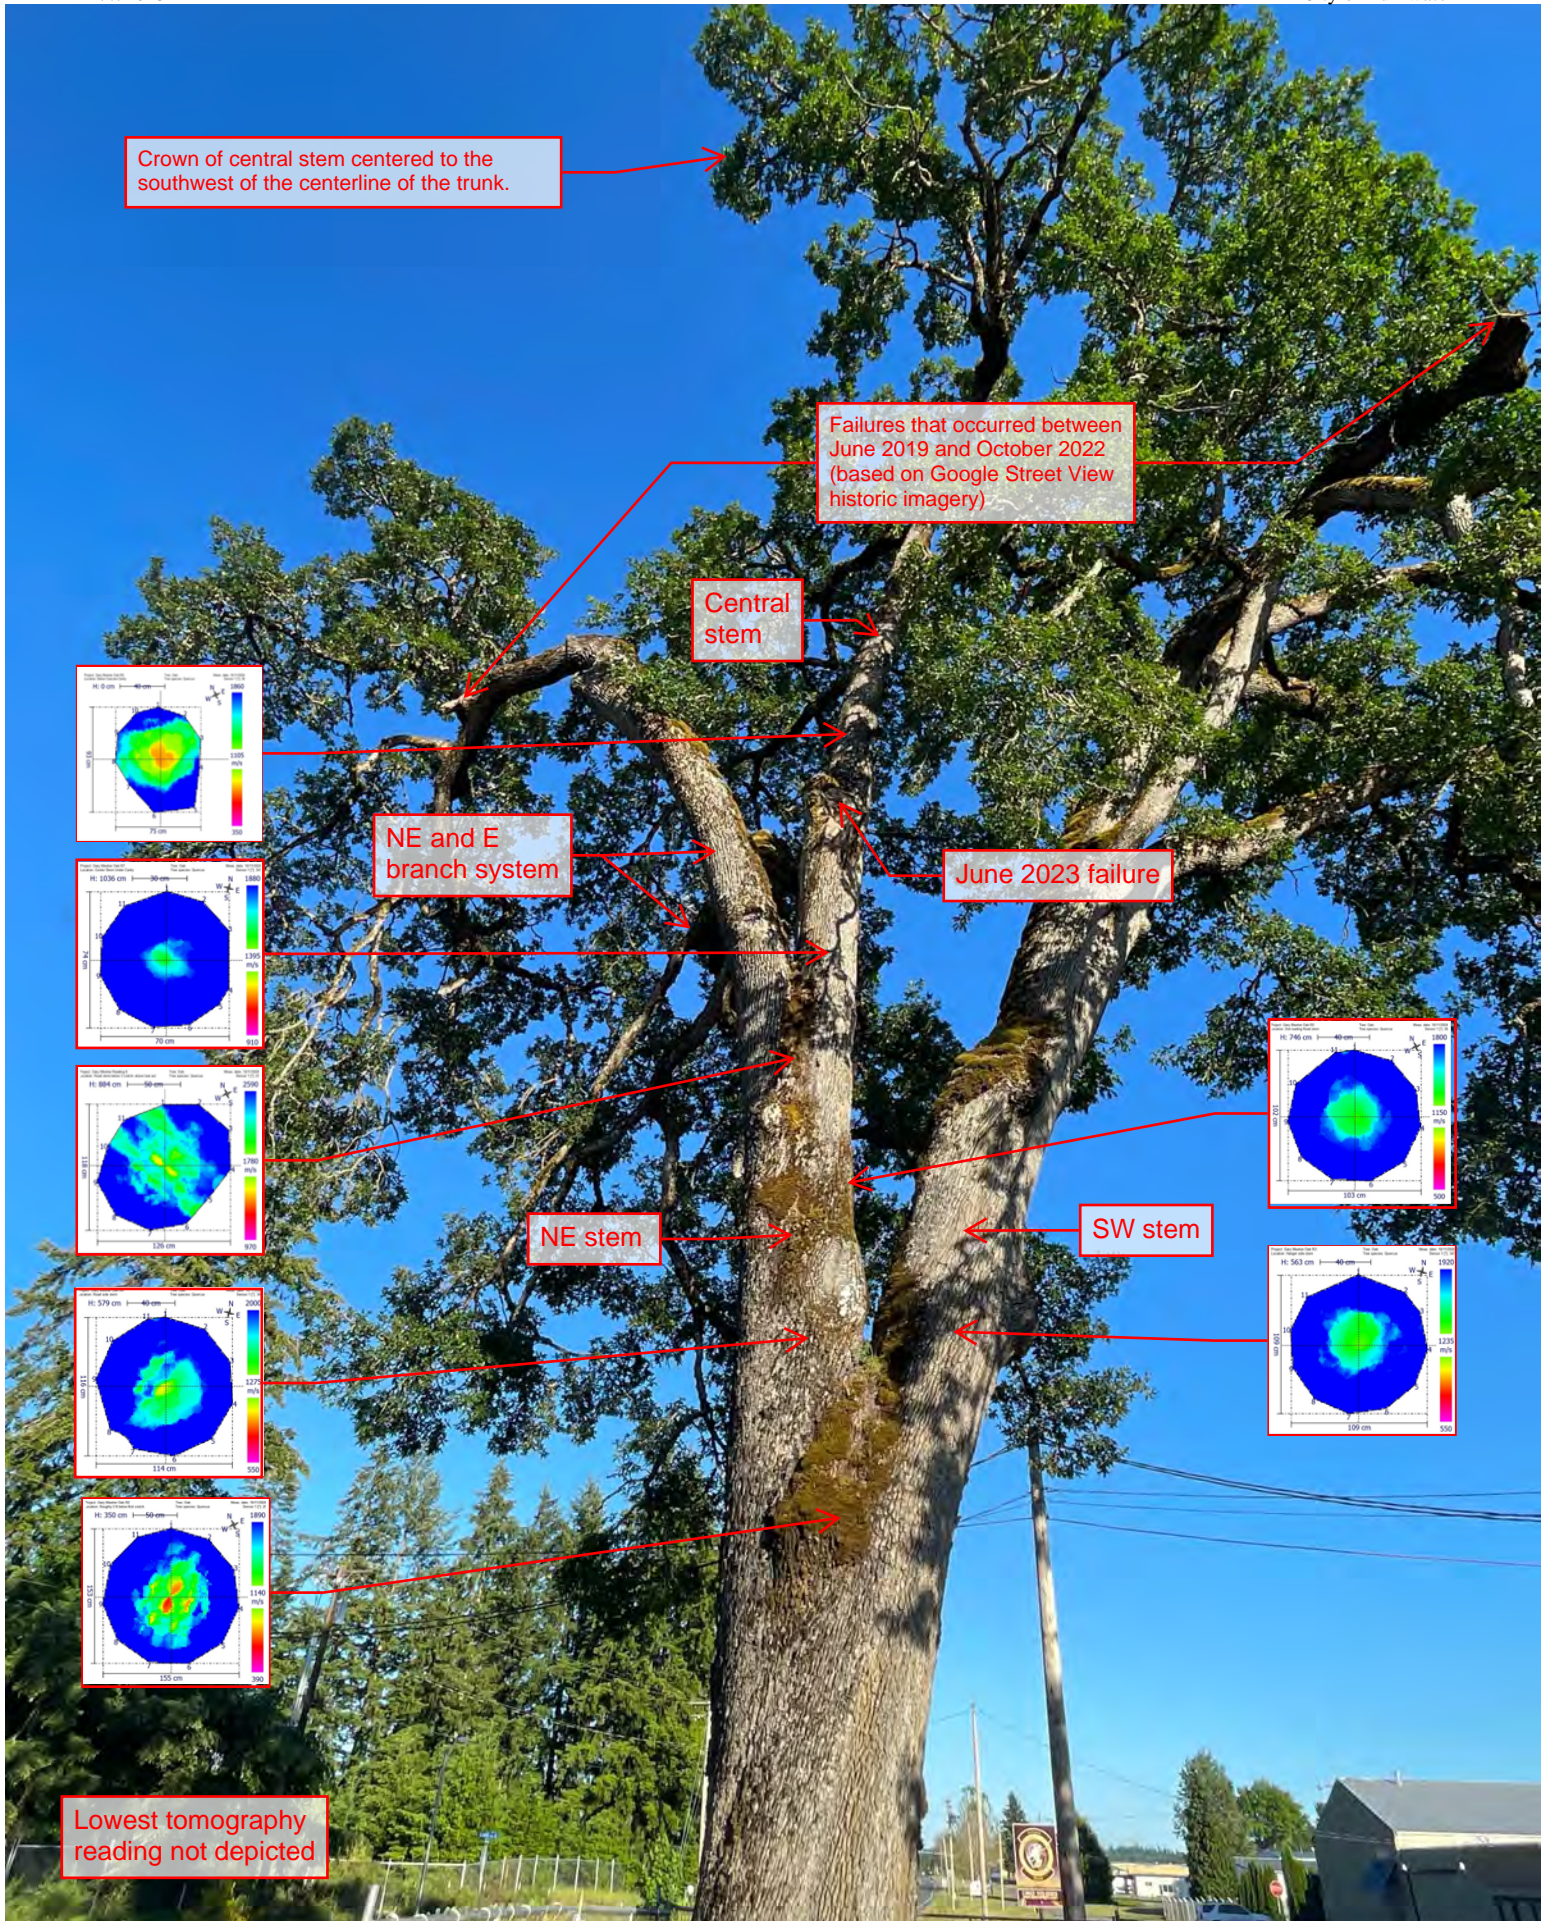
Crown of central stem centered to the southwest of the centerline of the trunk.

Failures that occurred between June 2019 and October 2022 (based on Google Street View historic imagery)

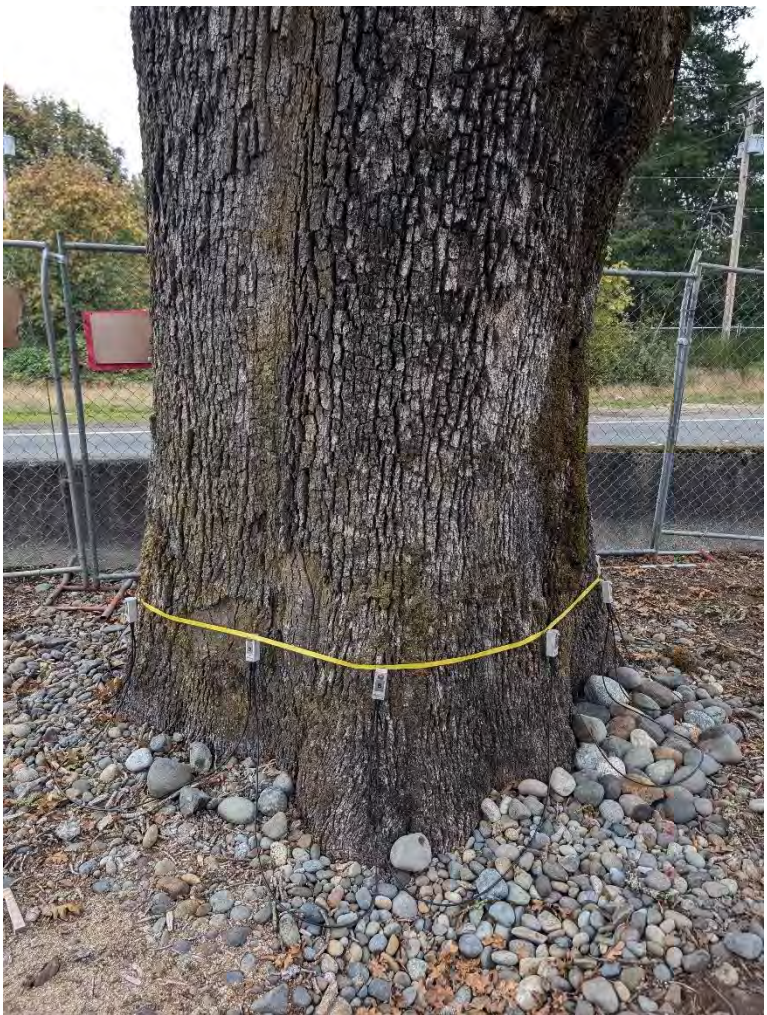
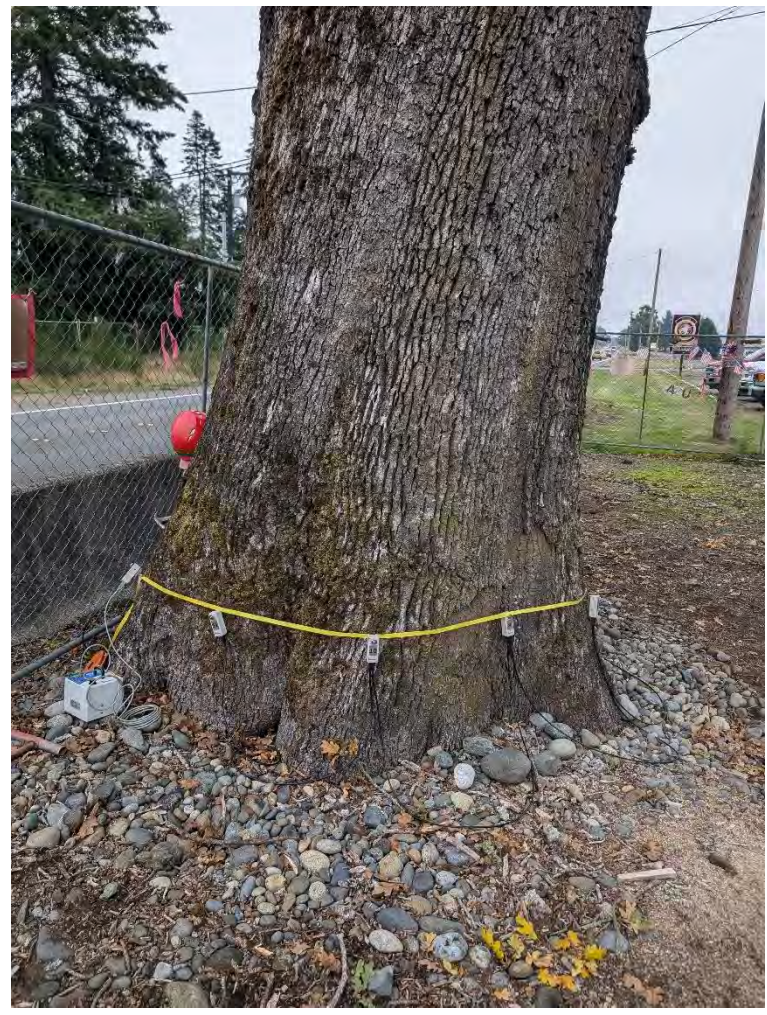
# Oak – Reading 1- 50cm

Below are pictures and the resulting graphs of the first reading taken on this tree. Eleven sensors were used to take this reading. Sensor number one was placed on the north side of the tree. Sensors were placed in locations to best represent the shape of the tree.

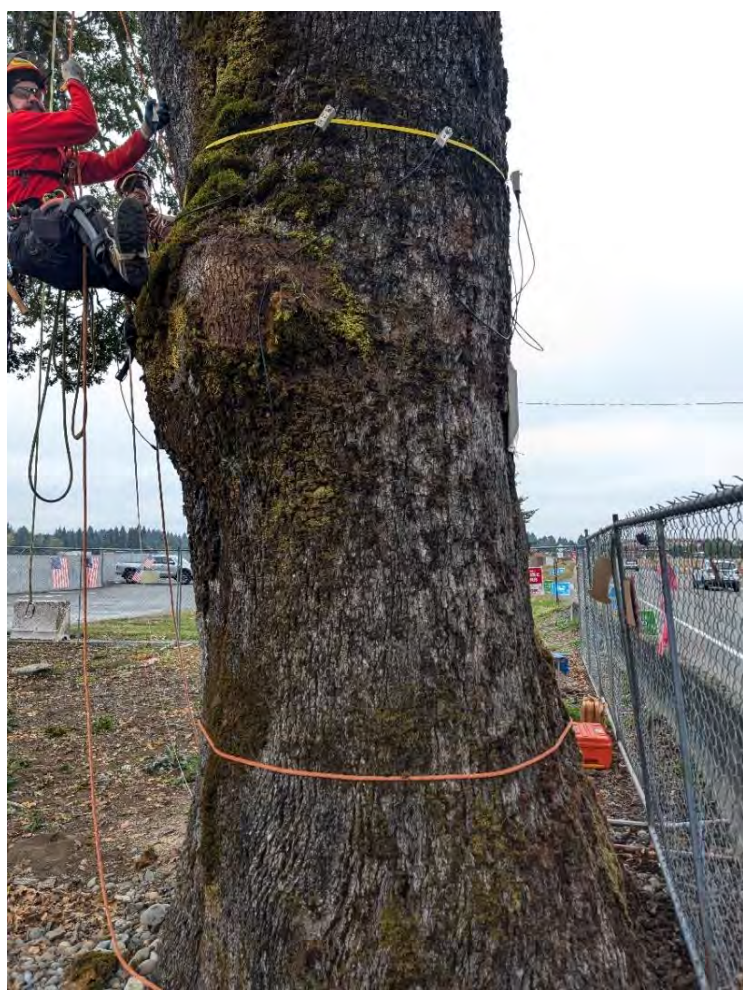
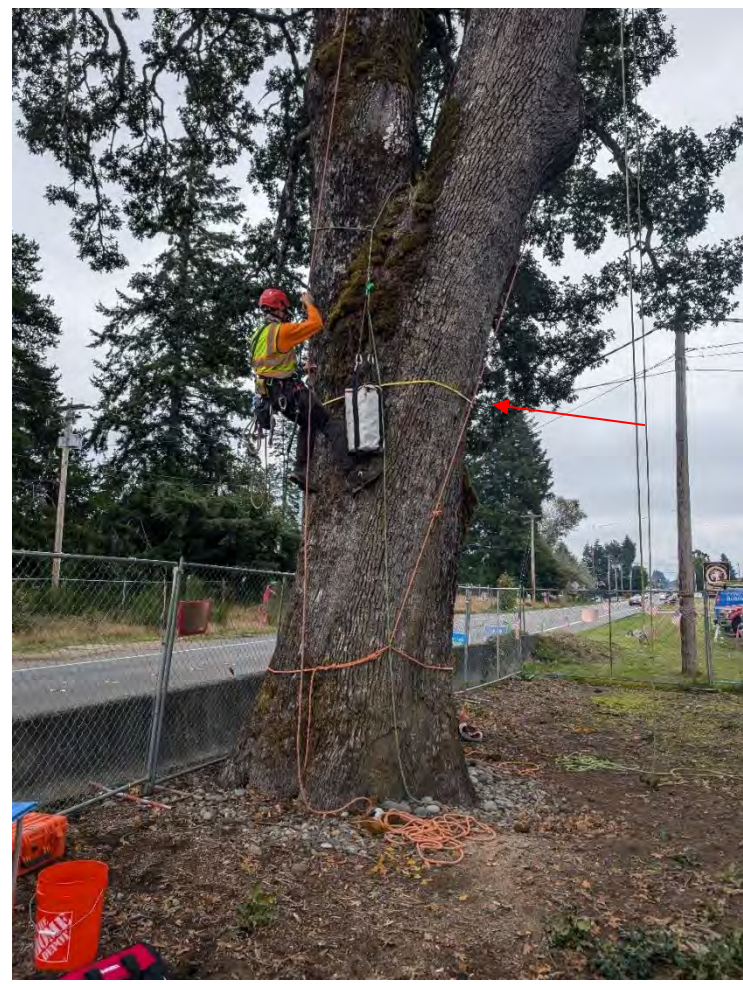
## Oak – Reading 2- 350cm

Below are pictures and the resulting graphs of the second reading taken on this tree. Eleven sensors were used to take this reading. Sensor number one was placed on the north side of the tree. Sensors were placed in locations to best represent the shape of the tree. Reading two was taken below the first primary crotch.

At this level there is a small amount of compromised wood in the center of the stem. The green indicates where the co-dominant inclusion is causing a weak attachment point.

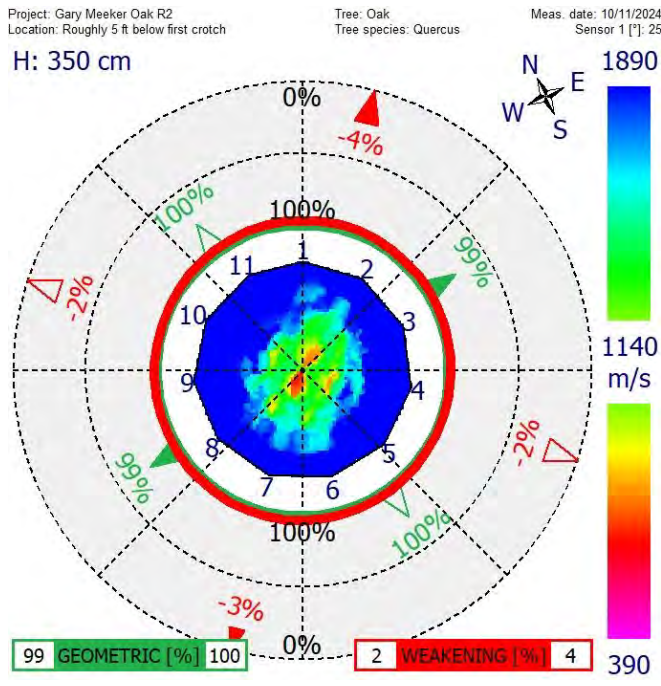
At this level there is between 2% and 4% strength loss. This is low strength loss.

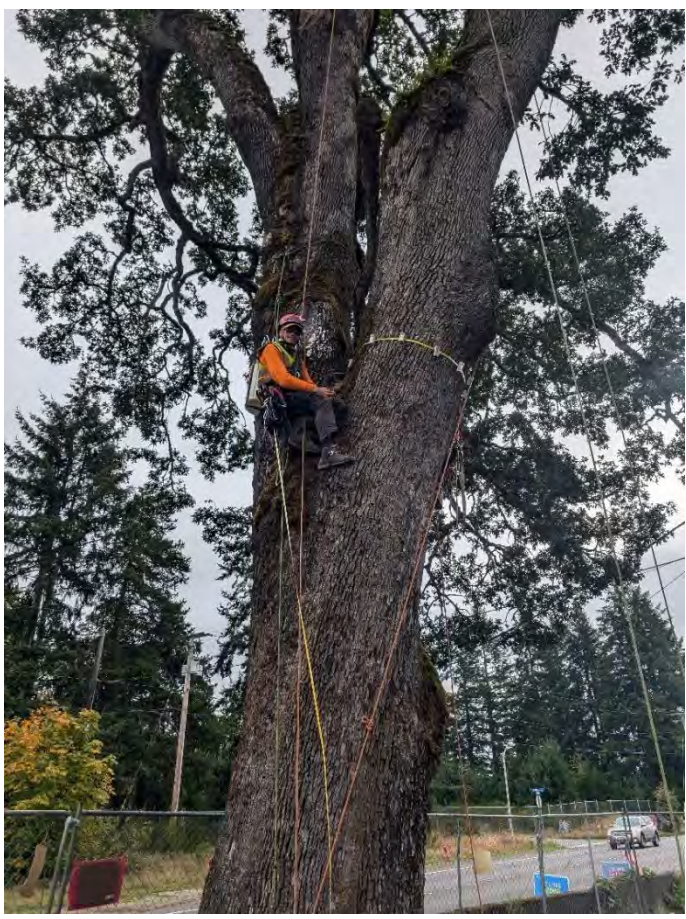
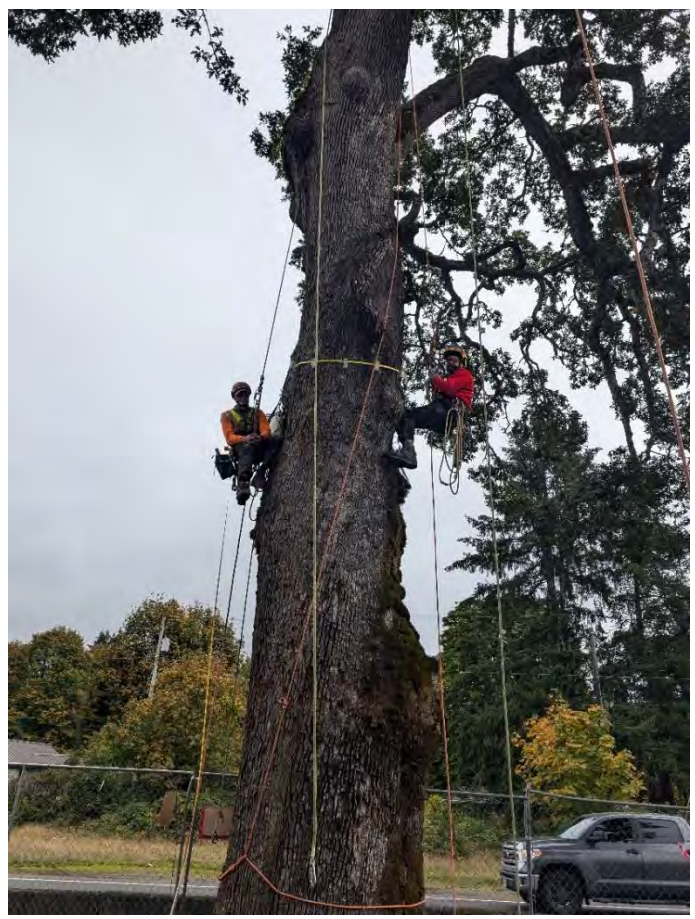
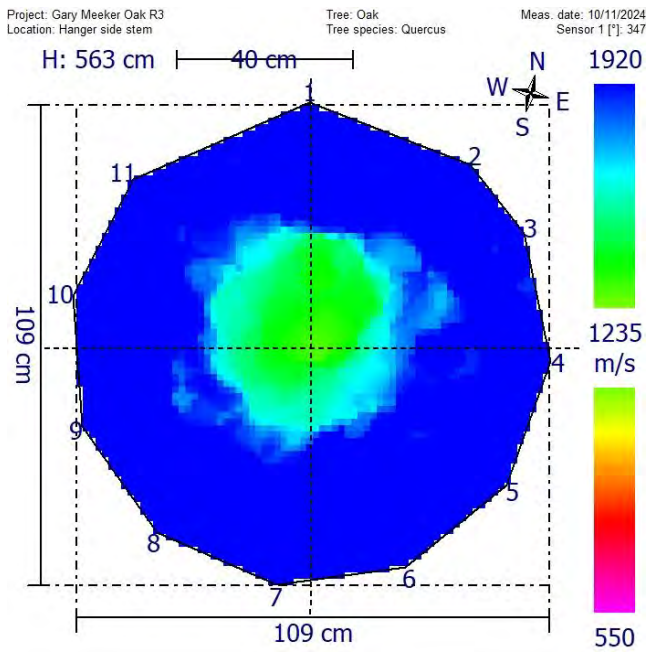
## Oak – Reading 3- 563cm

Below are pictures and the resulting graphs of the third reading taken on this tree. Eleven sensors were used to take this reading. Sensor number one was placed on the north side of the tree. Sensors were placed in locations to best represent the shape of the tree. This reading was taken on the SW stem, just above the first crotch.

At this level there is no sign of compromised wood.

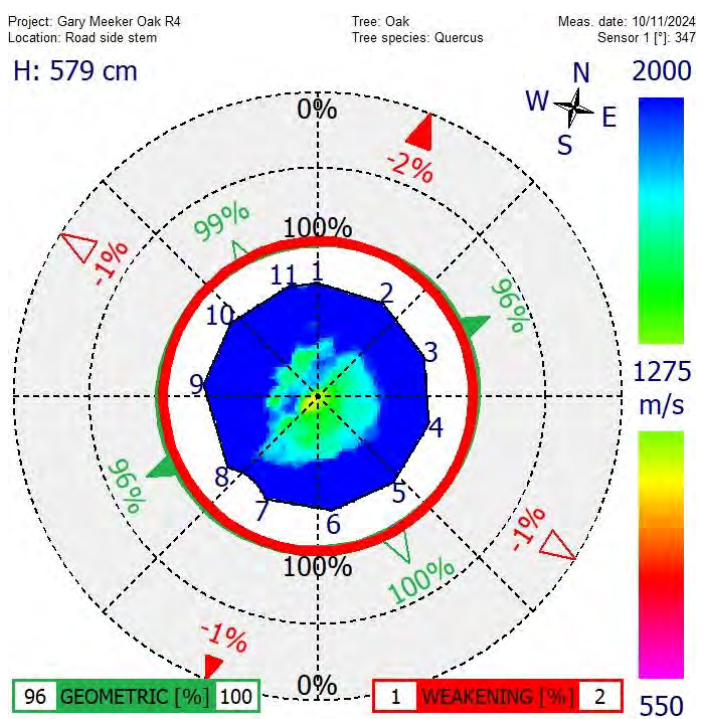
At this level there is between 1% and 2% strength loss. This is minimal strength loss.

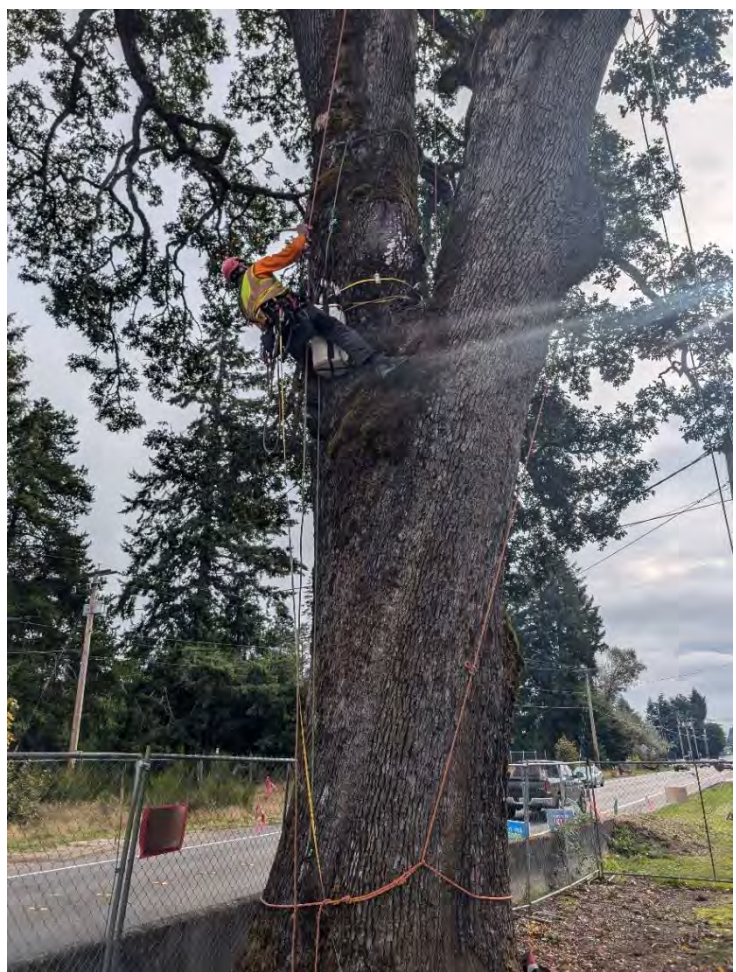
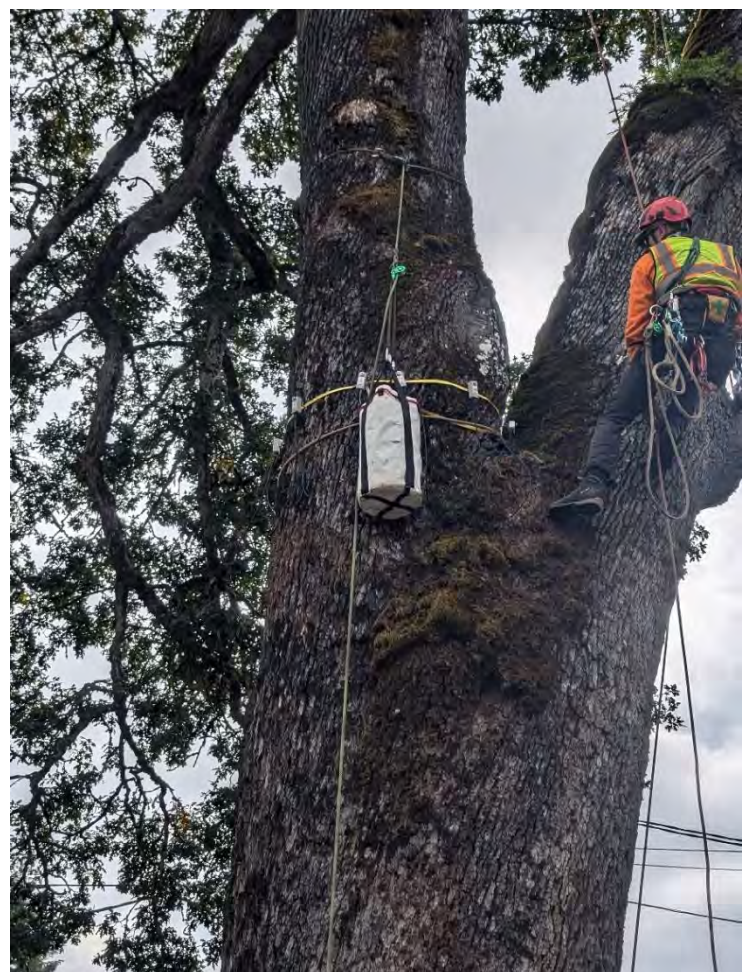
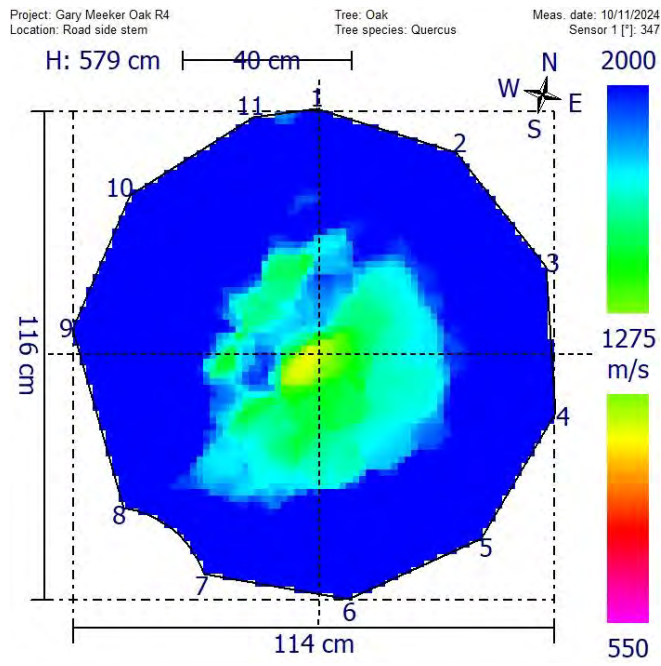
## Oak – Reading 4- 579cm

Below are pictures and the resulting graphs of the fourth reading taken on this tree. Eleven sensors were used to take this reading. Sensor number one was placed on the north side of the tree. Sensors were placed in locations to best represent the shape of the tree. This reading was taken on the northern stem roughly one foot above the crotch.

At this level there is no sign of compromised wood.

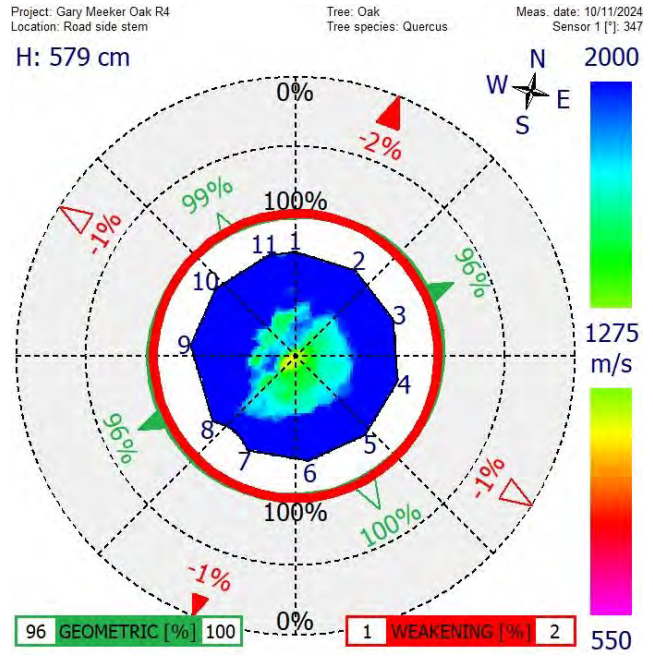
At this level there is between 1% and 2% strength loss. This is minimal strength loss.

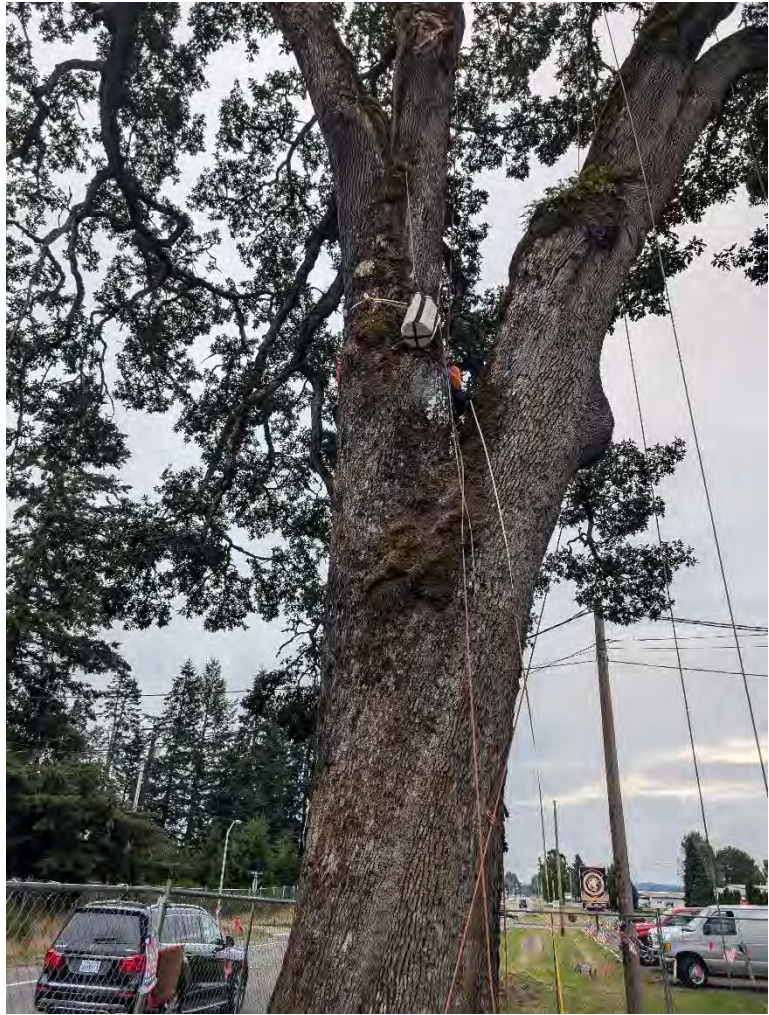
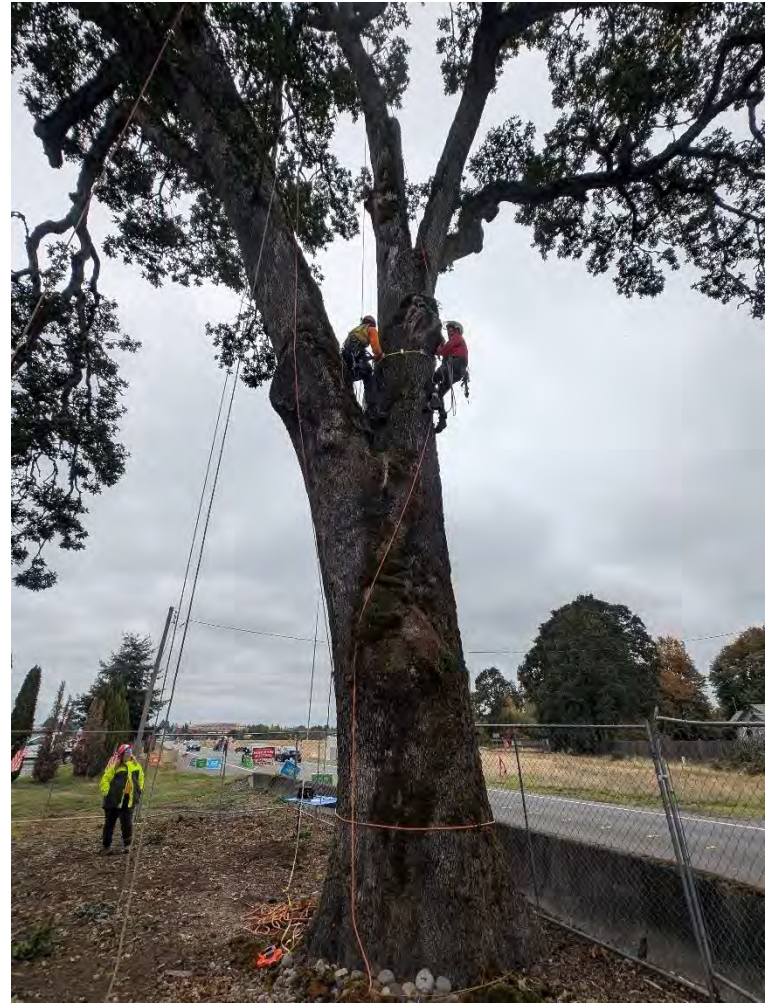
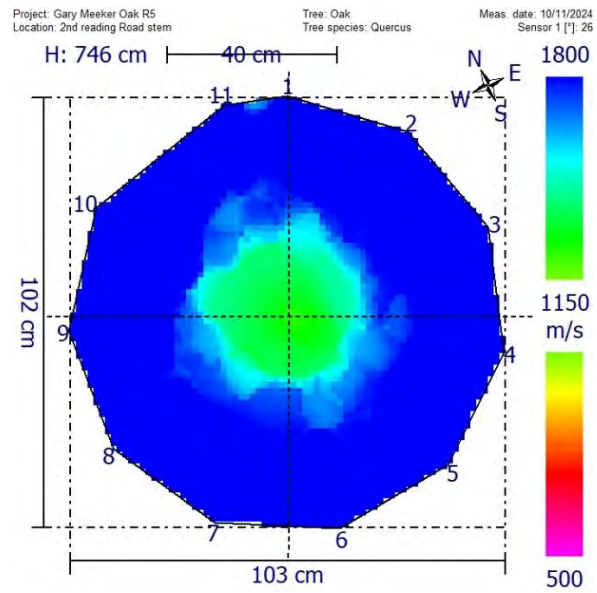
## Oak – Reading 5- 746cm

Below are pictures and the resulting graphs of the fifth reading taken on this tree. Eleven sensors were used to take this reading. Sensor number one was placed on the north side of the tree. Sensors were placed in locations to best represent the shape of the tree. This reading was taken on the northern stem placed just below the tear out on the NE side.

At this level there are no signs of compromised wood.

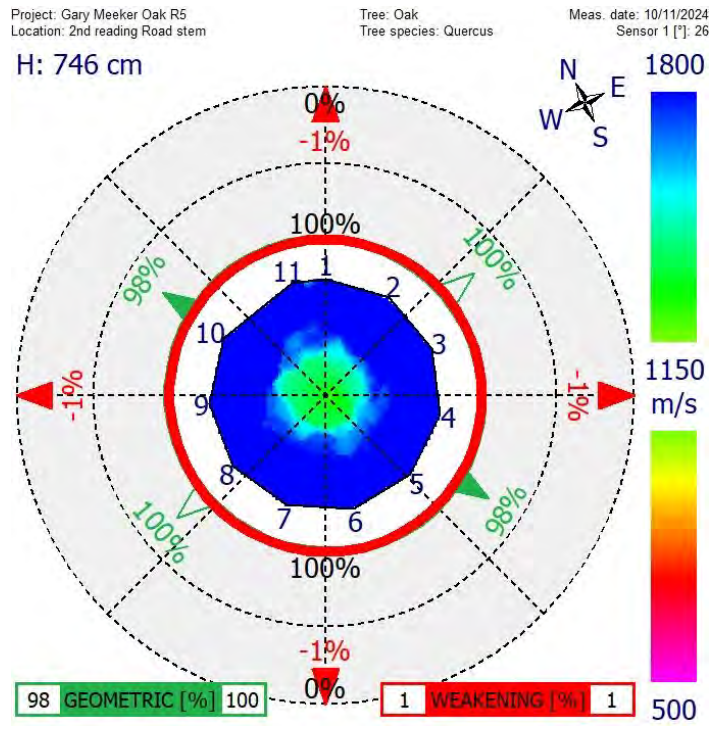
At this level there is less than 2% strength loss. This is minimal strength loss.

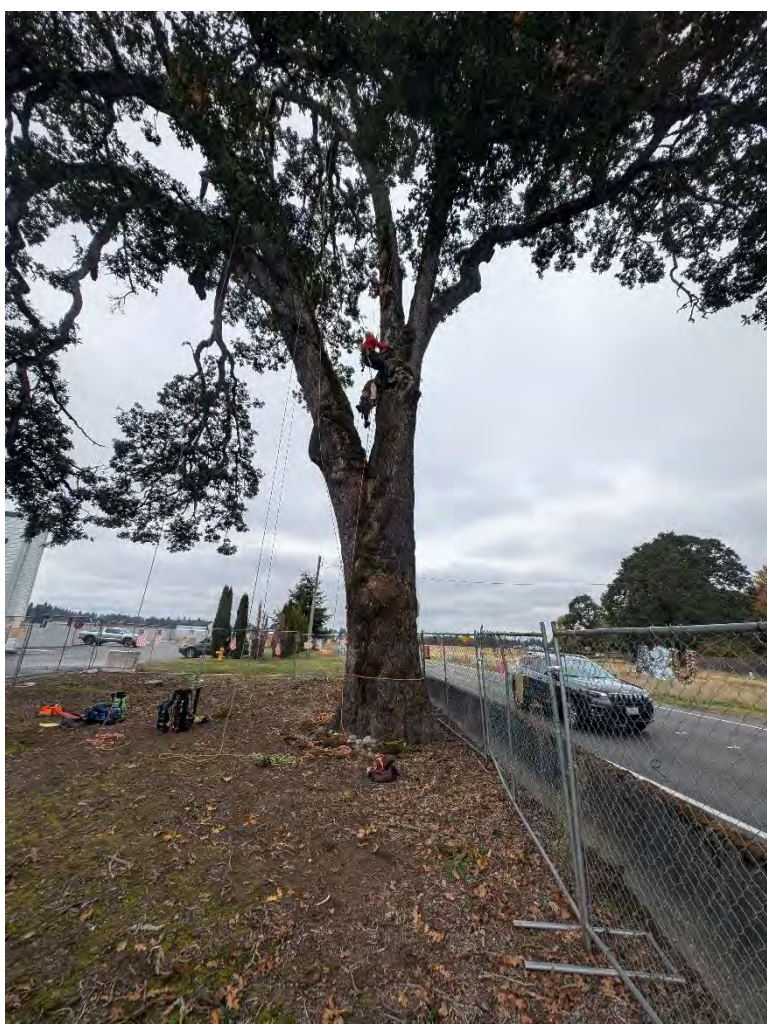
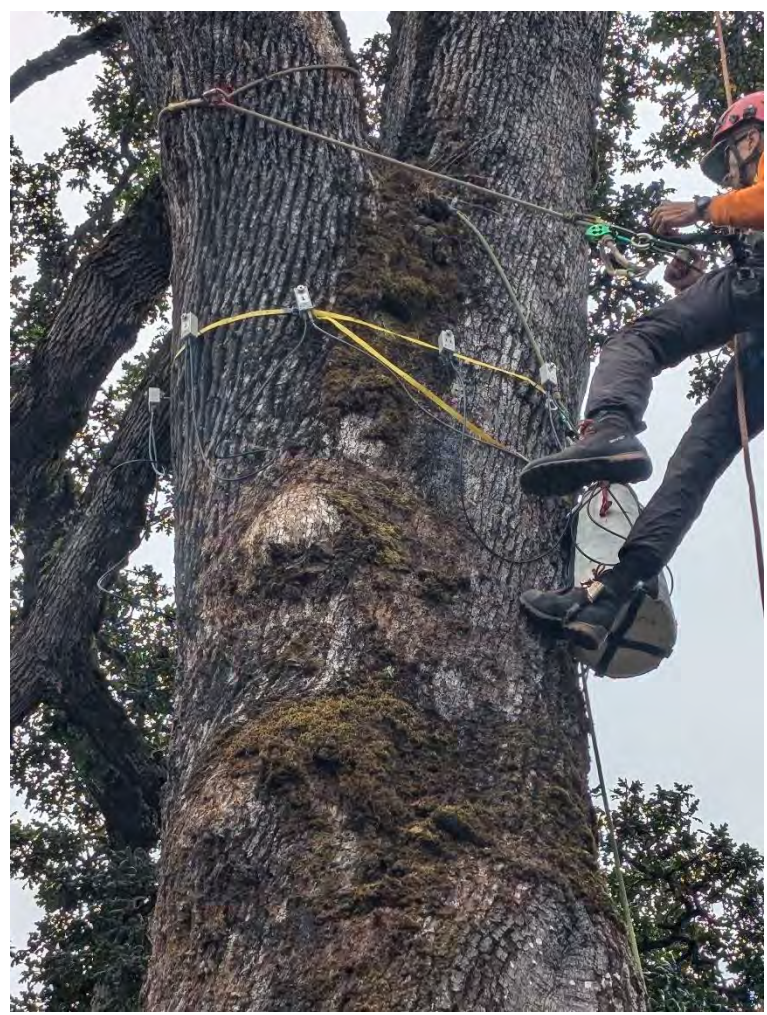
## Oak – Reading 6- 884cm

Below are pictures and the resulting graphs of the sixth reading taken on this tree. Eleven sensors were used to take this reading. Sensor number one was placed on the north side of the tree. Sensors were placed in locations to best represent the shape of the tree. This reading was taken below the second crotch on the northern leader, just above the tear out on the NE side.

At this level there is included bark throughout the center of the stem, where the three stems connect.

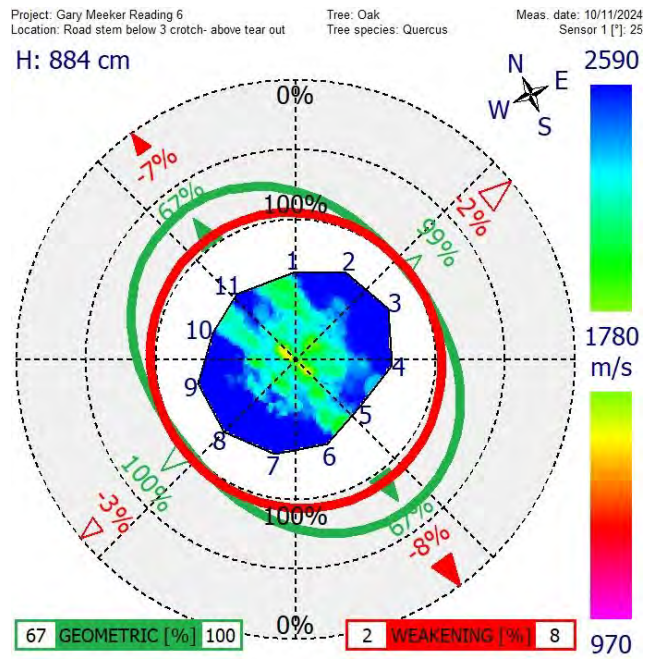
At this level there is between 2% and 8% strength loss. This is minimal strength loss.

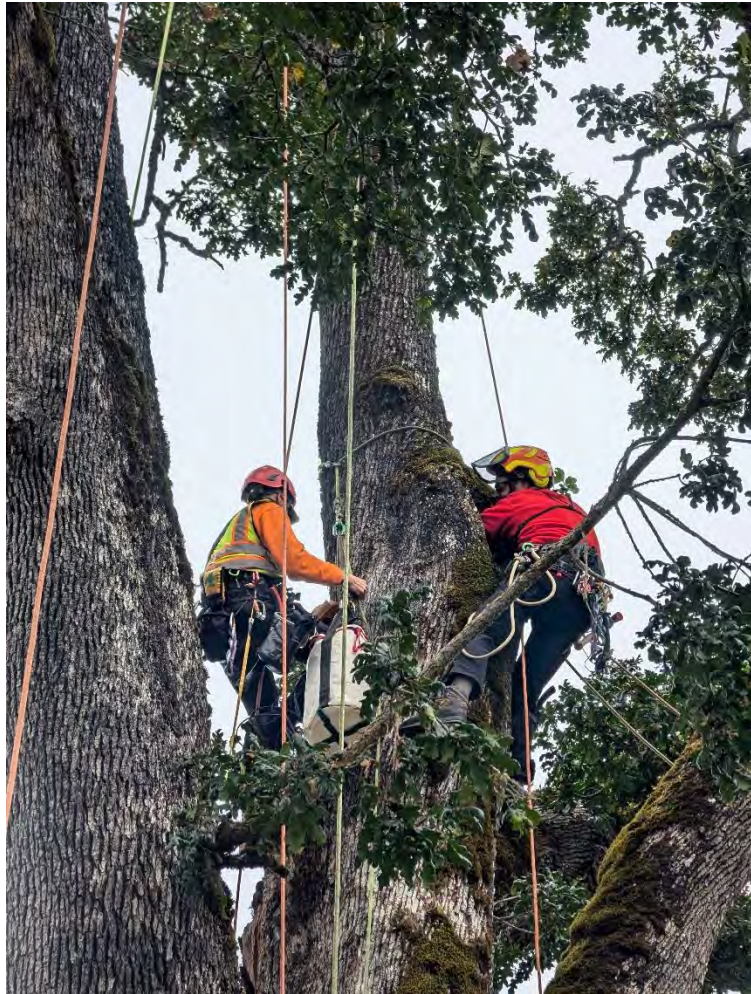
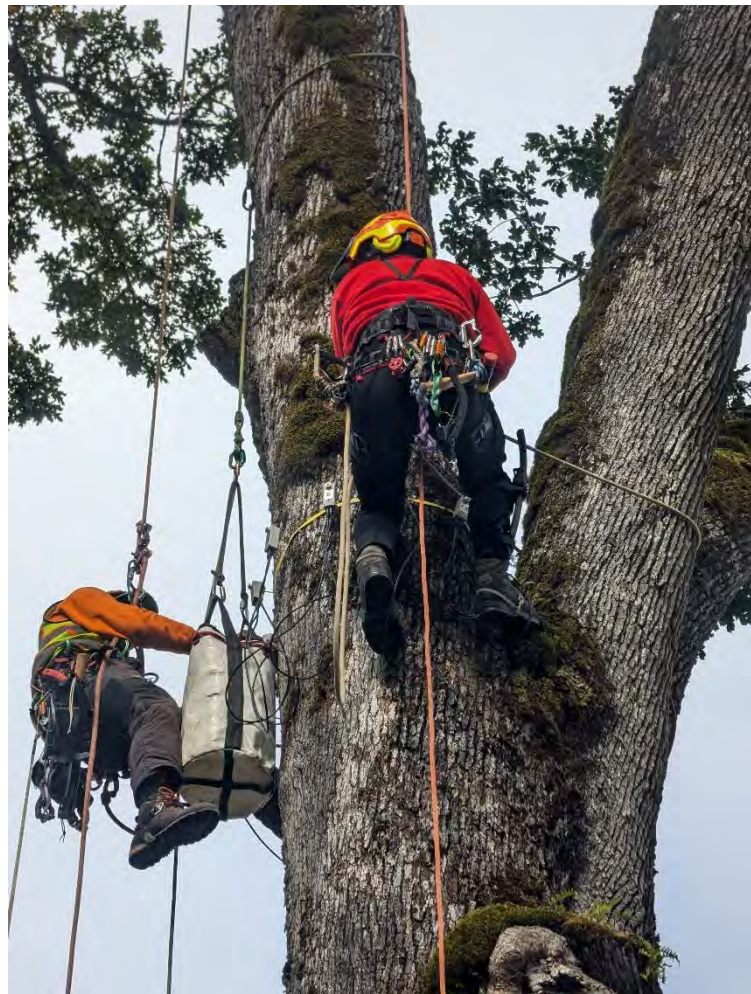
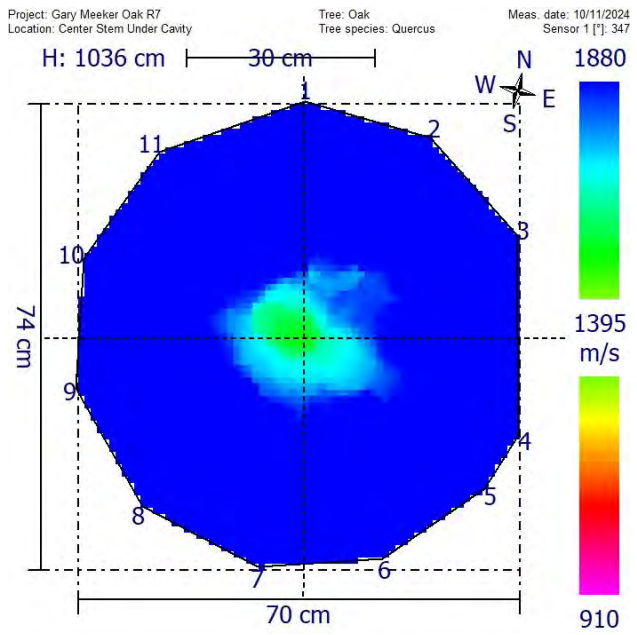
## Oak – Reading 7- 1036cm

Below are pictures and the resulting graphs of the seventh reading taken on this tree. Eleven sensors were used to take this reading. Sensor number one was placed on the north side of the tree. Sensors were placed in locations to best represent the shape of the tree. This reading was taken on the northern stem, just above the 3 stemmed crotch.

At this level there is no sign of compromised wood.

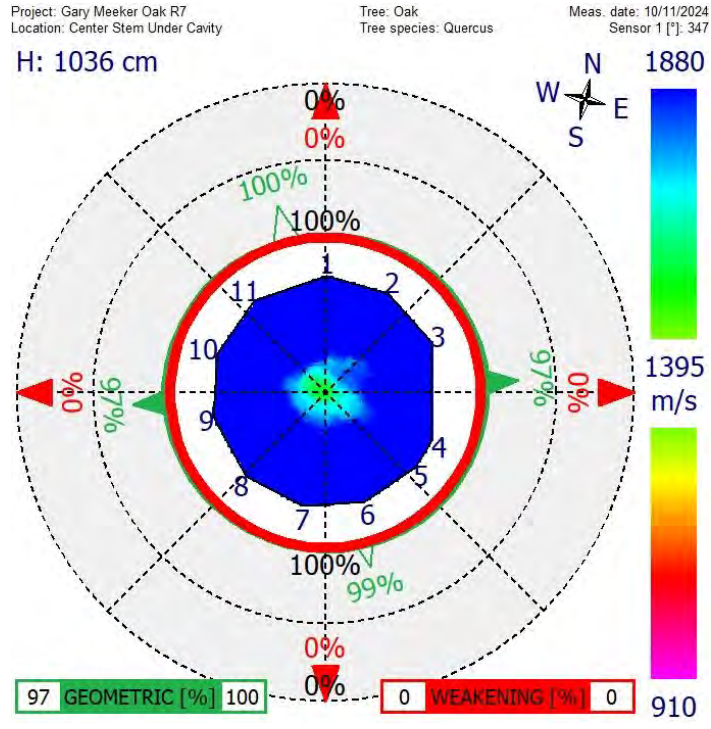
At this level there is no strength loss.

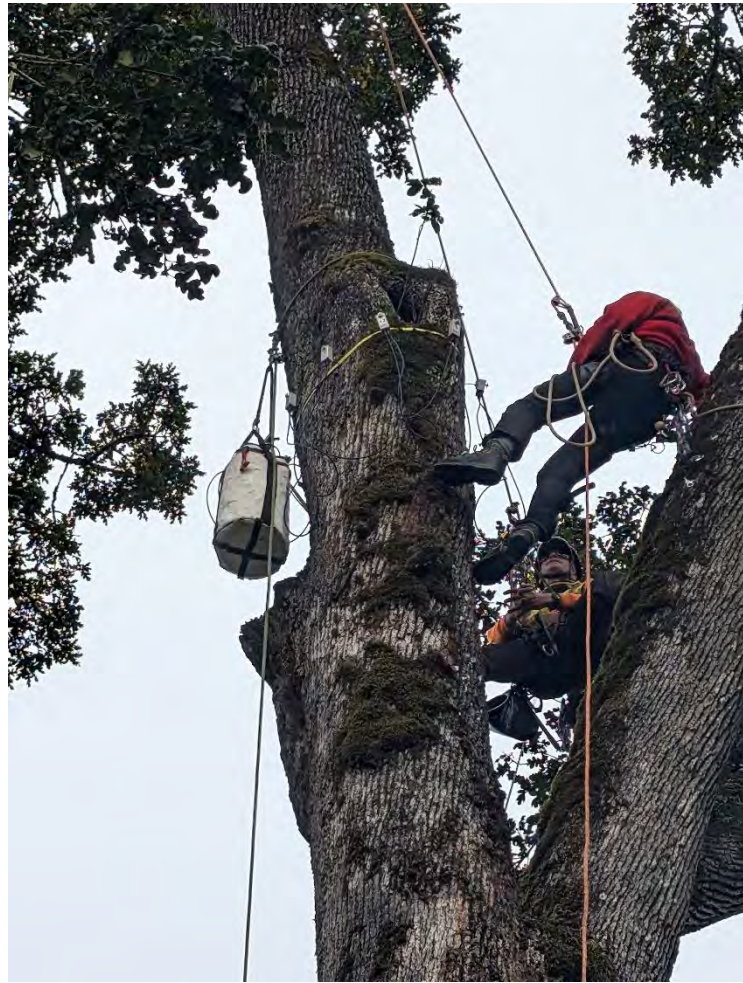
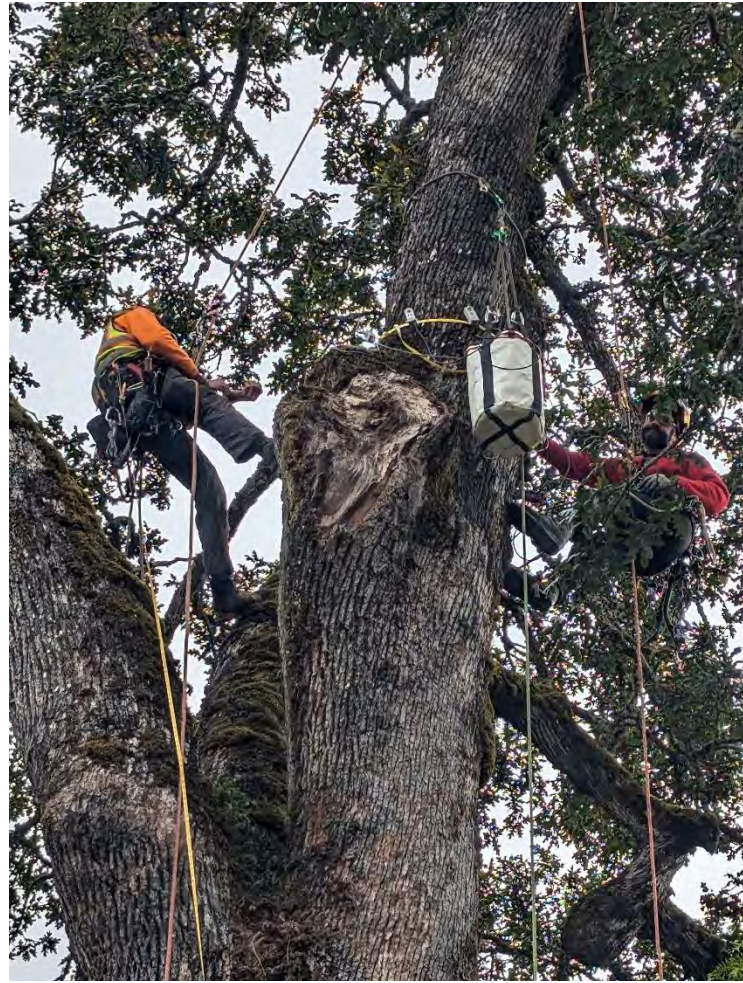
## Oak – Reading 8- 1381cm

Below are pictures and the resulting graphs of the eighth reading taken on this tree. Eleven sensors were used to take this reading. Sensor number one was placed on the north side of the tree. Sensors were placed in locations to best represent the shape of the tree. This reading was taken on the northern stem, just below the topmost tear out.

At this level there is less dense wood in the center of the stem. The center yellow spot indicates where the cavity above extends too.

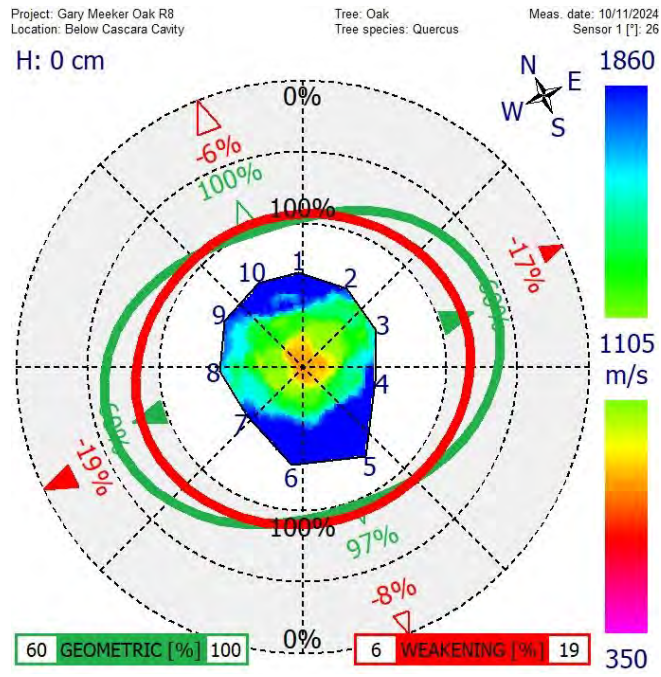
At this level there is between 6% and 19% strength loss. This is minimal strength loss.

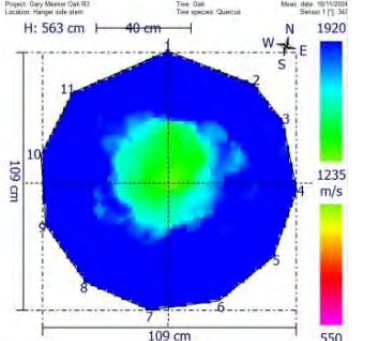
<p>At this level there is no sign of compromised wood.</p> <p>At this level there is between 1% and 2% strength loss. This is minimal strength loss.</p>
