**CITY COUNCIL WORK SESSION  
MEETING AGENDA**

TO: City Council  
FROM: Lisa Parks, City Administrator  
DATE: March 11, 2025  
SUBJECT: Davis Meeker Oak Tree Risk Assessment Final Report Briefing

The City of Tumwater contracted with Todd Prager and Associates LLC to perform a Level 3 Advanced Tree Risk Assessment for the Davis-Meeker Oak, a 66-inch diameter (DBH) Oregon white oak (*Quercus garryana*) and City of Tumwater-designated heritage tree. The advanced assessment included a thorough climbing inspection of the tree, sonic tomography testing at eight locations on the main stems of the tree, and a root crown excavation. The assessment also included a review of historic site conditions. The new information was used to categorize risk using the International Society of Arboriculture's tree risk assessment process. Based on that process, all but one tree part was rated as *low* risk, and one tree part was rated as *moderate* risk during the next three-year timeframe.

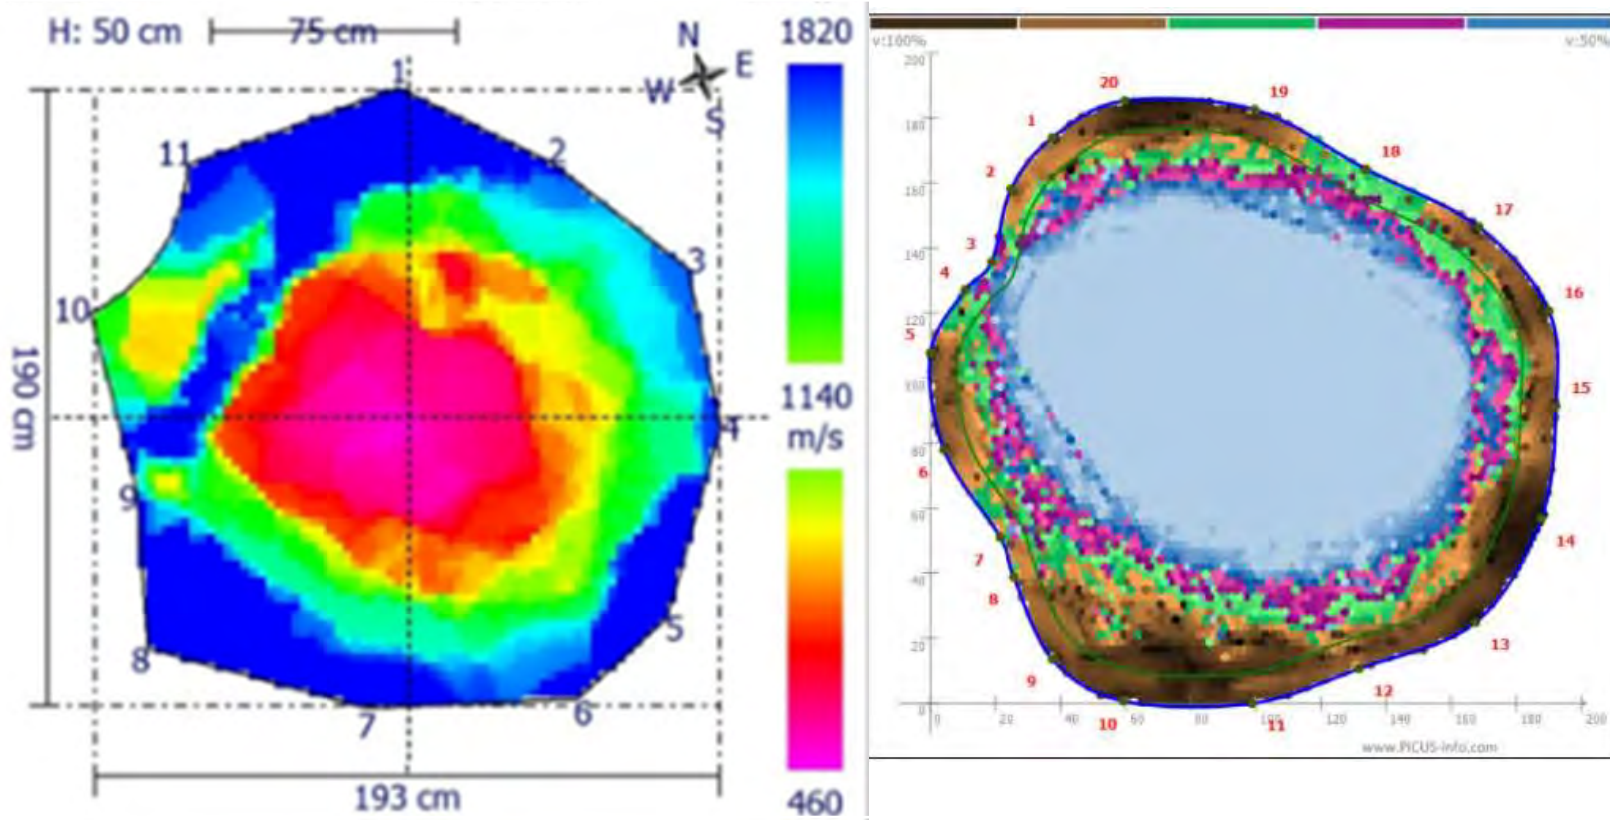
### Attachment 6 Table of Sonic Tomography Readings and Comparison to Tree Solutions

<p>Tree Solutions sonic tomography reading. Conclusion was that there is sufficient wood to support existing tree. The sonic tomography strength limit appears to have been set at approximately 80 percent hollow, or approximately 4-inches (10 cm) of sound wood based on the tree's diameter at the measurement point.</p>

Side-by-side comparison of the 2024 sonic tomography reading using the Arbotom® system and the 2023 sonic tomography using the PiCUS system

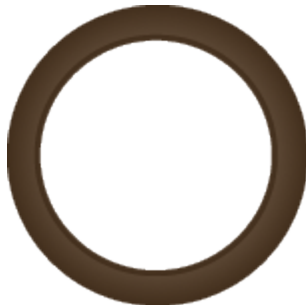
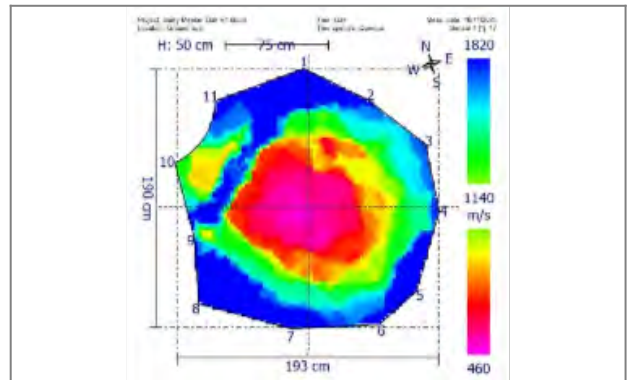
Basic safety: 11.16  
Desired factor of safety: 1.5

Stem safety factor: 6.27

Basic safety:	11.16
Desired factor of safety:	1.5
Stem safety factor:	6.27

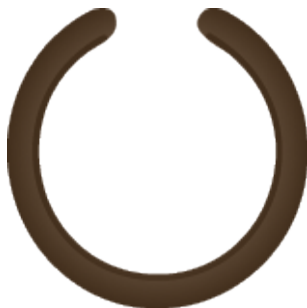
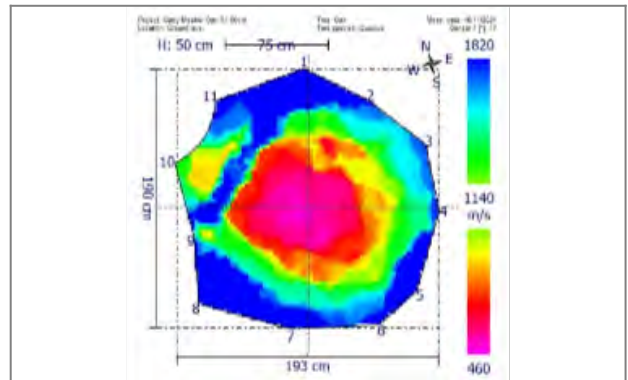
Basic safety: 11.16  
Desired factor of safety: 1.5

Stem safety factor: 6.27

Basic safety:	11.16
Desired factor of safety:	1.5
Stem safety factor:	6.27

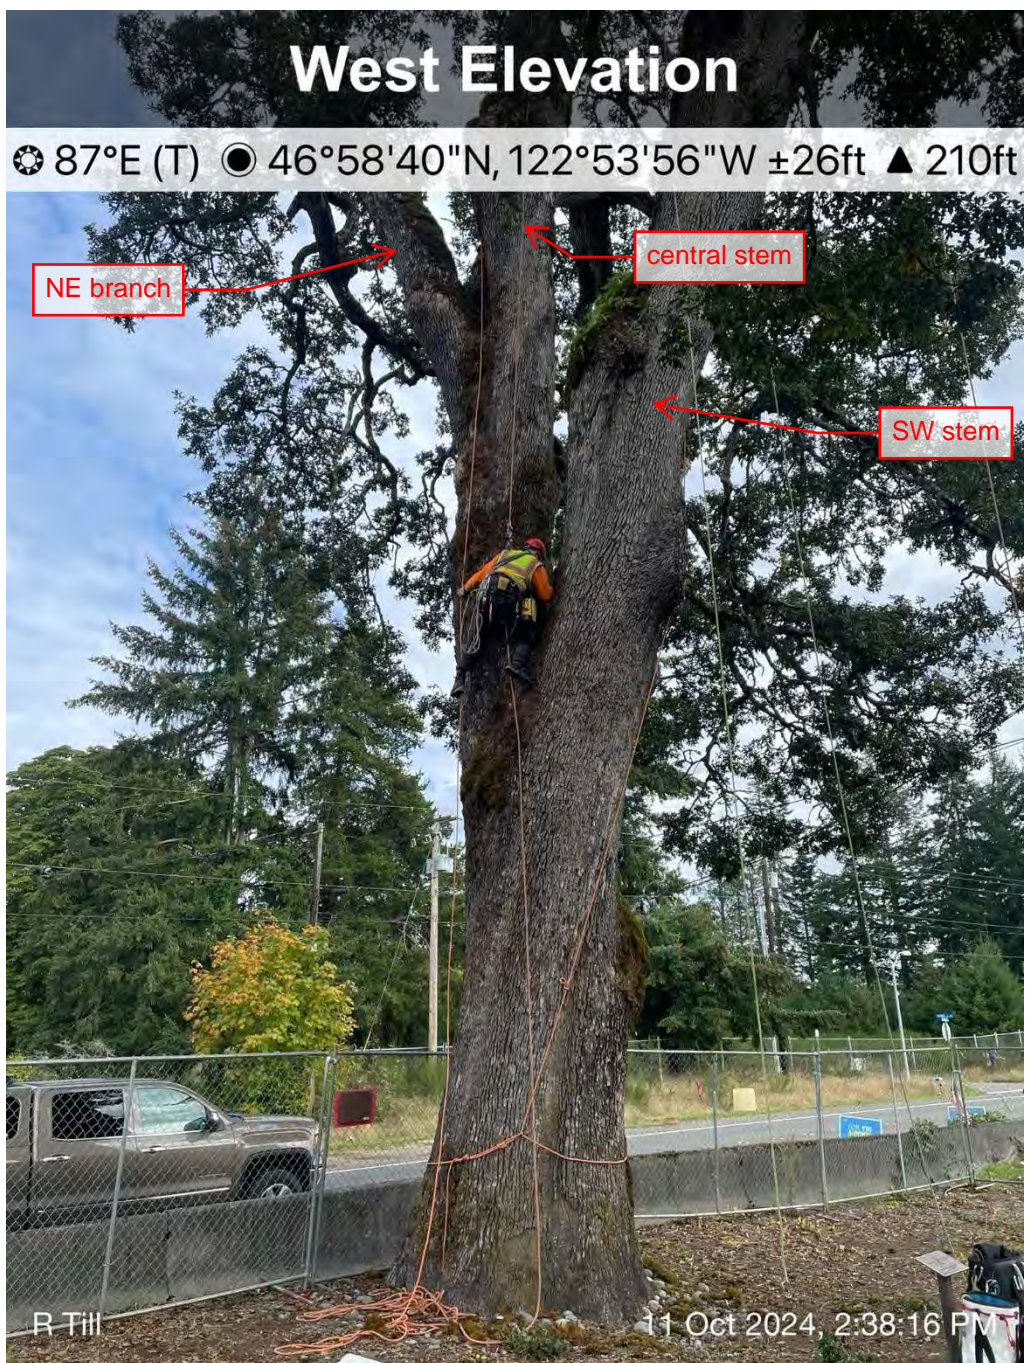
The primary codominant union is located at approximately 16 feet above ground. The union has included bark. This area was inspected with a ¼ inch metal probe and resistance was encountered indicating sold wood in the interior. Spiral grain, indicating adaptive growth, is visible on the southwest trunk.

Figure 1 Inspection of first codominant union. A ¼ inch steel probe was inserted between stems and encountered solid resistance below historic debris collecting between the stems.

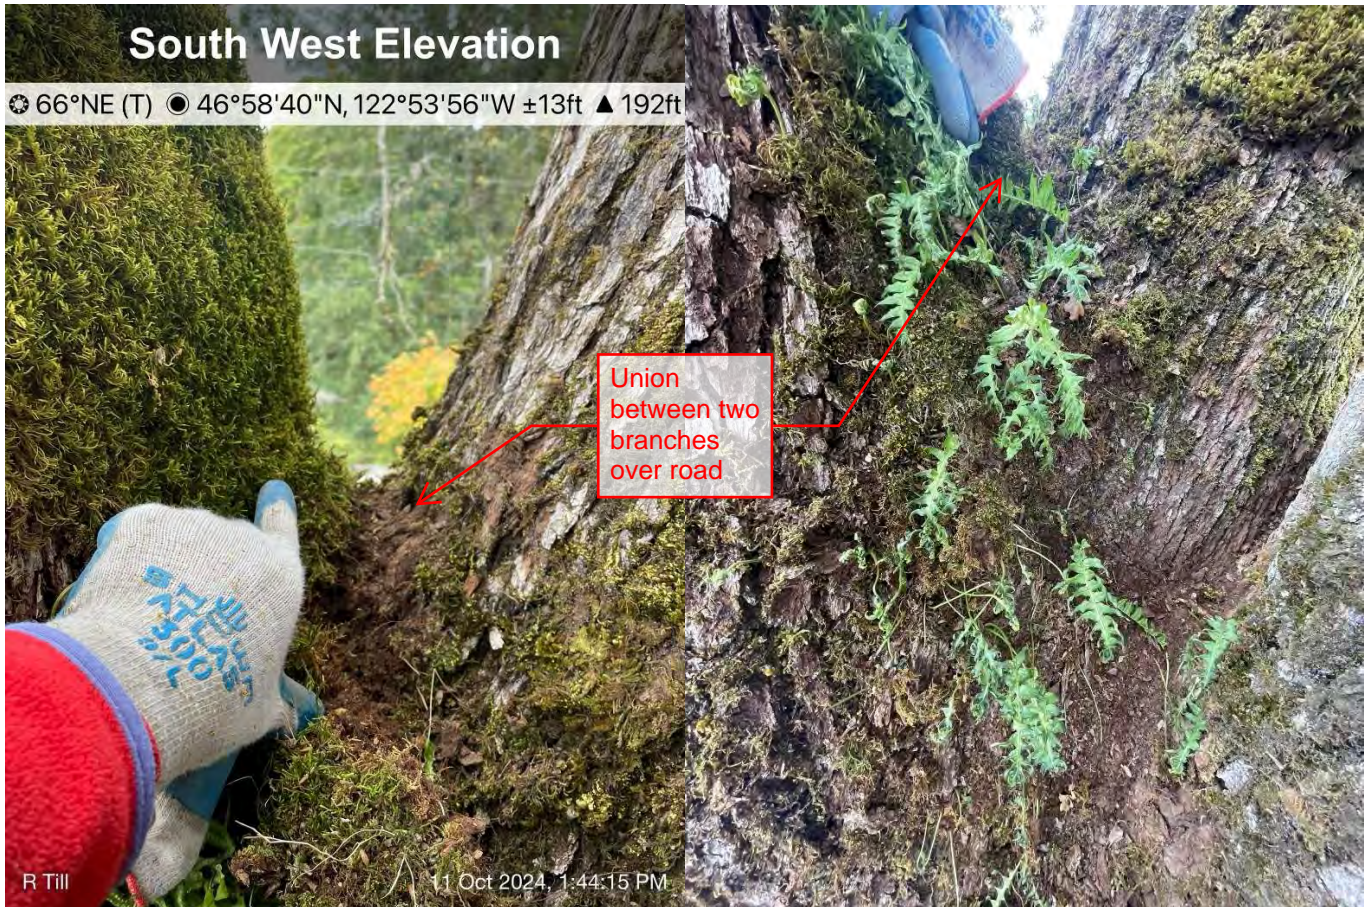
Figures 7 and 8 Southwest view of attachment between two secondary stems extending over the road. Exterior signs indicate a sound union.

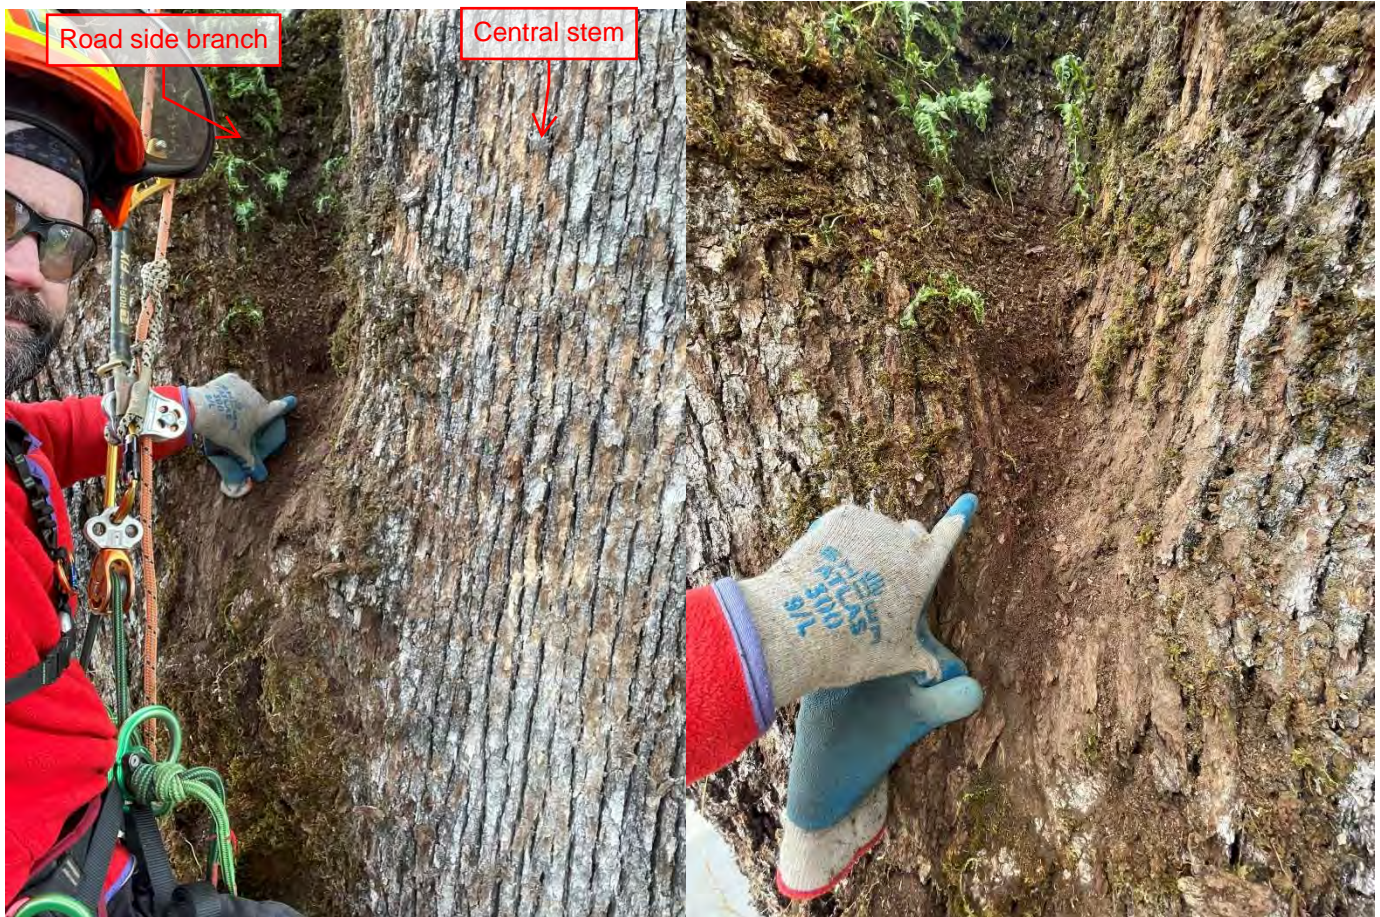
Figures 9 and 10 Northwest view of second codominant union. Included bark transitions into sound wood attachment.

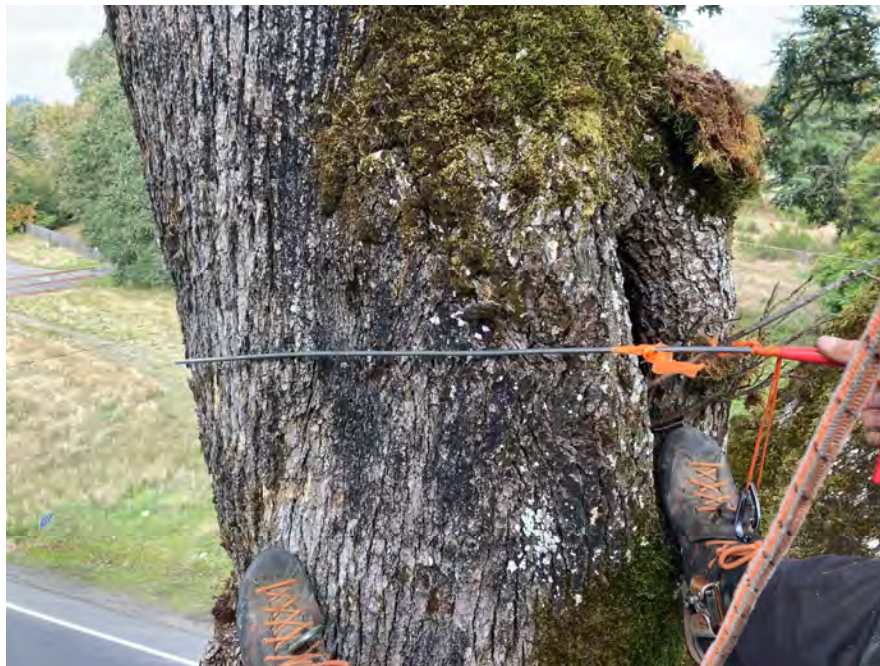
Figure 16 Correlating depth of the cavity, indicating substantial depth.

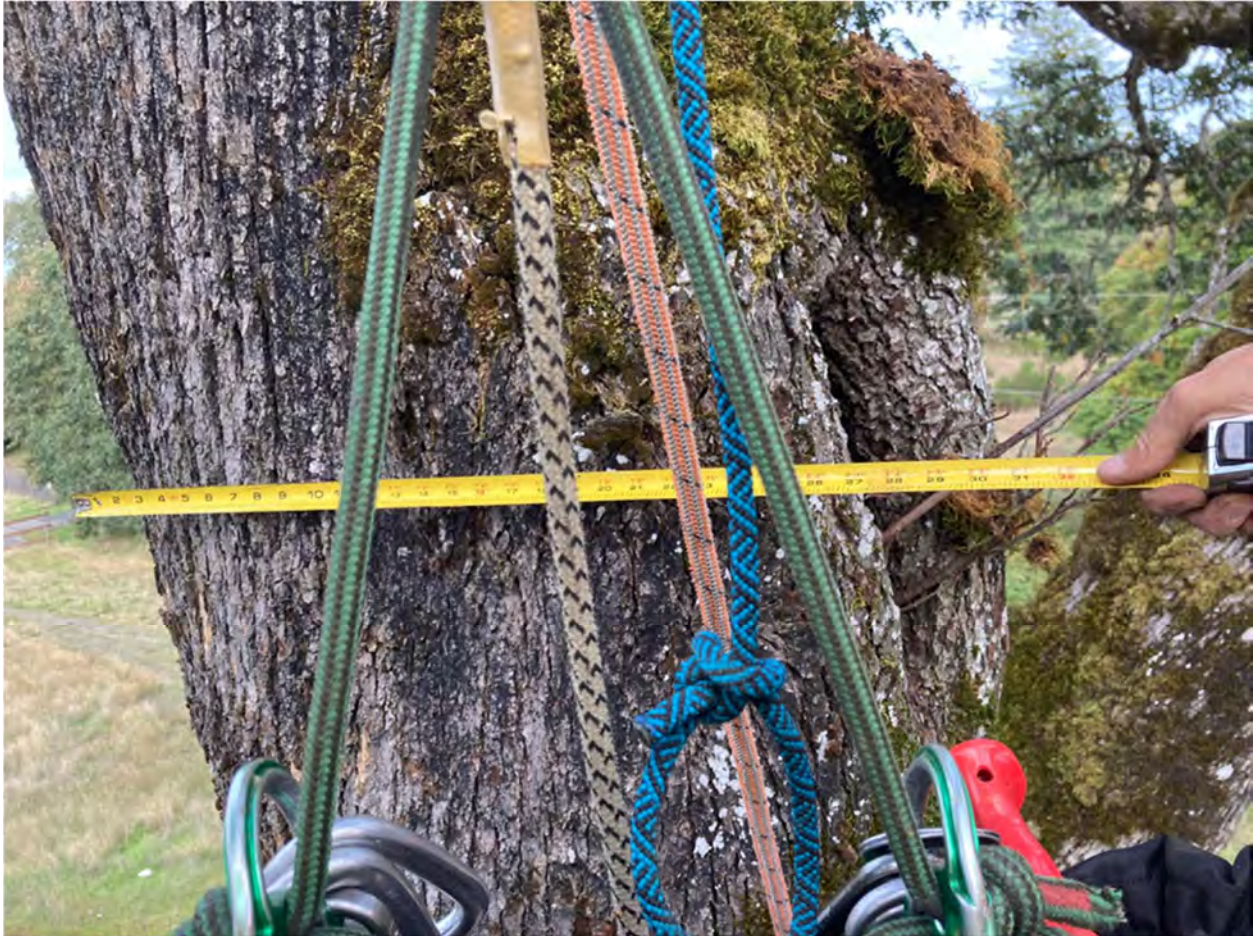
Figure 18 Approximate diameter of tree measured at approximately 27 inches.

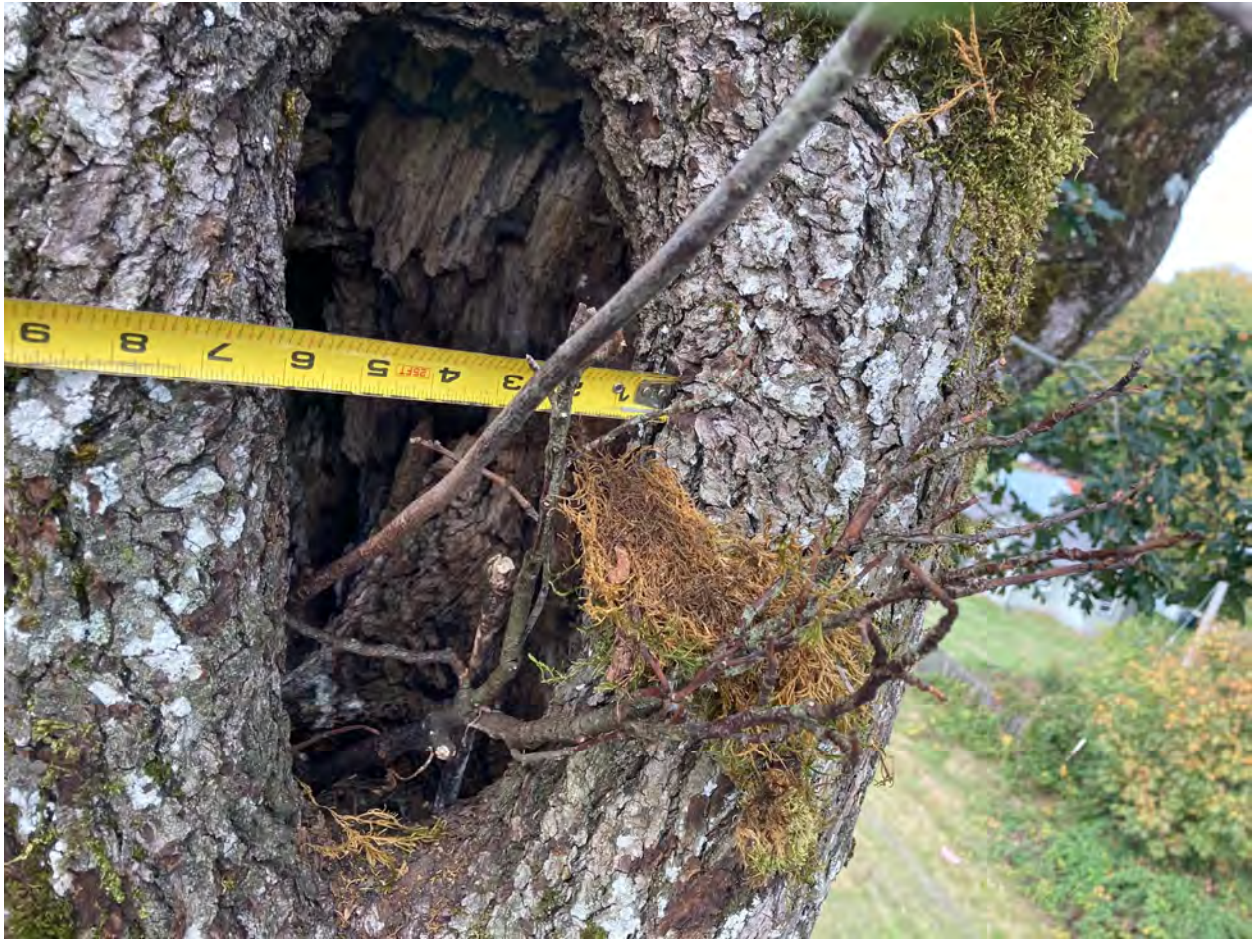
Figure 20 Measurement of diameter of cavity at 6 inches.

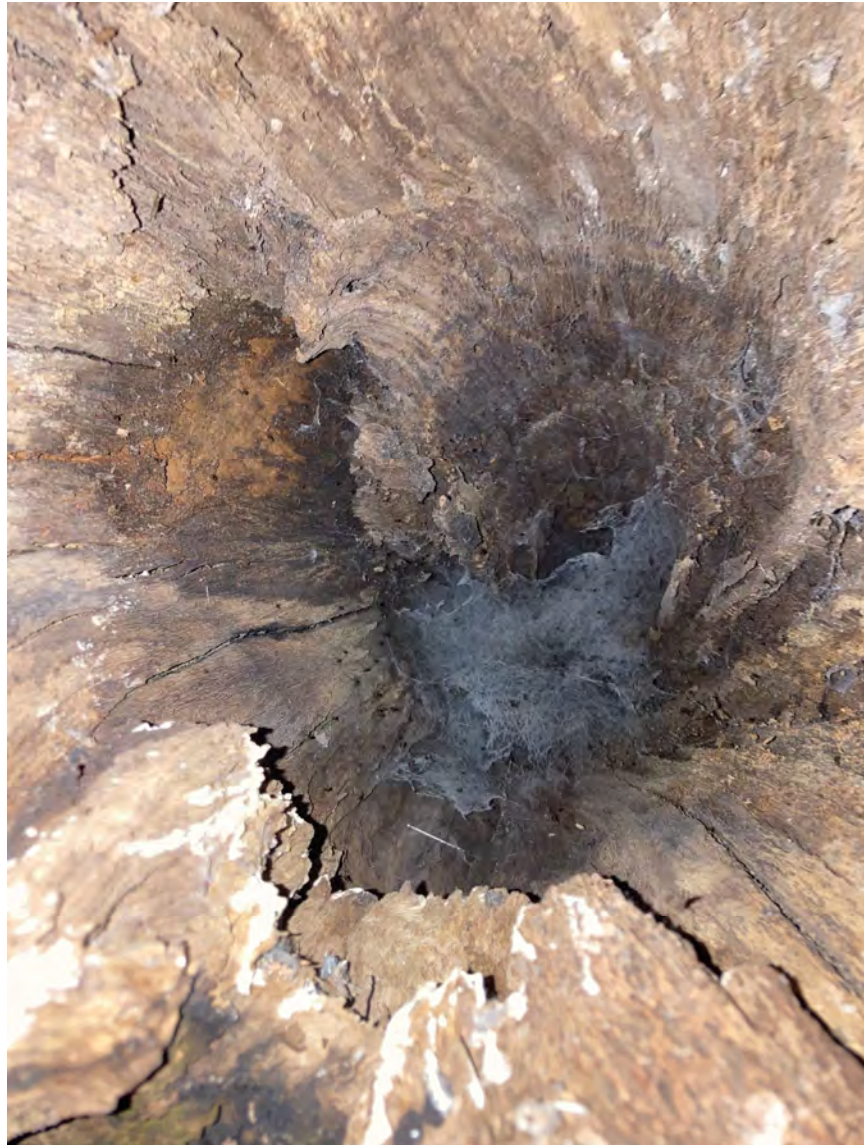
Figure 24 View vertically up the cavity.

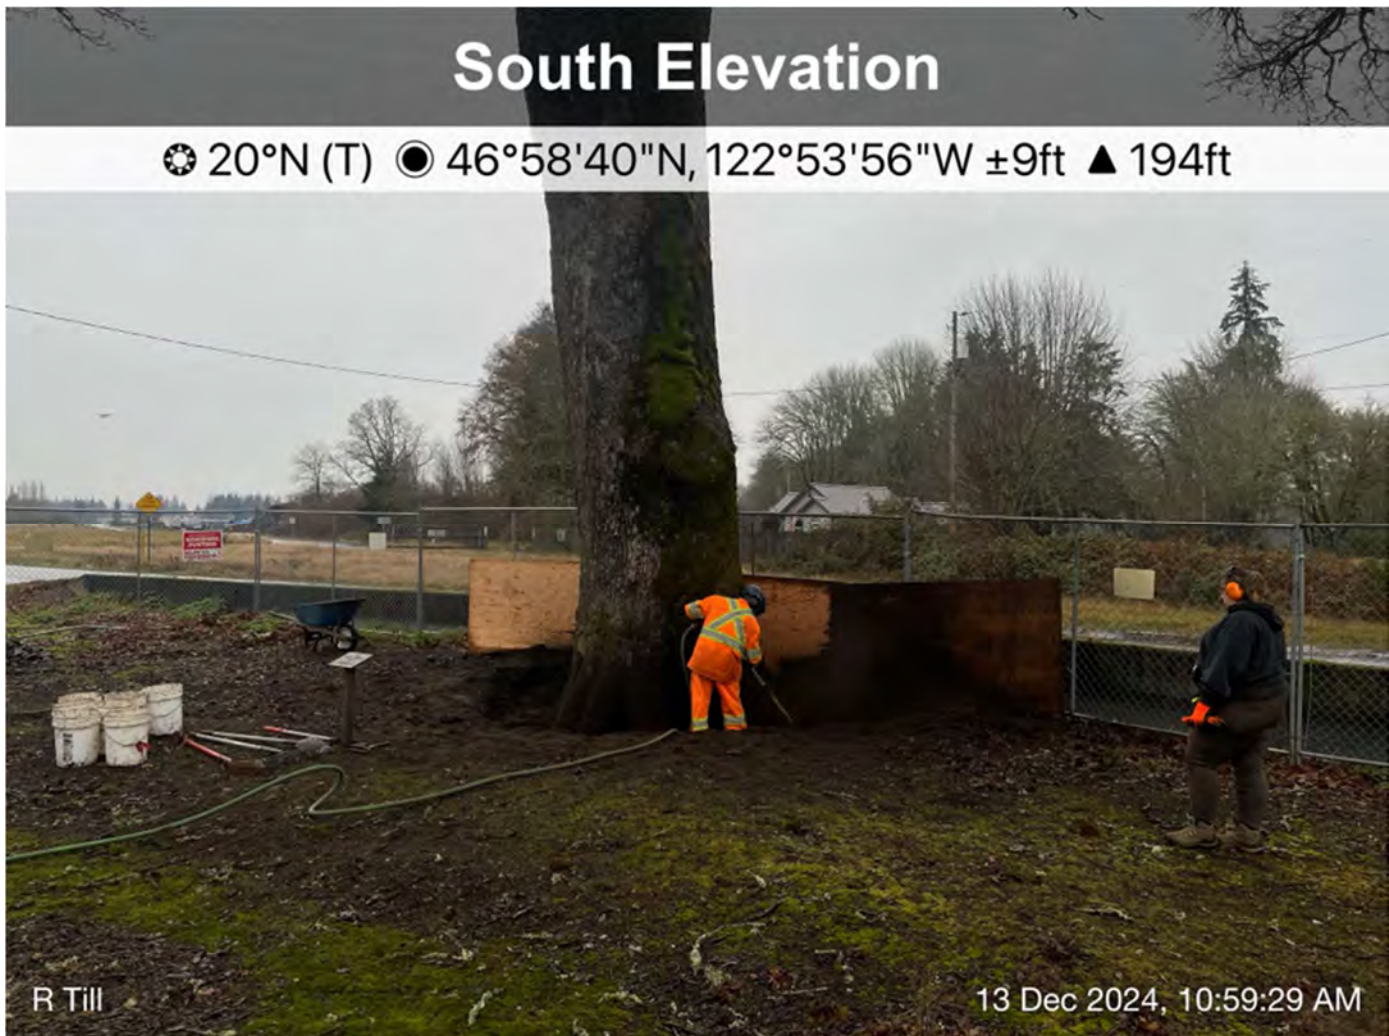
The inspection revealed adequate to robust buttress root growth around the entire tree. One historic decay cavity was revealed to be closing with substantial wound wood growth.

Figure 1 Root crown excavation employed an “air spade” that uses compressed air to remove fine soil. The excavation involved alternating between air spade removal of soil with hand removal of river cobble that was backfilled over the root flare after a prior root crown excavation. The project archaeologist oversaw all work.

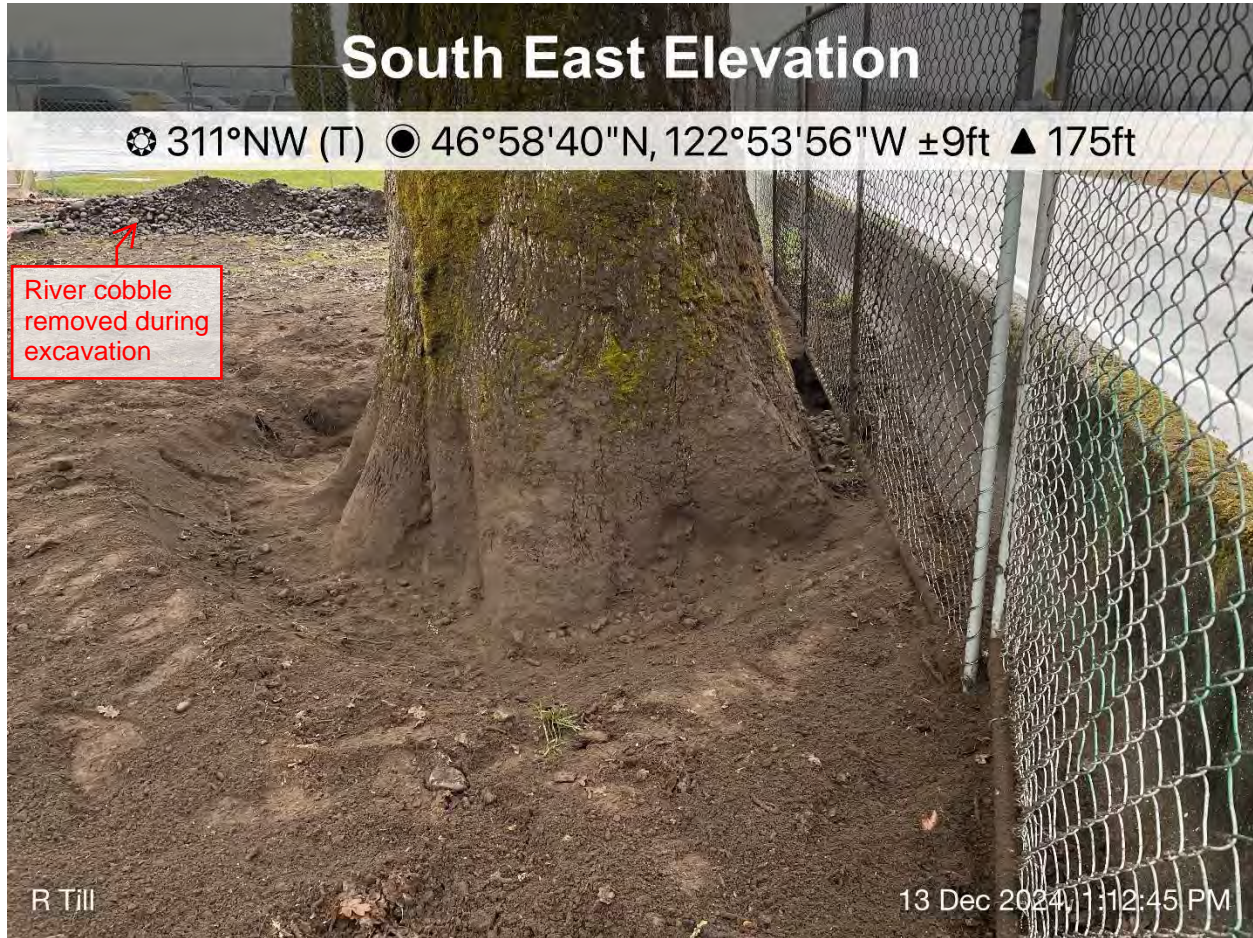
Figure 4 Temporary finished grade with river rock that was removed stacked in background.
