**HISTORIC PRESERVATION COMMISSION
MEETING AGENDA**

TO: Historic Preservation Commission
FROM: Chuck Denney, Parks and Recreation Director
DATE: April 18, 2024
SUBJECT: Davis/Meeker Oak Tree

RE: Meeker Oak Risk Assessment

Re: Sonic Tomography of One Garry Oak Tree

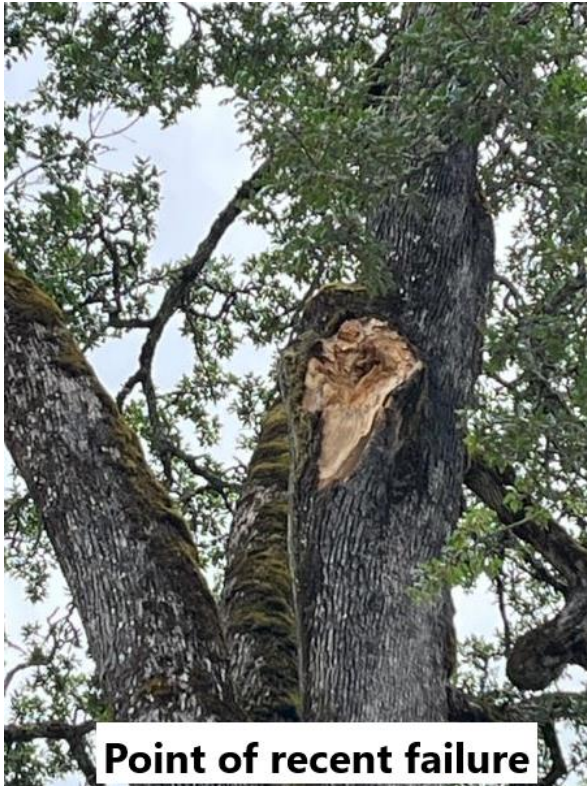
Photos

Upon your request, a thorough evaluation of the Meeker Oak located at the Olympia Regional Airport has been conducted. This tree has become of concern due to the recent failure of a two large diameter scaffold branches on the north side. Per your direction, this evaluation has included a risk assessment by myself, an aerial assessment by a climbing certified arborist and a sonic tomography by Tree Solutions Inc, all conducted during the months of June -August of this year. The purpose of this report is to present the findings and offer my recommendations based on those findings to the City of Tumwater.

Based on my findings and information I have been provided, I am recommending removal.
