## **Watertown Rock River Seawall**

### **Wall Condition Assessment and Feasibility Study**

**City of Watertown  
Watertown, Wisconsin**

**July 2026**

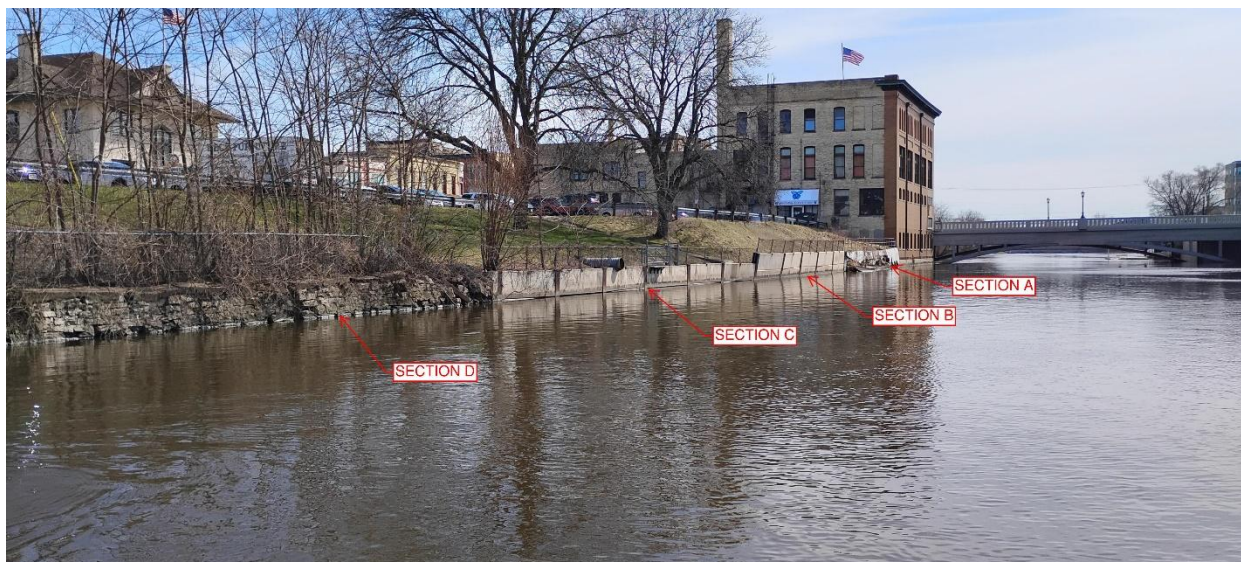
- A. Limestone masonry gravity wall with top elevation at approximately 814.2 feet<sup>1</sup>;
- B. Post-and-panel wall with top elevation at approximately 814.0 feet;
- C. Post-and-panel wall with top elevation at approximately 812.0 feet;
- D. Limestone masonry gravity wall with top elevation at approximately 812.0 feet.
- E. Limestone masonry gravity wall with top elevation at approximately 812.0 feet north of parking lot.

Per the request-for-proposal, Section E was not meant to be included in the scope of the study. However, given the wall's similarity to Section D and that each of the alternatives explored could easily be applied to Section E, this study includes this segment of the wall. A photograph of Sections A through D is shown in Figure 1. Section E is not shown but is identical to Section D.

**Figure 1. Each section of seawall along the east bank of the Rock River.**
