White Salmon Tree Board Meeting

Tree Assessment

May 2022

In May 2022, Treecology Consulting Group (TCG) conducted a risk assessment, and site evaluation for one street tree at 218 Jewett Blvd. in White Salmon, WA. The tree was assessed on May 20, 2022 by Ruth Williams, International Society of Arboriculture (ISA) Board Certified Master Arborist #WE-7317-BM, ISA Tree Risk Assessment Qualified. The results of this assessment are documented in this report. The goal of this assessment is to provide strategies to manage the tree and site that may impact people and property, and to guide long-term tree care decisions. Considerations include tree health, safety, and site history.

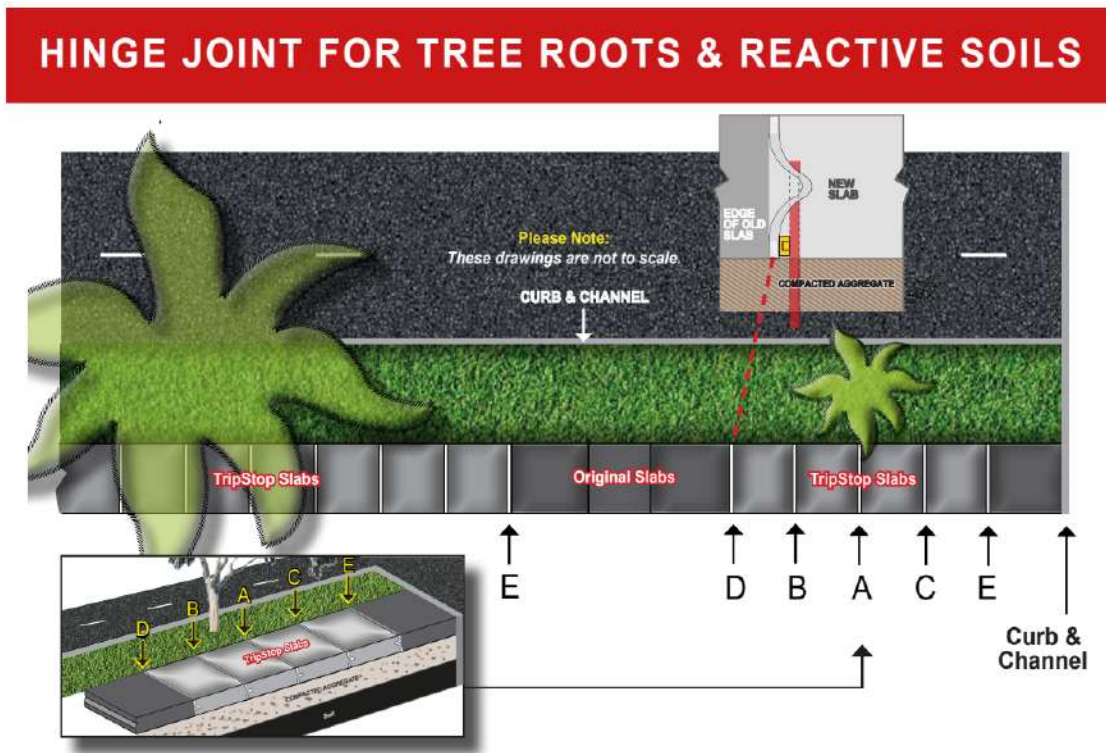
- Adjacent pavement was replaced within the decade, and has become disrupted. This site-related risk is likely to reoccur in a 3-8 year timeframe post sidewalk repair without an innovative solution that adapts to root growth. Minimal root pruning is possible, but is not likely to provide a complete solution that also allows tree preservation.

1. Root pruning may be conducted under the supervision of a Certified Arborist. This is most likely possible for roots under 2". Based on the nature of the pavement disruption, a significant root over 4" is likely present. If found, root pruning will likely not be recommended as that could destabilize the tree, leading to basal failure.
2. A. Fill over the root area with clear angular gravel overlaid with geotextile, sand, and pavers, or rubberized pavement or asphalt as a temporary solution. OR
 B. Pour new sidewalk panels that ramps over the roots in conjunction with hinge joints such as Tripstop(r) that maintain aligned sidewalk slab joints as roots grow. Evaluate the need for additional roadway asphalt to meet code requirements for curb height.
