White Salmon Tree Board Meeting

August 01, 2022 – 5:30 PM

Tree Assessment

May 2022

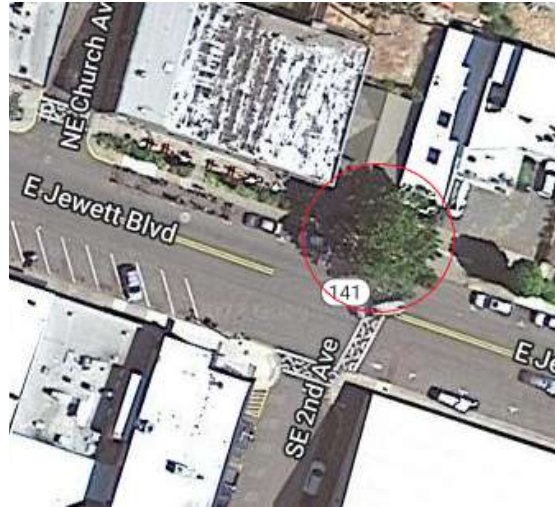
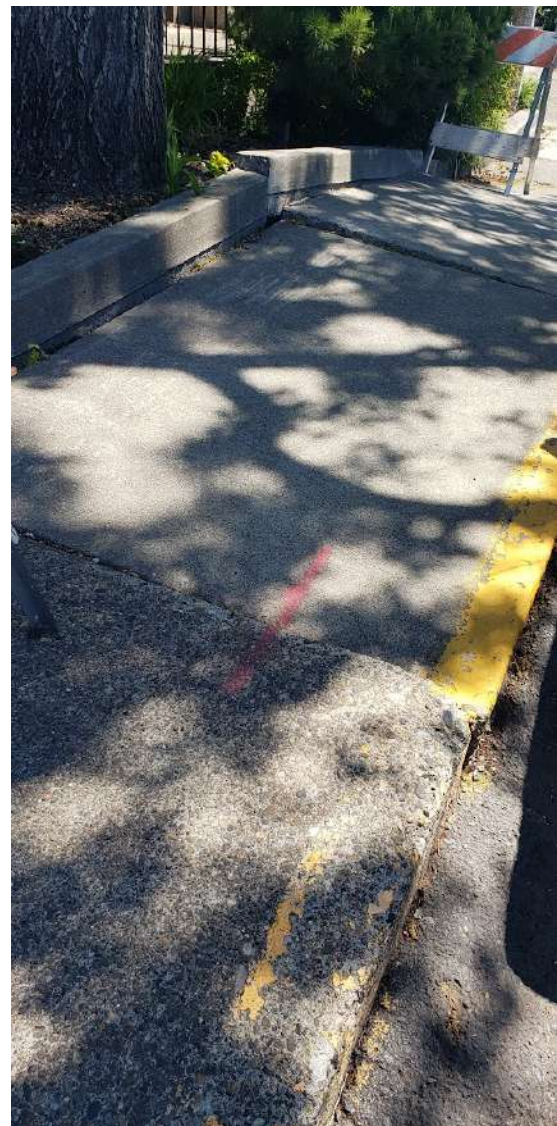
The adjacent pavement appeared new, as though it had been replaced recently. However, the new panels had already lifted unevenly creating a potential trip hazard, and eliminating ADA accessibility compliance. The pavement adjacent was within 6" of the tree trunk.

The site is not ideal for this large-stature-at-maturity tree with an aggressive root system. The ideal planter width for this species should be 8' wide.

The adjacent retaining wall and upper sidewalk should be monitored for cracking. They are currently in good condition, however, with the hillside condition, and unknown hydrology, it is possible tree roots can extend uphill if a water source and air are present.

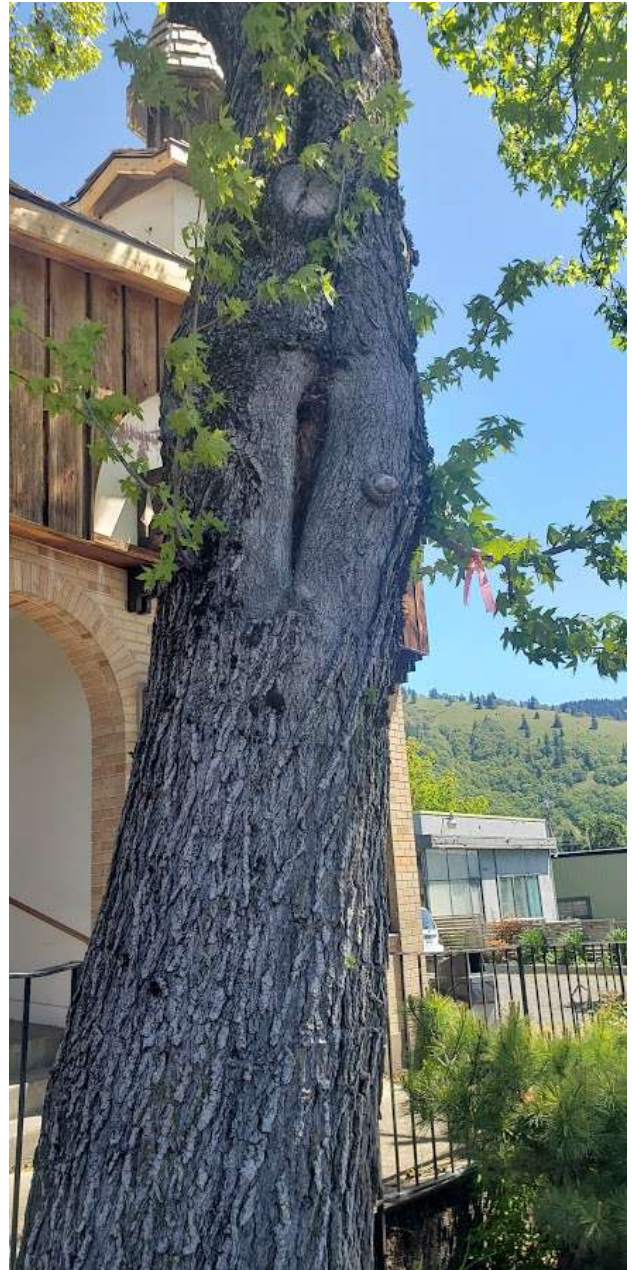
This tree is an open-grown tree with two prior limb failures. One was on the south side (photo, right), toward the street several years ago, and the wound has mostly sealed over. The outer 2-3" of wood beneath the wound is spongy and delayed. Minor epicormic sprouts are present near this wound. A second wound is visible on the north side, higher in the canopy. It looks recent, within the past 3 years. These wounds are consistent with the species that tends to have moderately brittle branches, and tends to fail where included bark is present.

South side limb failure (close up) shows decay/splintered wood indicating prior failure, not pruning wound. Smaller pruning wound above is sealed.

This tree has a history of branch failure and excessive end weight. The risk rating in its current condition is moderate - and the most likely mechanism of failure is branch failure in a wind event. Pruning for end weight reduction will reduce the risk rating of this tree to low.

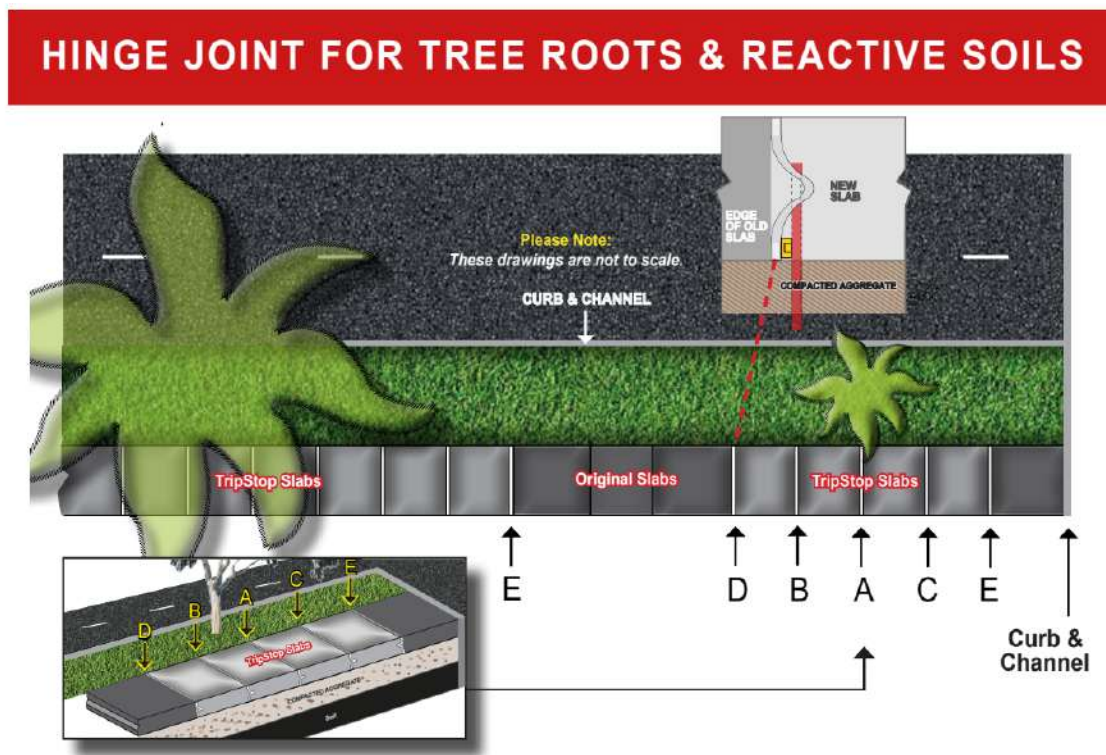
1. Root pruning may be conducted under the supervision of a Certified Arborist. This is most likely possible for roots under 2". Based on the nature of the pavement disruption, a significant root over 4" is likely present. If found, root pruning will likely not be recommended as that could destabilize the tree, leading to basal failure.
2. A. Fill over the root area with clear angular gravel overlaid with geotextile, sand, and pavers, or rubberized pavement or asphalt as a temporary solution. OR
B. Pour new sidewalk panels that ramps over the roots in conjunction with hinge joints such as Tripstop(r) that maintain aligned sidewalk slab joints as roots grow. Evaluate the need for additional roadway asphalt to meet code requirements for curb height.

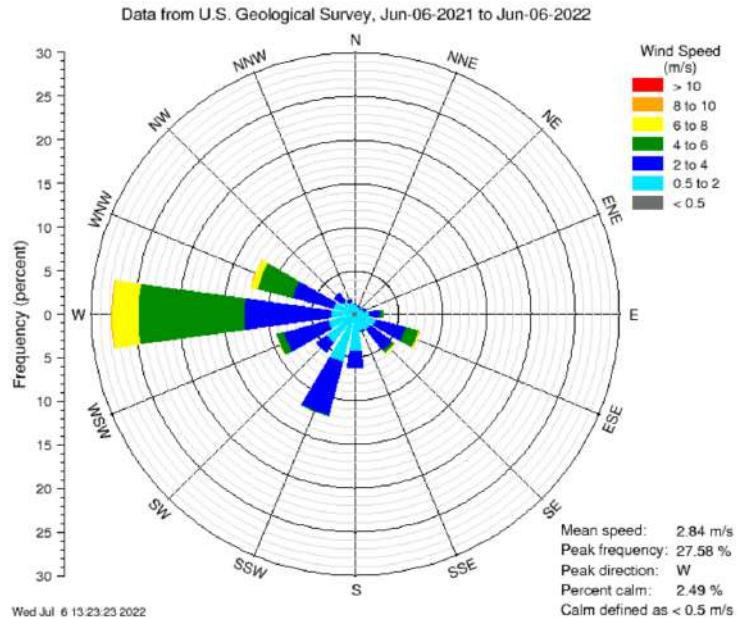
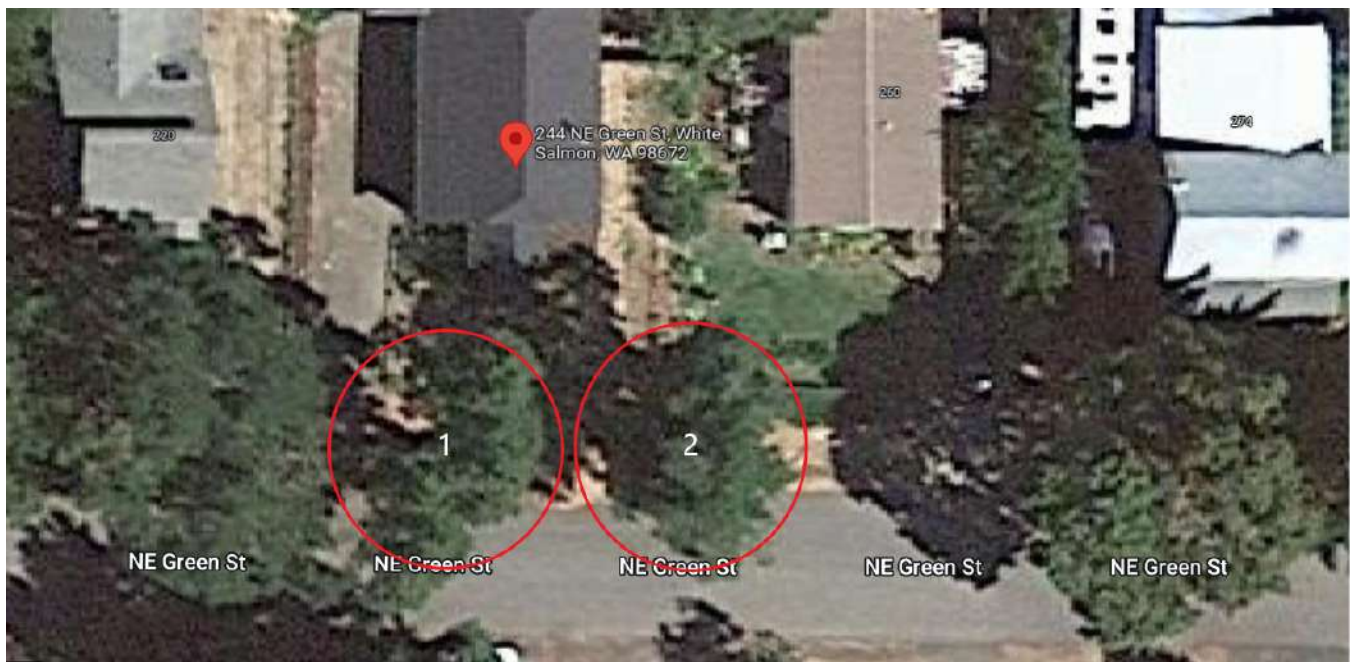
The site is adjacent to a low-traffic neighborhood street. The area is a maintained front yard. The trees are open-grown, no crowding of the canopies from other trees. There is asphalt and soil near the trunk. The site has elevation gain from the road to the adjacent buildings with a few stairs. The prevailing wind is from the west. A neighboring tree to the west at 220 NE Green St. provides shelter from wind for trees #1-2.
