CITY AND BOROUGH OF WRANGELL BARGE RAMP CONDITION ASSESSMENT

MARCH 2025

Subject: Wrangell Barge Ramp – Condition Assessment

WRANGELL BARGE RAMP CONDITION ASSESSMENT

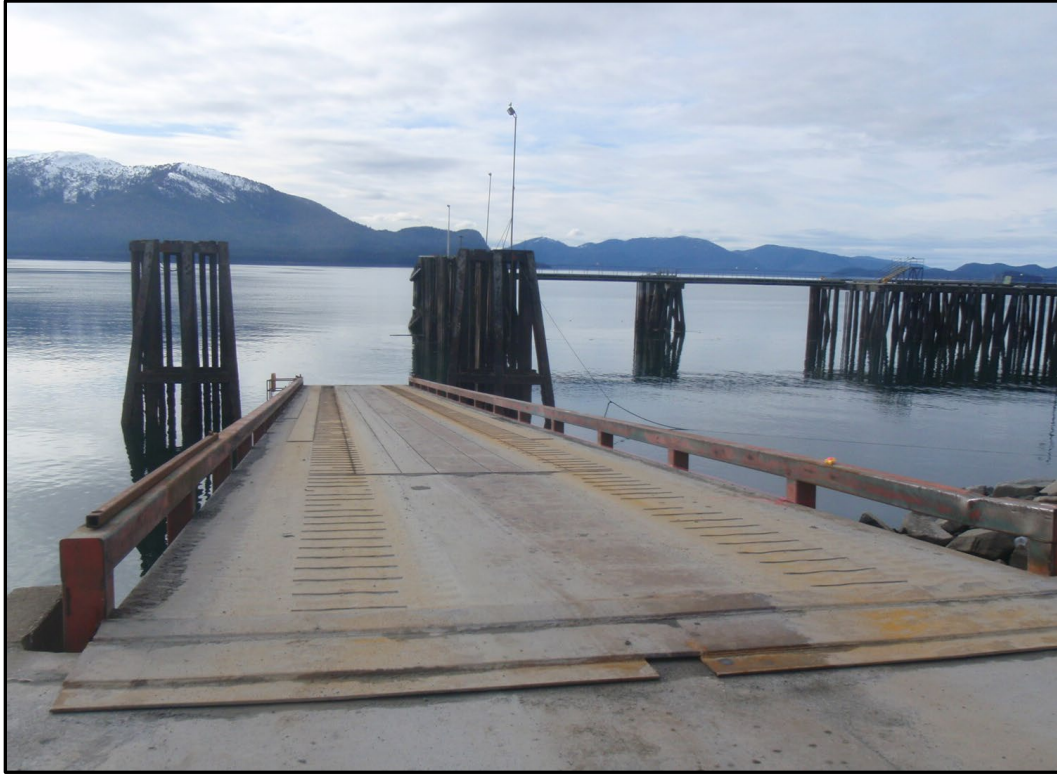
FIGURE 3. Barge ramp deck looking ramp from abutment.

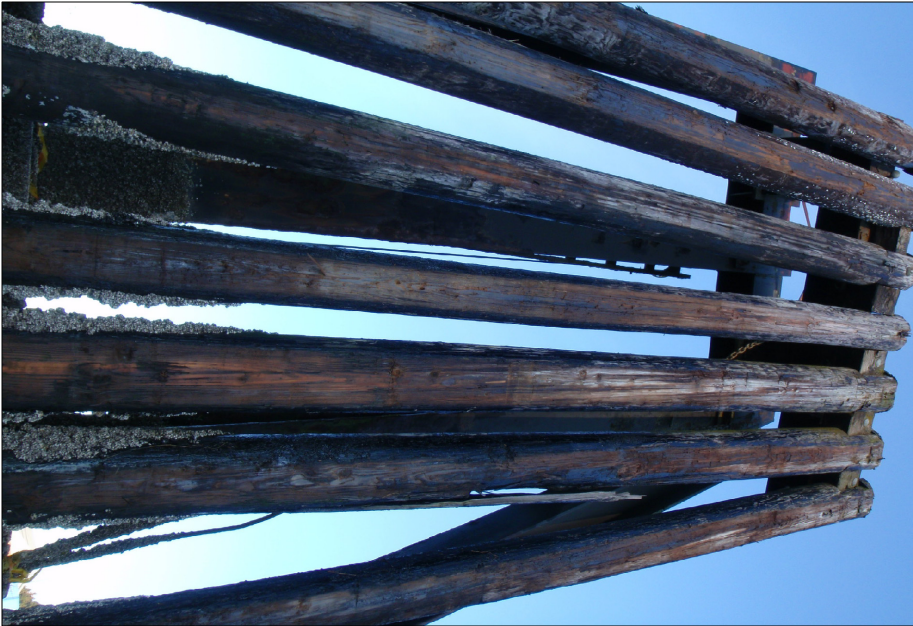
Displaced fender piles at Dolphin "D".

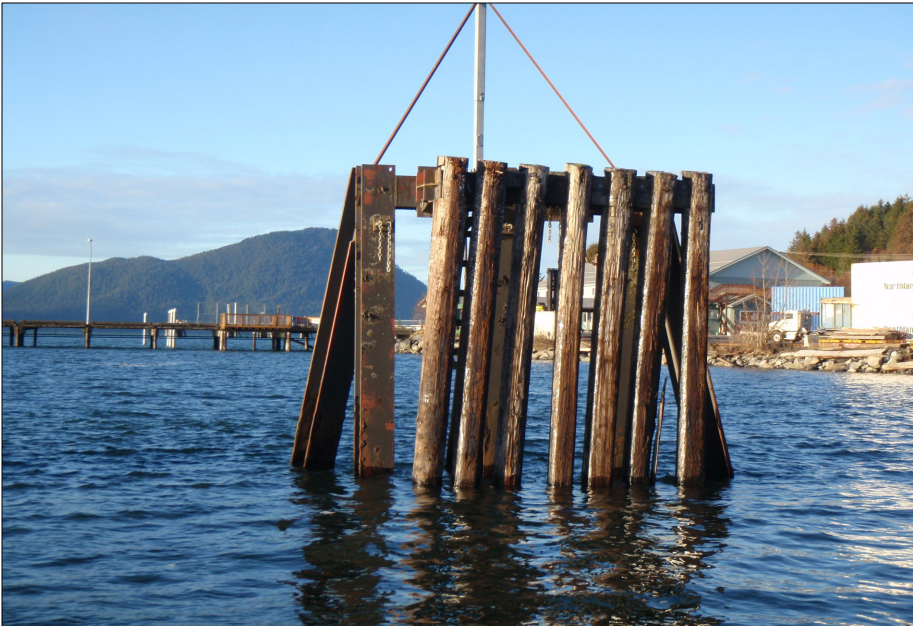
Displaced fender piles at Dolphin "D", looking north.

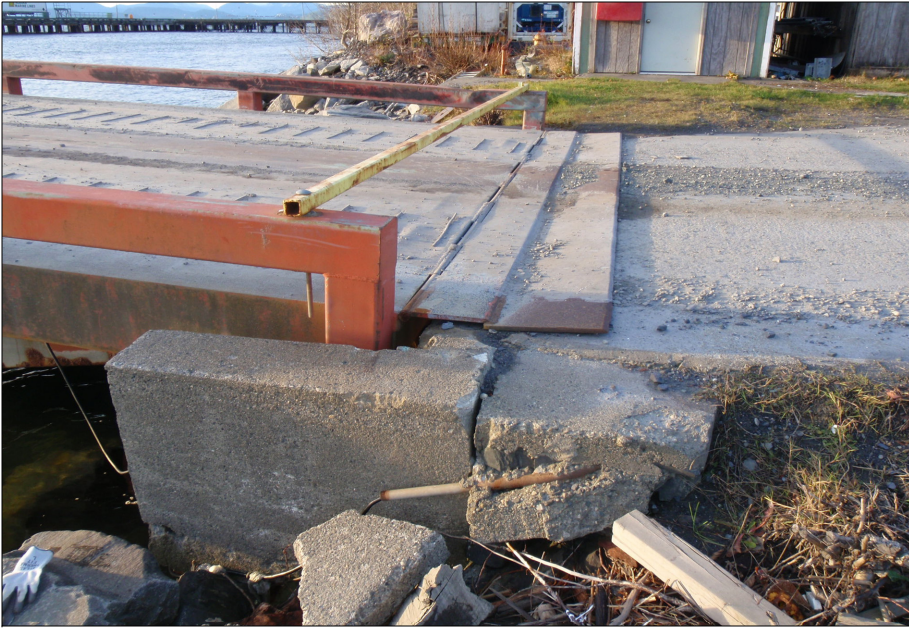
Transition plate at barge ramp abutment.

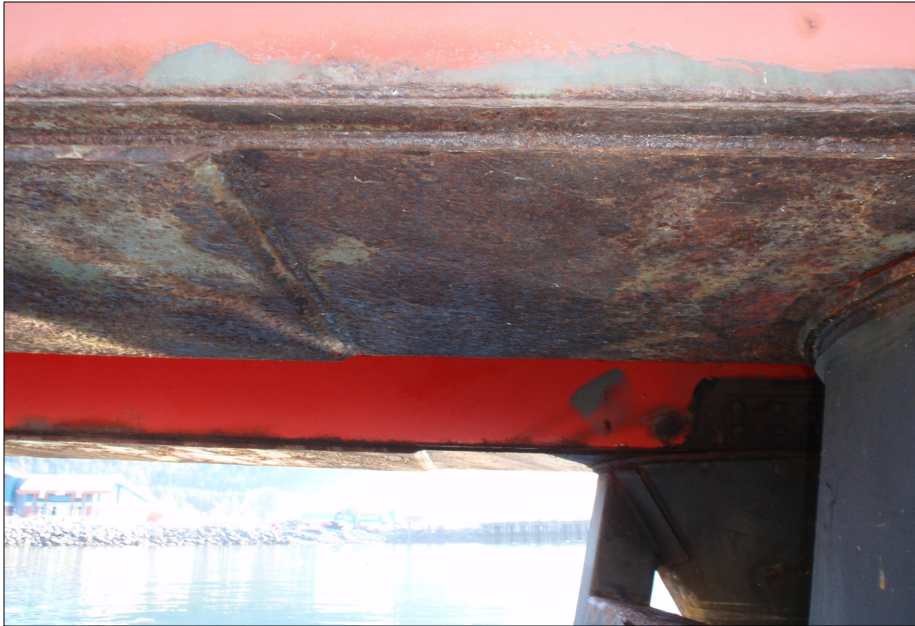
Typical minor corrosion of ramp girder bottom flange.

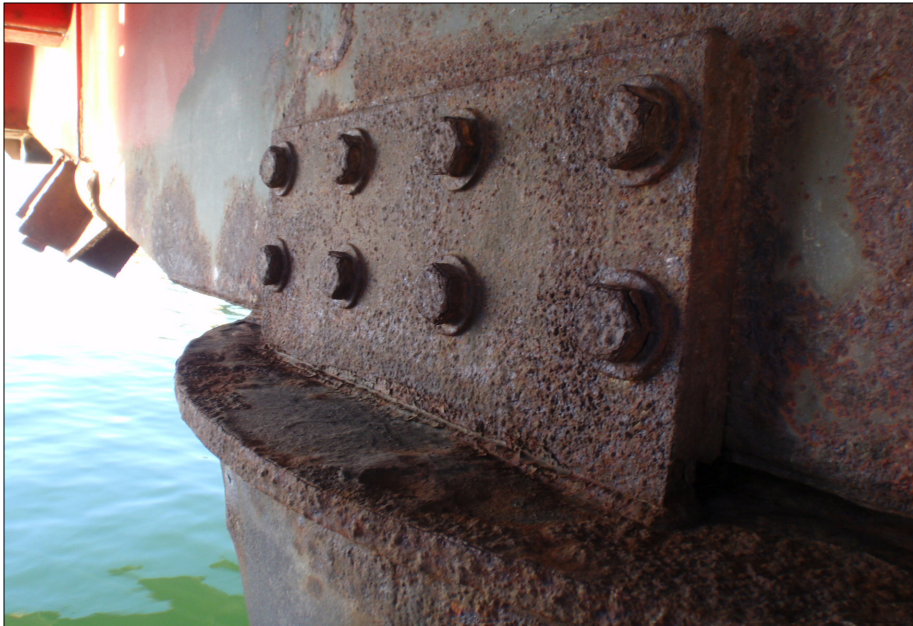
Coating failure/corrosion at ramp/support tank connection assemblies.

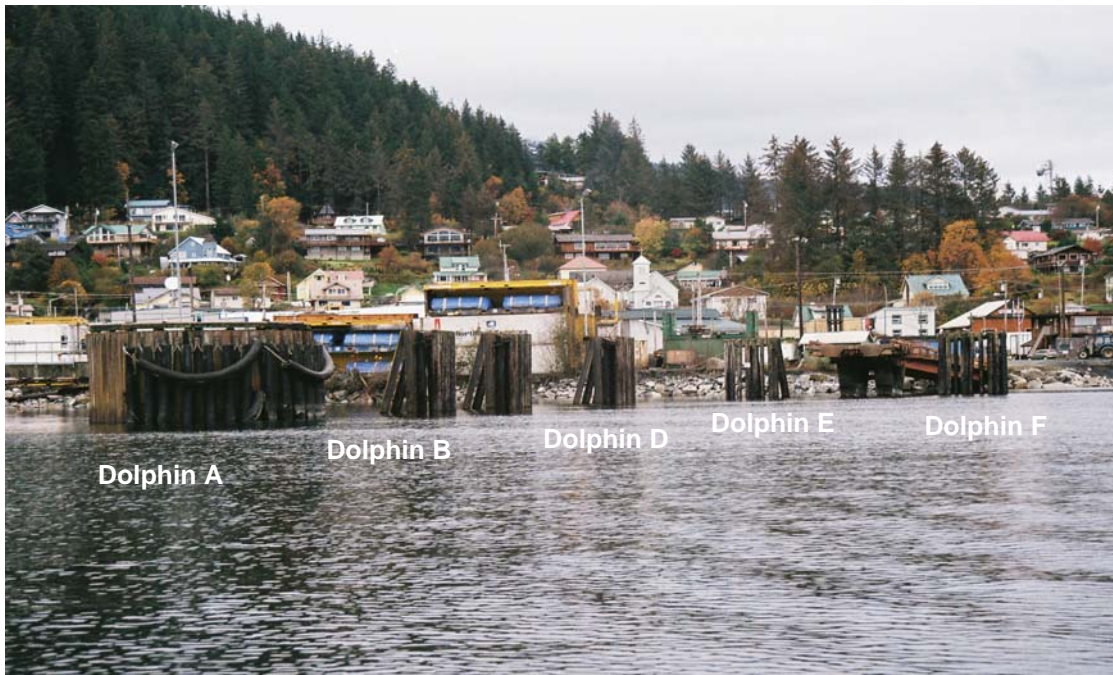
PHOTO No. 1: Wrangell Barge Facility Looking Northeast – Note the transfer span hinged off the shore. Also note the circular cofferdam, Dolphin A and the H-pile supported breasting Dolphins B – F.
