City and Borough of Wrangell  
Special Borough Assembly Meeting  
AGENDA

- a.     **Discussion Item:** Executive Summary of the Wrangell Public Safety Building Assessment Report
- b.     **RESOLUTION No. 11-20-1553** OF THE ASSEMBLY OF THE CITY AND BOROUGH OF WRANGELL, ALASKA AMENDING THE FY 2021 BUDGET IN THE GENERAL FUND TRANSFERRING \$58,500 FROM THE GENERAL FUND RESERVES TO THE PUBLIC SAFETY BUILDING FACILITIES MAINTENANCE AND REPAIR ACCOUNT FOR THE PUBLIC SAFETY BUILDING SHORING WALL PROJECT AND AUTHORIZING ITS EXPENDITURE
- c.     Approval of a Contract Award to Johnson Construction & Supply, Inc. in the Amount of \$35,750 for the Public Safety Building Shoring Wall Project

## CITY & BOROUGH OF WRANGELL, ALASKA BOROUGH ASSEMBLY AGENDA STATEMENT

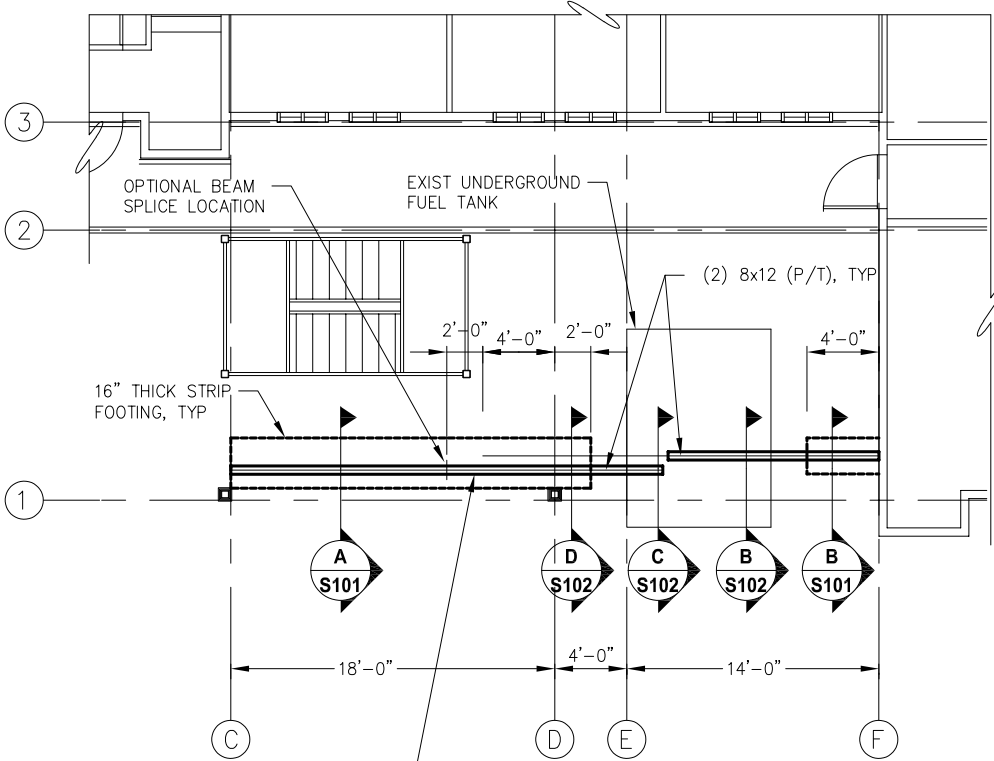
1 FOUNDATION PLAN

SHORING WALL w/ (2) 2x8 (P/T) @ 16" OC. AND 1/2" PLYWOOD (P/T) WITH 2x8 (P/T) BLKG AND 10d @ 6" OC AT PANEL EDGES AND 10d @ 12" OC IN THE FIELD. ALL NAILS SHALL BE GALV., TYP
