Wylie Historic Review Commission Regular Meeting

June 23, 2022 – 6:00 PM

1. Consider and act upon a recommendation to the City Council regarding the approval for substantial renovations in accordance with Ordinance 2013-17 for the remodel of an existing commercial structure, located at 108 E. Marble Street within the Downtown Historic District.
2. Consider and act upon a recommendation to the City Council regarding a request for demolition of a residential structure in accordance with Ordinance No. 2022-34. Property located at 100 S. Cottonbelt St. within the Downtown Historic District.

Consider and act upon a recommendation to the City Council regarding a request for demolition of a residential structure in accordance with Ordinance No. 2022-34. Property located at 100 S. Cottonbelt St. within the Downtown Historic District.

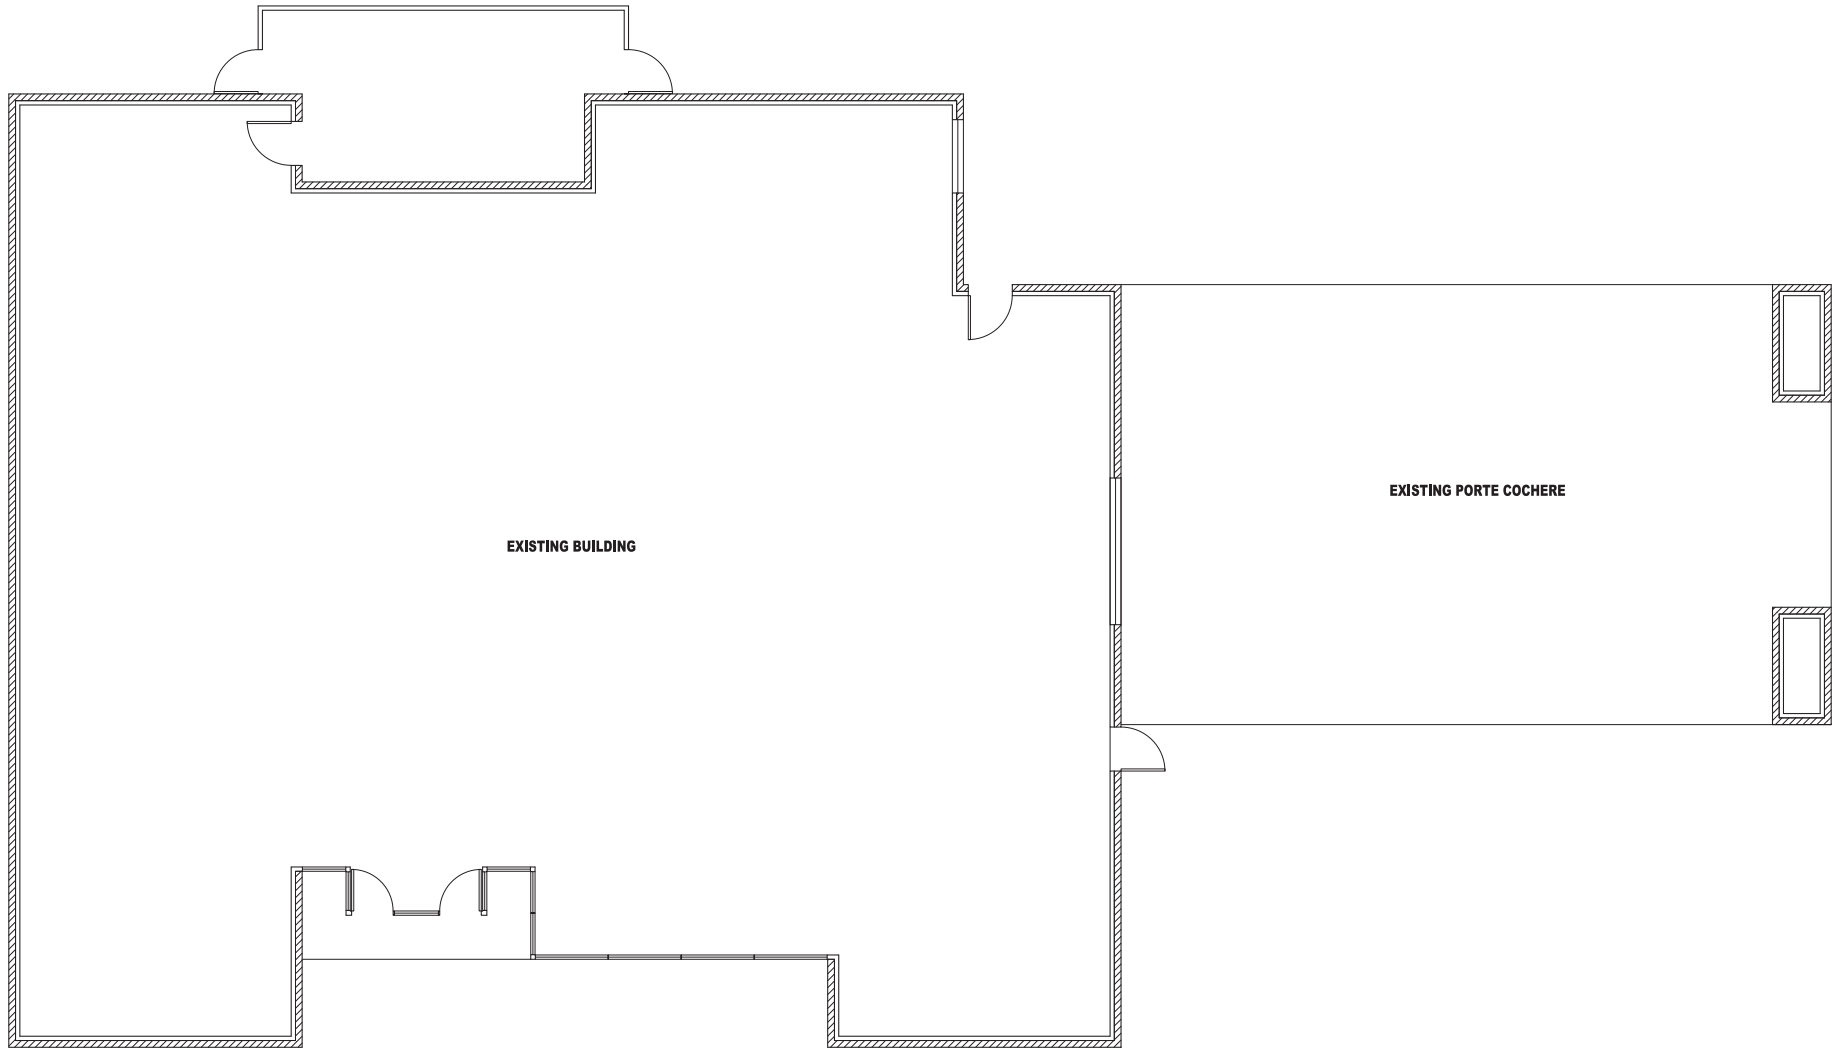
T-1

EXISTING BUILDING

EXISTING PORTE COCHERE

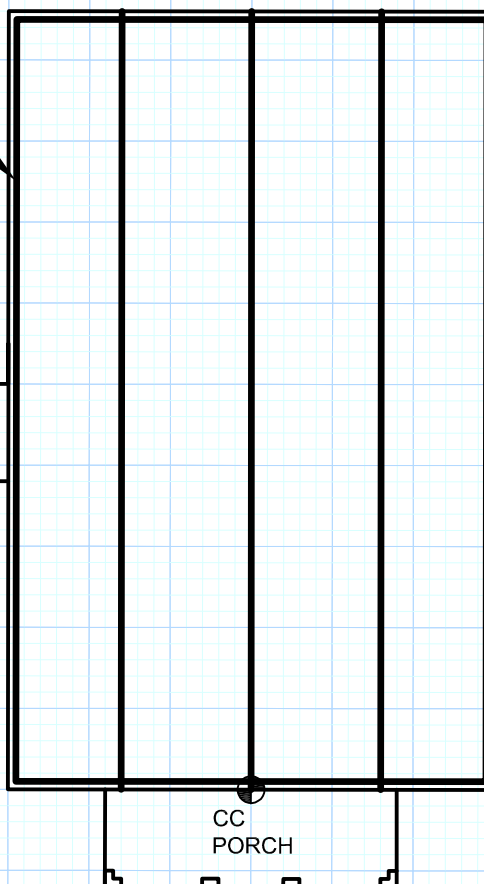
FRONT

ADD
SINGLE
2X6 TO
MAKE
TRIPLE

CC
PORCH

- OBTAIN A FRAMING INSPECTION PRIOR TO ANY REPAIRS.
- INSTALL A FULL GUTTERING SYSTEM WITH DOWNSPOUT EXTENSIONS.
- REGRADE THE PERIMETER OF THE STRUCTURE TO PITCH WATER AWAY FROM THE FOUNDATION.
- USE FANS TO DRY THE CRAWLSPACE AREA AFTER THE PERIMETER IS REGRADED.
- INSTALL 300 LF OF BEAM.
- ADD A SINGLE 2X6 TO EXISTING 2(2X6) BEAMS TO MAKE TRIPLE.
- INSTALL 1,152 LF OF JOISTS AT 15" SPACING SO THEY RUN ON TOP OF BEAMS COHESIVELY FROM ONE END TO THE OTHER.
- INSTALL 156 LF OF RIM JOIST.
- RESET/RE-SHIM THE ENTIRE BLOCK AND BASE PORTION OF THE FOUNDATION WITH STEEL TO IMPROVE LEVELING.
