AGENDA

CITY COUNCIL WORKSHOP

KANSAS TRAFFIC ENGINEERING ASSISTANCE PROGRAM

INTERSECTION ANALYSES

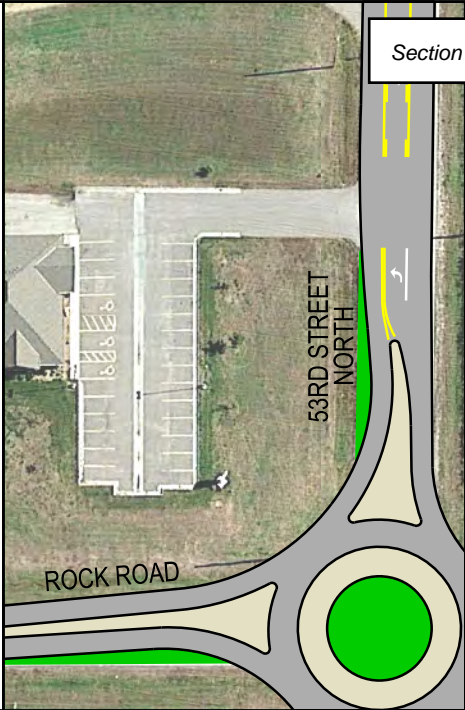
ROUNDABOUT IMPROVEMENT CONCEPT ROCK ROAD AND 53RD STREET NORTH		Intersection Analyses Bel Aire, Kansas		August 2021	Figure
				No Scale

Based on all factors, we would initially recommend that the city install multiway stop control at this intersection, but at the same time, plan for installation of a roundabout as the safest and most efficient long-term form of control to implement when funding becomes available. Interim use of multiway stop control offers a potential solution to address the crash history at the intersection, and it can be implemented rather quickly and at a relatively low cost. However, roundabout control is the preferred long-term modification for this location since this form of control should provide much more efficient operations than multiway stop control while also eliminating the angle and left-turn collisions that have been occurring at this location. In conjunction with this, we would recommend that the city reserve right-of way in the intersection quadrants prior to any additional development of the adjacent land.

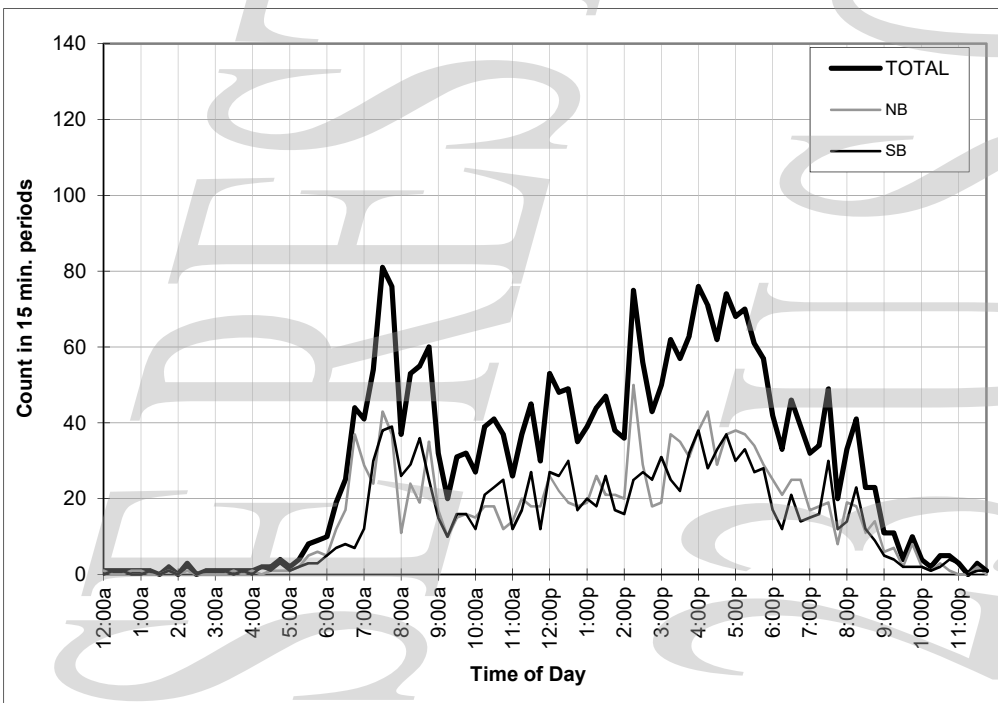
HOURLY TOTALS

Period Start	NB	SB	TOTAL
12:00a	2	2	4
1:00a	2	2	4
2:00a	1	3	4
3:00a	1	3	4
4:00a	3	6	9
5:00a	14	9	23
6:00a	71	27	98
7:00a	133	119	252
8:00a	89	116	205
9:00a	58	57	115
10:00a	63	81	144
11:00a	70	68	138
12:00p	85	100	185
1:00p	87	81	168
2:00p	117	93	210
3:00p	122	110	232
4:00p	147	136	283
5:00p	138	118	256
6:00p	96	64	160
7:00p	62	73	135
8:00p	62	58	120
9:00p	23	13	36
10:00p	7	9	16
11:00p	2	5	7

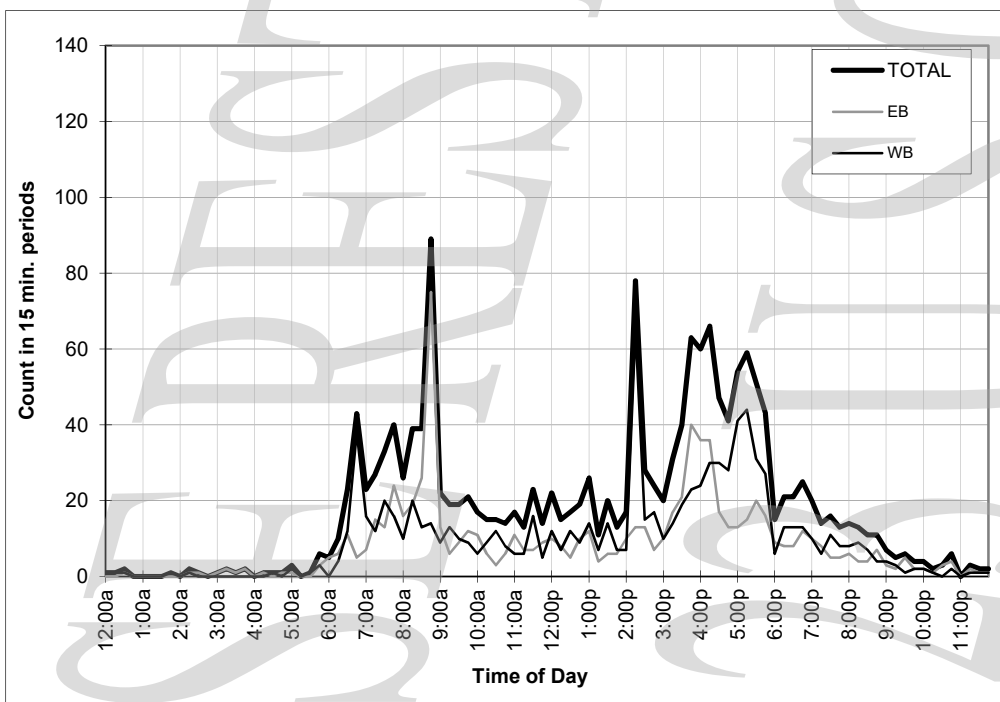
HOURLY TOTALS

Period Start	EB	WB	TOTAL
12:00a	1	3	4
1:00a	0	1	1
2:00a	2	1	3
3:00a	6	0	6
4:00a	2	1	3
5:00a	4	6	10
6:00a	27	54	81
7:00a	59	64	123
8:00a	136	57	193
9:00a	40	41	81
10:00a	26	35	61
11:00a	34	33	67
12:00p	33	40	73
1:00p	28	42	70
2:00p	43	104	147
3:00p	88	66	154
4:00p	102	112	214
5:00p	64	143	207
6:00p	37	45	82
7:00p	28	35	63
8:00p	21	28	49
9:00p	12	10	22
10:00p	10	5	15
11:00p	4	3	7

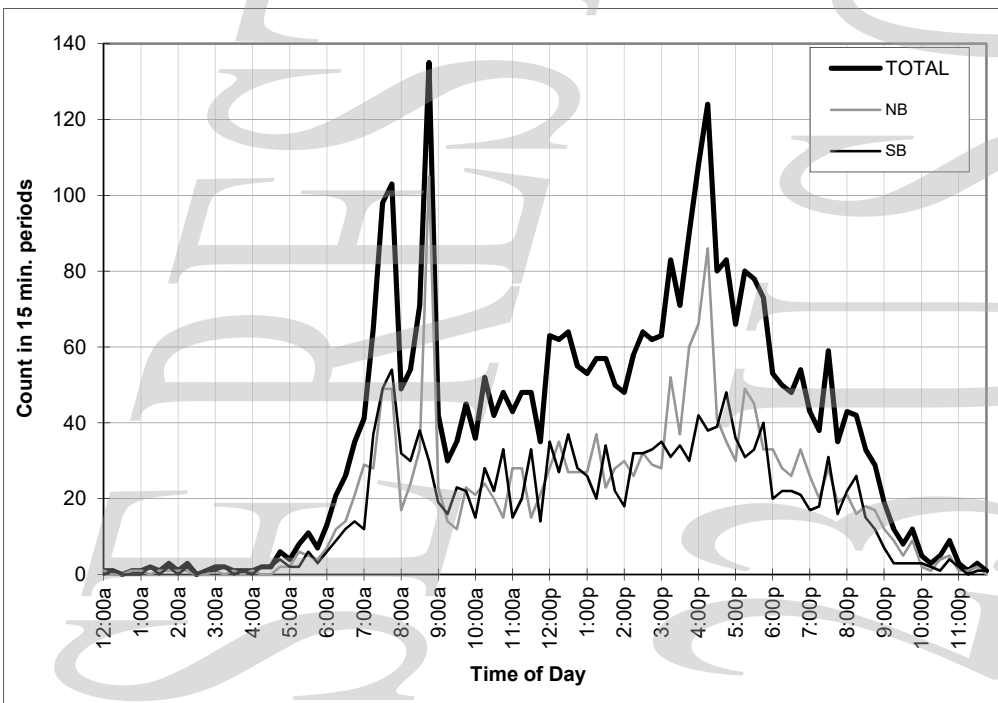
HOURLY TOTALS

Period Start	NB	SB	TOTAL
12:00a	2	1	3
1:00a	3	4	7
2:00a	2	3	5
3:00a	2	4	6
4:00a	3	8	11
5:00a	17	13	30
6:00a	54	41	95
7:00a	155	152	307
8:00a	179	130	309
9:00a	72	80	152
10:00a	80	98	178
11:00a	92	82	174
12:00p	117	127	244
1:00p	115	102	217
2:00p	117	115	232
3:00p	177	130	307
4:00p	228	167	395
5:00p	157	140	297
6:00p	120	85	205
7:00p	93	82	175
8:00p	72	75	147
9:00p	35	16	51
10:00p	12	10	22
11:00p	4	4	8

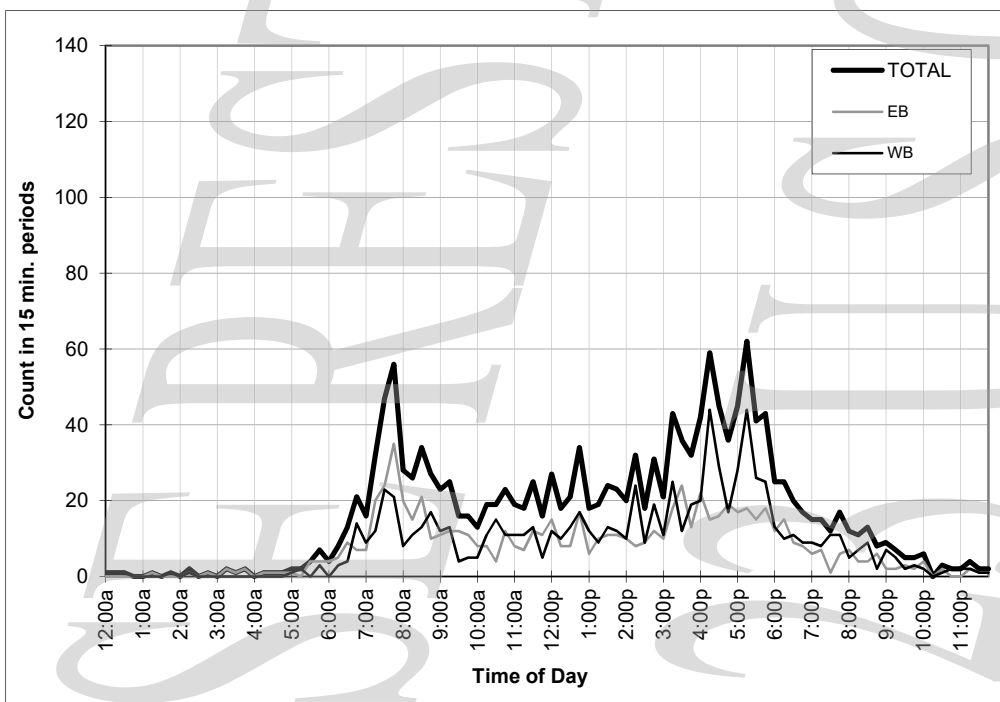
HOURLY TOTALS

Period Start	EB	WB	TOTAL
12:00a	0	3	3
1:00a	1	1	2
2:00a	2	1	3
3:00a	5	0	5
4:00a	3	0	3
5:00a	9	6	15
6:00a	25	21	46
7:00a	86	65	151
8:00a	66	49	115
9:00a	46	34	80
10:00a	32	42	74
11:00a	38	40	78
12:00p	48	52	100
1:00p	38	46	84
2:00p	39	62	101
3:00p	65	67	132
4:00p	72	110	182
5:00p	68	123	191
6:00p	44	43	87
7:00p	20	39	59
8:00p	21	23	44
9:00p	9	17	26
10:00p	6	5	11
11:00p	4	6	10

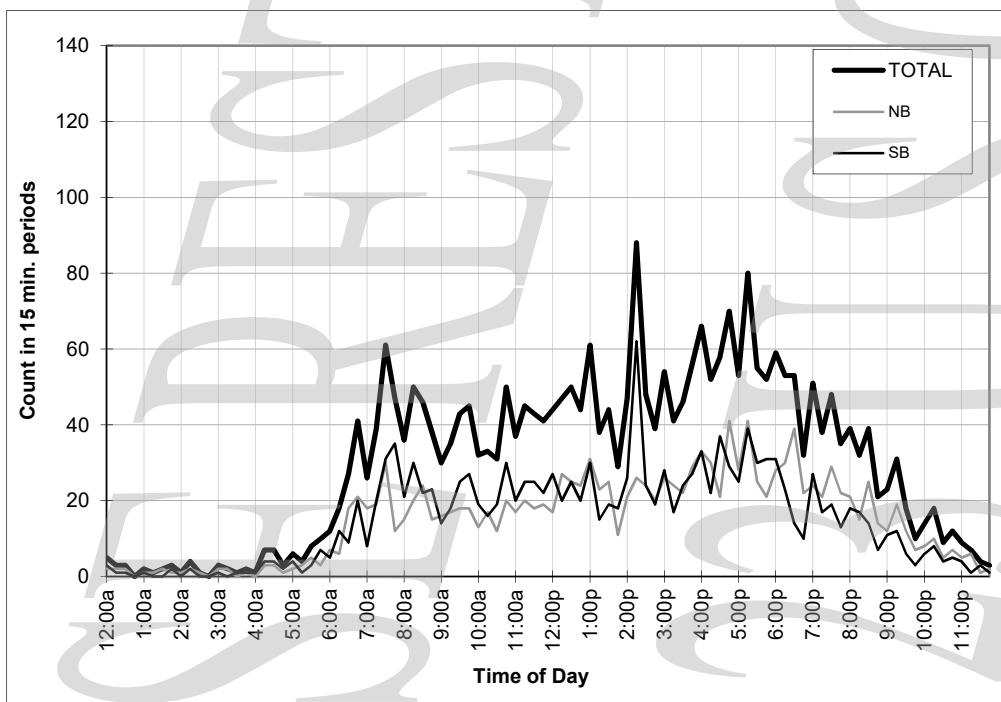
HOURLY TOTALS

Period Start	NB	SB	TOTAL
12:00a	6	5	11
1:00a	5	3	8
2:00a	4	2	6
3:00a	5	3	8
4:00a	7	11	18
5:00a	13	15	28
6:00a	52	46	98
7:00a	79	94	173
8:00a	74	96	170
9:00a	69	84	153
10:00a	62	84	146
11:00a	74	92	166
12:00p	93	92	185
1:00p	90	82	172
2:00p	91	131	222
3:00p	101	96	197
4:00p	125	121	246
5:00p	115	125	240
6:00p	119	78	197
7:00p	96	76	172
8:00p	75	56	131
9:00p	50	32	82
10:00p	30	23	53
11:00p	14	9	23

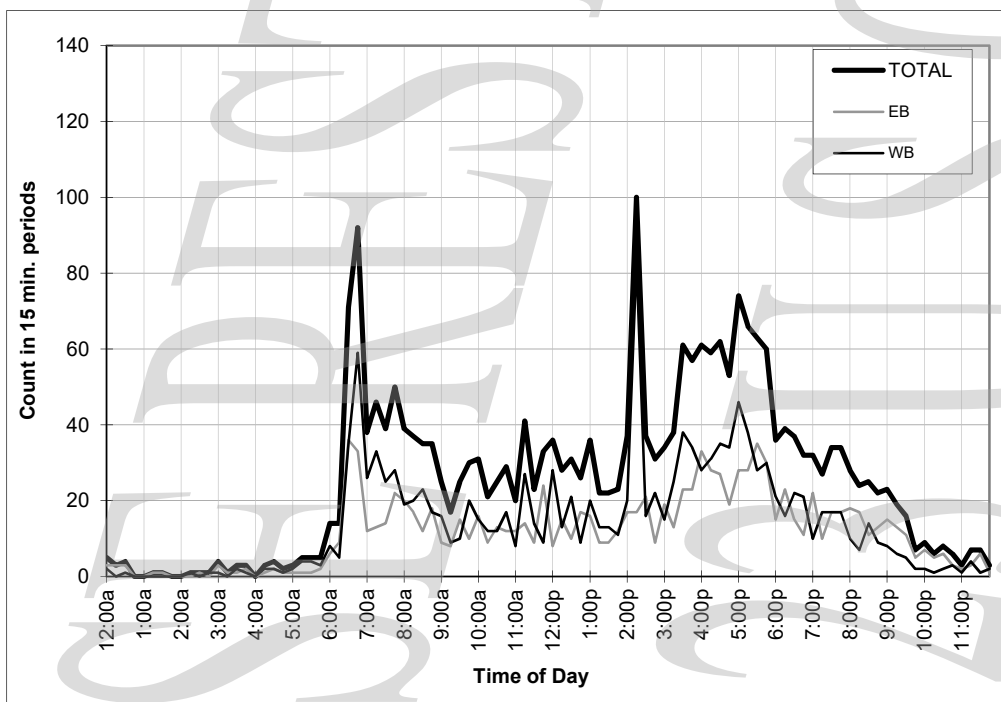
HOURLY TOTALS

Period Start	EB	WB	TOTAL
12:00a	9	3	12
1:00a	2	0	2
2:00a	1	2	3
3:00a	7	4	11
4:00a	4	5	9
5:00a	5	13	18
6:00a	84	107	191
7:00a	61	112	173
8:00a	67	79	146
9:00a	42	55	97
10:00a	50	56	106
11:00a	59	58	117
12:00p	50	71	121
1:00p	46	57	103
2:00p	64	141	205
3:00p	78	112	190
4:00p	107	128	235
5:00p	121	142	263
6:00p	64	80	144
7:00p	66	61	127
8:00p	59	40	99
9:00p	44	21	65
10:00p	21	8	29
11:00p	12	8	20

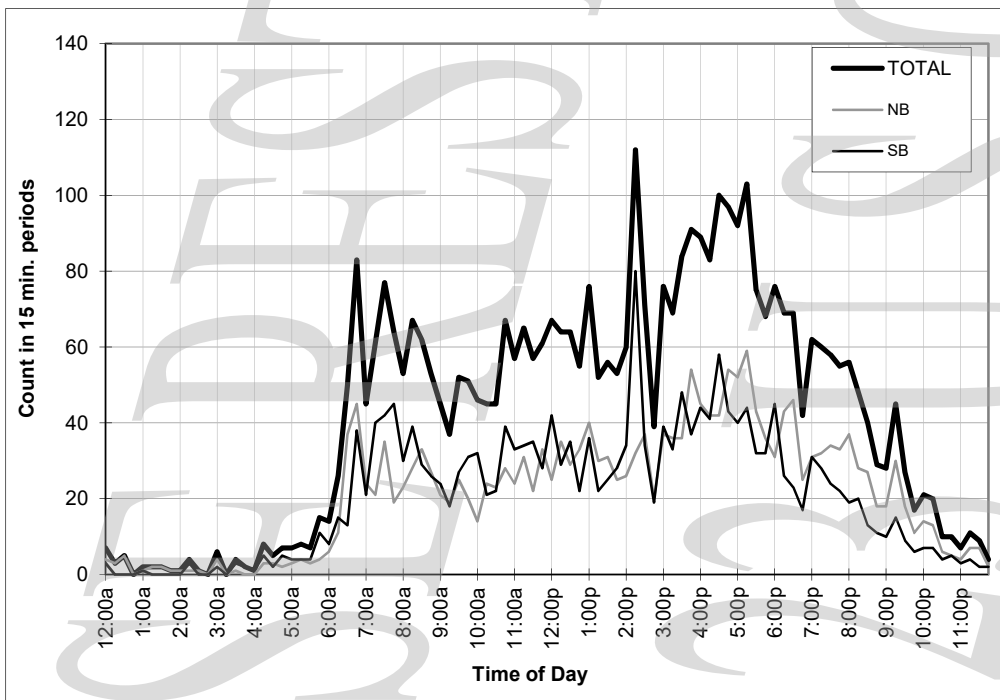
HOURLY TOTALS

Period Start	NB	SB	TOTAL
12:00a	12	3	15
1:00a	6	1	7
2:00a	3	3	6
3:00a	5	7	12
4:00a	8	13	21
5:00a	14	23	37
6:00a	99	74	173
7:00a	99	148	247
8:00a	111	124	235
9:00a	85	100	185
10:00a	89	114	203
11:00a	110	130	240
12:00p	122	128	250
1:00p	126	111	237
2:00p	115	167	282
3:00p	163	157	320
4:00p	183	186	369
5:00p	190	148	338
6:00p	145	111	256
7:00p	130	105	235
8:00p	110	63	173
9:00p	77	40	117
10:00p	38	23	61
11:00p	20	11	31

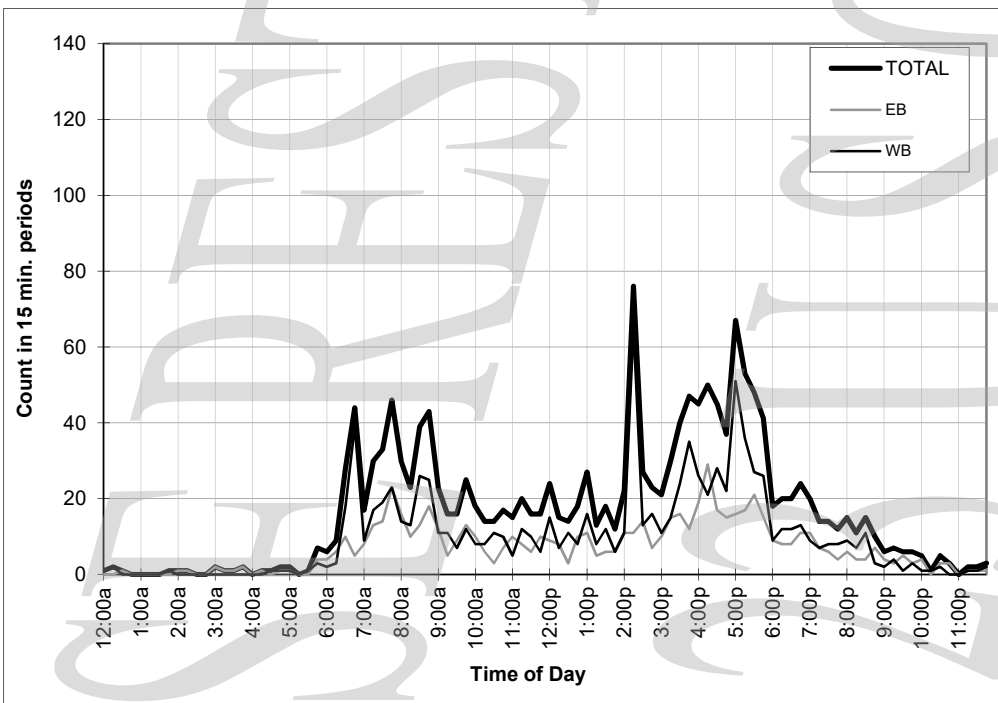
HOURLY TOTALS

Period Start	EB	WB	TOTAL
12:00a	1	3	4
1:00a	0	1	1
2:00a	2	0	2
3:00a	6	0	6
4:00a	2	2	4
5:00a	5	5	10
6:00a	25	62	87
7:00a	58	68	126
8:00a	57	78	135
9:00a	39	41	80
10:00a	26	37	63
11:00a	34	33	67
12:00p	30	41	71
1:00p	28	42	70
2:00p	43	105	148
3:00p	53	85	138
4:00p	80	97	177
5:00p	69	140	209
6:00p	36	46	82
7:00p	28	32	60
8:00p	21	30	51
9:00p	15	10	25
10:00p	10	4	14
11:00p	3	4	7

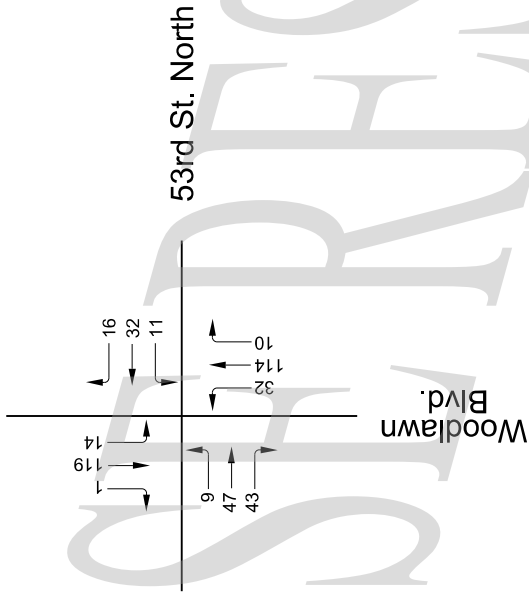
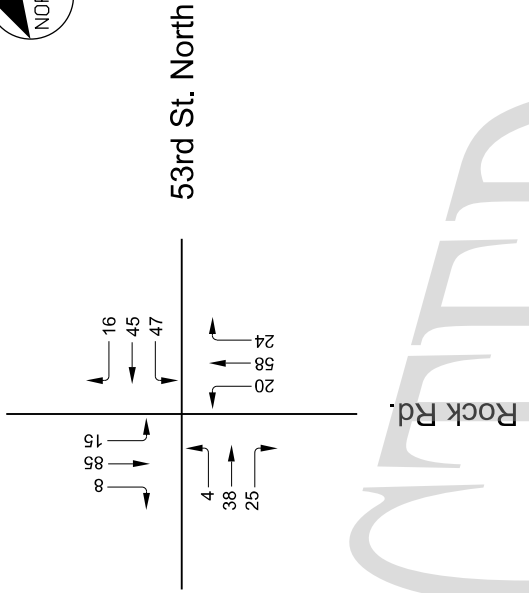
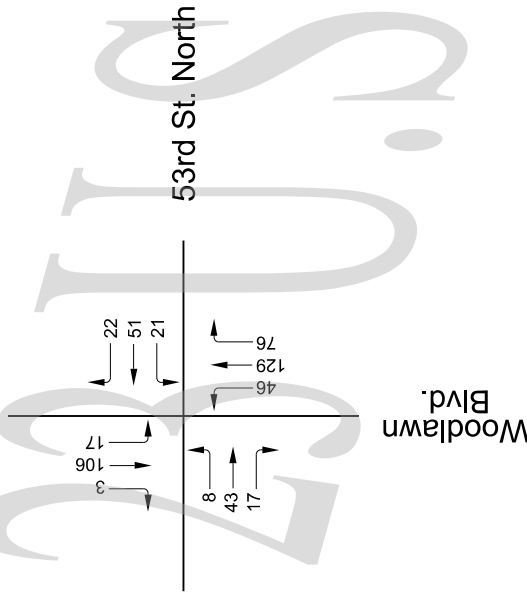
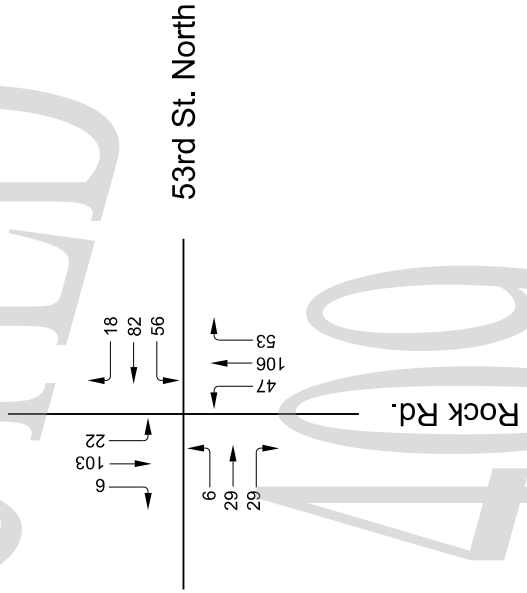
EXISTING PEAK HOUR TRAFFIC VOLUMES

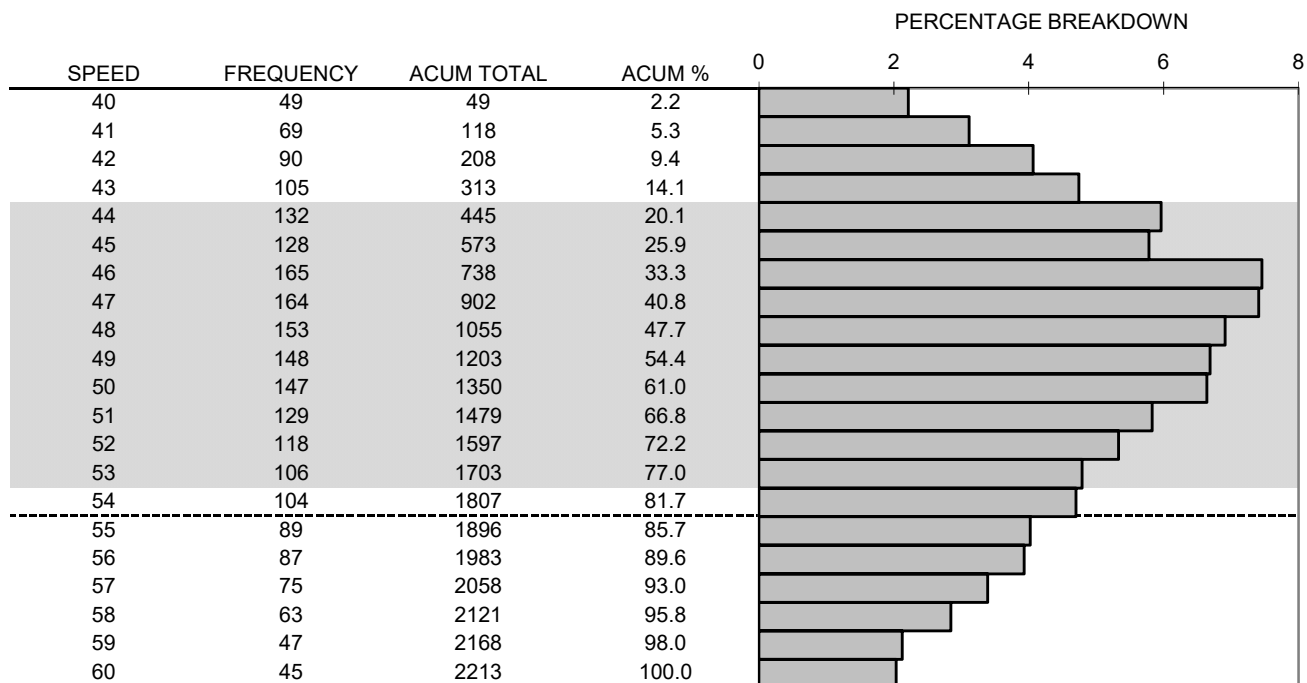
LOCATION: Woodlawn Blvd. 700' North of 53rd St. North
 TIME START: 12:00 AM
 TIME END: 11:59 PM

AVERAGE SPEED = 49.3
 50th PERCENTILE = 48.3
 85th PERCENTILE = 54.8
 90th PERCENTILE = 56.1
 95th PERCENTILE = 57.7

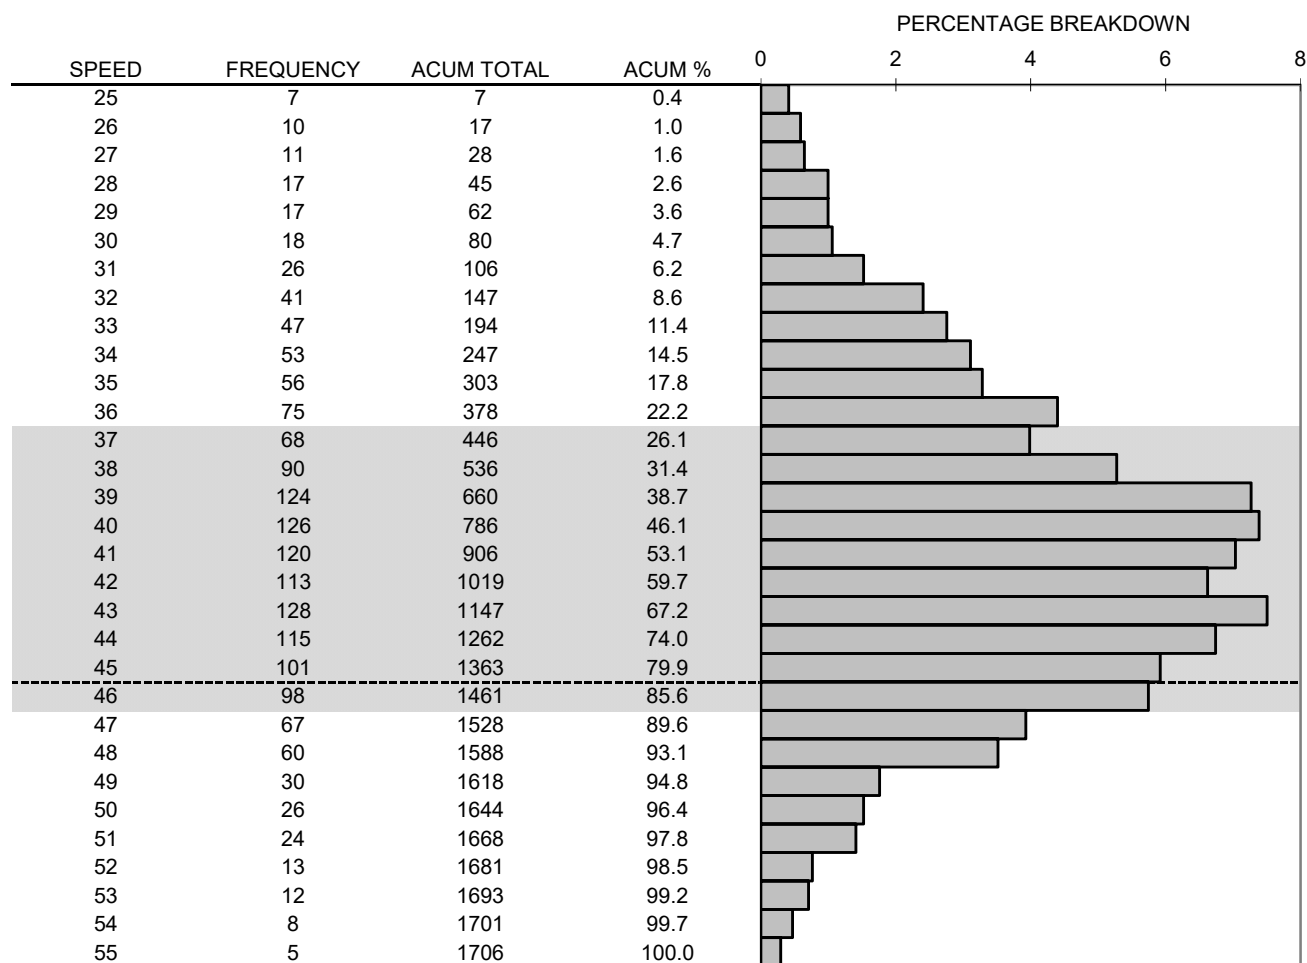
LOCATION: 53rd St. North 500' East of Woodlawn Blvd.
 TIME START: 12:00 AM
 TIME END: 11:59 PM

AVERAGE SPEED = 40.7
 50th PERCENTILE = 40.6
 85th PERCENTILE = 45.9
 90th PERCENTILE = 47.1
 95th PERCENTILE = 49.1

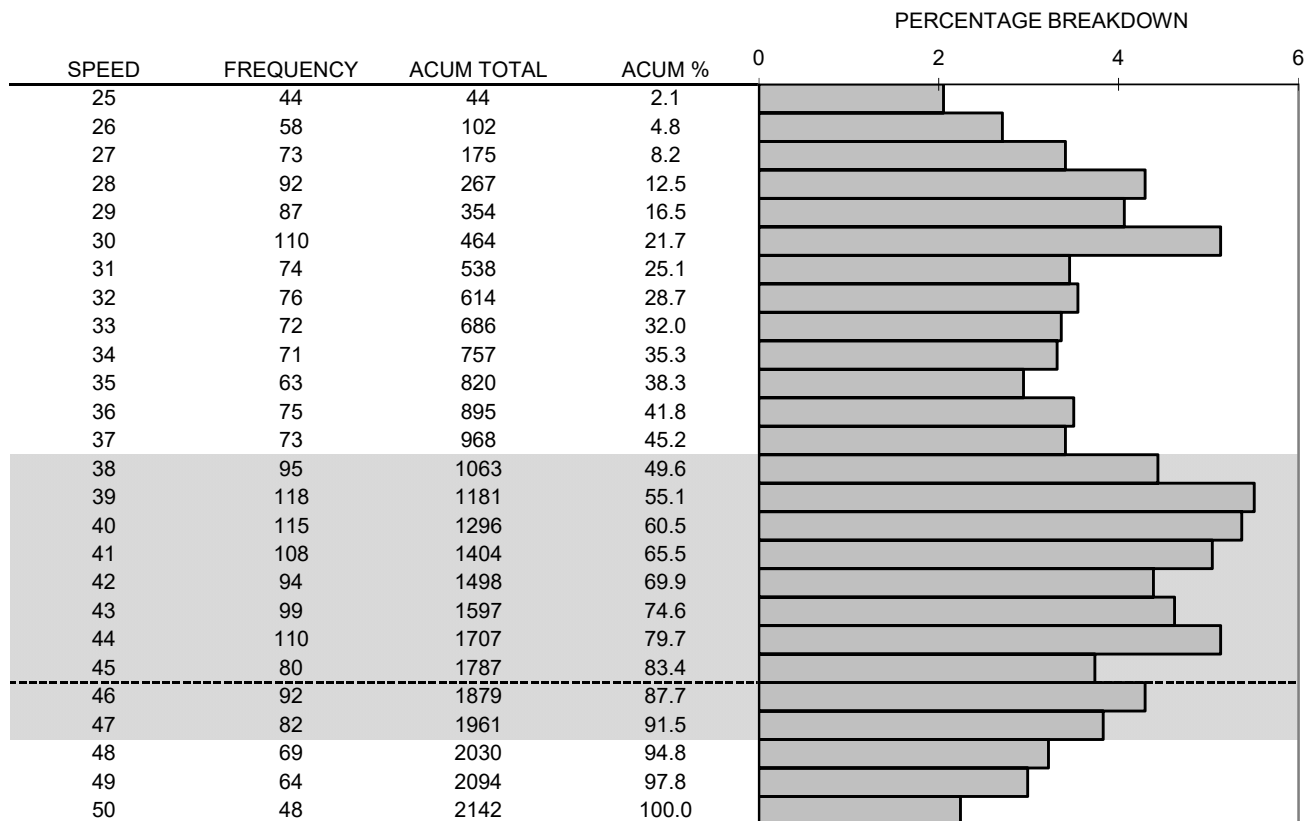
LOCATION: Woodlawn Blvd. 200' South of 53rd St. North
 TIME START: 12:00 AM
 TIME END: 11:59 PM

AVERAGE SPEED = 37.8
 50th PERCENTILE = 38.1
 85th PERCENTILE = 45.4
 90th PERCENTILE = 46.6
 95th PERCENTILE = 48.1

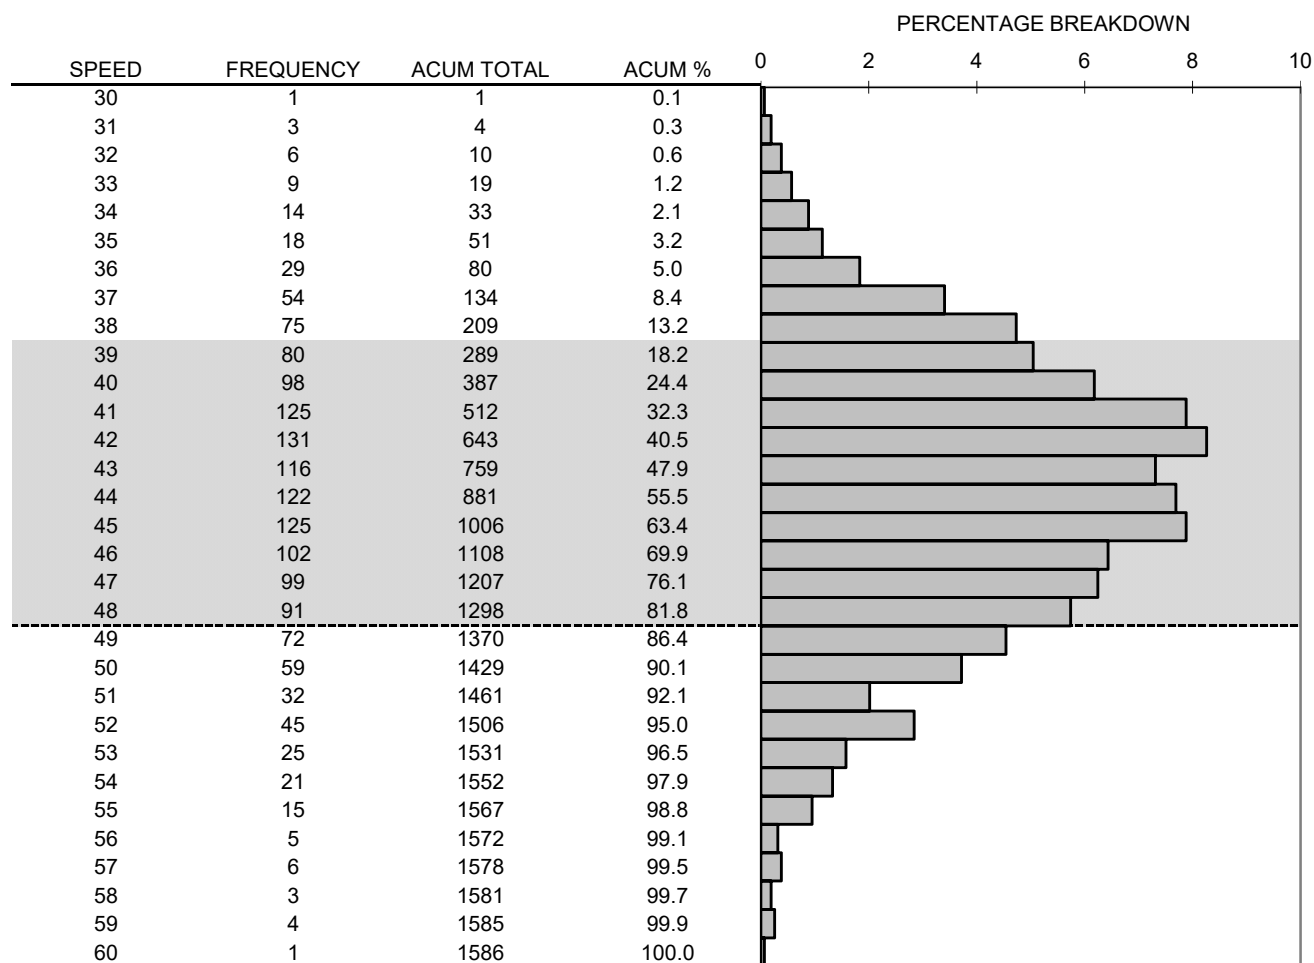
LOCATION: 53rd St. North 800' West of Woodlawn Blvd.
 TIME START: 12:00 AM
 TIME END: 11:59 PM

AVERAGE SPEED = 44.
 50th PERCENTILE = 43.3
 85th PERCENTILE = 48.7
 90th PERCENTILE = 50.
 95th PERCENTILE = 52.

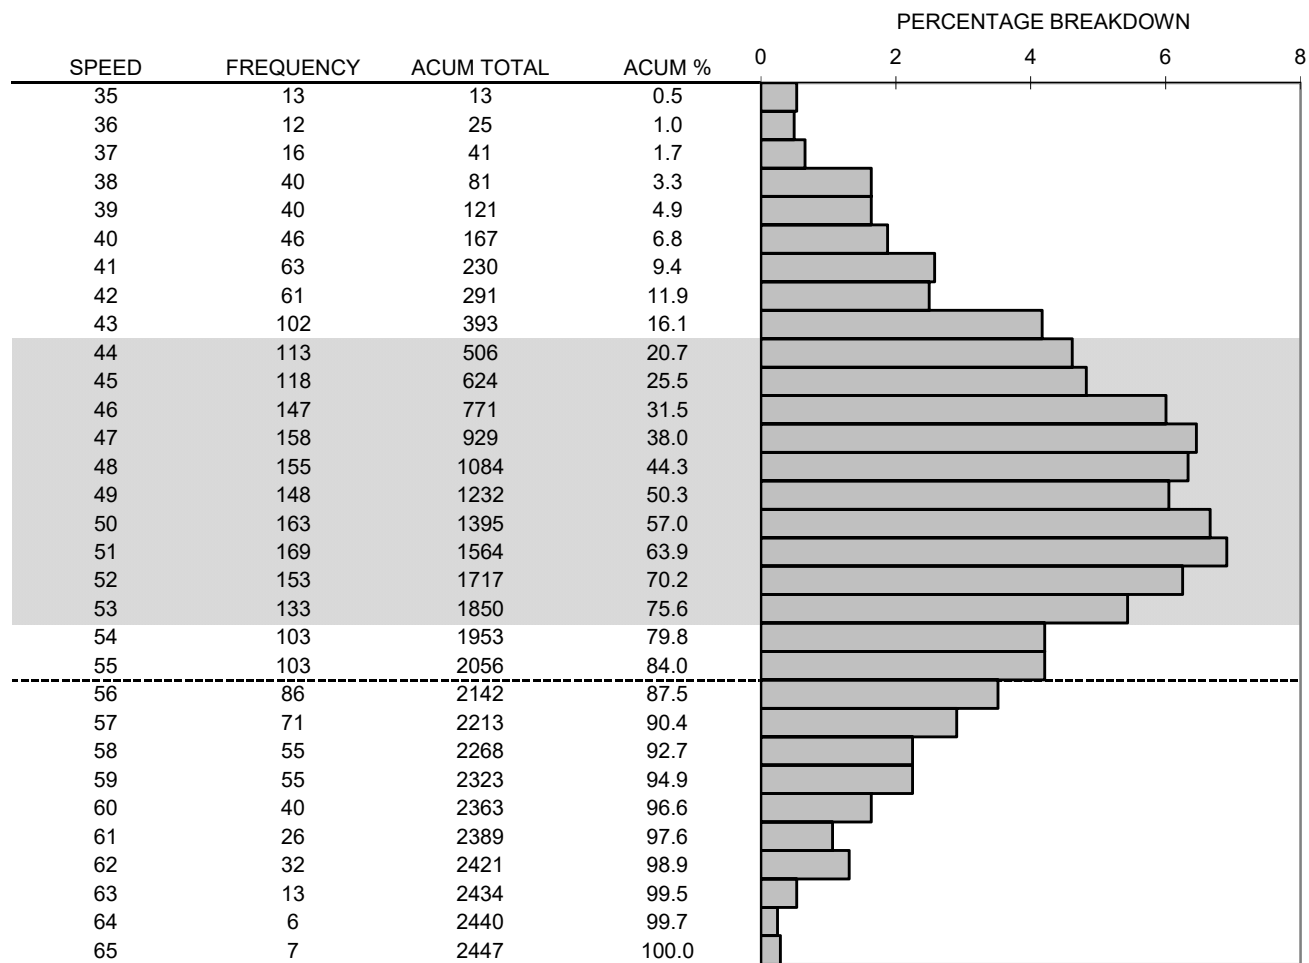
LOCATION: Rock Road 600' North of 53rd St. North
 TIME START: 12:00 AM
 TIME END: 11:59 PM

AVERAGE SPEED = 49.5
 50th PERCENTILE = 48.9
 85th PERCENTILE = 55.3
 90th PERCENTILE = 56.8
 95th PERCENTILE = 59.

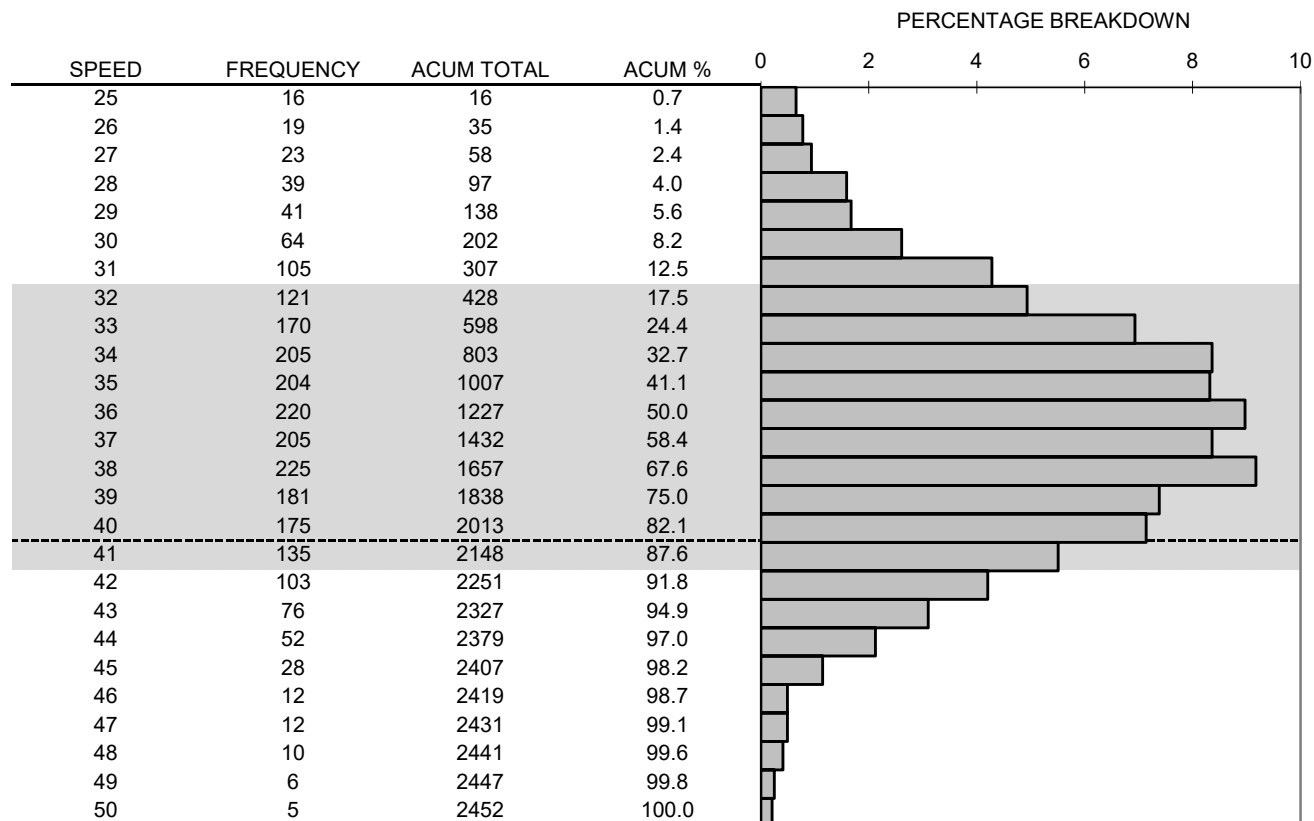
LOCATION: 53rd St. North 500' East of Rock Rd.
 TIME START: 12:00 AM
 TIME END: 11:59 PM

AVERAGE SPEED = 36.5
 50th PERCENTILE = 36.
 85th PERCENTILE = 40.5
 90th PERCENTILE = 41.6
 95th PERCENTILE = 43.

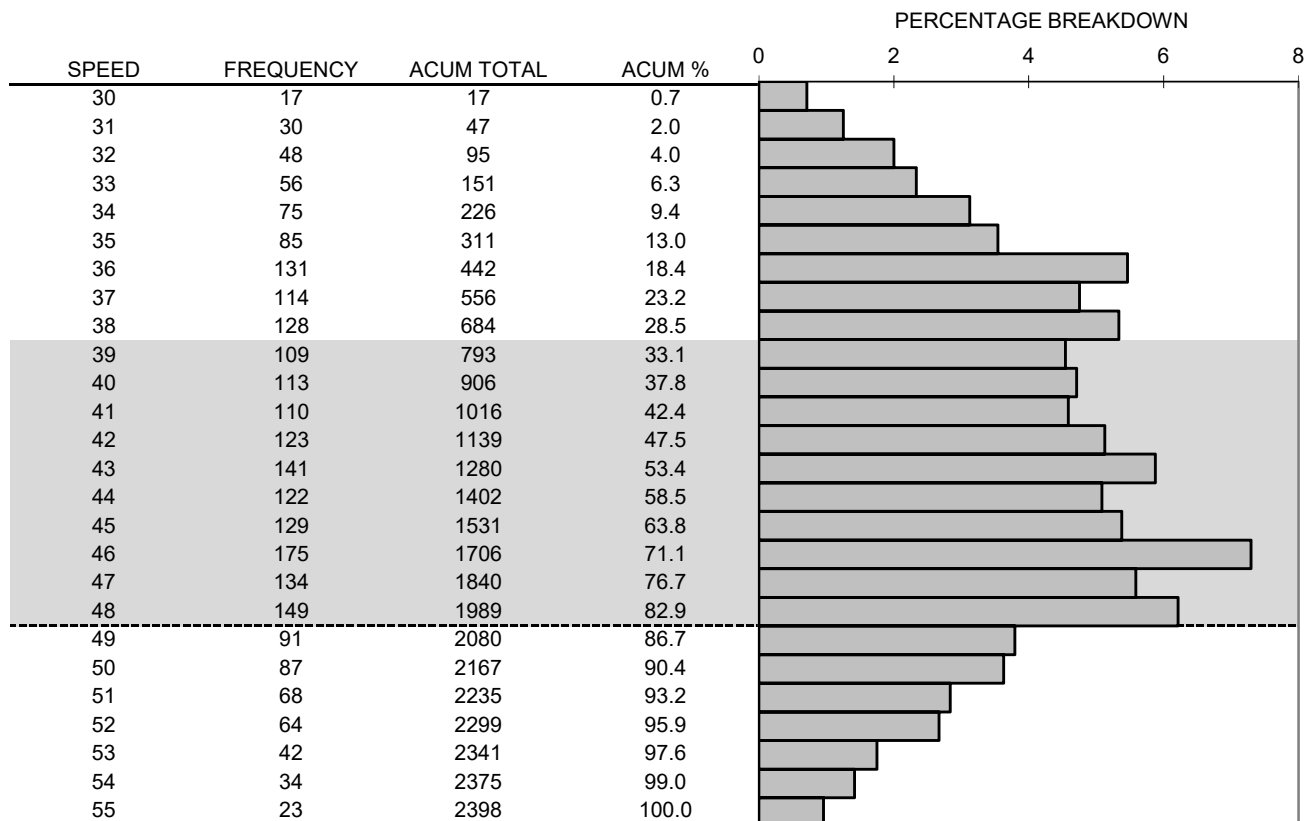
LOCATION: Rock Road 300' South of 53rd St. North
 TIME START: 12:00 AM
 TIME END: 11:59 PM

AVERAGE SPEED = 42.6
 50th PERCENTILE = 42.4
 85th PERCENTILE = 48.5
 90th PERCENTILE = 49.9
 95th PERCENTILE = 51.7

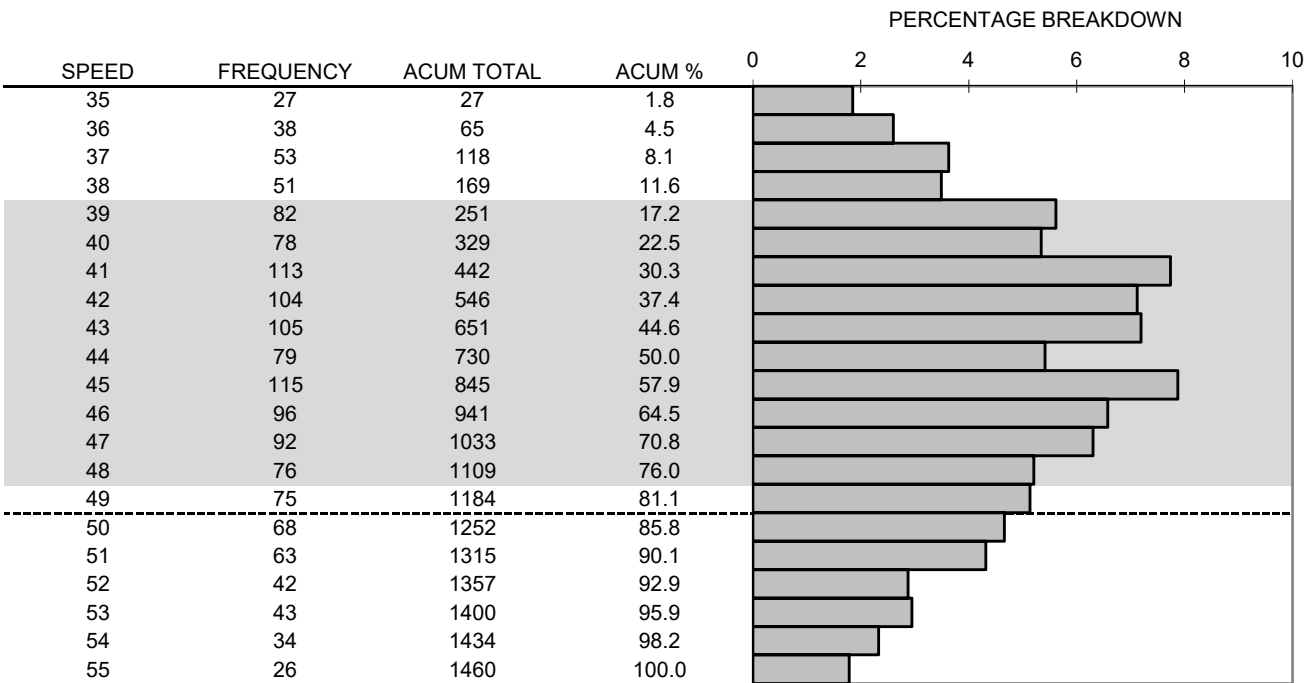
LOCATION: 53rd St. North 600' West of Rock Rd.
TIME START: 12:00 AM
TIME END: 11:59 PM

AVERAGE SPEED = 44.6
50th PERCENTILE = 44.
85th PERCENTILE = 49.8
90th PERCENTILE = 51.
95th PERCENTILE = 52.7

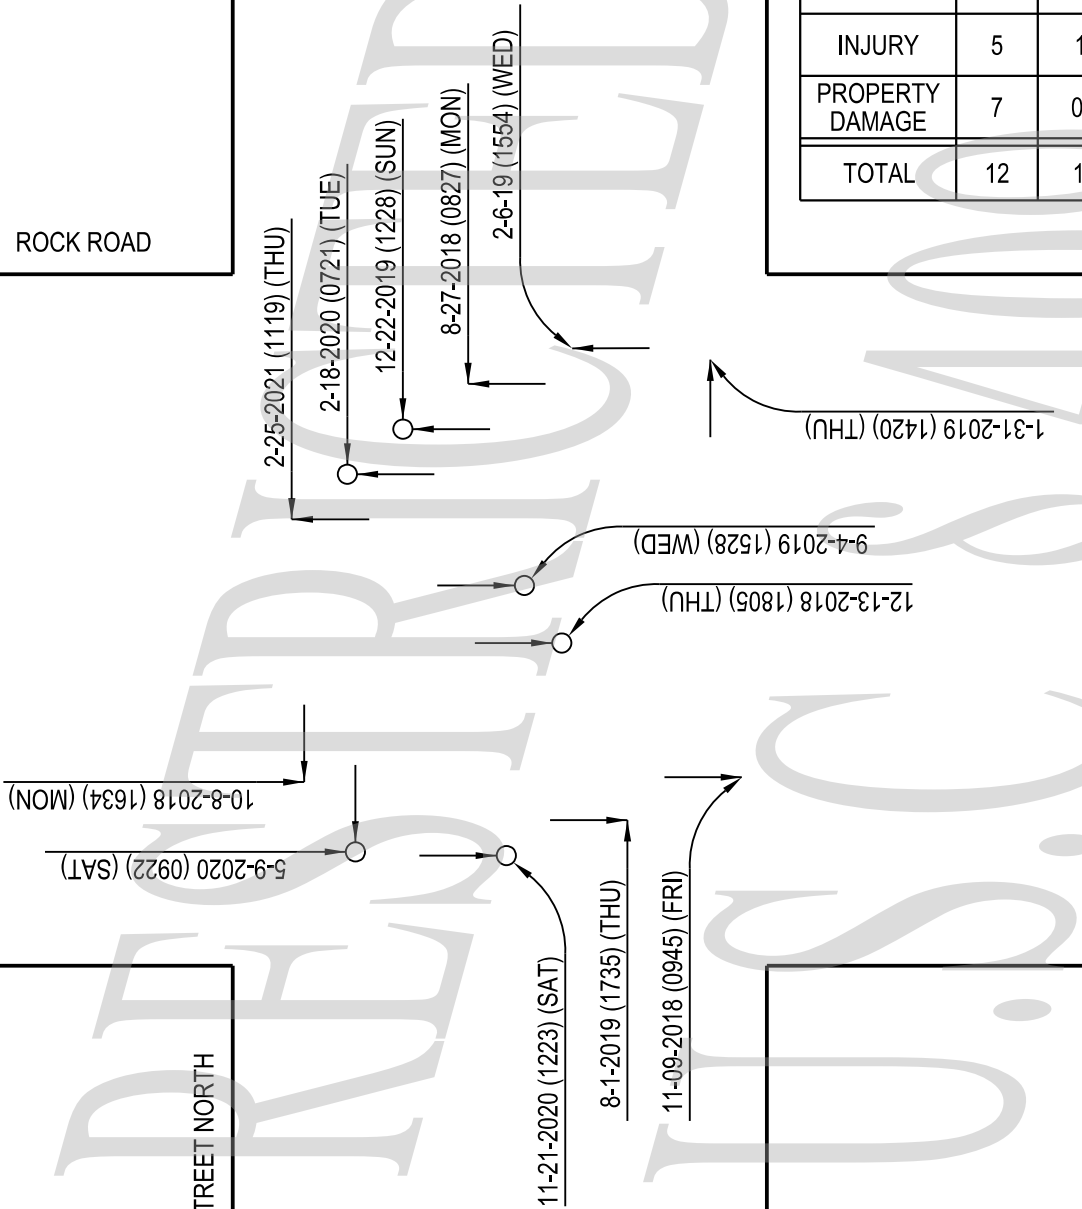
- Eleven (11) of the 13 total crashes were angle collisions. Seven (7) involved a westbound driver on 53rd Street North that either failed to stop entirely (3 occurrences) or failed to yield to oncoming traffic after stopping (4 occurrences). Four (4) involved an eastbound driver on 53rd Street North, and in three (3) of these, the eastbound driver failed to stop entirely. The other two (2) crashes were left-turn collisions involving drivers on northbound Rock Road who failed to yield to southbound traffic.

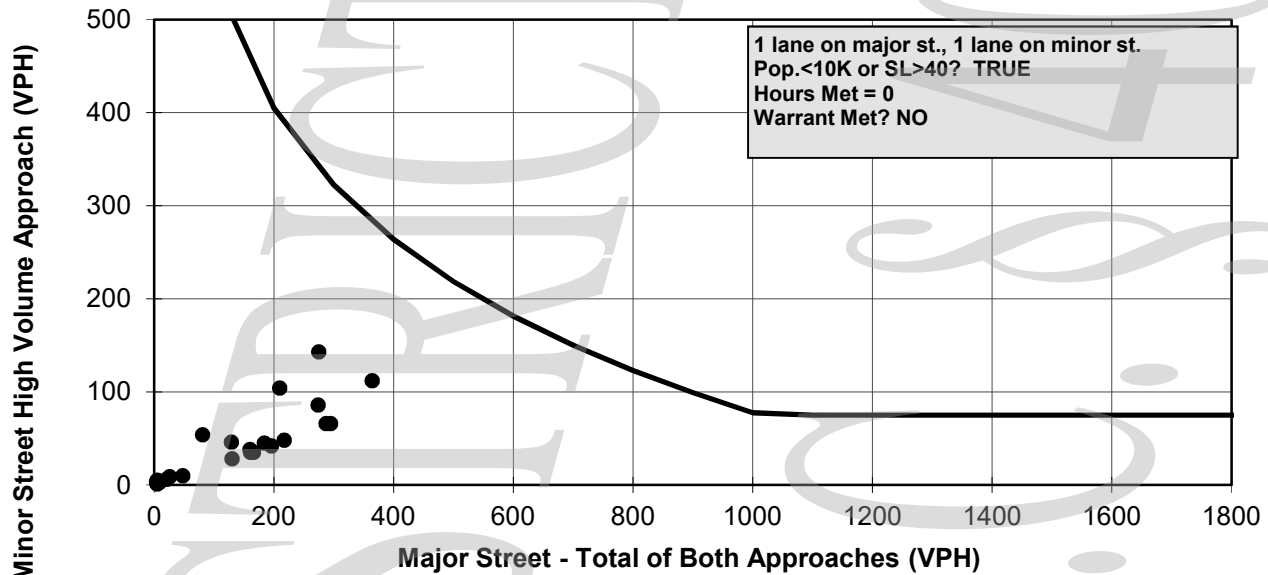
PEAK HOUR VOLUME WARRANT 53rd Street North @ Woodlawn Boulevard

In evaluating each of these MUTCD warrants for the Woodlawn Boulevard and 53rd Street North intersection, we found that the intersection does not fully satisfy the requirements of any warrant at this time. Completed worksheets for the traffic signal volume warrants (Warrants 1, 2 and 3) have been included in the Appendix (Pages A-20 and A-21). Only one (1) of the eight (8) hours with the highest traffic volume totals meet the traffic volume thresholds of Warrant 1, Condition A, and no hours meet the thresholds for Warrant 1, Condition B. There are no hours that satisfy the requirements of Warrants 2 or 3. Warrants 5, 6, 8 and 9 do not apply at this location, and the intersection has not experienced the number of crashes required to satisfy Warrant 7 as identified in the MUTCD (five or more reported crashes in a 12-month period that are susceptible to correction by a traffic control signal). Based on these findings, traffic signal control is not recommended at the intersection of Woodlawn Boulevard and 53rd Street North at this time.

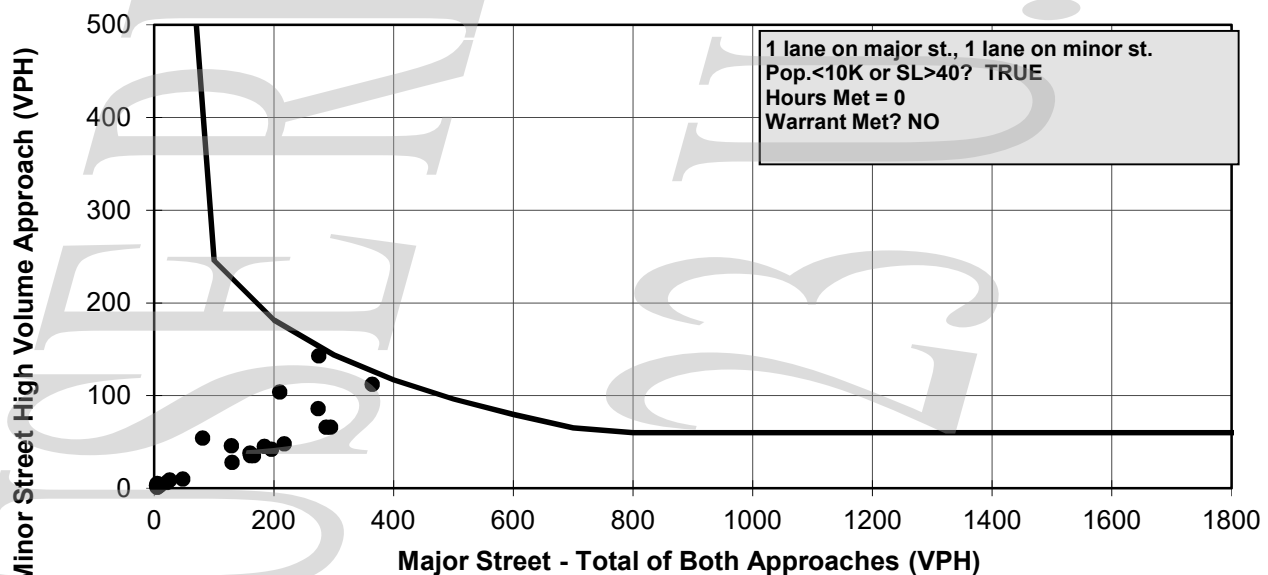
FOUR HOUR VOLUME WARRANT 53rd Street North @ Woodlawn Boulevard

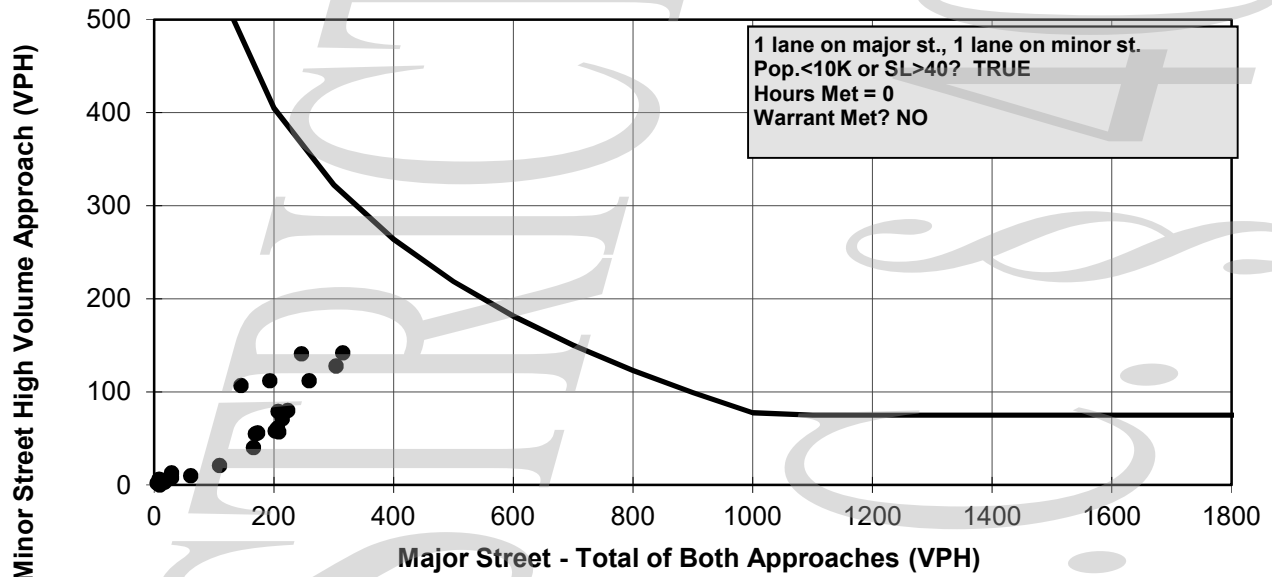
PEAK HOUR VOLUME WARRANT 53rd Street North @ Rock Road

When evaluating the MUTCD warrants for traffic signal control at the Rock Road and 53rd Street North intersection, we found that the intersection does not fully satisfy the requirements of any warrant at this time. Completed worksheets for the traffic signal volume warrants (Warrants 1, 2 and 3) have been included in the Appendix (Pages A-22 and A-23). None of the eight (8) hours with the highest traffic volume totals meet the traffic volume thresholds of Warrant 1, Condition A or Condition B. Only one (1) of the required four (4) hours with the highest traffic volume totals satisfy the requirements of Warrant 2, and no hours satisfy the requirements of Warrant 3. Warrants 5, 6, 8 and 9 do not apply at this location. Warrant 7 applies, and while there is a frequency of correctible crashes that satisfies the crash experience component of the warrant, there is insufficient traffic volume to meet the Warrant 7 requirements. Based on these findings, traffic signal control is not recommended at the intersection of Rock Road and 53rd Street North at this time.

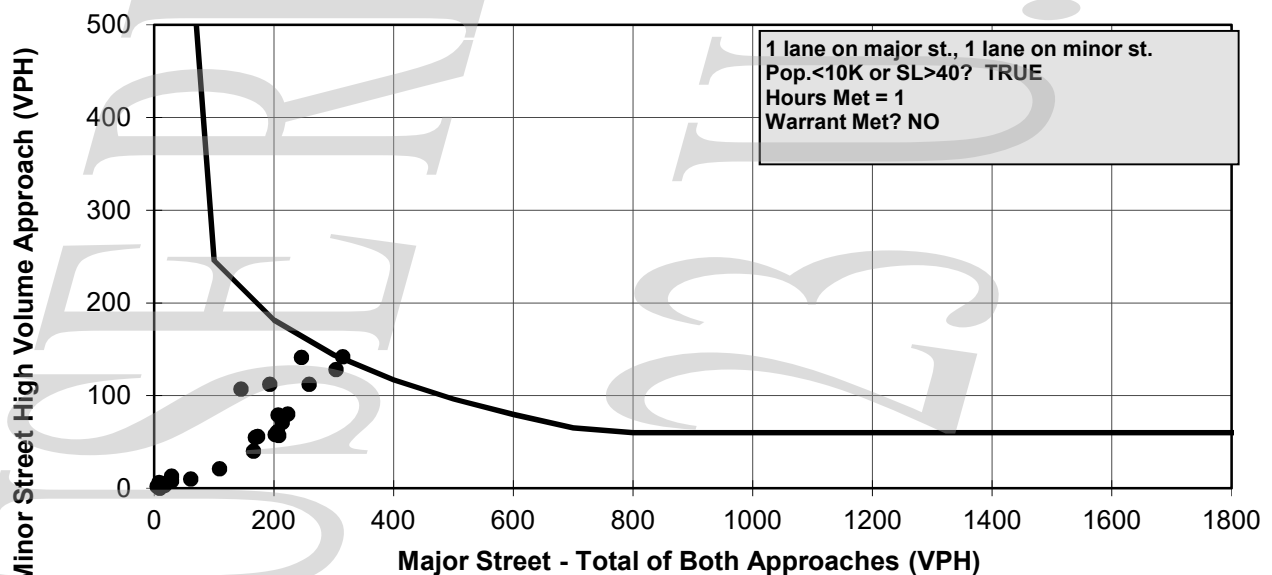
FOUR HOUR VOLUME WARRANT 53rd Street North @ Rock Road
