AGENDA

CITY COUNCIL WORKSHOP

KANSAS TRAFFIC ENGINEERING ASSISTANCE PROGRAM

INTERSECTION ANALYSES

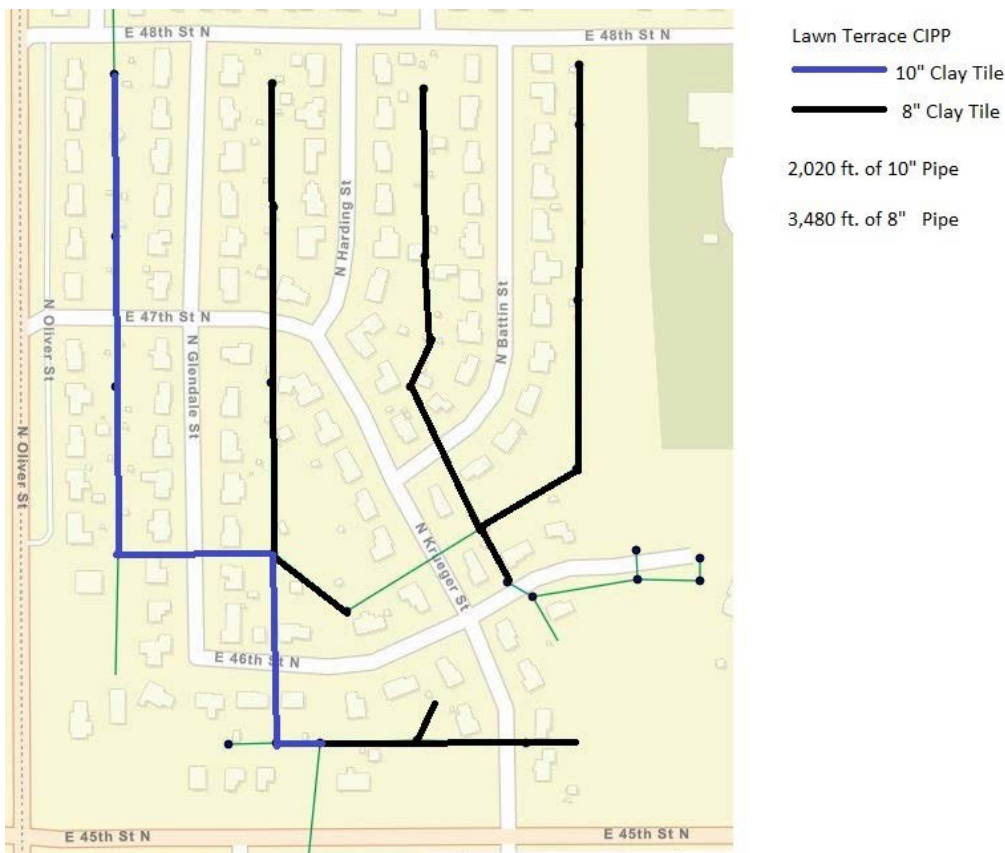
- Continue Cured-In-Place Pipe (CIPP) lining project in Pearson's (see map)
 - o The stretches identified for this work include approximately 5,110 linear feet of 8" pipe and 4,013 linear feet of 10" pipe. This work was bid in 2021, and is currently under construction. The bid price for this work was **\$286,551.50** with an additional cost of \$220 for the removal of protruding taps. At this point, we have not seen an invoice for any work performed thus far.
- Begin Cured-in-Place Pipe (CIPP) lining project in Lawn Terrace. This project will include approximately 2,020 linear feet of 10" pipe and 3,480 linear feet of 8" pipe. We estimate that this project will cost **\$200,000**.
