**Special Meeting - Lake Management Plan Agenda**  
**Thursday, September 28, 2023, 5:30 PM**  
**Council Chambers, 616 NE 4th AVE**

# Lakes Management Plan Update

Special City Council Workshop  
September 28, 2023

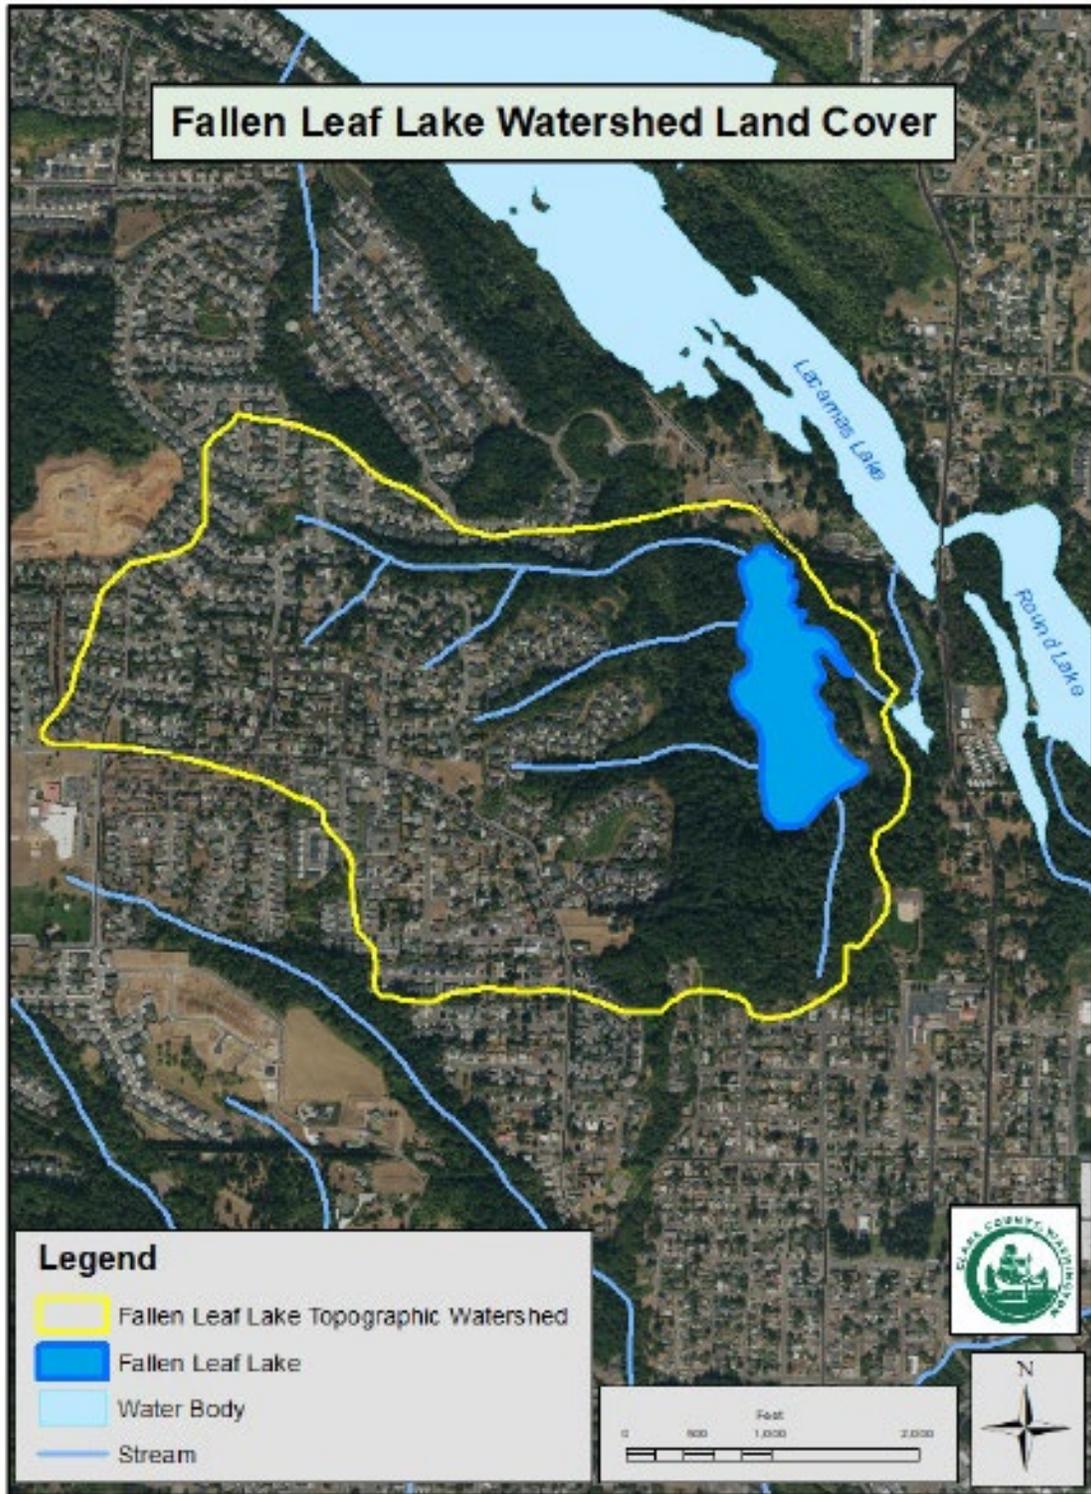
Figure 4. Fallen Leaf Lake watershed (Clark County, 2021)

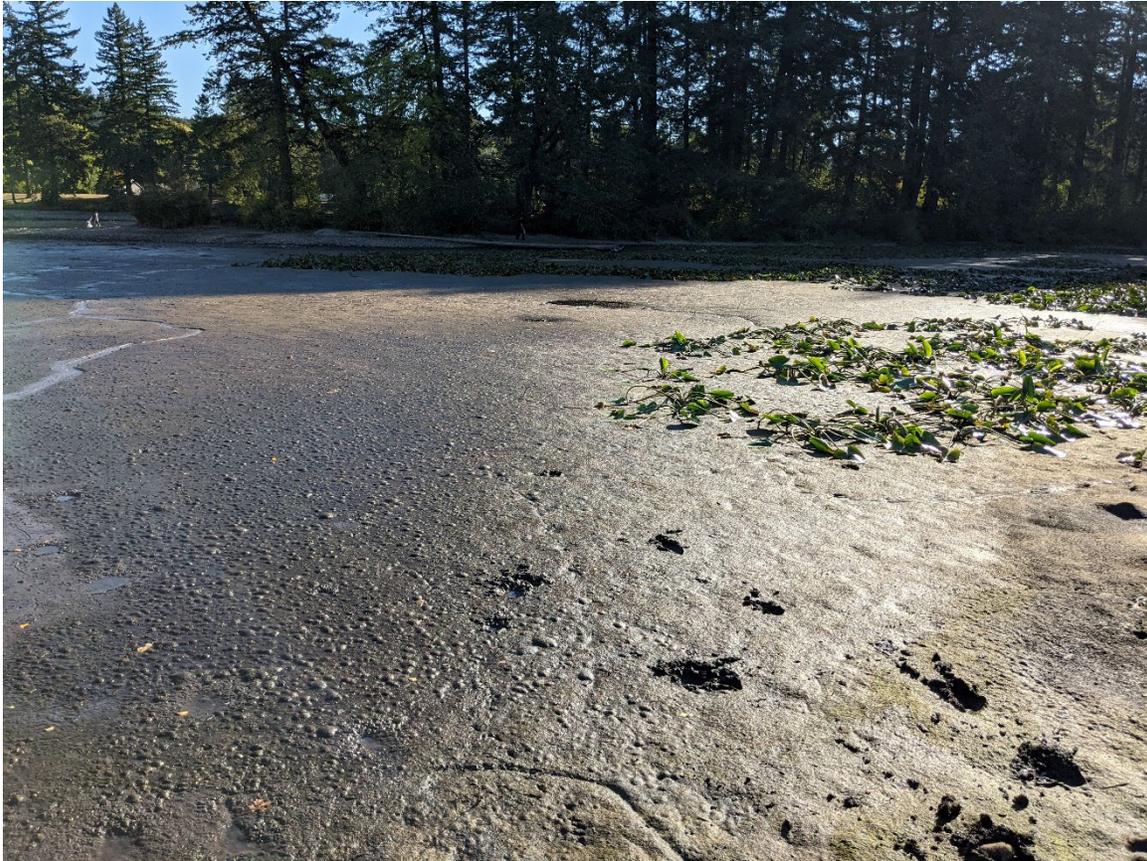
**Figure 3**  
Lacamas Lake on September 25, 2021, showing bare sediment and Rocky Mountain pond-lily during the annual lake drawdown. Photo courtesy of Rob Annear.

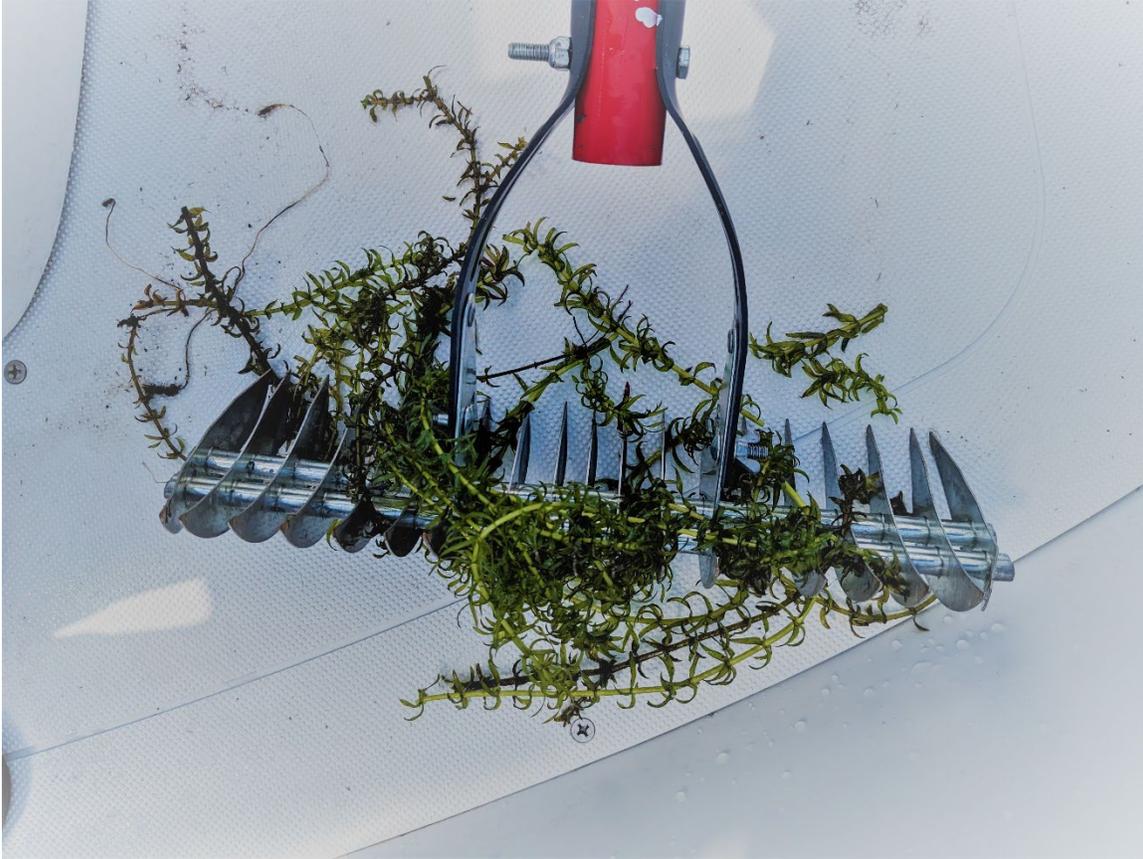
**Figure 6**  
Grab sample collected from a submerged aquatic plant bed at the southern end of Lacamas Lake on June 27, 2023. This was the densest sample collected and was composed of Brazilian waterweed.
