TREE BOARD

Riverwalk Segments

Riverwalk Urban Forest Plan

June 16, 2015

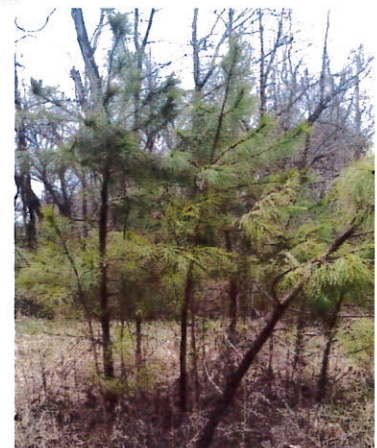
Figure 2-Small pockets of trees along trail

Young pockets of trees growing up along the trail- As new trees start grow along the trail, in particular, pine trees, the trees may form small dense areas where the trees are growing too close together. As the trees grow, the trees will compete for space and nutrients and eventually the losers will die off, creating a hazard tree for the public. We recommend while the trees are young (at least 3-5 years of age), choose one or two dominant and healthy trees to keep and remove the other seedlings and saplings that are growing. Try to create a spacing of at least 10-12 feet between trees. Doing this when the trees are small will make the work much easier.

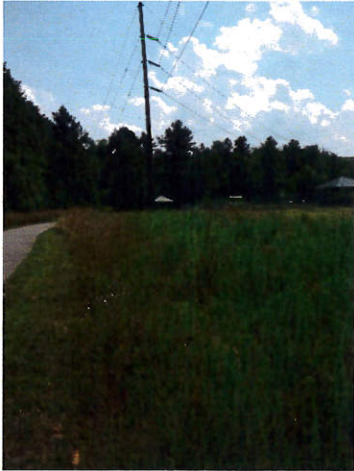
Area underneath the Powerline-

Mow underneath the powerlines at least every two years so that trees do not become established. Trees are a hazard to powerlines and would only create maintenance issues in the future. Leaving these small areas to grow creates early succession habitat which consists of grasses and weeds where an array of birds and small mammals can forage and take refuge. It also seems to keep foot traffic down.

To add a little more color to the area, the Town could disk the area every few years and plant a mix of wildflowers that will attract an array of bird species. This would only be appropriate in the drier areas along the powerline and not in the wetland areas.

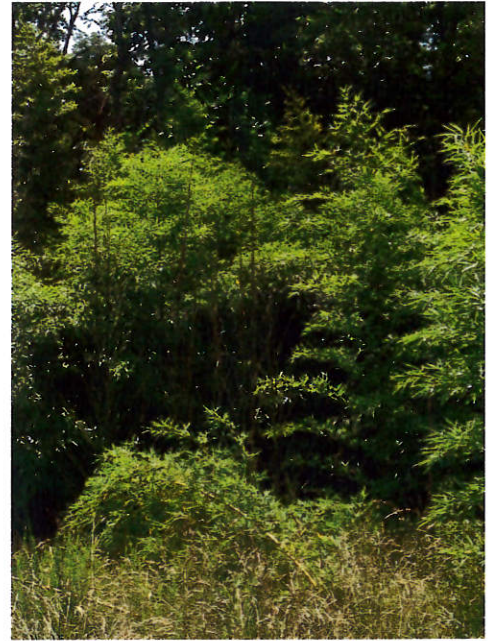
Figure 3-Bamboo in Gold Park

Manage the Invasive Species-There is a plethora of invasive species growing like the Bamboo, Chinese Privet, Tree of Heaven, Japanese Stilt Grass, Honeysuckle, and multi-flora rose. Eradication of the invasive plants in this area will be almost impossible if herbicide use is not desired. However, controlling the spread of some of the species is achievable.

The spread of the Bamboo could be controlled by digging a ditch or trench that is deeper than the rhizomes, typically 2 feet deep, completely around the area of Bamboo that will prevent new rhizomes from growing.

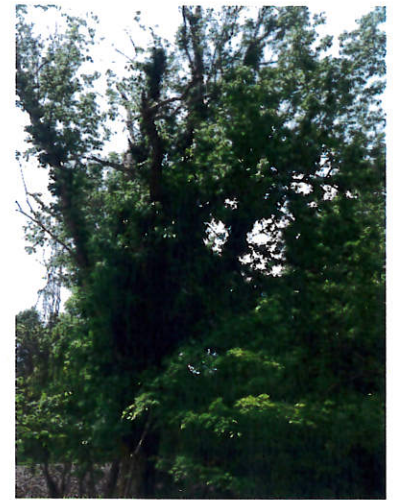
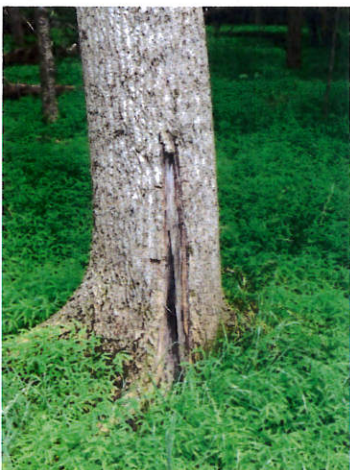
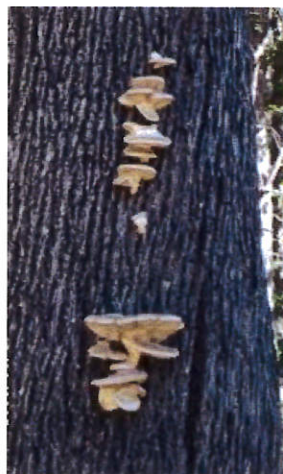
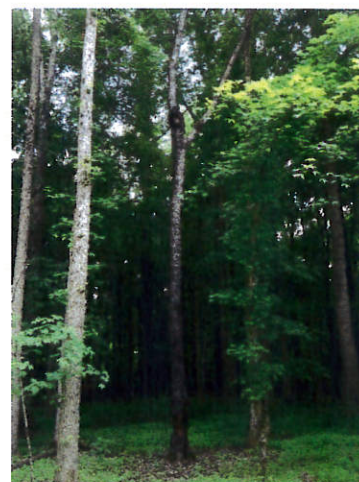
If you notice any of the following signs, the tree could be stressed due to an insect attack, disease, or damage and should be monitored.

- If the tree is a pine, do the branches look reddish or yellowish in color?
- Is there “popcorn” up and down the main bole of the tree?
- Is there “sawdust” laying at the bottom of the tree?
- Is there dieback, or loss of leaves, on some of the limbs?
- Is the tree defoliated?
- Is there open holes or the appearance of rot in the bottom of the tree?
- Is there mushroom like structures growing on the bole of the tree or around the base of the tree?
- Are there any galls or fruiting bodies growing on the side of the tree or limbs?
- Is the bark pulling away from or falling off of the tree?
