# Lakes Advisory Committee Meeting

**Monday, June 23, 2025 - 4:30 PM**

**Lakes Advisory Committee Meeting Minutes**  
**Wednesday, April 2, 2025 – 4:30 pm**  
**Cravath Lakefront Room**  
**312 W. Whitewater Street**  
**Whitewater, WI 53190**  
**Hybrid Meeting**

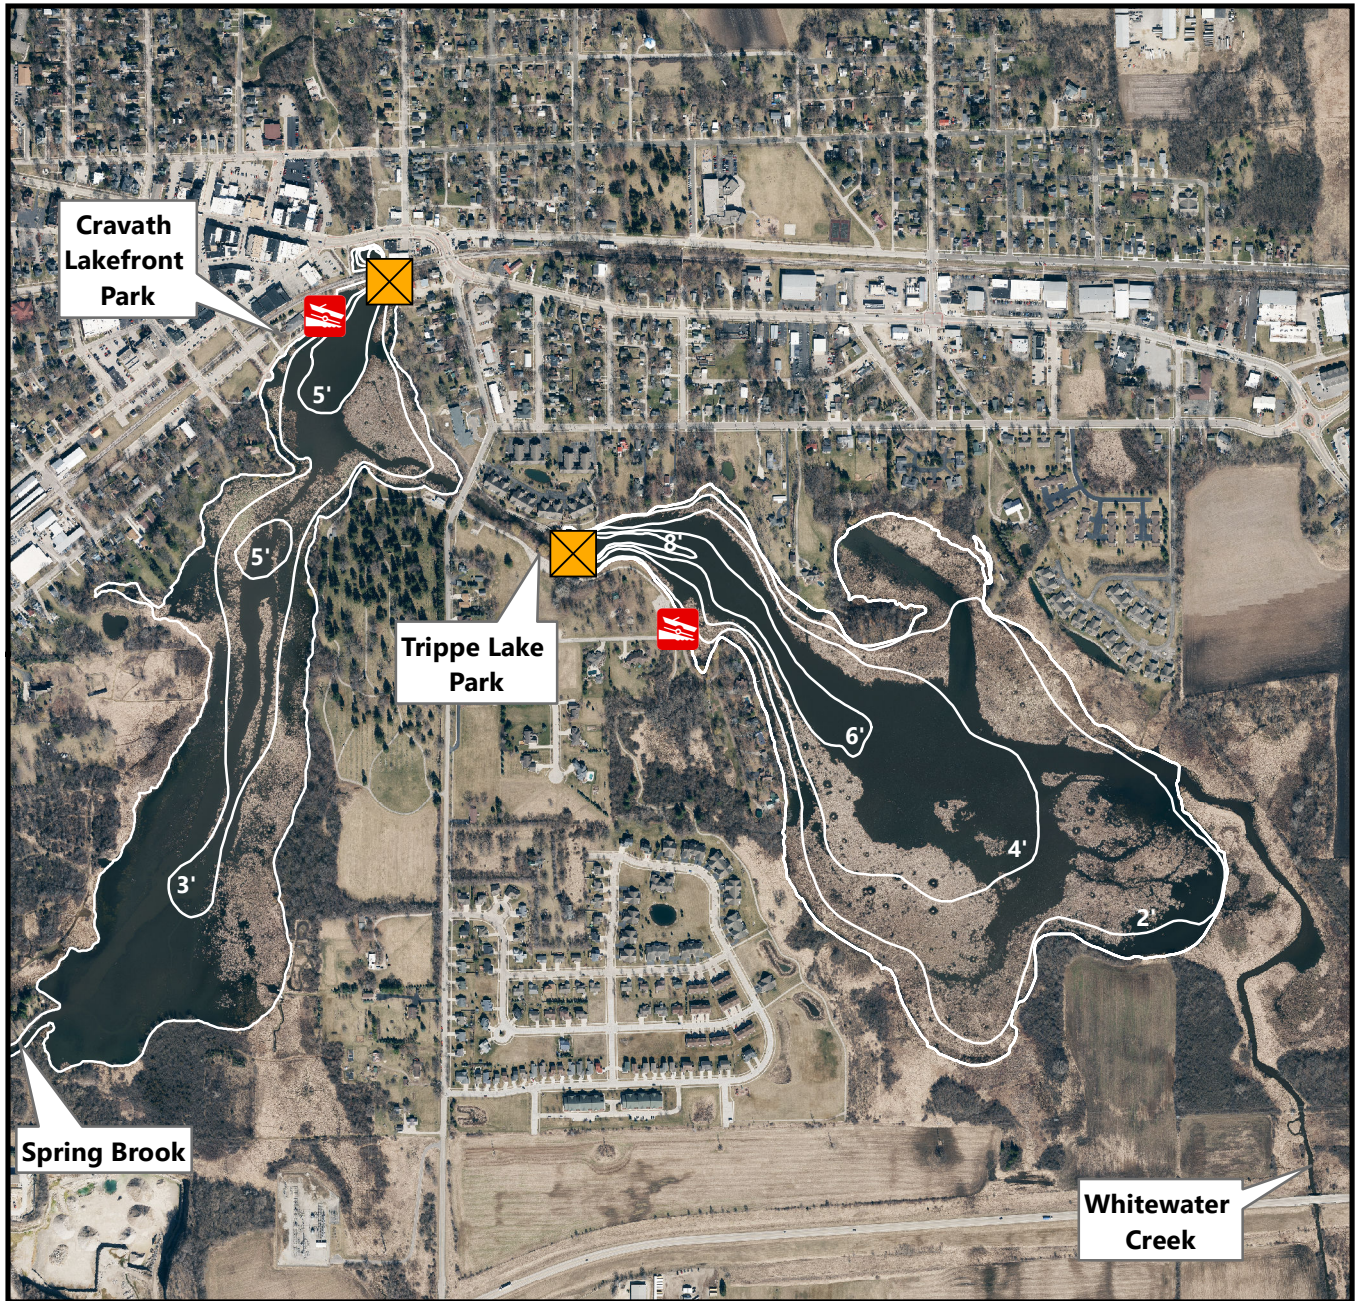
**Map 1.1**  
**Location, Public Access, and Bathymetry of Cravath and Trippe Lakes**

NOTE: Aerial imagery from 2024; Bathymetry depths are from WDNR, Trippe Lake's contours are from 1961 and Cravath Lake's contours are from 1966 and thus may not reflect the current depth of the lakes.

Cravath Lake is a 70-acre impounded drainage lake located in the City of Whitewater in Walworth County. It is fed by both Spring Brook and Trippe Lake, and outflows to the Whitewater Creek, to the Bark River, and then to the Rock River (see [Map 1.1](#)).<sup>1</sup> Attaining a maximum depth of 10 feet, the Lake can support aquatic plant growth throughout most of its surface area. A 2017 survey performed by Lake and Pond Solutions observed 12 aquatic plant species in the Lake which included several beneficial native species such as Sago pondweed (*Stuckenia pectinata*), Illinois pondweed (*Potamogeton illinoensis*), and American lotus (*Nelumbo lutea*). Invasive aquatic plant species, including Eurasian watermilfoil (*Myriophyllum spicatum*) and curly-leaf pondweed (*Potamogeton crispus*) were also observed during the survey.

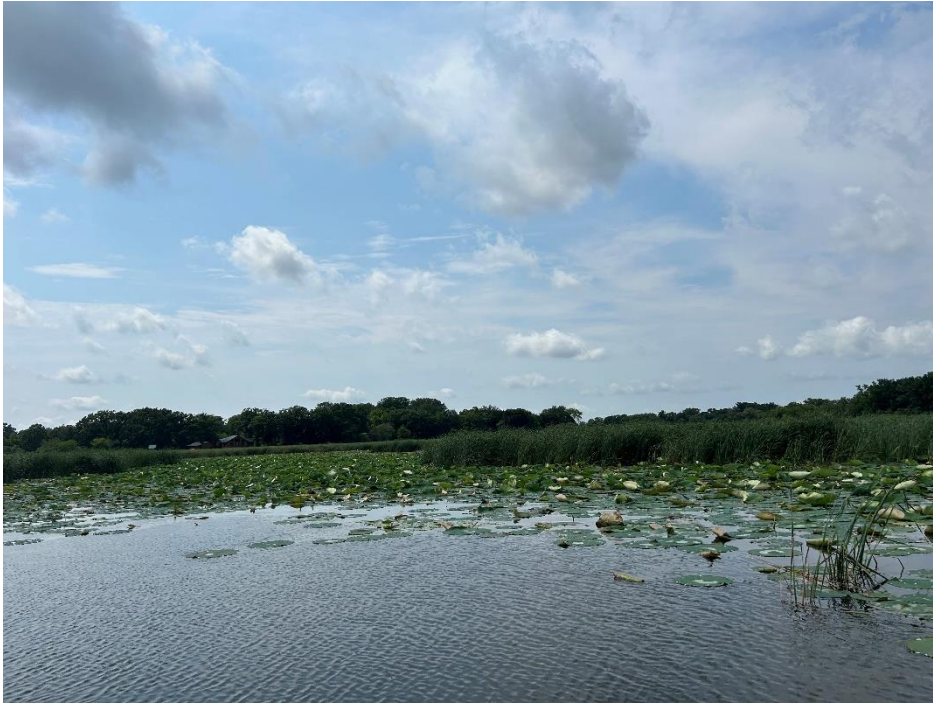
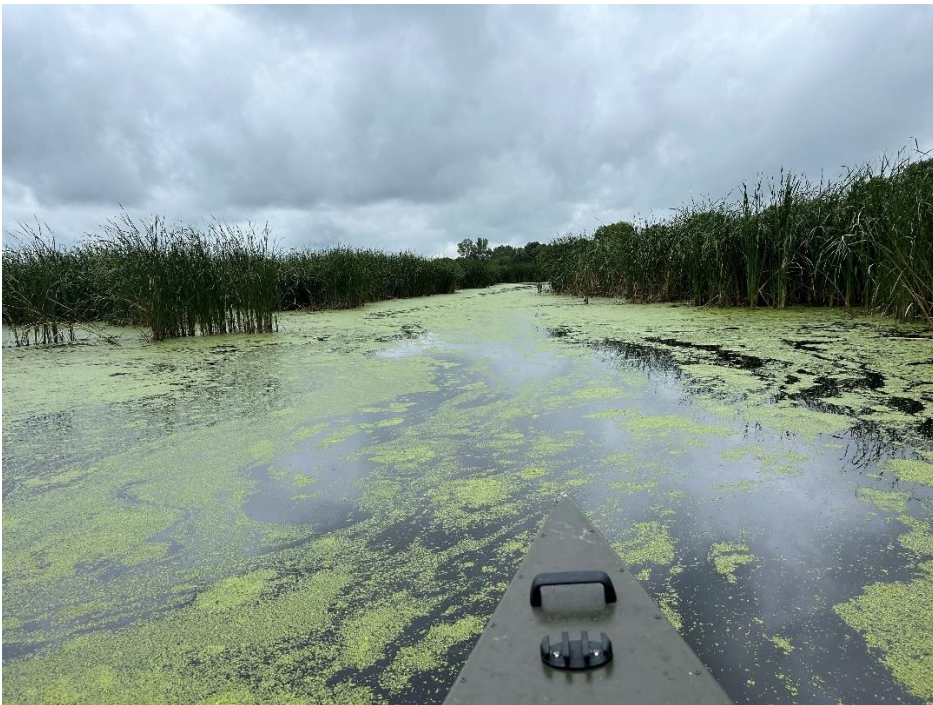
**Figure 2.12**  
**Hybrid Cattails in Cravath and Trippe Lakes: July 2024**

Trippe Lake Cattails

Cravath Lake Cattails

Commission staff were unable to sample large portions of the lake due to the dense growth of hybrid cattails (see Figure 2.10 and Figure 2.11). Much of the shoreline was unable to be seen or accessed from the Lakes' open water due to the dense growth (see Figure 2.12). Commission staff used aerial imagery to

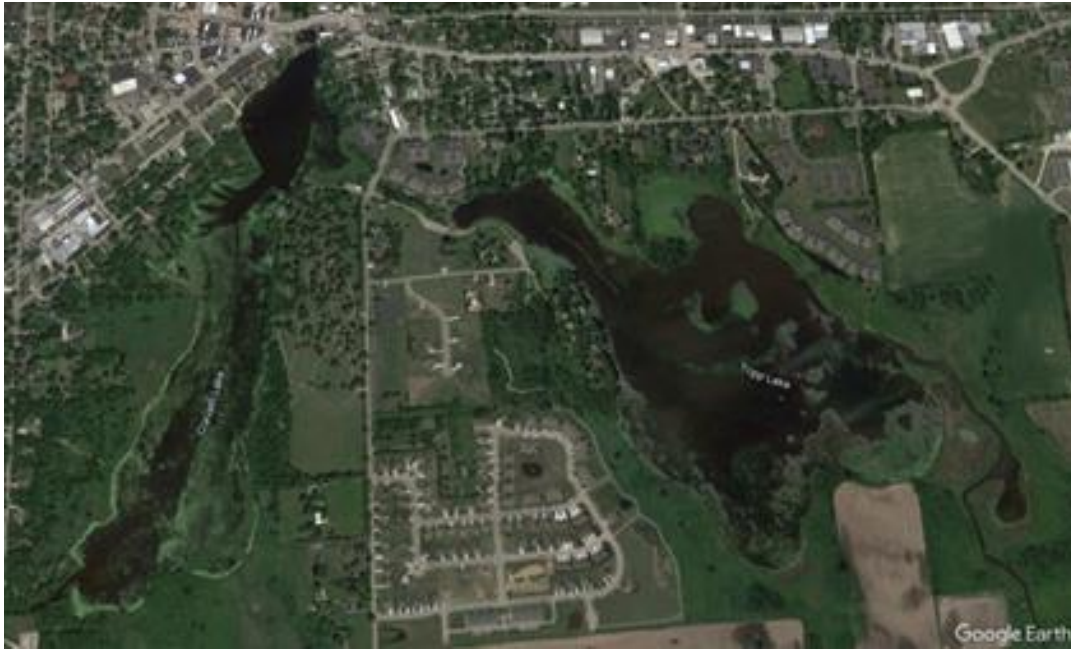
**Figure 2.13**  
**Hybrid Cattail Extent in Cravath and Trippe Lakes**

June 2015 Cattails

May 2023 Cattails

estimate the increase of cattail growth in the Lakes from pre draw-down conditions in 2015 as well as recent cattail conditions in 2023 (see **Figure 2.13**)<sup>25</sup>. The cattail coverage on Trippe Lake in June 2015 was estimated to be 27 acres, or 22%. Comparatively, the cattail coverage in May 2023 was estimated to be 50 acres, or 41% of the lake acreage. Cravath Lake's cattail coverage in June 2015 was estimated to be 3 acres, or 5%. Comparatively, the cattail coverage in May 2023 was estimated to be 33 acres, or 47%.
