## **Historic Resources Advisory Committee Agenda**

February 22, 2024 at 5:00pm

# STRUCTURAL CONDITION SURVEYS

Project Number I1817.23001; RSI-3411

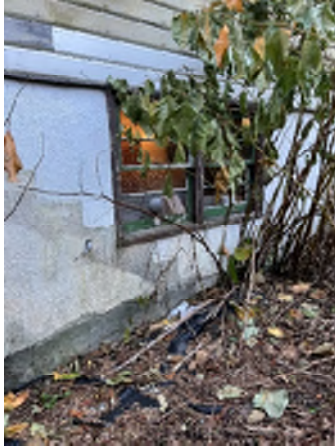
**Figure 1-7.** Replaced and Repainted Pieces of Siding.

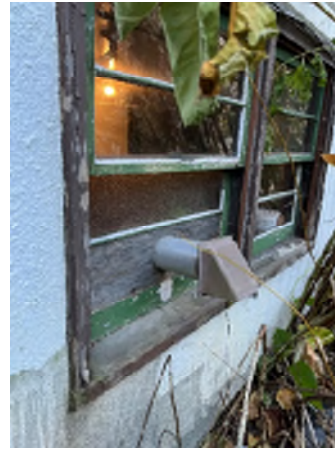
**Figure 1-8.** Rotten Window Sill.

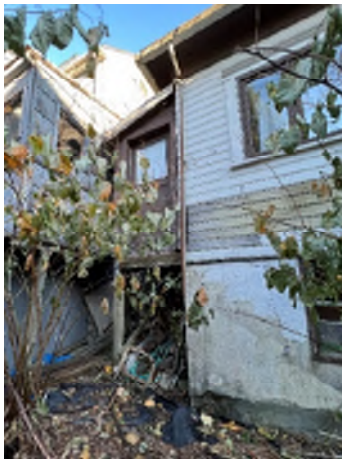
**Figure 1-9.** A Door More Than 6 Feet Above Ground With No Stairs.

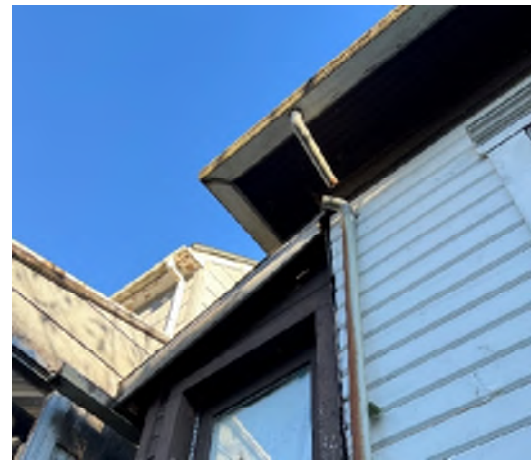
**Figure 1-10.** The Drainpipes Are Disconnected, and Water Is Not Directed Away From the Building.

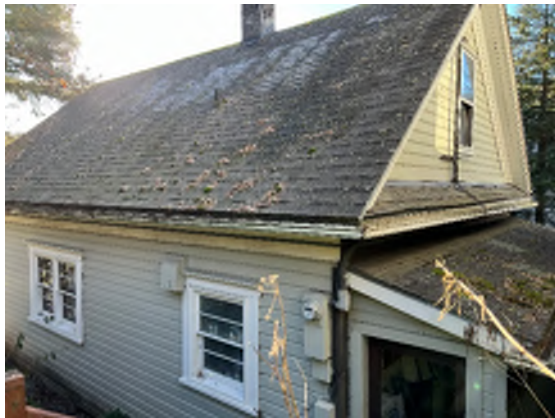
**Figure 1-15.** East Side of the Building With Wooden Gutters.

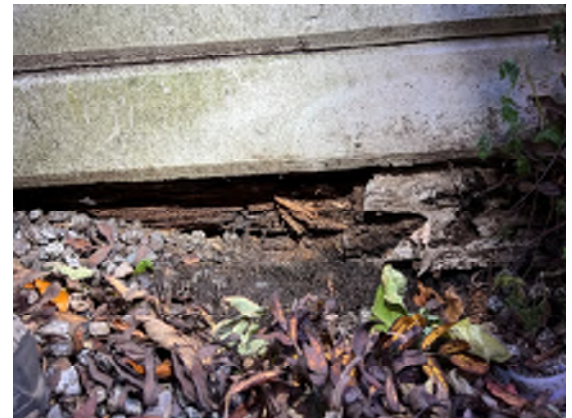
**Figure 1-16.** Exposed Wood Beneath the Siding Is Rotten.

This building is generally in fair condition for its age. Rusty hardware at post and beam connections, chipped paint, some rot, and significant moss growth exist. The extent of the rot below the siding on the east side of the building is unknown.

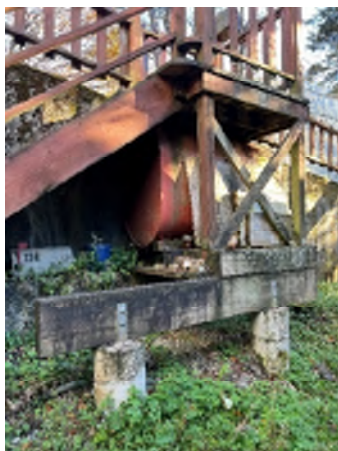
**Figure 1-17.** Fuel Tank Wedged in the Space Under the stairs.

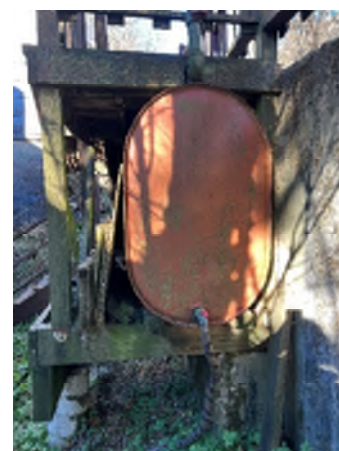
**Figure 1-18.** The Stair Member Was Cut to Allow for the Vent Pipe at the Top of the Tank.

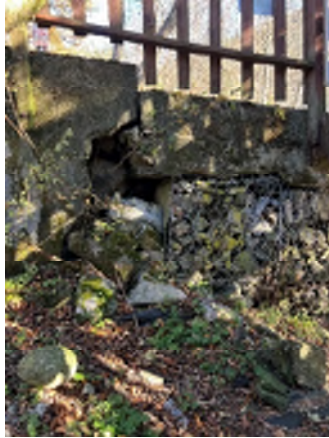
**Figure 1-19.** Undermining of the Road at the Interface Between the Two Retaining Wall Systems.

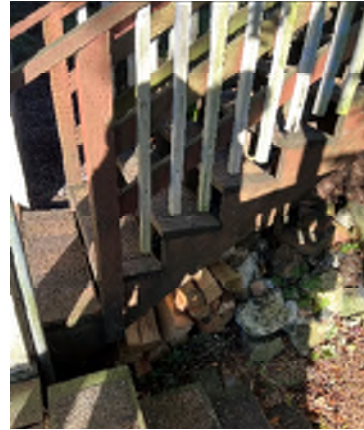
**Figure 1-20.** A Long Crack on the Side of the Stringer.

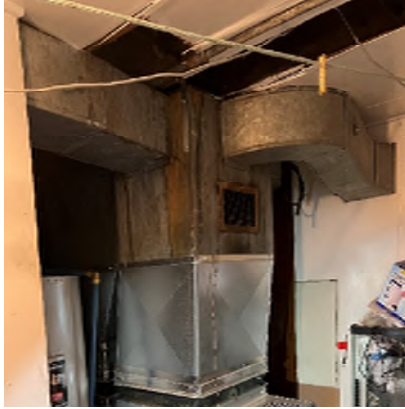
**Figure 1-25.** Staining on the Ducting Indicating Past Leaks.

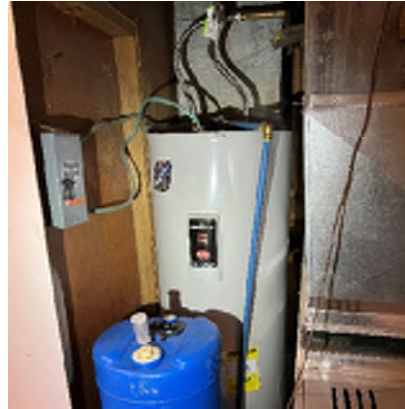
**Figure 1-26.** Water Heater Without Seismic Strapping.

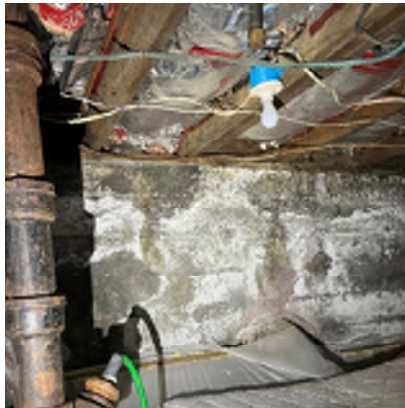
**Figure 1-27.** Many Signs of Water Infiltration Exist on this Concrete Wall From the Discoloration. The sill plate is rotten from the outside.

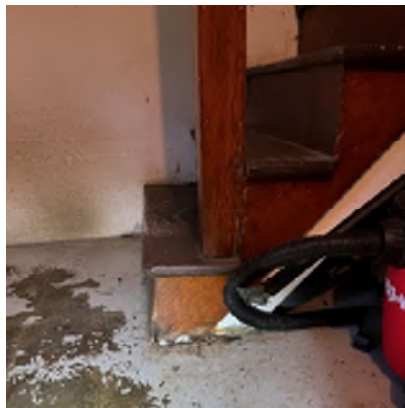
**Figure 1-29.** Wood at the Bottom of the Stairs Has Some Water Damage.

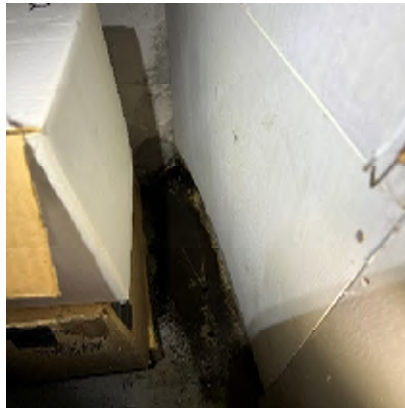
**Figure 1-30.** Channel Under the Stairs Where Water Frequently Flows In. This is the location of the large concrete crack on the north side wall.

The foundation is in fair condition for a structure that is 113 years old. There are issues that need to be addressed, including concrete cracks and a lack of reinforcement. A large concrete crack exists on the north and south sides of the building. Minimal cracks to the finishes inside the residence were seen. Buildings constructed in the early 1900s do not have the same standards for code minimums that we do today. Reinforcement in the concrete walls is unlikely and would not meet the current minimum standards. Reinforcements were not observed during the inspection. Water frequently flows in the basement on the residence's north side at the foundation crack's location. The bottom of the trim in the basement is rotten, indicating water has previously reached it. At a minimum, the cracks can be sealed to help minimize water infiltration and a water proof membrane can be installed on the outside of the foundation. Full repair would include replacement of the foundation, which would include installing a properly reinforced foundation with a modern water proofing system.

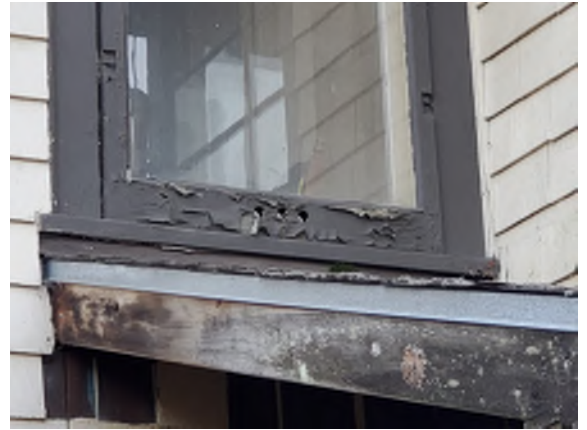
**Figure 2-2.** Three Holes in the Window That Could Allow Water to Enter the Building.

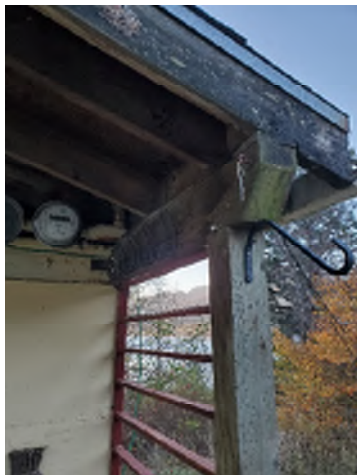
**Figure 2-3.** Roof Members on the Canopy Appear Rotten. No uplift connection exists between the post and beam.

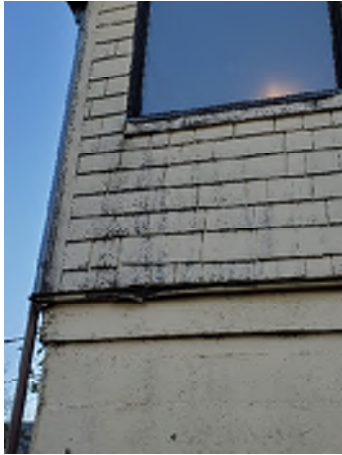
**Figure 2-7.** Black Mold on the Siding at the Southwest Corner.

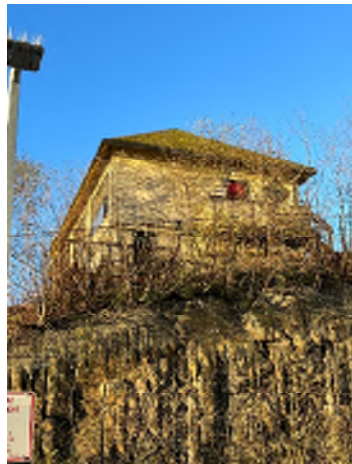
**Figure 2-9.** East Side of Building With Moss on the Roof.

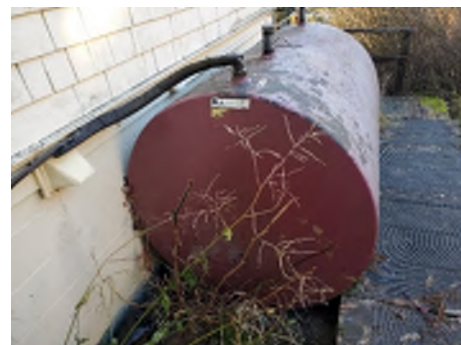
**Figure 2-12.** Tank Is Not Seismically Anchored.

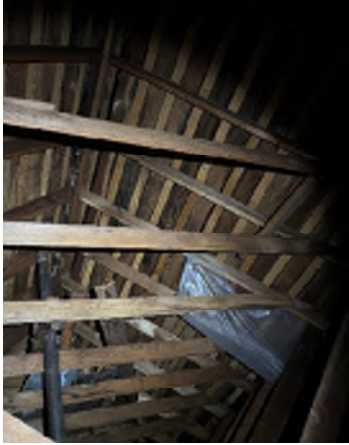
**Figure 2-13.** Attic Trusses and Most of the Wood Appears Dry. The roof rafters and site built trusses are under sized for current snow loads.

The attic is poorly insulated. The heat loss of the building through the roof is likely melting the snow. If the attic was insulated to current standards, the roof would have a higher load, likely exceeding the roof framing and connections capacity. If additional insulation is considered, the roof will need to be analyzed, and the trusses will likely need to be replaced.

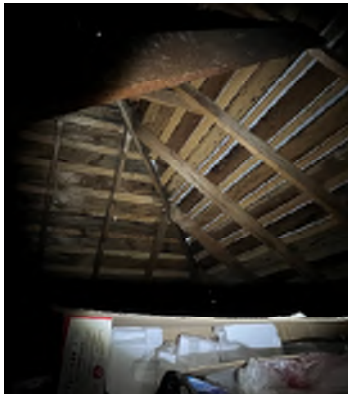
**Figure 2-15.** Daylight Is Visible Through Holes in the Northwest Corner of the Roof, Which Allows Water to Penetrate the Roof. This is the cause of the water damage seen on the ceiling of the second level. A roof replacement is in progress.

This building has visually deteriorated. Chipped paint, siding, and a lack of floor coverings exist. It appears the roof was in the process of being replaced, but there are holes in the old portion of the roof. Rot in the window frames, mold on the siding, and signs of pipe leaks indicate water has infiltrated the building. With the finishes in place, the extent of the water damage and the effect on the structural elements is unknown. The framing of the building is with rough-sawn, old-growth lumber. Most of the visible wood appears to be dry.

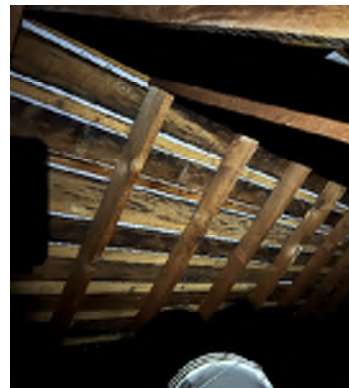
**Figure 2-16.** Indications of Previous Leak Repairs. Water infiltration can cause the structural members to rot. The roof rafters and site built trusses are under sized for current snow loads.

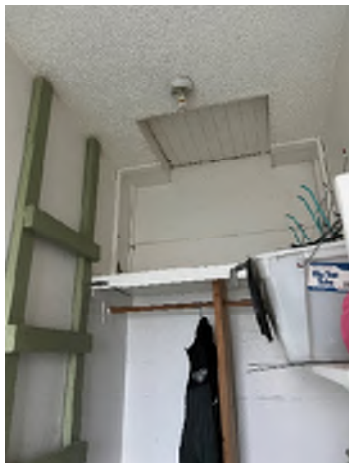
**Figure 2-19.** Inadequate Framing to Support the Closet Used for Attic Access.

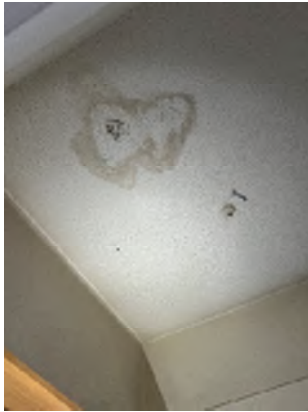
**Figure 2-23.** Water Damage, Cracks, and Exposed Wiring in the Closet on the Northeast Side of the Building.

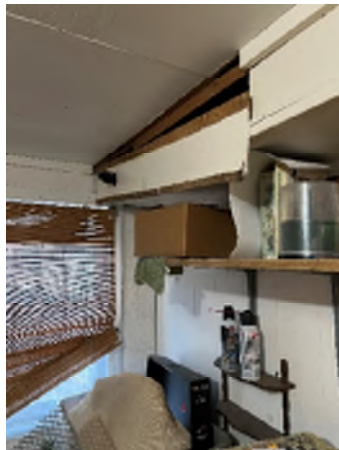
**Figure 2-27.** Wall Finishes Have Detached.

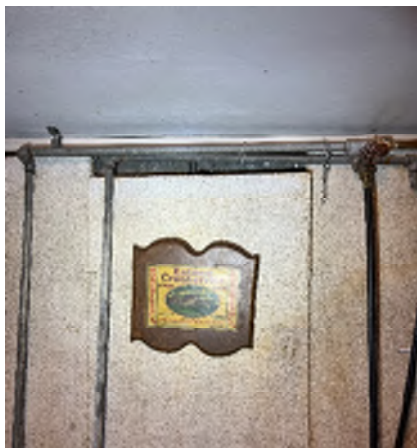
**Figure 2-29.** Wall Panel Has Detached From the Wall.

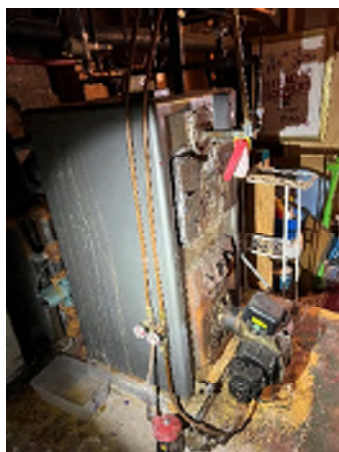
**Figure 2-33.** Signs of Leaks Exist With the Staining on the Side of the Unit.

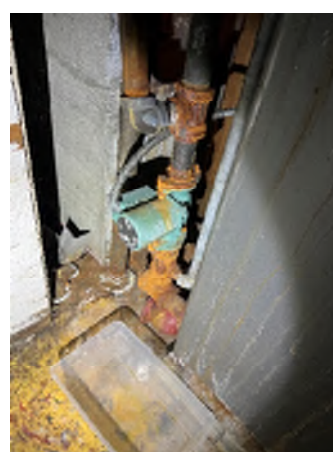
**Figure 2-34.** Signs of Leaks Exist at the Pipe Connections.

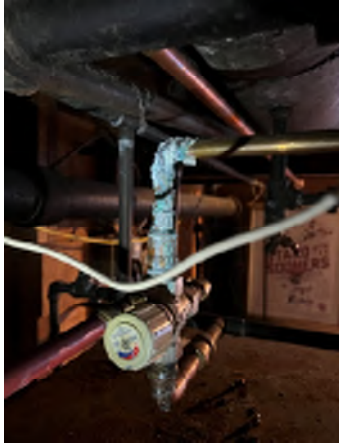
**Figure 2-35.** Signs of Leaks and Corrosion Exist at the Pipe Connections.

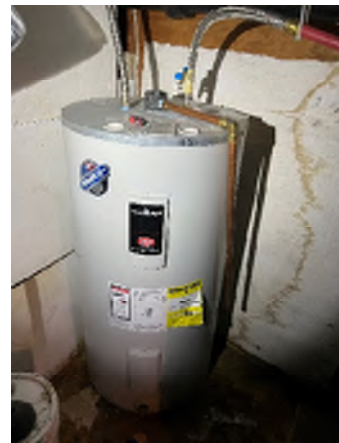
**Figure 2-36.** No Seismic Strapping Around the Water Heater.

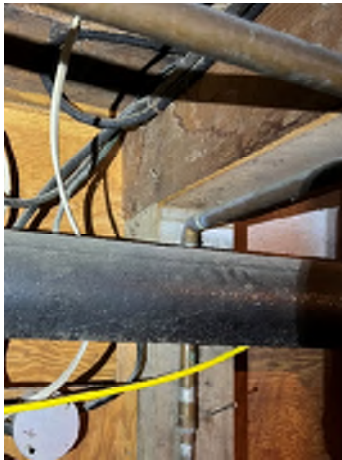
**Figure 2-37.** Columns Are Toe-Nailed at the Top to the Beam. No positive connection at the base of the column to the concrete exists.

The lateral resisting system is inadequate. The columns observed are sitting directly on the slab without a connection to the concrete. The top of the columns may or may not be toe-nailed to the beam they are supporting. In a seismic event, posts can shift out from under the beam they are supporting without positive connections. The roof and floor diaphragms appear to consist of tongue-and-groove boards. Without plywood, the tongue-and-groove boards can resist lateral forces well in one direction but not in the other direction. While the building has stood since 1900, its shear walls would not meet current seismic demands. In general, the lateral load path is lacking proper seismic detailing, including connections, between the roof and floor diaphragms to the shear walls and the foundation.

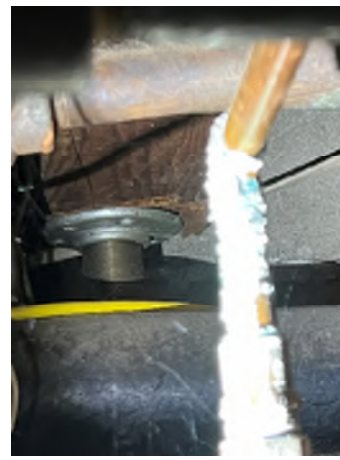
**Figure 2-38.** A Pipe Supporting a Beam With No Positive Connections at the Top or Base.

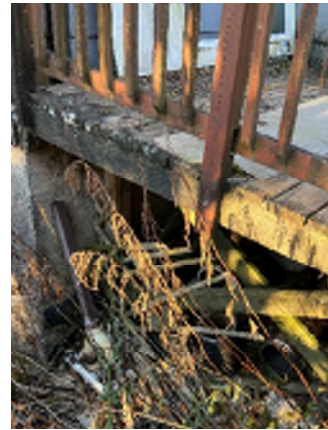
**Figure 3-2.** Drainpipe Is Disconnected and the Deck Framing Appears Rotten.

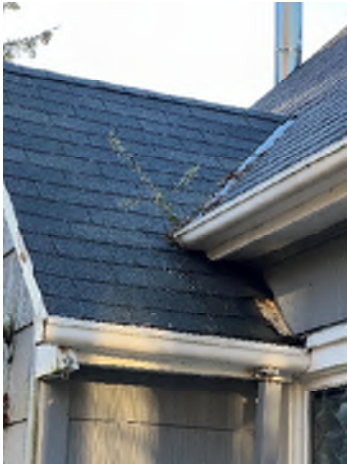
**Figure 3-3.** Plant Growth Indicates Build-up in Gutter.

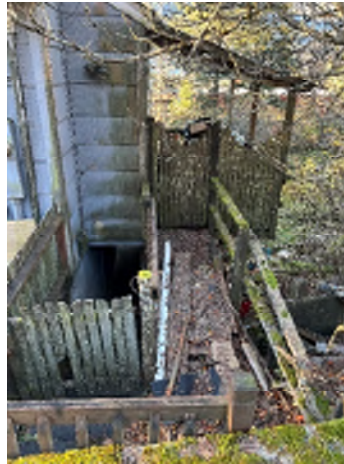
**Figure 3-4.** Rotten Gates, Railings, and Deck Framing Pose a Safety Hazard and Should Not Be Used.

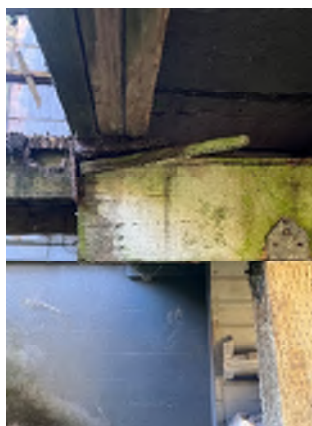
**Figure 3-6.** The Beam Supporting the Deck Is Shimmed Likely Due to Rot. No connection exists between the beam to deck framing.

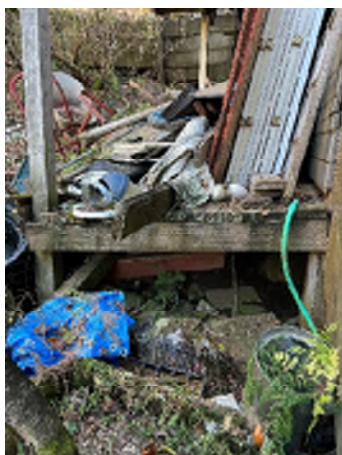
**Figure 3-7.** Moss and Rot on the Deck.

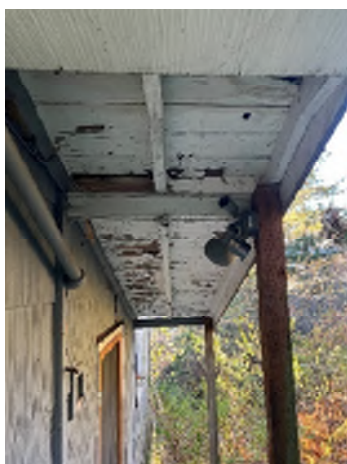
**Figure 3-9.** Peeling Paint and Fixtures Missing Bulbs; Open Fixtures or Exposed Wiring Can Be Hazardous.

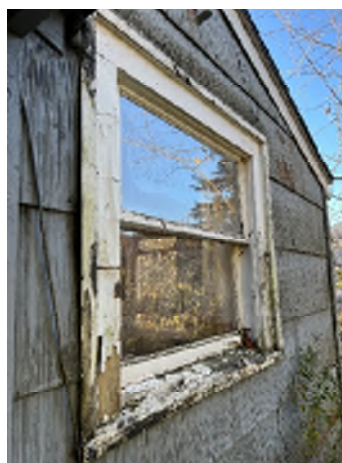
**Figure 3-10.** Rotten Windowsill and Siding in Poor Condition.

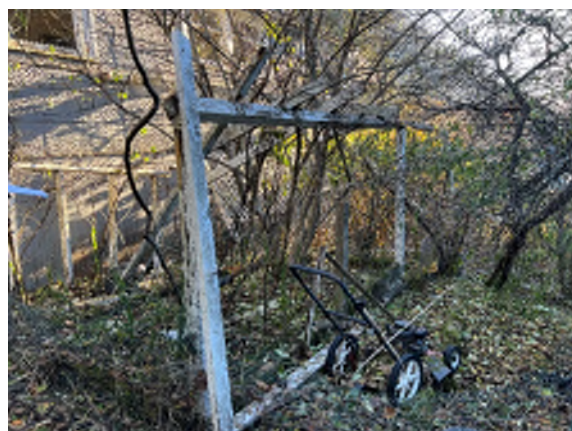
**Figure 3-12.** The Collapsed Greenhouse.

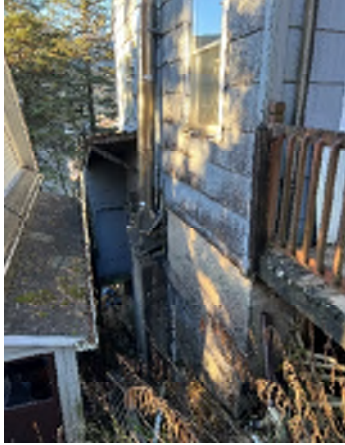
**Figure 3-13.** South Side of the Building and Rotten Deck.

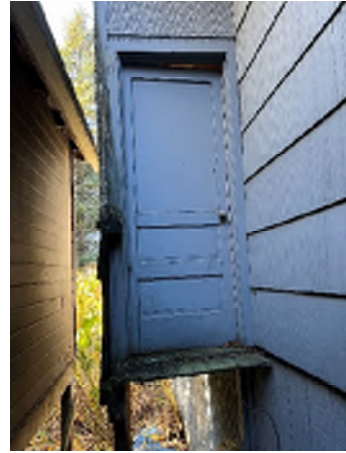
**Figure 3-14.** A Door Without Stairs Approximately 6 Feet Above the Ground. Some of the framing around the door is rotten.

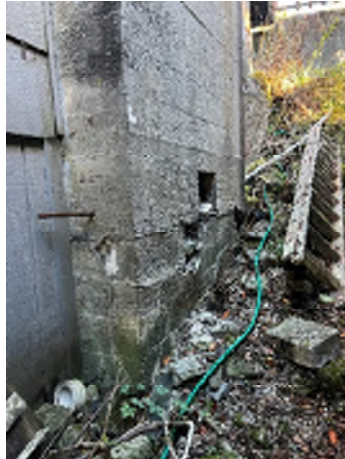
**Figure 3-15.** Failed Chimney Foundation Wall. Collapse Hazard.

Buildings constructed in the early 1900s do not have the same standards for code minimums that we do today. Reinforcement in the concrete walls is unlikely; if it does exist, it most likely does not meet current minimum standards. No reinforcements were observed where the wall was cracked and had shifted. Both the chimney and building foundation walls have cracked, settled, and failed.

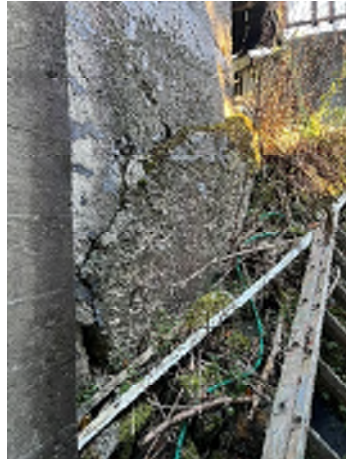
**Figure 3-16.** Cracked Concrete Wall/ Failed Foundation, Possibly From Flexure and Shifting. No reinforcement was observed. Collapse Hazard.

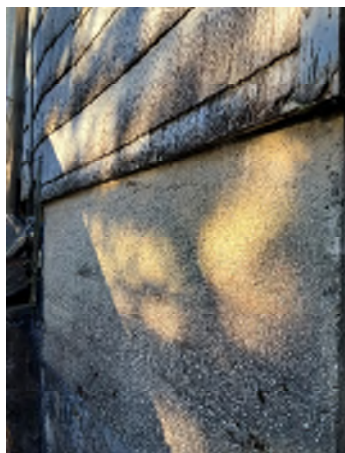
**Figure 3-17.** Long Crack at the Top of the Wall.

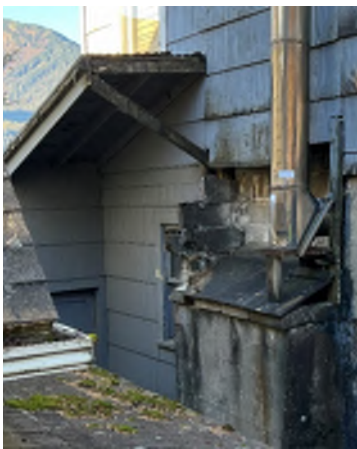
**Figure 3-18.** Concrete Blocks Not Adequately Secured. The new stack is partially supported on a rotten piece of plywood.

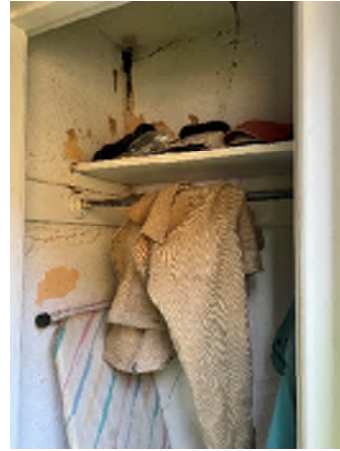
**Figure 3-20.** Significant Sheetrock Damage in the Closet.

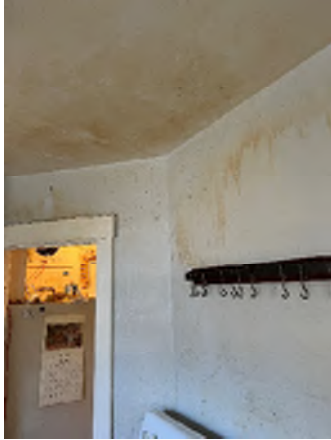
**Figure 3-25.** A Significant Amount of Discoloration on the Sheetrock Above the Stove in the Kitchen, Water Damage.

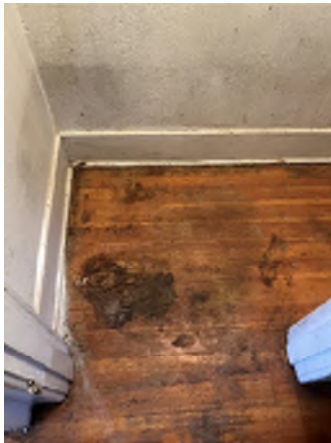
**Figure 3-27.** Floor Damage.

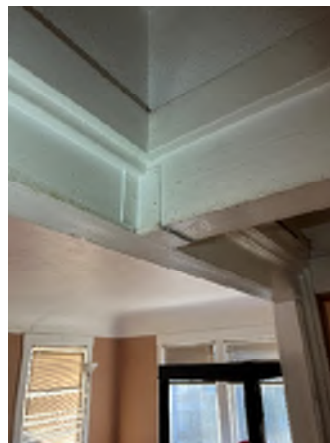
**Figure 3-30.** A Beam Hanger Observed at the Framing Near the Stair Opening.

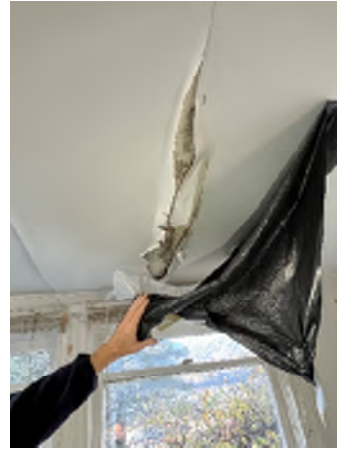
**Figure 3-32.** More Damage From a Roof Leak Under the Bag.

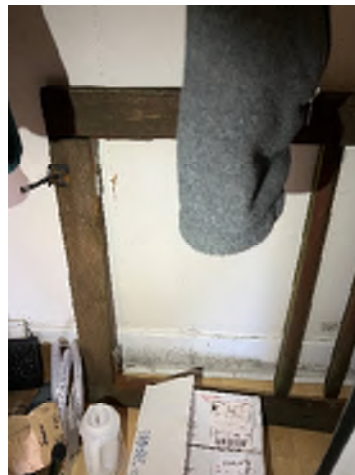
**Figure 3-36.** Sheetrock Crack in the Closet and Mold on the Baseboard.

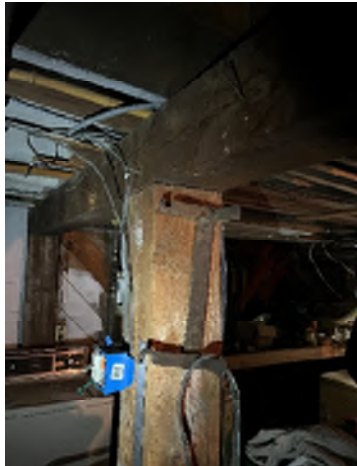
**Figure 3-37.** No Hardware Providing Connections from the Columns to Beam Above.

The lateral force resisting system is inadequate. The observed columns are sitting directly on the slab without connecting to the concrete. The top of the columns may or may not be toe-nailed to the beam it is supporting. During an earthquake, posts can shift from under the beam they are supporting without positive connections. While the building has stood since 1935, its shear walls would not meet current seismic demands. In general, the lateral load path is lacking proper seismic detailing, including connections, between the roof and floor diaphragms to the shear walls and the foundation.

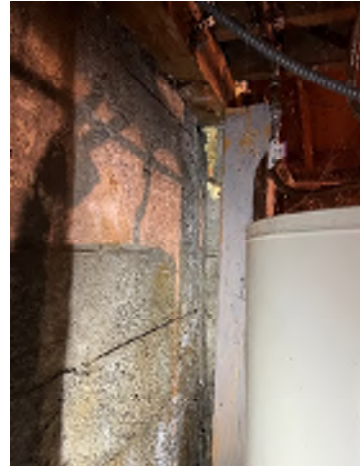
**Figure 3-38.** No Positive Connection From this Column to the Beam Above and the Column Has Shifted.

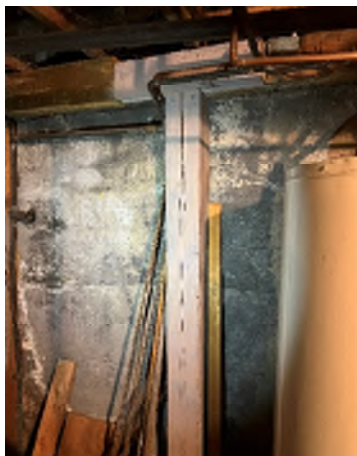
**Figure 3-39.** Significant Checking in this Column.

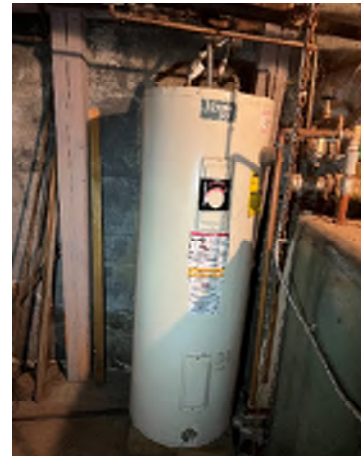
**Figure 3-40.** No Seismic Strapping Around the Water Heater.

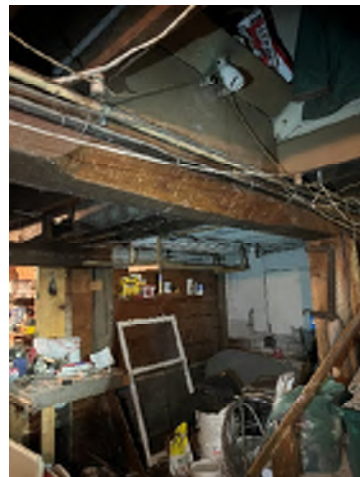
**Figure 3-42.** Notched Large Beam at the Bottom of the Stairs to prevent head injury.

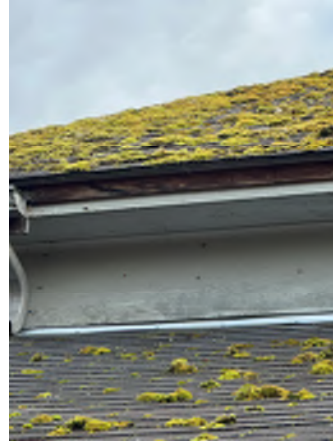
**Figure 4-2.** Exposed, Rotting Wood on the Eave.

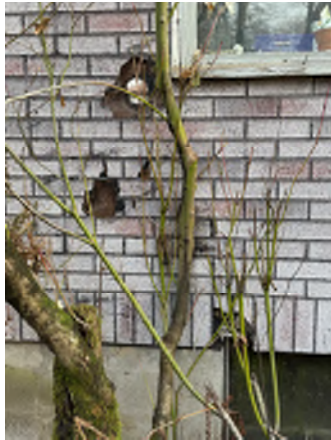
**Figure 4-3.** Holes in the Siding.

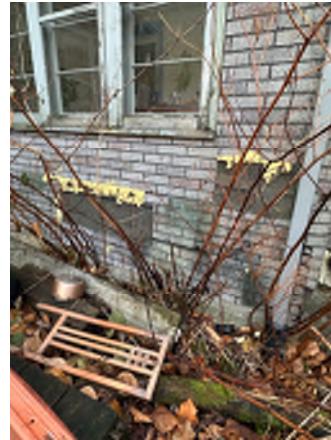
**Figure 4-4.** Siding Replaced With Roof Shingles and Spray Foam.

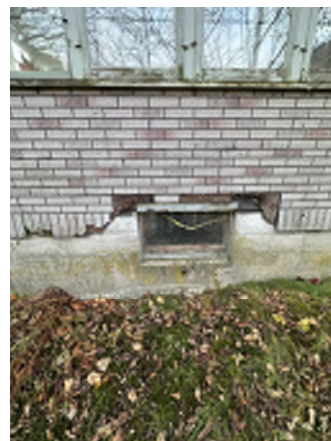
**Figure 4-6.** Deteriorated Siding and Windowsills.

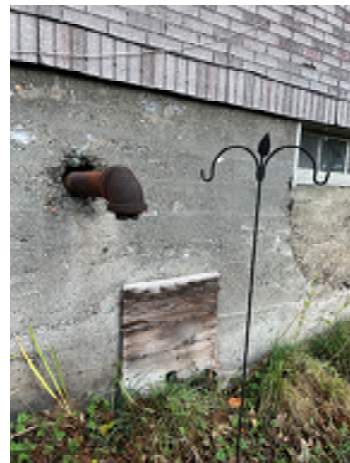
**Figure 4-10.** Large Hole Where Pipe Exits the Basement and Cracking Between the Different Concrete Pours Under Window.

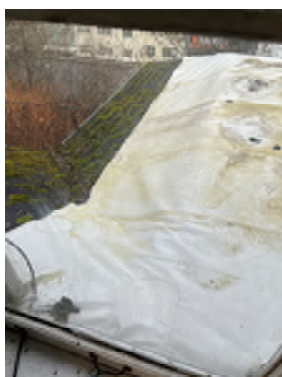
**Figure 4-11.** Tarp Covering the East Roof. There are known leak issues at the interface of the lower roof and wall.

This building is in poor condition. The roof is covered in moss and has a tarp on the east and west low roofs in an attempt to prevent water leaks. The siding has deteriorated and is missing in some locations. The exterior windowsills are deteriorating and rotten. The windows and window frames are in rough condition; many of them have blue tape around the interior to prevent drafts in the winter. In the interior, many finishes are stained, bubbled, or peeling from leaks and water damage at different times. It is unknown if the leaks have caused mold to grow in the wall cavities or rot to the structural members, without removing finishes to inspect. The rafters in the attic spaces show signs of water damage, and in some locations, the rafter members had been cut, which increases the loads to the surrounding members. The rafter members are under designed for current snow loads and likely the only reason they have not collapsed is because the heat from the building melts the snow during the winter, so it never builds up.

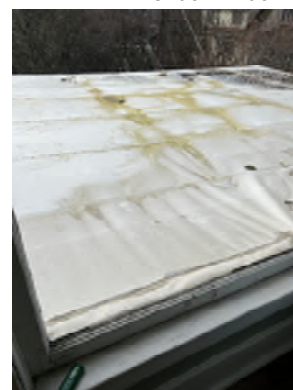
**Figure 4-12.** Tarp Covering the West Roof.

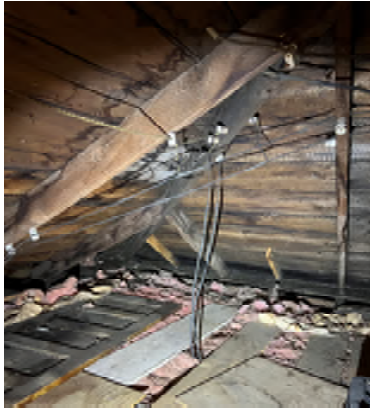
**Figure 4-13.** Cut Rafter Member and Extensive Water Damage From Past Events.

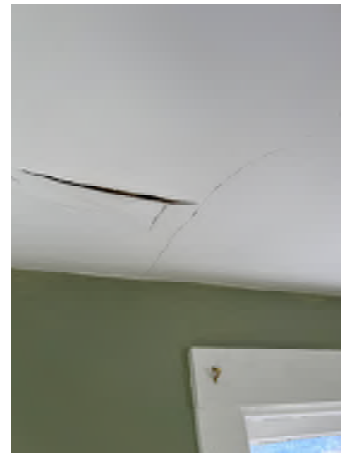
**Figure 4-16.** Cracked Sheetrock and Peeling Paint on the Ceiling.

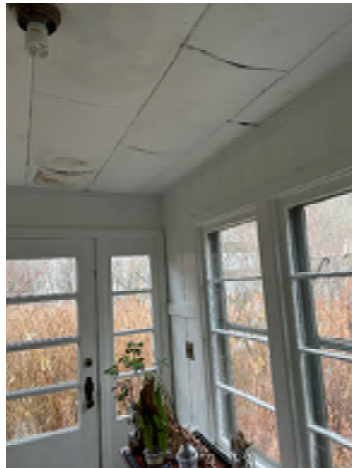
**Figure 4-21.** Sagging Ceiling and Signs of Water Damage in the East Entryway.

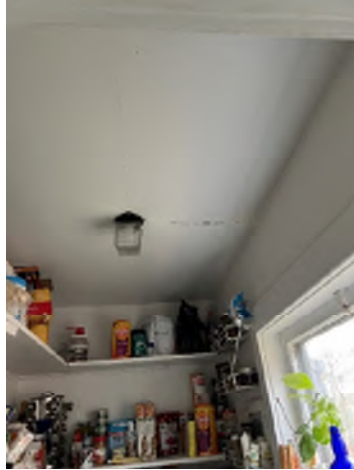
**Figure 4-25.** Sheetrock Cracks at Panel Edges.

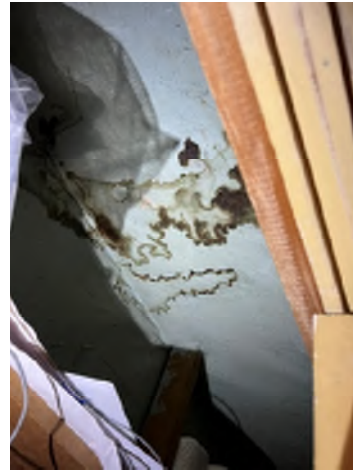
**Figure 4-26.** Staining on Ceiling.

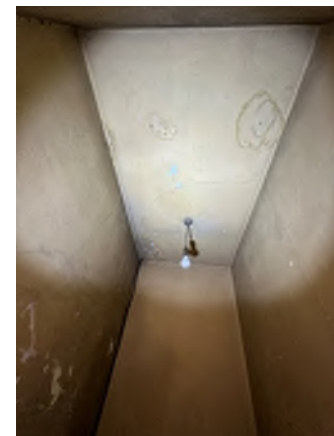
**Figure 4-30.** Cracking on the Ceilings and Walls and Signs of Water Damage.

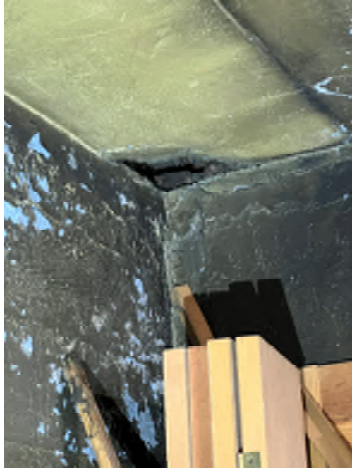
**Figure 4-31.** Deteriorated Ceiling.

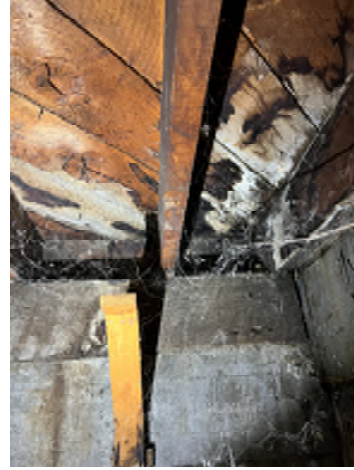
**Figure 4-32.** Rotting Floorboards.

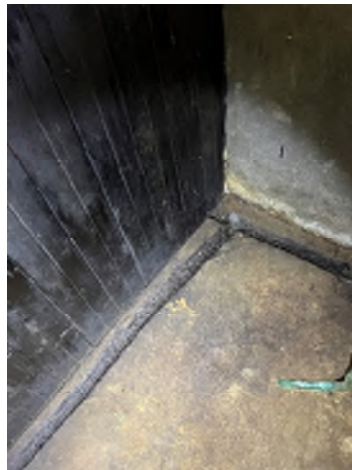
**Figure 4-33.** Trench Around the Perimeter for Water Flow.

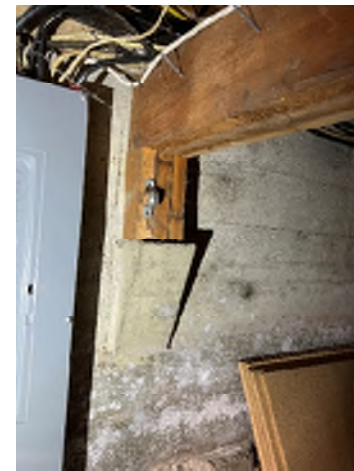
**Figure 4-34.** Nonstandard Beam Support.

The lateral resisting system is inadequate. The columns observed in the basement sit directly on the slab/pilasters without connection to the concrete. The top of the columns may or may not be toe-nailed to the beam it supports. In a seismic event, posts can shift from under the beam they are supporting without positive connections. While the building has stood since 1882, its shear walls would not meet current seismic demands. In general, the lateral load path is lacking proper seismic detailing, including connections, between the roof and floor diaphragms to the shear walls and the foundation. Multiple additions over the years could have unforeseen seismic defects.

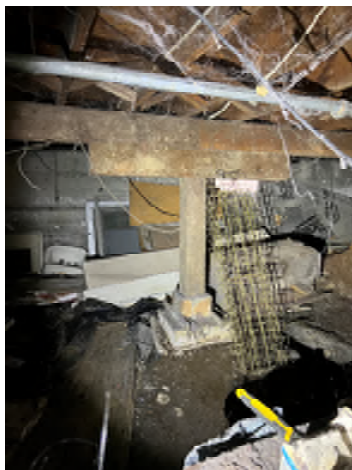
**Figure 4-35.** Column Sitting Directly on the Foundation With No Positive Connection to the Concrete or to the Beam.

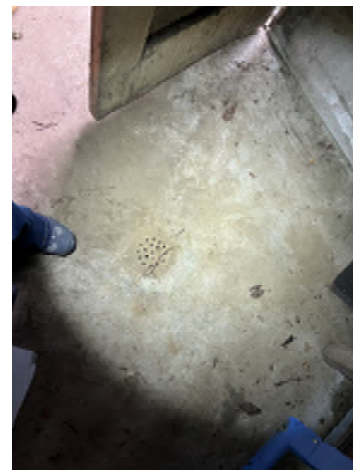
**Figure 4-36.** Drain Leads Directly Under the Foundation, Potentially Undermining the Foundation.

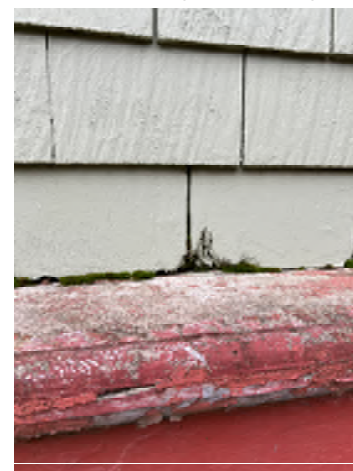
**Figure 5-4.** Deteriorated Siding With Moss Growing in the Gaps.

This building has some deterioration. The roof is covered in moss except for the recently replaced peak. The siding has moss growing in some of the gaps. The deck and stairs at the northeast corner of the building are rotten and have become dangerous. The columns supporting the stair and deck framing do not have positive connections at the base or to the beam its supporting. The exterior of the concrete basement walls have cracking spanning significant lengths. The roof members have watermarks, most likely from past water infiltration before the roof peak was replaced. The roof rafters / site built trusses are under designed for current snow loads and likely the only reason they have not collapsed is because the heat from the building melts the snow during the winter, so it never builds up. Cracked drywall and signs of water damage exist throughout the building. A particular area of concern is the watermarks on the ceiling around many of the light fixtures. If the light fixtures consistently experience water infiltration, the wiring may corrode and create a fire hazard.

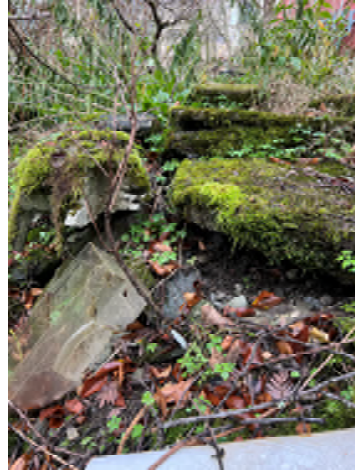
**Figure 5-8.** Undermined Walkway on the West Side of the Building.

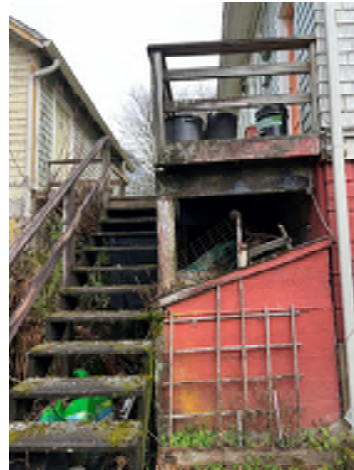
**Figure 5-10.** Rotted Deck and Stairs. Deck posts are not anchored and have no positive connection to joists.

current standards and a framing and seismic retrofit could be performed. Rotten members could be replaced, foundation cracks could be patched, and deteriorated finishes could be replaced. At a minimum, the exterior wood stairs should be demolished and rebuilt to prevent an injury, and the home needs to be retrofitted. Unless the building is saved as a historic building, it is likely not economically feasible for CBJ to own or rent the property.

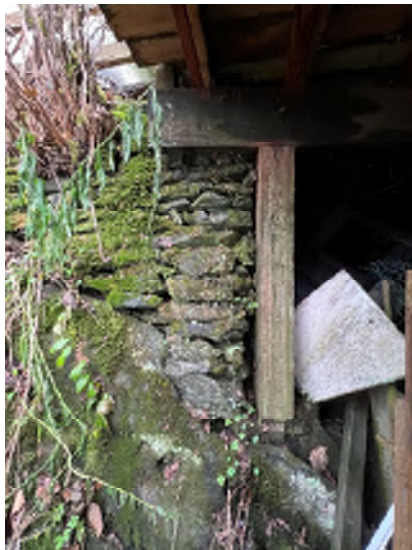
**Figure 5-11.** Column is Sitting on a Rock.

The lateral force resisting system is inadequate. The observed columns are sitting directly on the slab/rock without connection to the concrete. The top of the columns may or may not be toe-nailed to the beam it is supporting. In a seismic event, posts can shift from under the beam they are supporting without positive connections. While the building has stood since 1913, its shear walls would not meet current seismic demands. In general, the lateral load path is lacking proper seismic detailing, including connections, between the roof and floor diaphragms to the shear walls and the foundation.

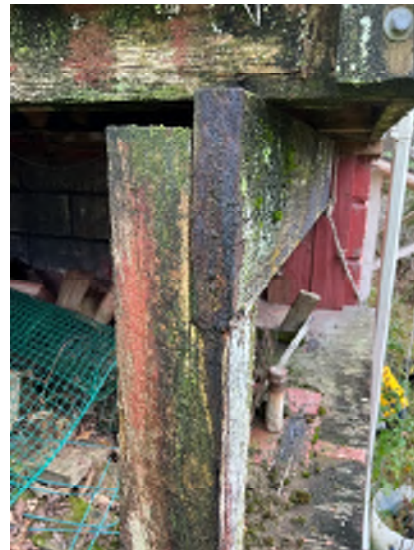
**Figure 5-12.** Rotten Beam Support and Deck.

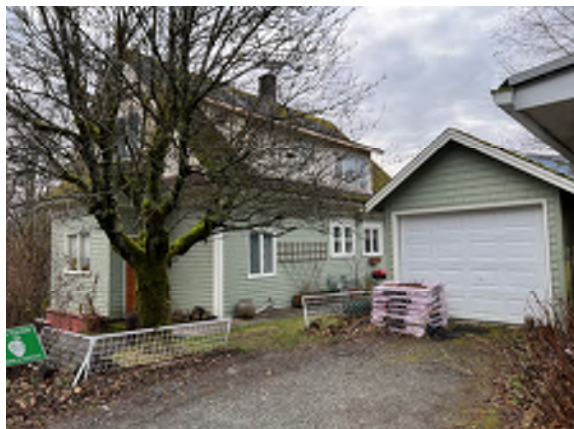
**Figure 5-13.** North Side of the Building. No Shear Wall / Lateral System on Front on Garage.

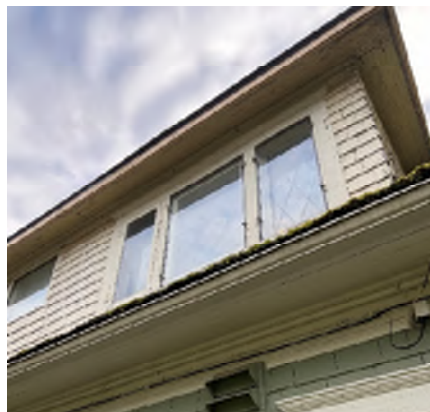
**Figure 5-14.** Moss on the Roof and Peeling Paint on the Eave.

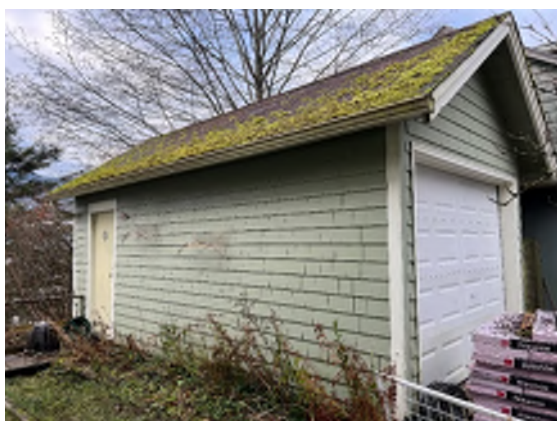
**Figure 5-15.** South Side of Garage. Moss on the roof.

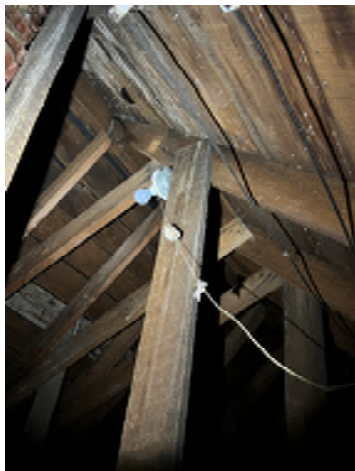
**Figure 5-19.** Indications of Water Damage on the Roof Rafters.

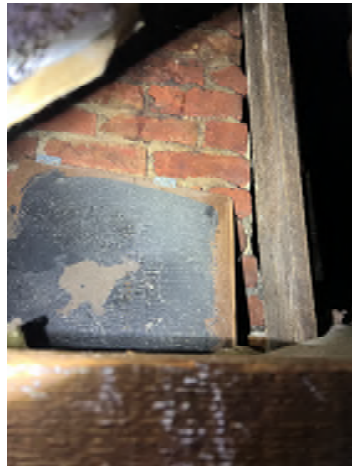
**Figure 5-20.** Deteriorating Chimney.

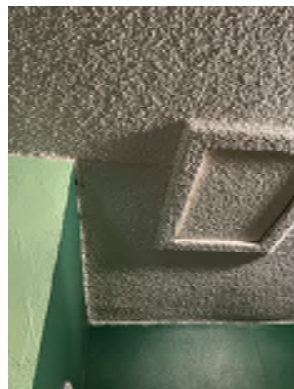
**Figure 5-22.** Cracked Ceiling Drywall.

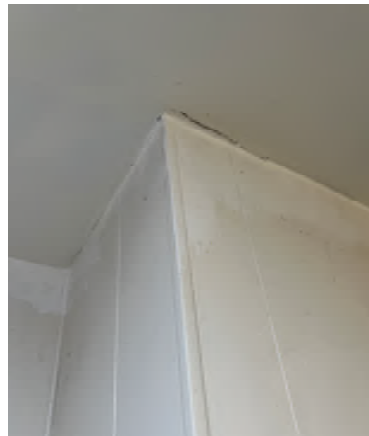
**Figure 5-24.** Continuous Ceiling Crack Around a Corner.

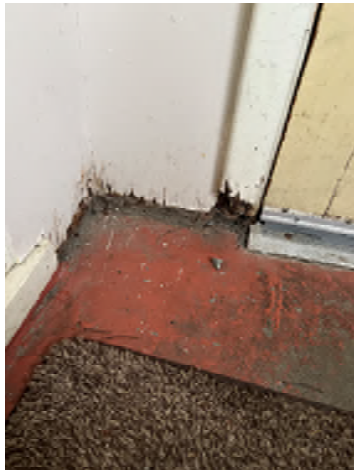
**Figure 5-25.** Rotting Wood Next to the Entryway Door.

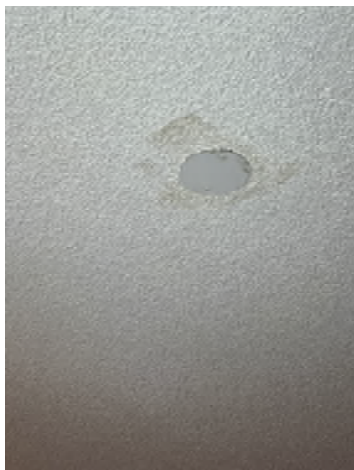
**Figure 5-27.** Water Damage Around Light Wiring Cover.

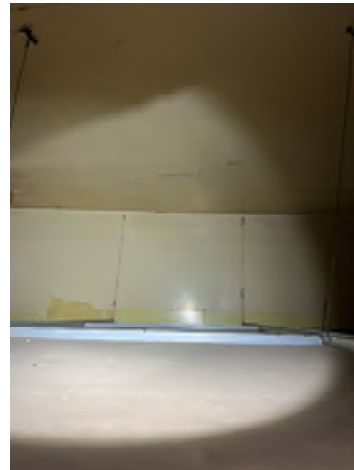
**Figure 5-28.** Cracks in the Ceiling Above the Dropped Ceiling in the Kitchen.

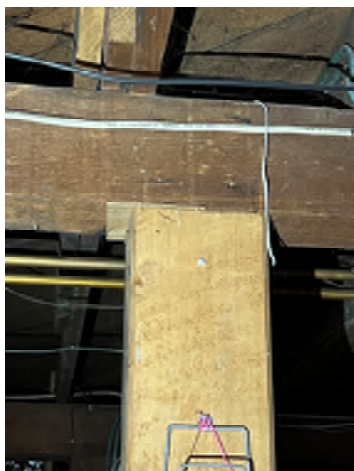
**Figure 5-29.** Shimmed Column With No Positive Connection to the Beam.

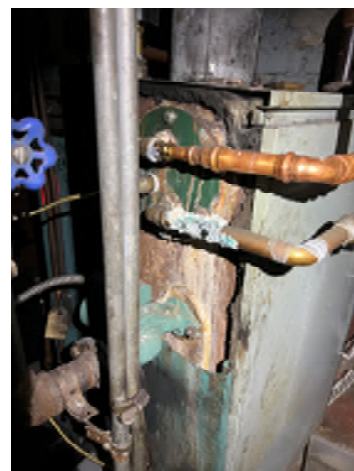
**Figure 5-30.** Significant Corrosion on the Boiler.

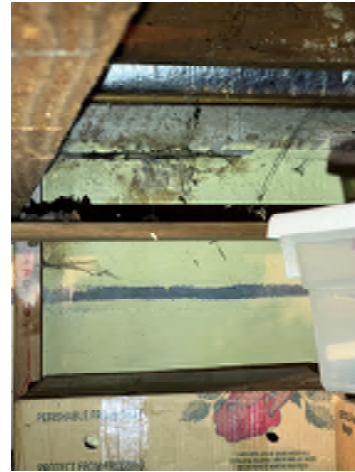
**Figure 5-32.** Large Crack on the Interior of the Concrete Basement Wall.

The interior of the concrete basement wall has significant cracking in a few locations, and watermarks indicate previous water infiltration. Buildings constructed in the early 1900s do not have the same standards for code minimums that we do today. Reinforcement in the concrete walls or slab is unlikely; if it does exist, it most likely does not meet current minimum standards.

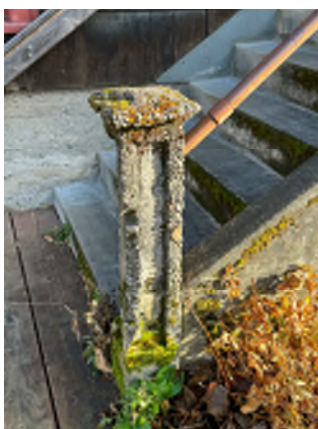
**Figure 6-3.** Damaged Concrete Post.

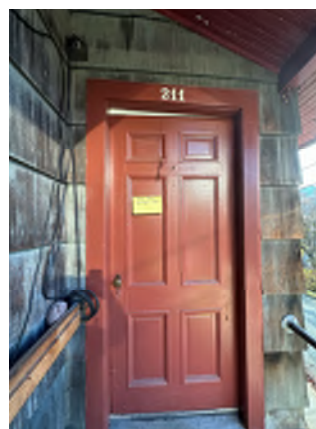
**Figure 6-4.** Large Gap Between the Door and Doorframe.

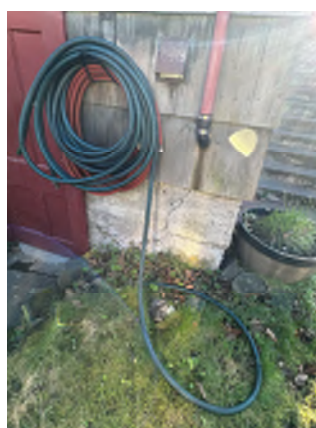
**Figure 6-6.** Cracking in the Concrete Foundation at the Northeast Corner of the Building.

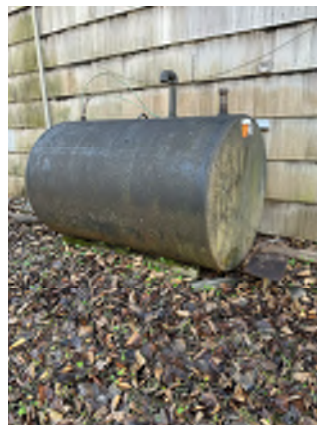
**Figure 6-8.** Fuel Tank Is Not Seismically Anchored.

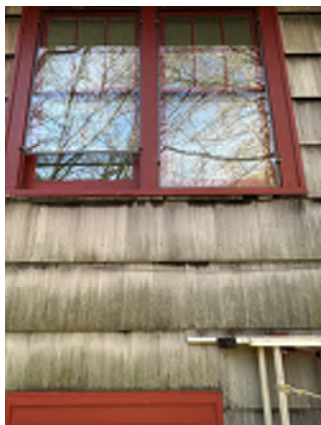
**Figure 6-9.** Deteriorating Window Sill.

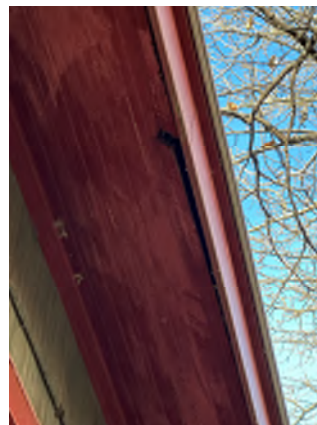
**Figure 6-10.** Damaged Eave.

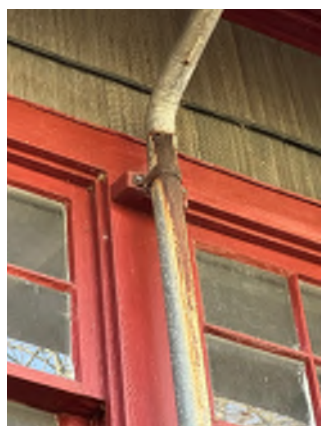
**Figure 6-11.** Drainpipe Is Rusted.

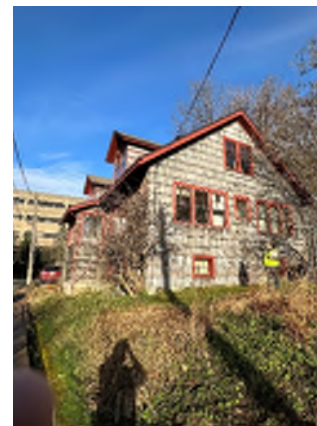
**Figure 6-12.** South Side of the Building.

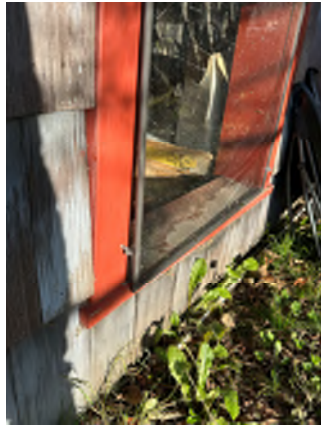
**Figure 6-13.** Gap in the Storm Window.

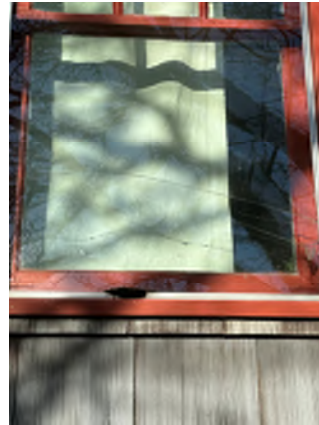
**Figure 6-14.** Crack in the Storm Window.

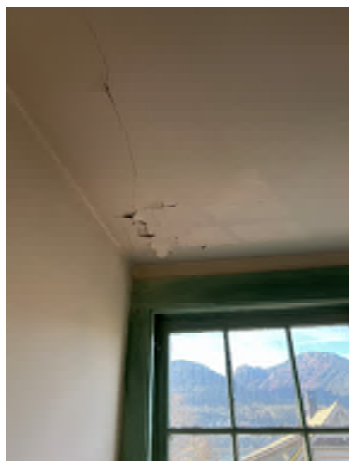
**Figure 6-17.** Cracking and Peeling Paint on the Ceiling.

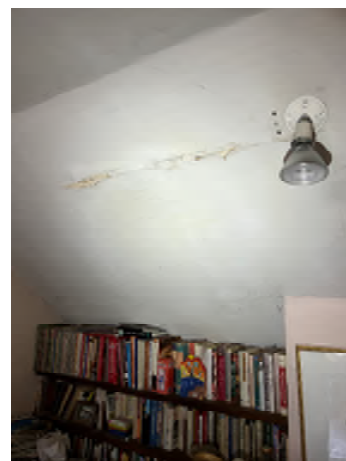
**Figure 6-18.** Cracking and Indications of Water Damage on the Ceiling.

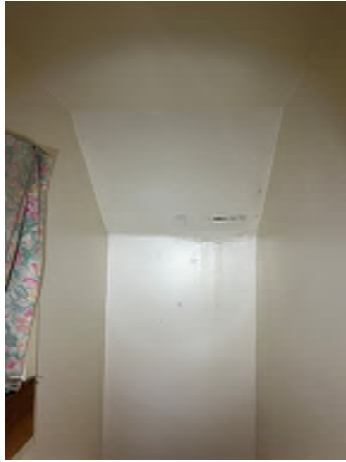
**Figure 6-19.** Cracking and Water Damage Indications Above the Stairs.

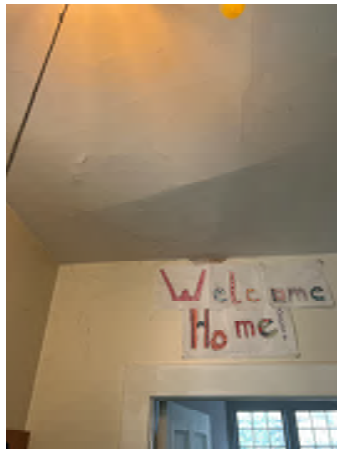
**Figure 6-20.** Cracked Drywall and Drooping Ceiling.

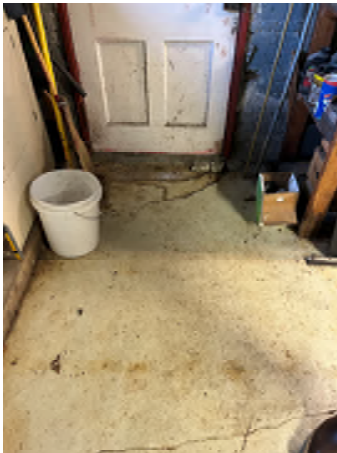
**Figure 6-22.** Cracked Slab-on-Grade at the North Basement Entrance.

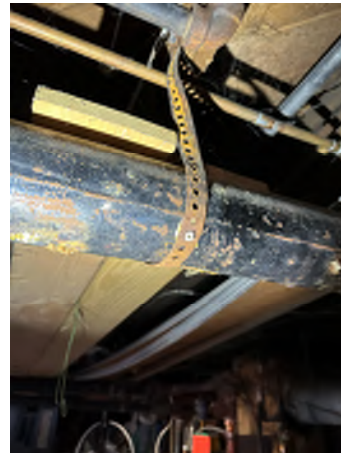
**Figure 6-23.** Rusty Strap.

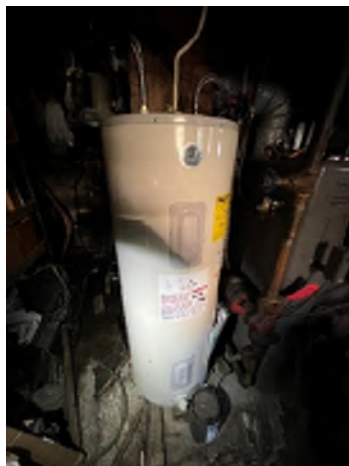
**Figure 6-26.** No Seismic Strapping on the Water Heater.
