## **Historic Resources Advisory Committee Agenda**

February 22, 2024 at 5:00pm

# STRUCTURAL CONDITION SURVEYS

Project Number I1817.23001; RSI-3411

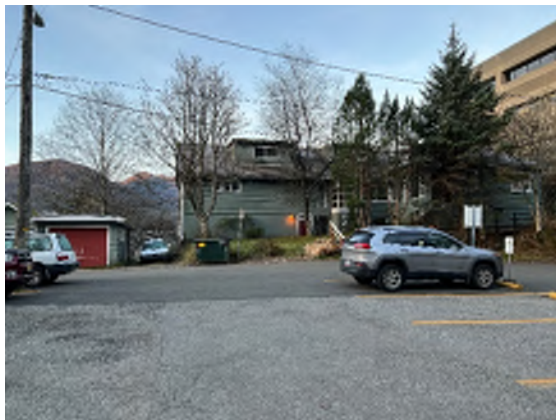
**Figure 7-1.** East Side of the Building.

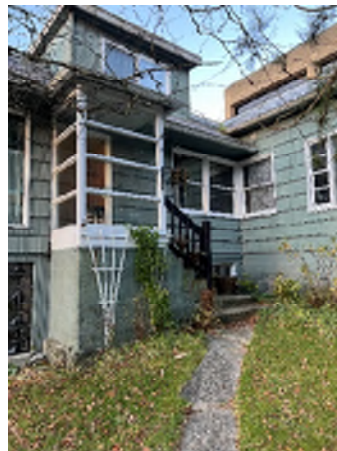
**Figure 7-2.** There Is Some Deterioration to the Exterior, Including a Cracked Window and Spalled Concrete.

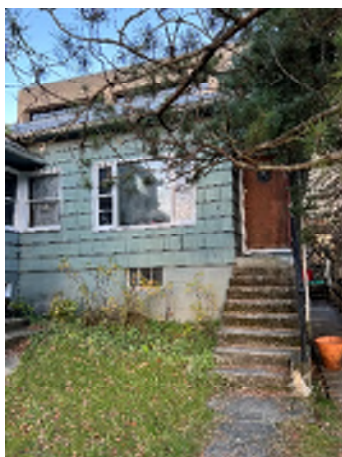
**Figure 7-3.** Moss on the Concrete Stairs.

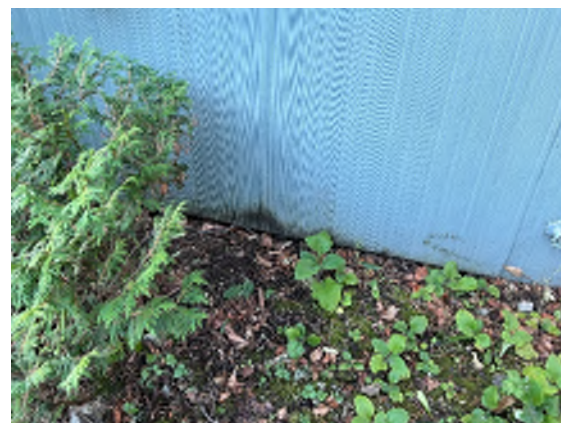
**Figure 7-4.** Soft Wood at the Base of the Siding.

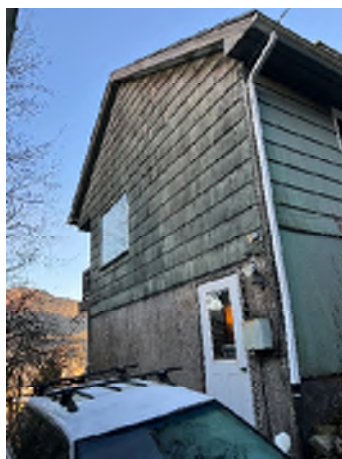
**Figure 7-5.** South Side of the Building.

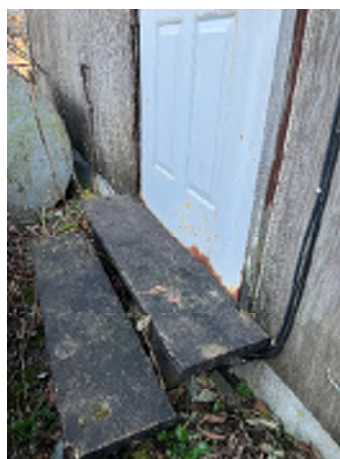
**Figure 7-6.** Unprotected Plywood Sheathing by the Siding and Rust Around the Man Door.

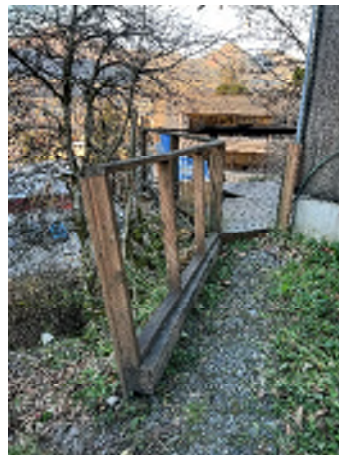
**Figure 7-8.** Leaning Handrails.

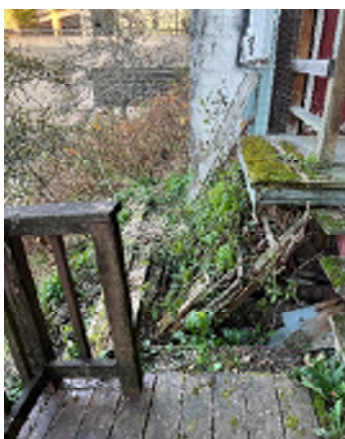
**Figure 7-11.** Moss on the Stair Landing and a Pile of Wood on the Ground.

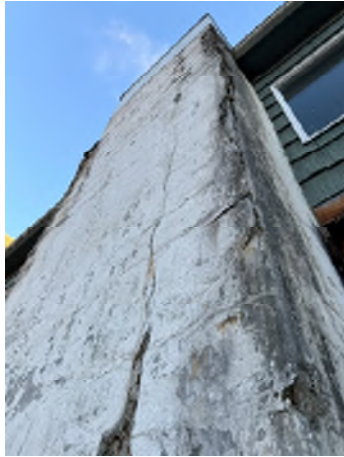
**Figure 7-13.** A Long Crack Up the Side of the Chimney.

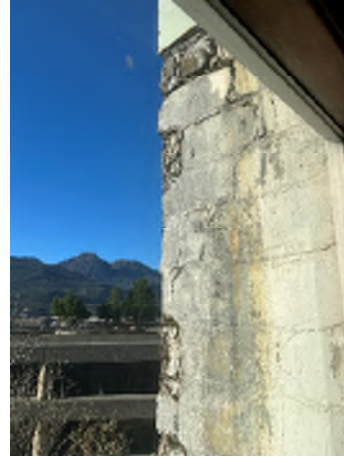
**Figure 7-14.** Concrete Falling Off the Side of the Chimney.

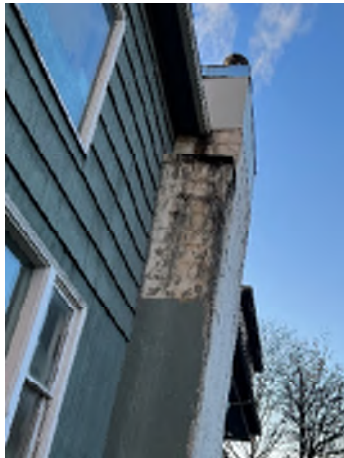
**Figure 7-15.** Water-Stained Chimney With Visible Cracks.

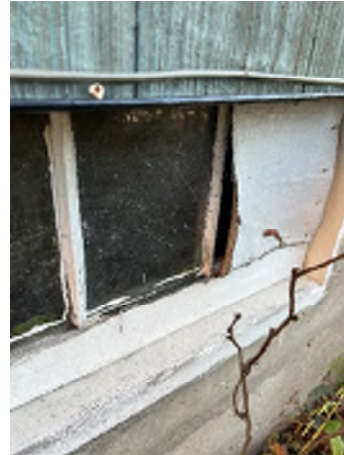
**Figure 7-16.** A Basement Broken Window, Which Is Not Adequately Sealed, That Can Allow Water or Animals Inside.

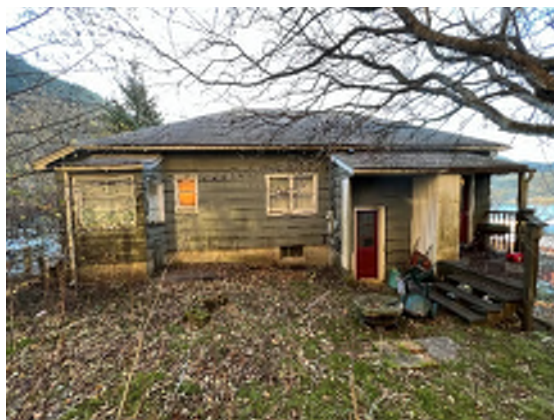
**Figure 7-17.** North Side of the Building.

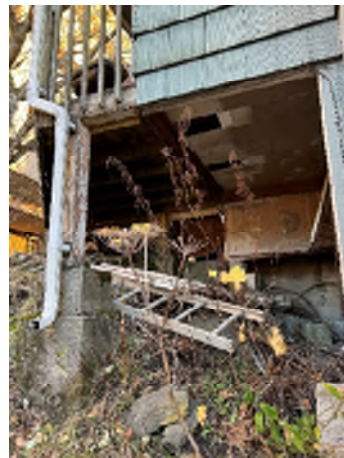
**Figure 7-18.** Missing Soffit Panels. The column is sitting on a concrete pile.

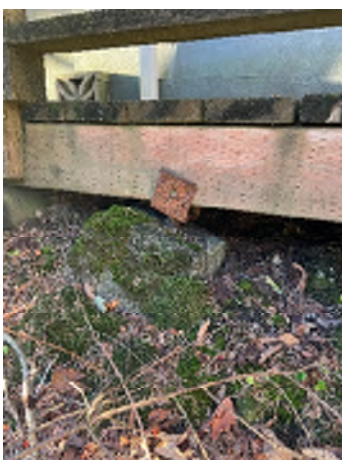
**Figure 7-23.** A Rotated Walkway Support Connector.

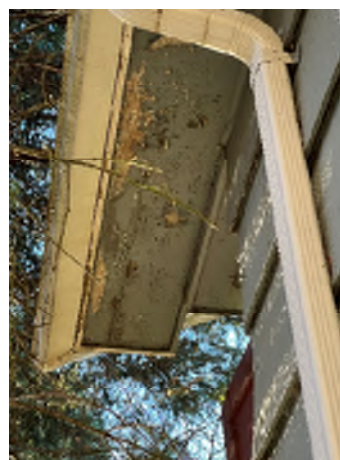
**Figure 7-24.** Deterioration to the Underside of the Eave.

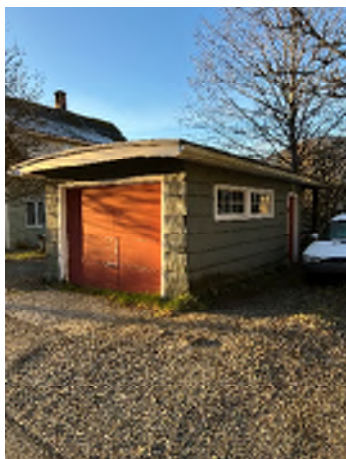
**Figure 7-25.** Garage/Shed on the South Side of the Building. No Lateral System on Front.

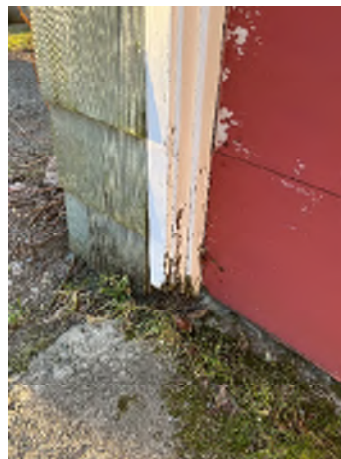
**Figure 7-26.** Rot Near the Ground.

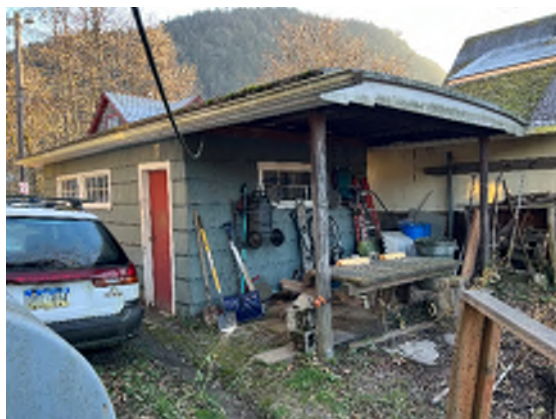
**Figure 7-27.** West Side of the Garage Building.

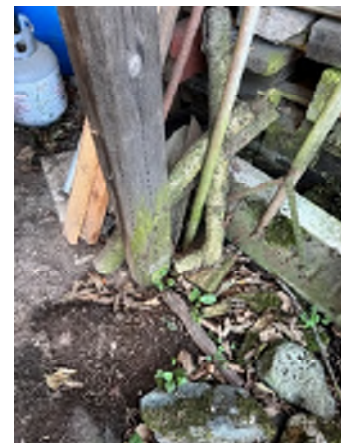
**Figure 7-28.** Moss Growing on Main Column Supports That Are not Pressure Treated. These columns can rot quicker untreated.

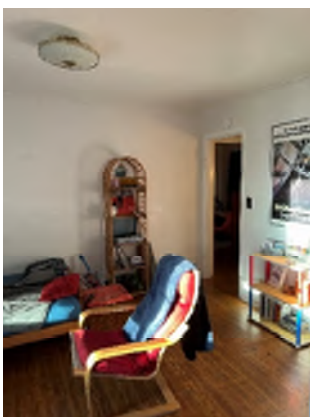
**Figure 7-29.** Small Cracks at the Sheetrock Panel Edges.

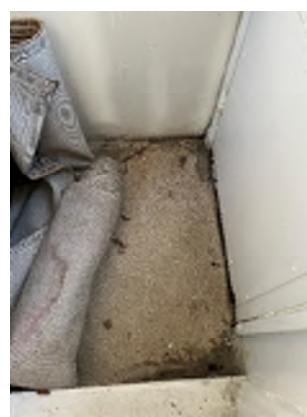
**Figure 7-30.** Moisture Damage and Rot in the Back Entryway.

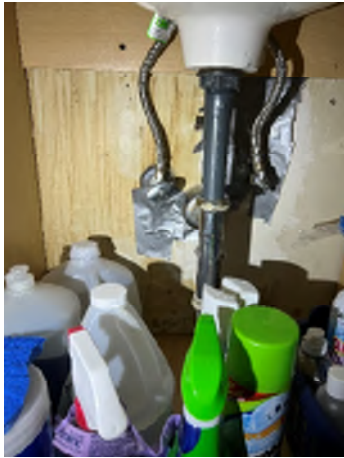
**Figure 7-31.** An Upper-Level Sink Leaked.

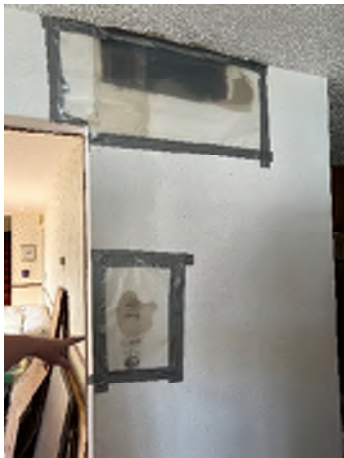
**Figure 7-33.** Damage to the Finishes Caused by the Sink Leak.

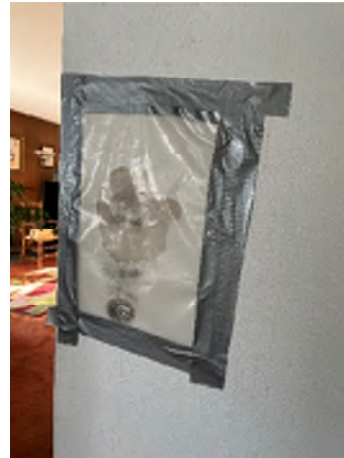
**Figure 7-34.** Mold Is Growing Under the Vapor Barrier. The Extent of Damage in the Wall Cavity Is Unknown.

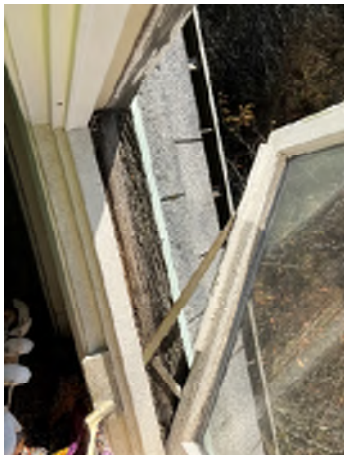
**Figure 7-35.** Rot Under Some Windows.

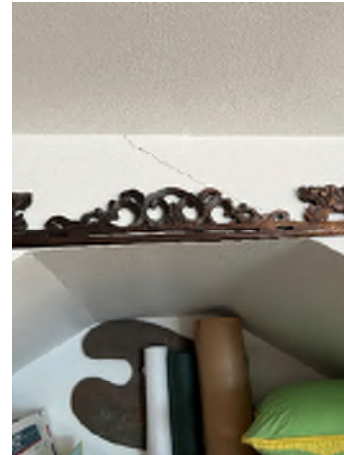
**Figure 7-36.** Sheetrock Cracks Through the Unit.

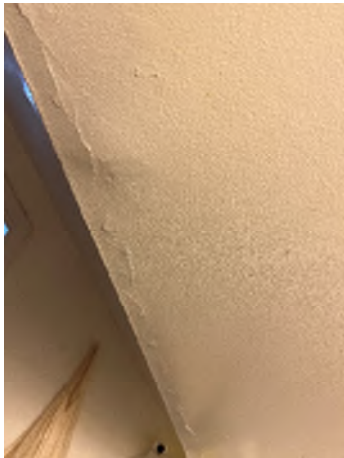
**Figure 7-37.** Paint Is Chipped, and the Sheetrock Fasteners Are Visible in Some Places.

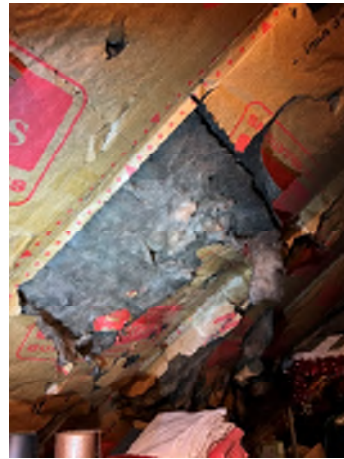
**Figure 7-38.** Paper Came off the Insulation, and the Insulation Corners Are Falling in the Attic Space.

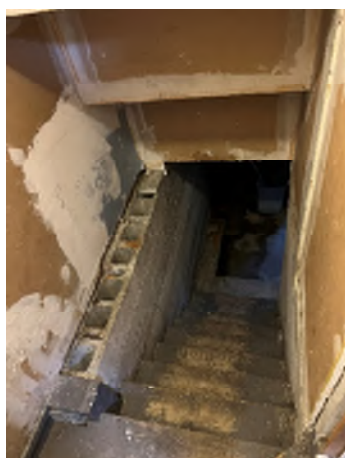
**Figure 7-45.** No Grout Columns Were Observed in the Visible Portion of the Masonry Wall. This wall is likely unreinforced.

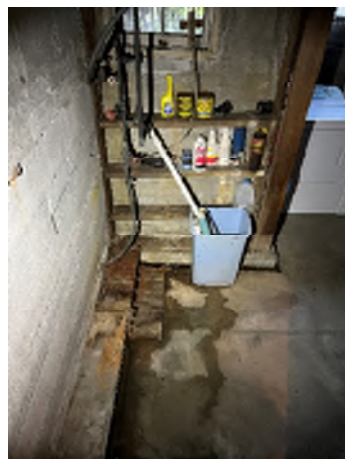
**Figure 7-47.** Multiple Signs of Water on the Basement Floor. There is a small trench for water around the perimeter.

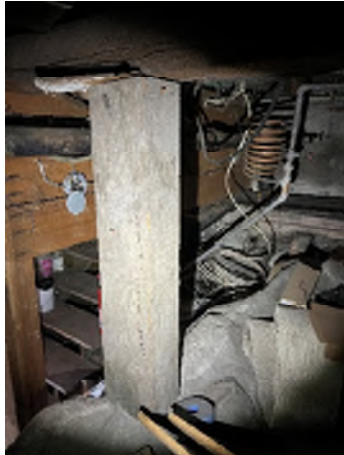
**Figure 7-48.** One Column Is Sitting on the Bedrock With No Connections. There are shims at the top of the column.

The lateral resisting system is inadequate. The observed columns have shims above or below the post. If toe nails exist, they do not reach the beam. In a seismic event, posts can shift from under the beam they are supporting without positive connections. The concrete block wall in the basement likely does not contain reinforcement that meets current minimum standards. While the building has stood since 1947, its shear walls would not meet current seismic demands. In general, the lateral load path is lacking proper seismic detailing, including connections, between the roof and floor diaphragms to the shear walls and the foundation.

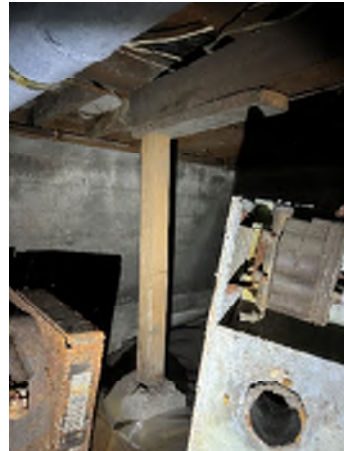
**Figure 7-49.** A Large Shim at the Top of the Column.

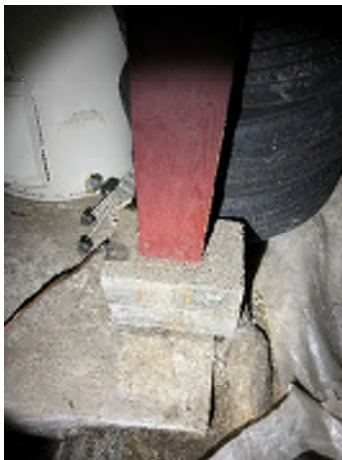
**Figure 7-50.** The Column Is on a Concrete Block That Is Not Sitting Fully on the Concrete Below.

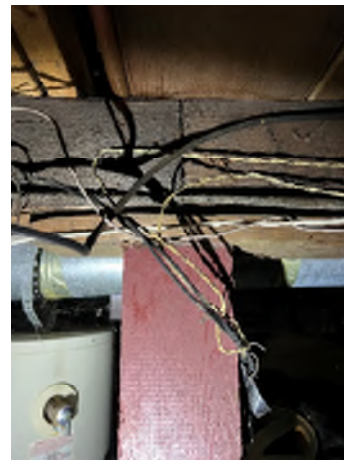
**Figure 7-51.** The Top of the Column Has a Shim. Even if toe-nails were present, it may not reach the beam its supporting.

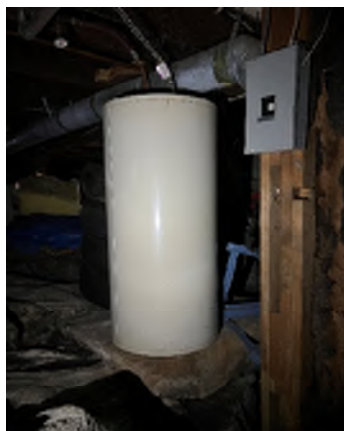
**Figure 7-52.** The Tank Is Not Seismically Secured.

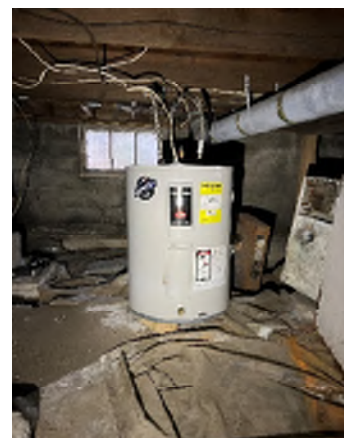
**Figure 7-53.** The Tank Is Not Seismically Secured.

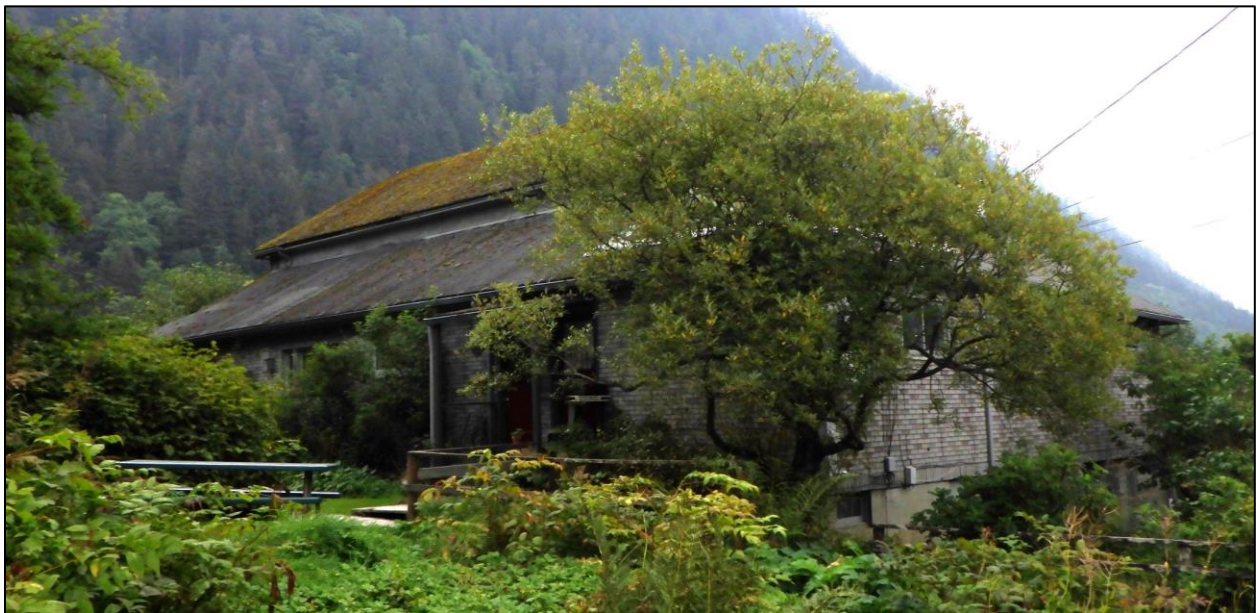
During the 2023 site visit, the Edward Webster House (JUN-00070) (Figure 5) was found to be standing but appeared to have been heavily modified, with modern doors, windows, and siding. The building also appeared to have been divided into apartments. Additional research would be required to determine how much the building has been altered since its period of significance, if it is eligible for listing on the NRHP, and if it is a contributing or non-contributing element to a historic district or districts.

**Figure 5. Looking east from Dixon St. at the Edward Webster House (JUN-00070) in 2023 (NLURA Photograph).**

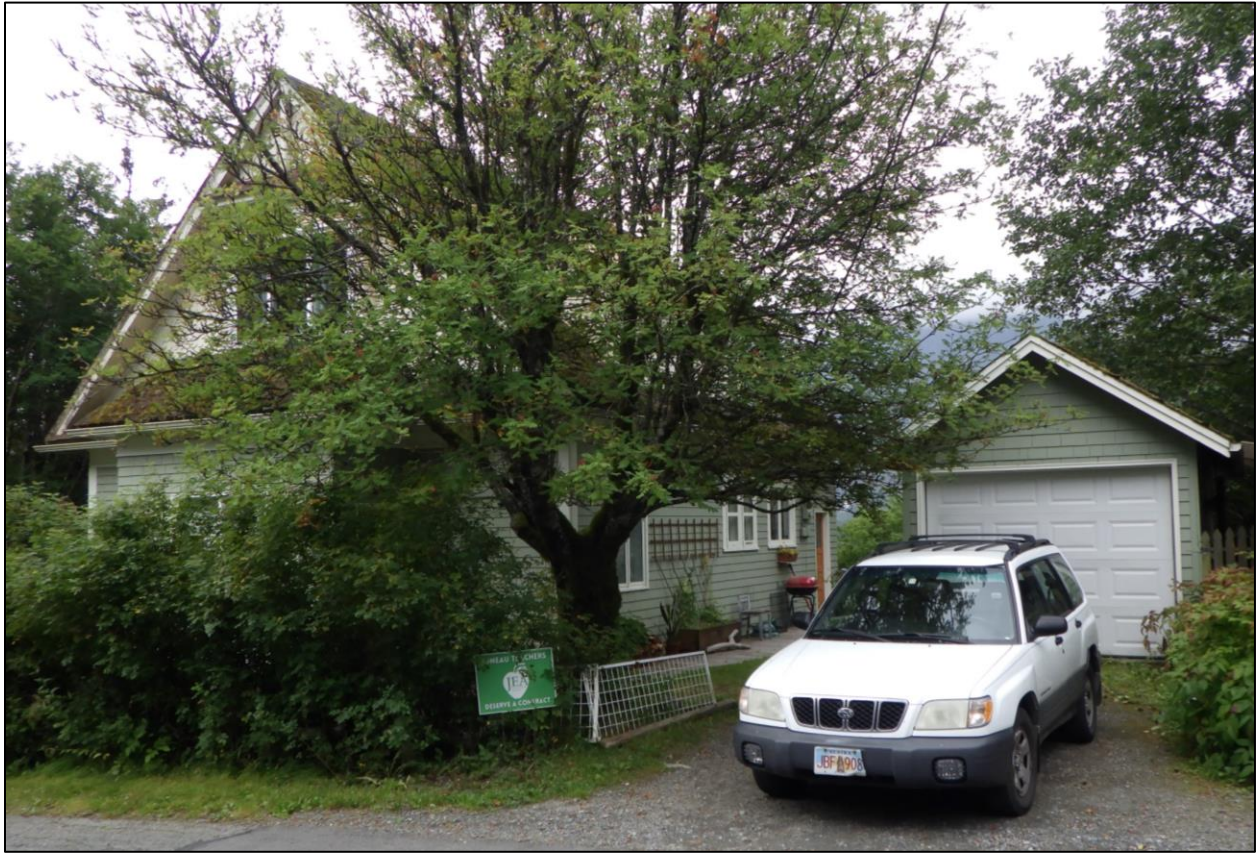
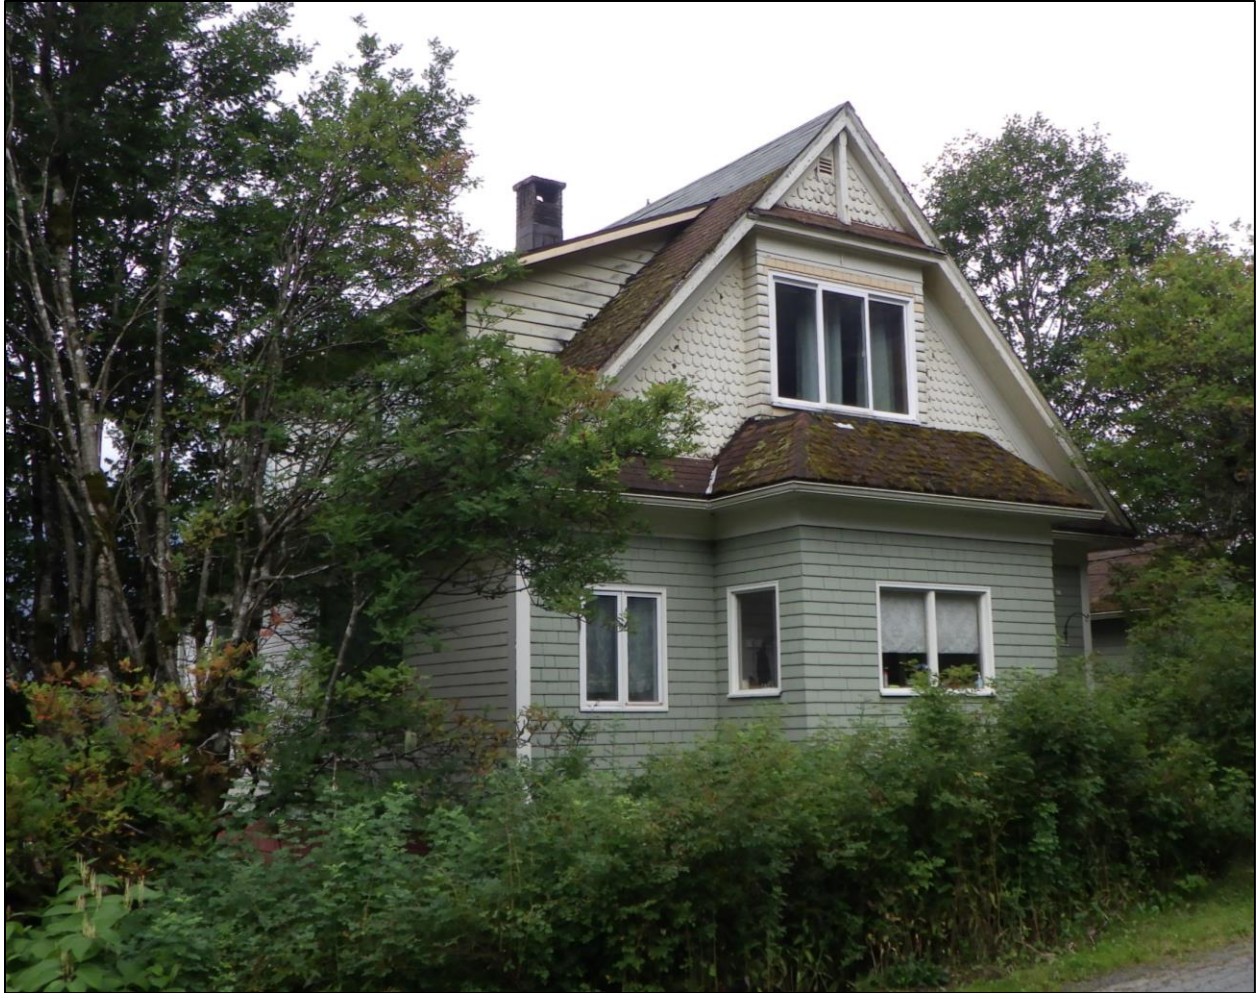
During the 2023 site visit, the Bosch/Carrigan House (JUN-00291) was found to be standing and retained windows, doors, siding, and fenestration consistent with its date of construction. A small garage located on the north side of the house had a modern garage door, but otherwise had an appearance consistent with the age of the house. Additional research would be required to determine how much the building has been altered since its period of significance, if it is eligible for listing on the NRHP, and if it is a contributing or non-contributing element to a historic district or districts.

**Figure 6. Looking southwest from Dixon St. at the Bosch/Carrigan House (JUN-00291).**

**Figure 7. Looking west from Dixon St. at the Bosch/Carrigan House (JUN-00291). Note the Victorian style shingles in the gable end (NLURA photograph).**

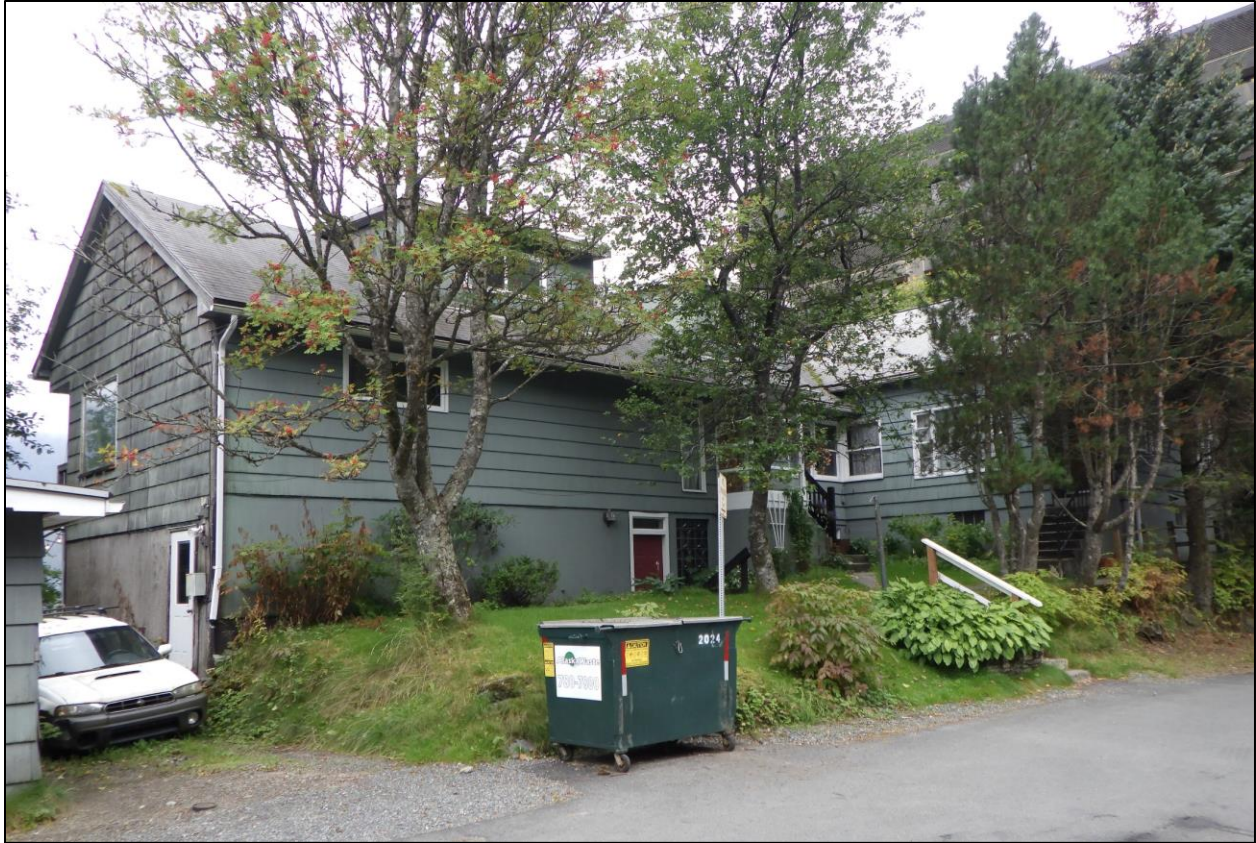
During the 2023 site visit, the Peterson/Kasnick House (JUN-00292) (Figure 8) was found to be standing and retained windows, doors, siding, and fenestration consistent with its date of construction. A small garage (Figure 9) located on the south side of the lot had an appearance consistent with the age of the house. Additional research would be required to determine how much the building has been altered since its period of significance, if it is eligible for listing on the NRHP, and if it is a contributing or non-contributing element to a historic district or districts.

**Figure 8. Looking northwest from Dixon St. at the Peterson/Kasnick House (JUN-00292) (NLURA photograph).**

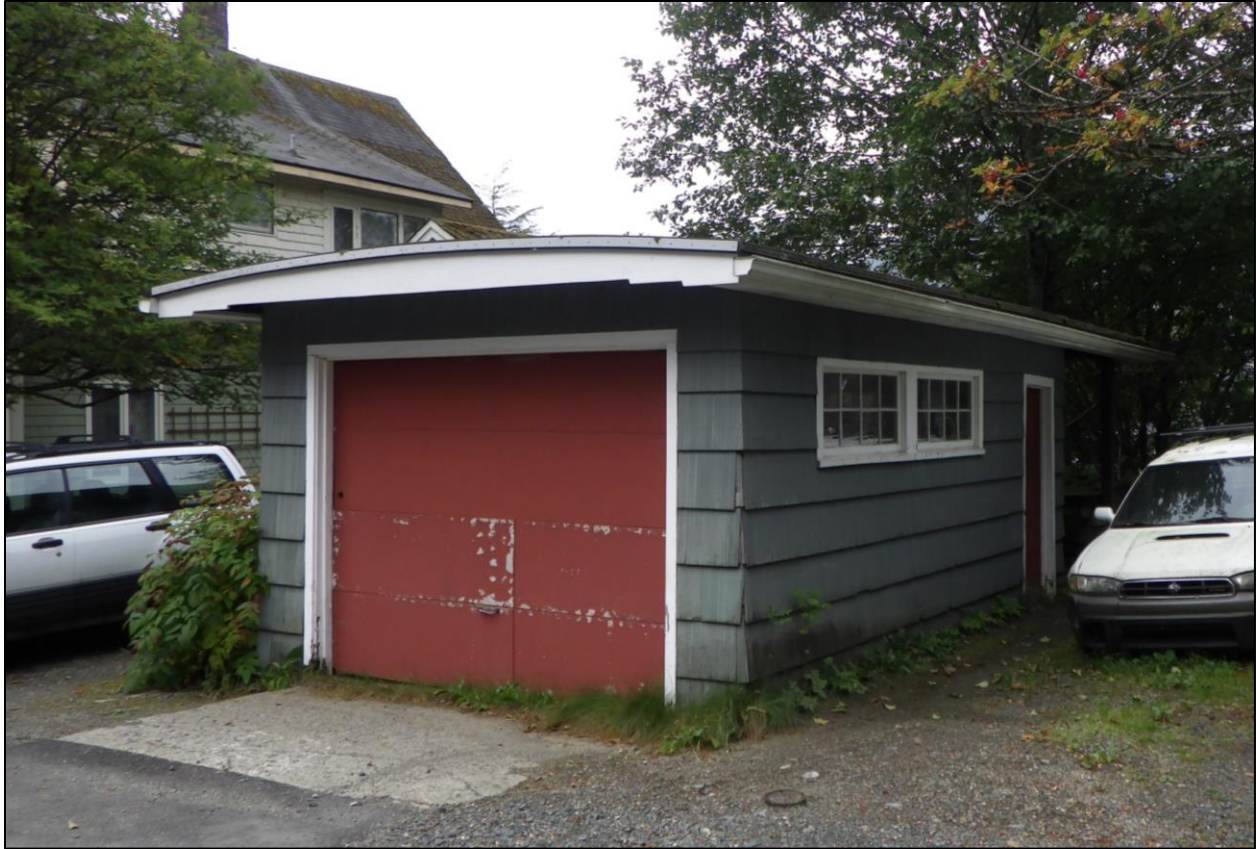
**Figure 9. Looking west from Dixon St. at the garage of the Peterson/Kasnick House (JUN-00292) (NLURA photograph).**

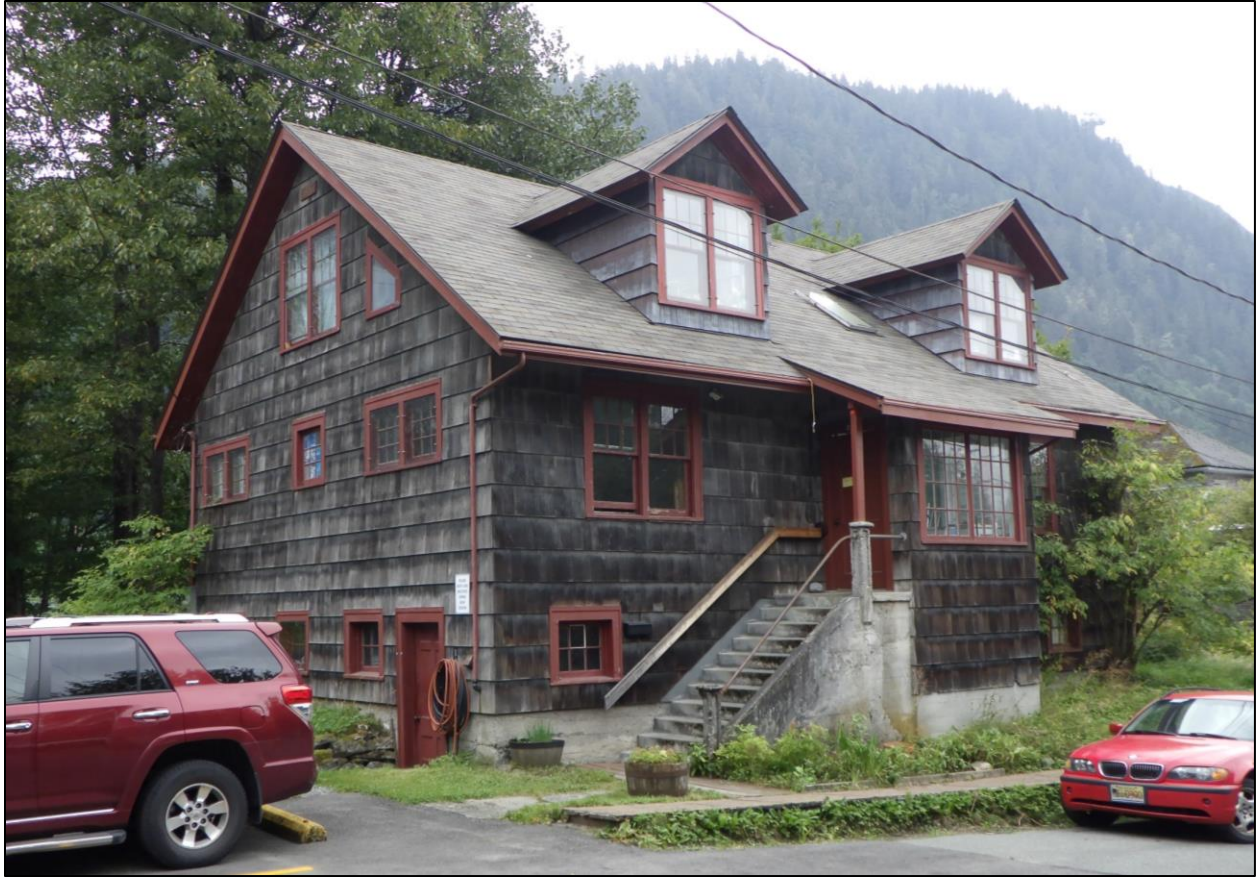
During the 2023 site visit, the Bayless/Powers House (JUN-00293) was found to be standing and retained windows, doors, siding, and fenestration consistent with its date of construction. Additional research would be required to determine how much the building has been altered since its period of significance, if it is eligible for listing on the NRHP, and if it is a contributing or non-contributing element to a historic district or districts.

**Figure 10. Looking east from Dixon Steet at the Bayless/Powers House (JUN-00293) (NLURA photograph).**

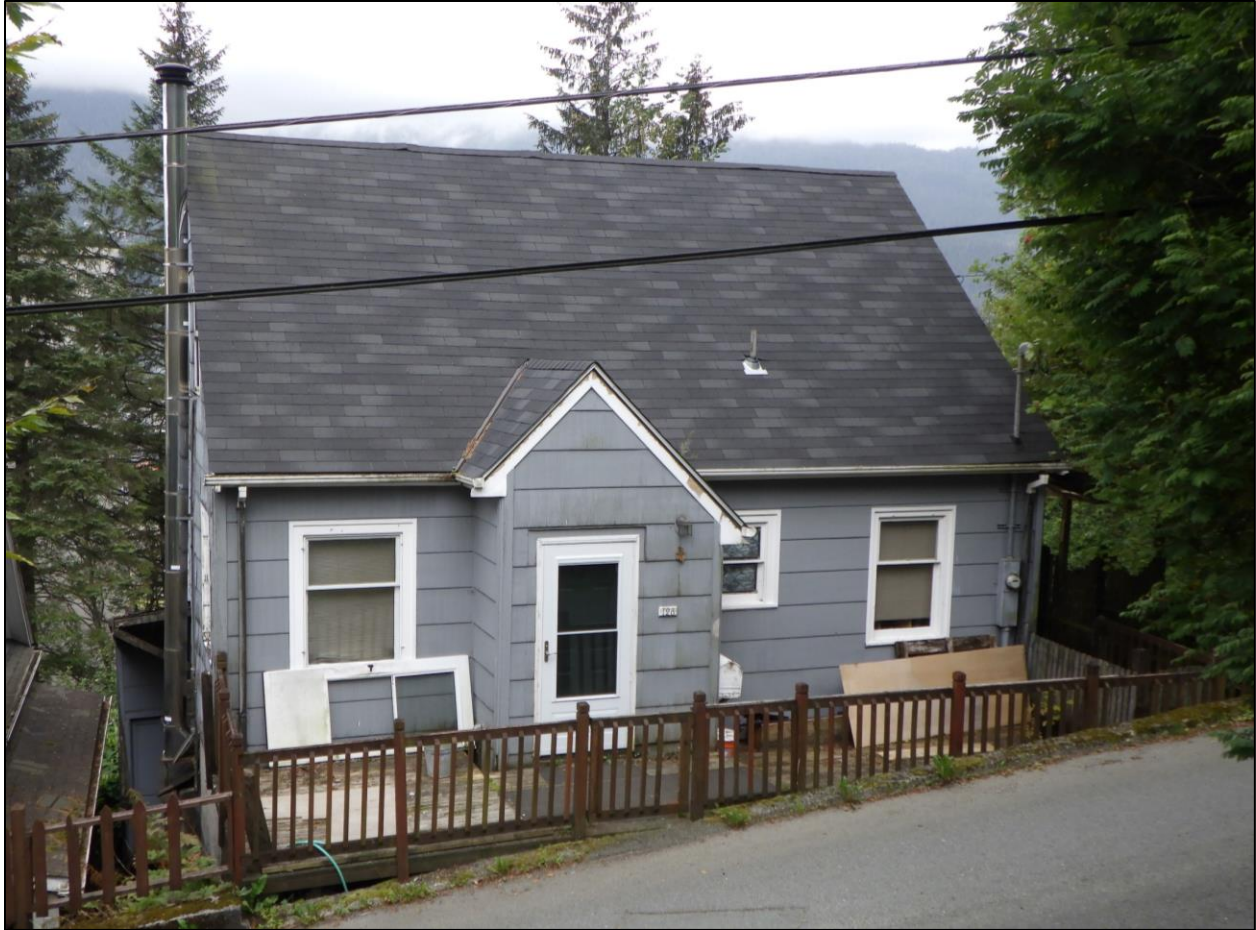
During the 2023 site visit, the Martin/Johnston House (JUN-00294) was found to be standing and retained windows, siding, and fenestration consistent with its date of construction, though the door appears to be modern. Additional research would be required to determine how much the building has been altered since its period of significance, if it is eligible for listing on the NRHP, and if it is a contributing or non-contributing element to a historic district or districts.

**Figure 11. Looking west from Dixon St. at the Martin/Johnston House (JUN-00294) (NLURA photograph).**

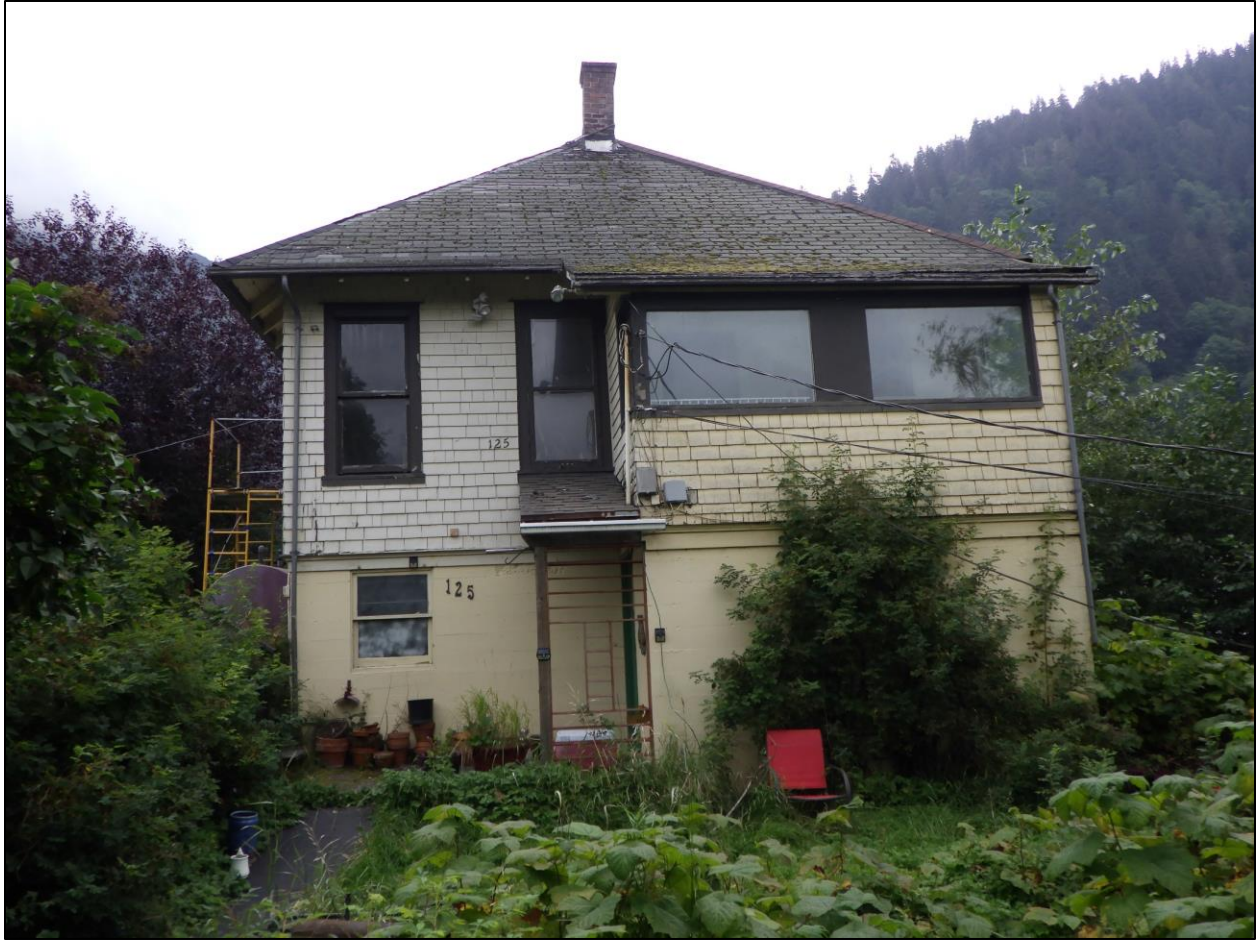
During the 2023 site visit, the Webster/Hurley House (JUN-00295) (Figure 12) was found to be standing and retained windows, doors, siding, and fenestration consistent with its date of construction. Additional research would be required to determine how much the building has been altered since its period of significance, if it is eligible for listing on the NRHP, and if it is a contributing or non-contributing element to a historic district or districts.

**Figure 12. Looking east from Dixon St. at the Webster/Hurley House (JUN-00295) (NLURA photograph).**

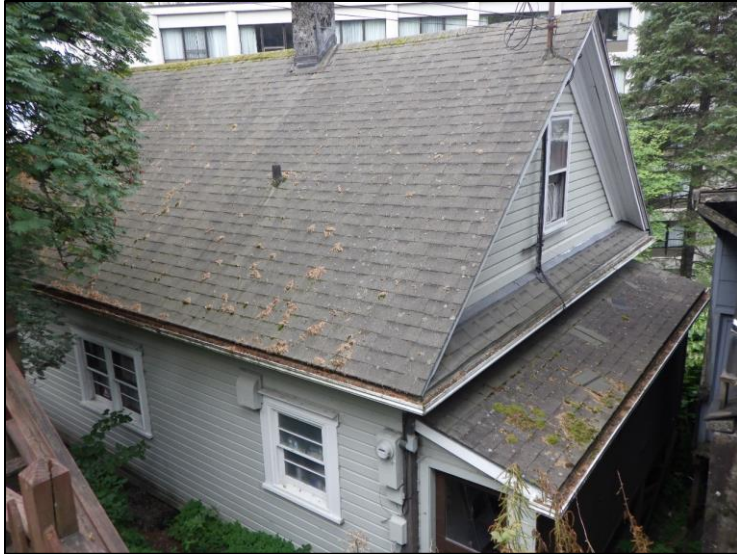
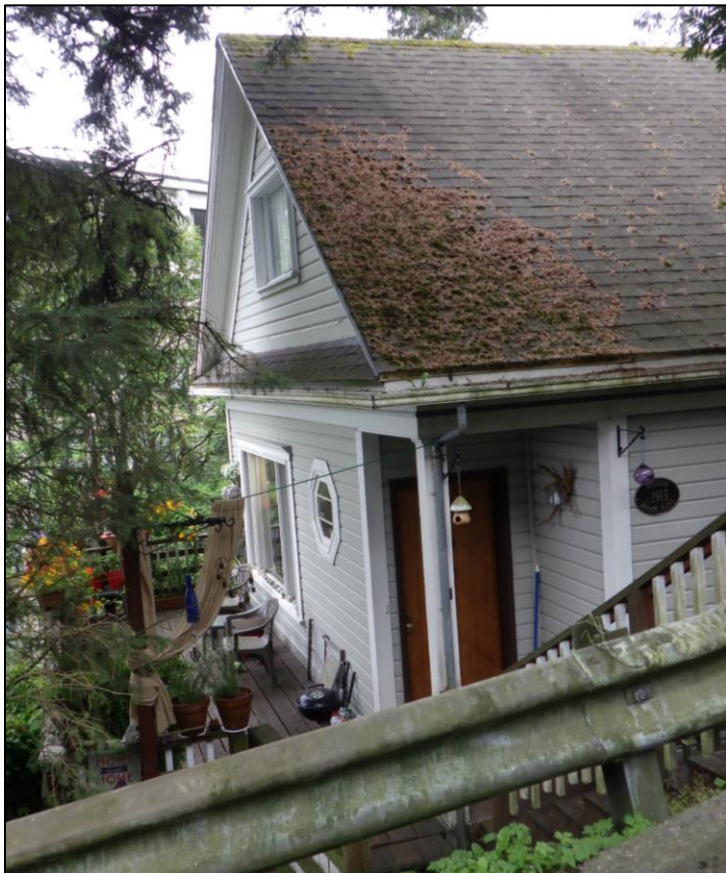
During the 2023 site visit, the Augustus Brown House (JUN-00296) was found to be standing and retained windows, doors, siding, and fenestration consistent with its date of construction. Additional research would be required to determine how much the building has been altered since its period of significance, if it is eligible for listing on the NRHP, and if it is a contributing or non-contributing element to a historic district or districts.

**Figure 13. Looking southwest from Dixon St. at the Augustus Brown House (JUN-00296) (NLURA photograph).**

**Figure 14. Looking west from Dixon St. at the Augustus Brown House (JUN-00296) (NLURA photograph).**

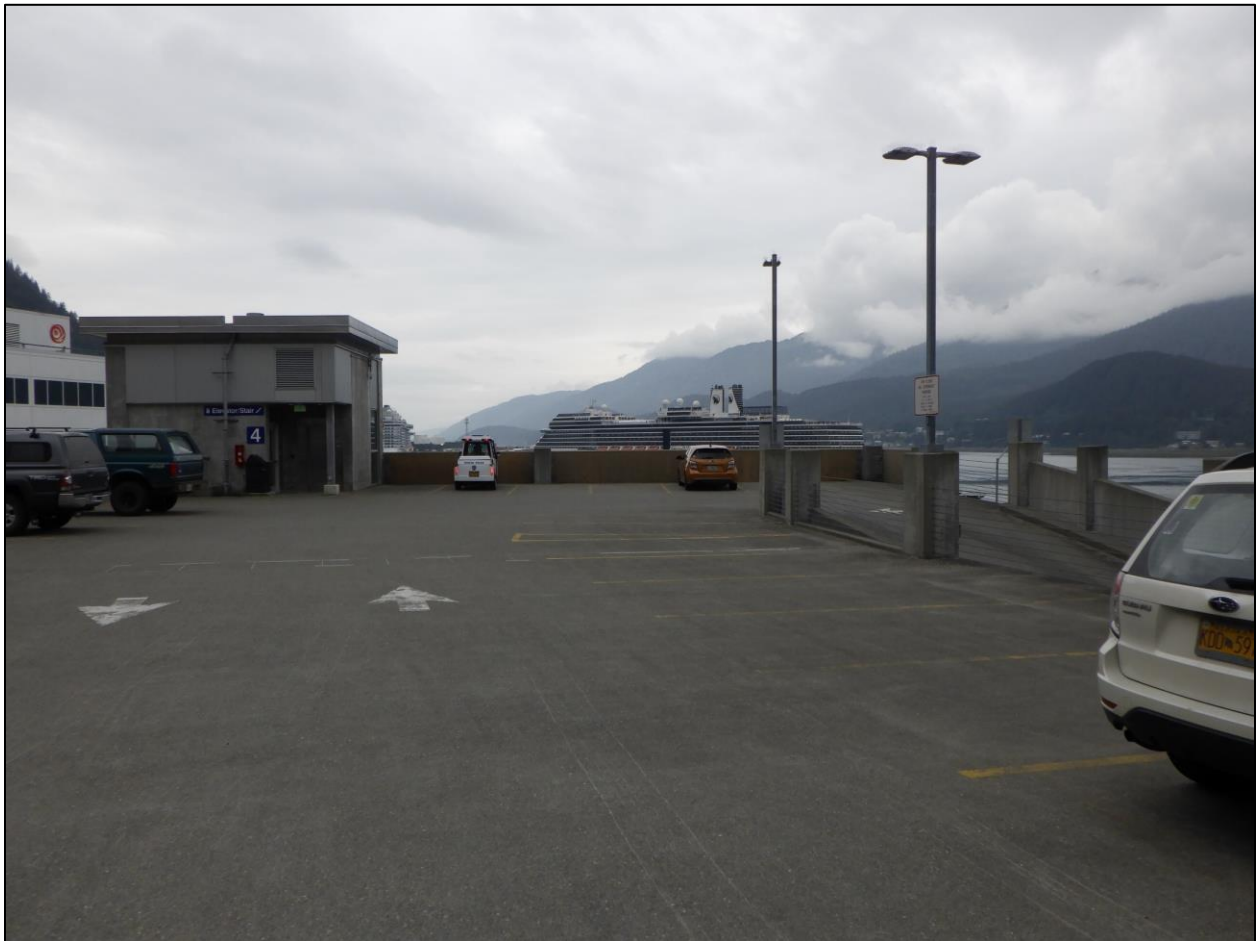
During the 2023 site visit, the Kodzoff House (JUN-00297) was found to have been demolished and was within the footprint of the parking garage on the east side of Telephone Hill (Figure 15). No additional research is recommended for this building as it lacks the integrity required for listing on the NRHP.

**Figure 15. Looking roughly south at the former location of the Kodzoff House (JUN-00297) (NLURA Photograph).**

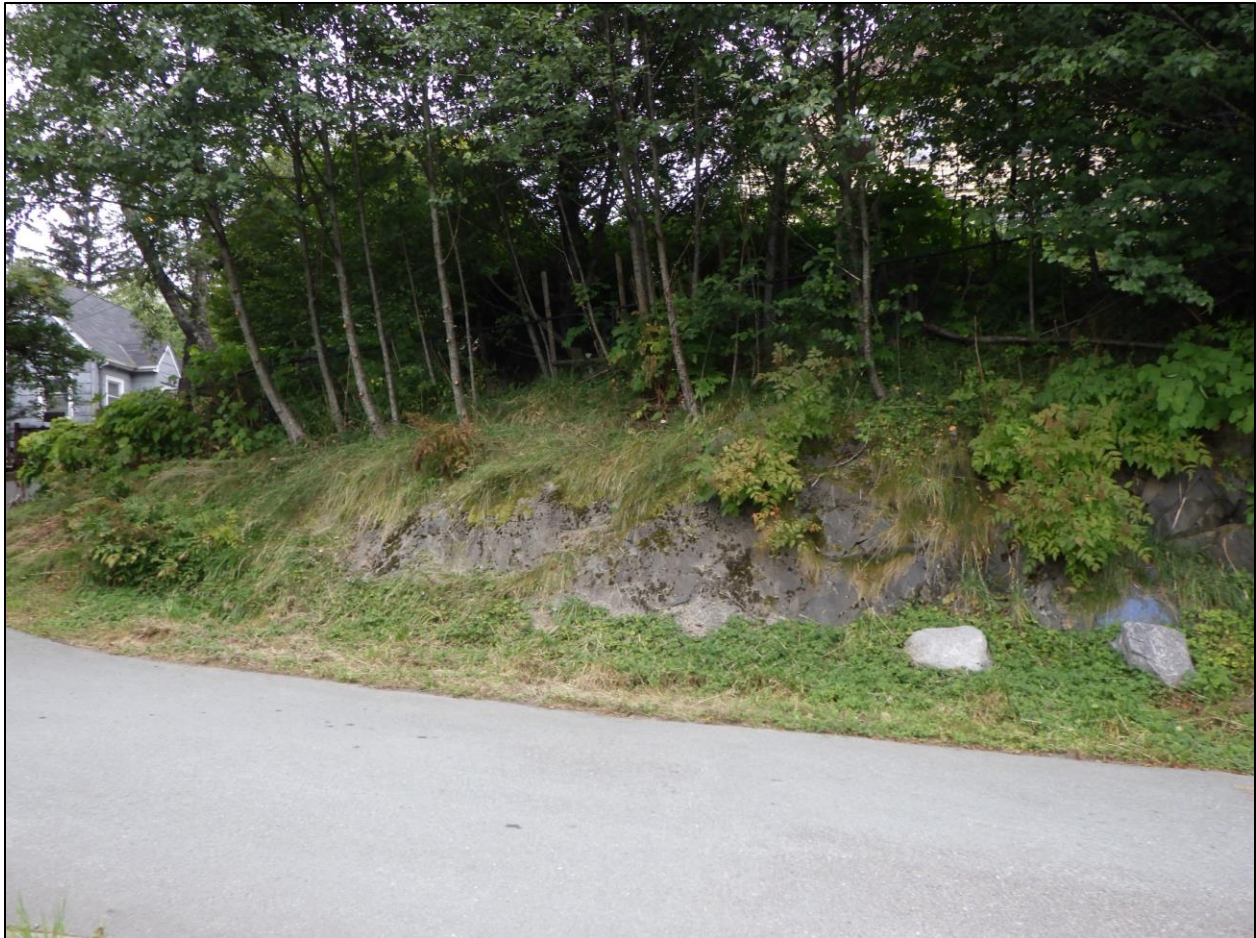
During the 2023 site visit, the Alexander House (JUN-00976) was found to have been demolished (Figure 16). No additional research is recommended for this building as it lacks the integrity required for listing on the NRHP.

**Figure 16. Looking north at the former location of the Alexander House (JUN-00976) showing the site is demolished (NLURA photograph).**

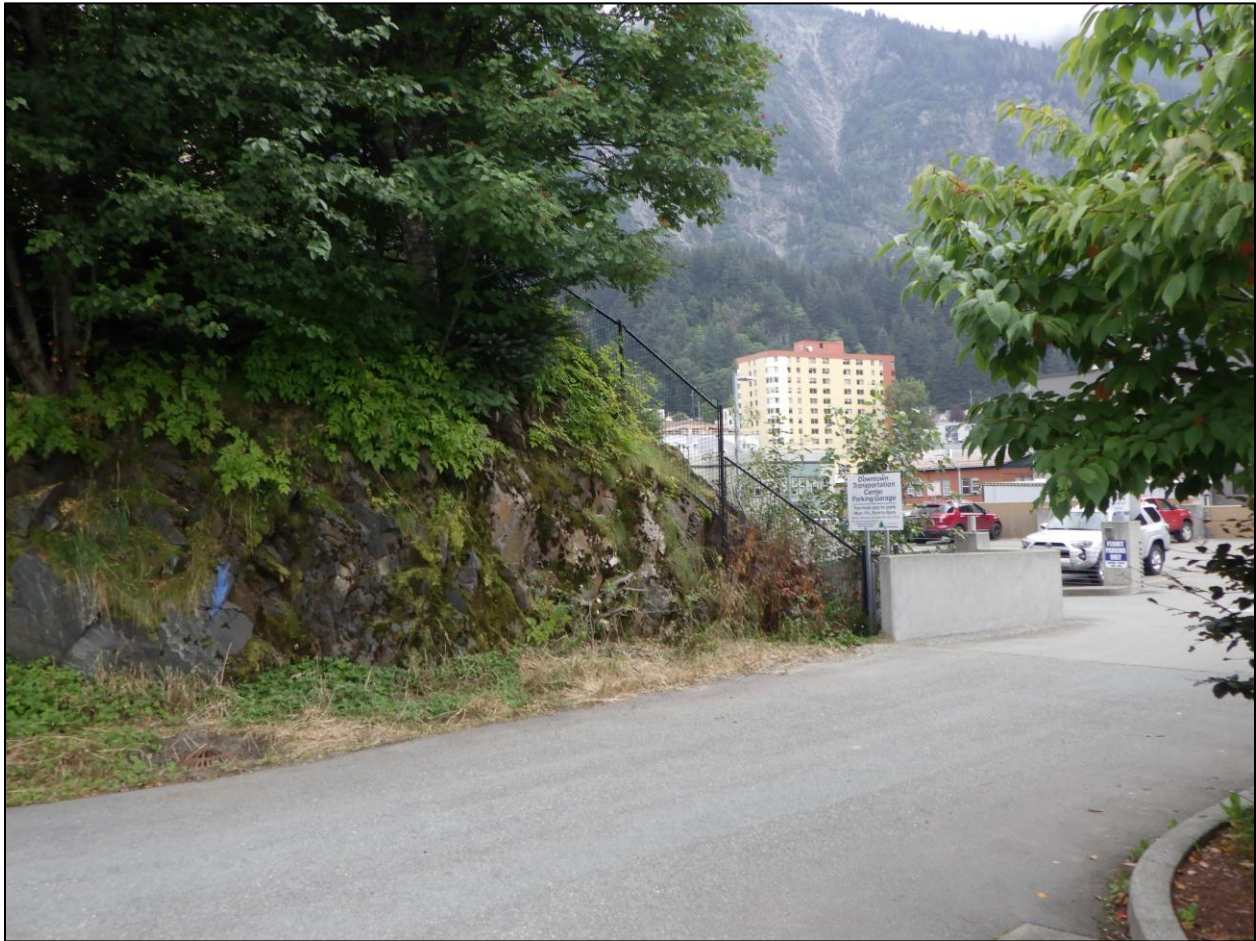
During the 2023 site visit, the Percy Reynolds House (JUN-00977) was found to have been demolished (Figure 17). No additional research is recommended for this building as it lacks the integrity required for listing on the NRHP.

**Figure 17. Looking northwest at the former location of the Percy Reynolds House (JUN-00977) showing the site is demolished (NLURA photograph).**
