## **Historic Resources Advisory Committee Agenda**

February 22, 2024 at 5:00pm

# STRUCTURAL CONDITION SURVEYS

Project Number I1817.23001; RSI-3411

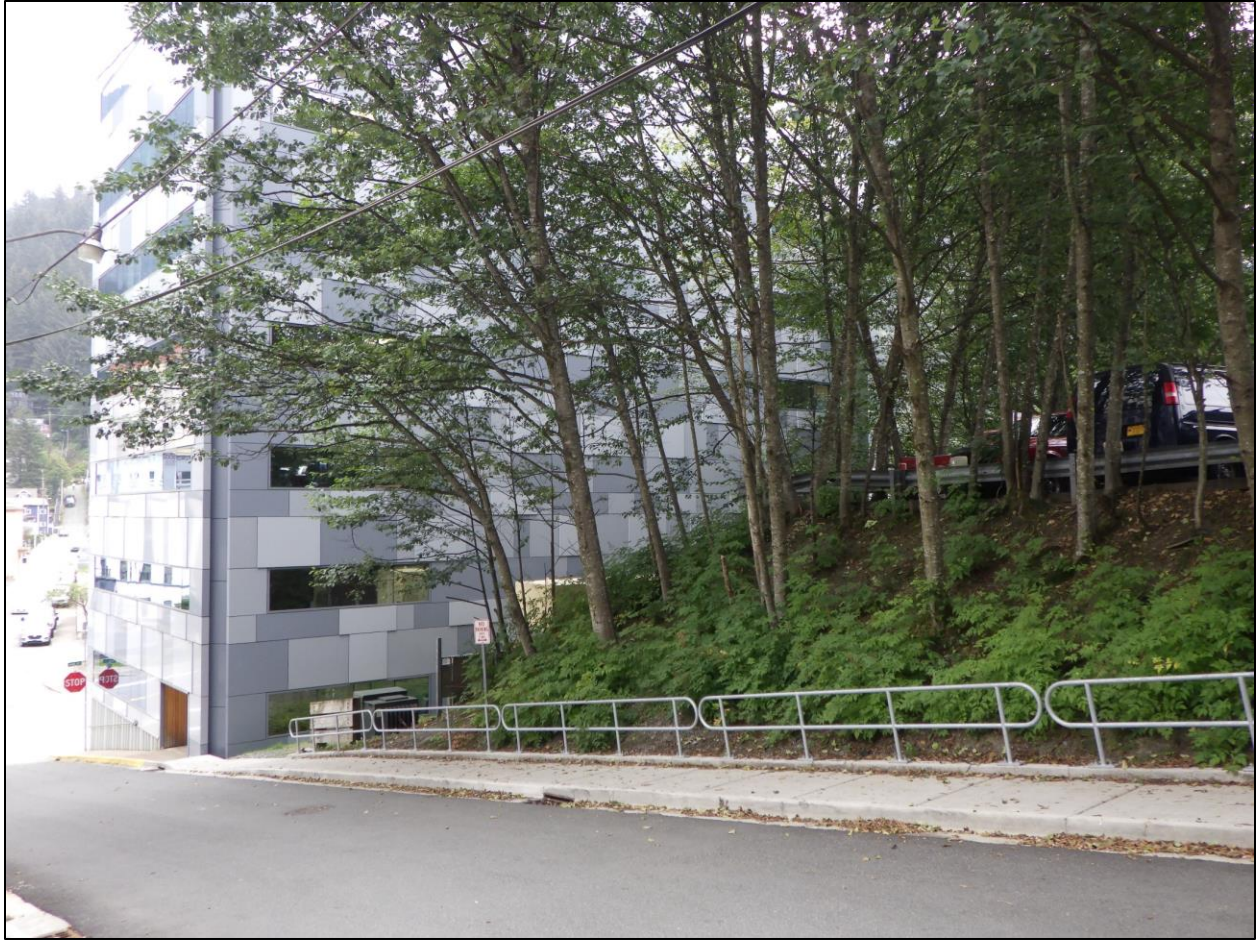
During the 2023 site visit, the Engstrom Building (JUN-00981) was found to have been demolished (Figure 18). No additional research is recommended for this building as it lacks the integrity required for listing on the NRHP.

**Figure 18. Looking roughly east from West 3rd St. at the former location of the Engstrom Building (JUN-00981) showing the site is demolished (NLURA photograph).**

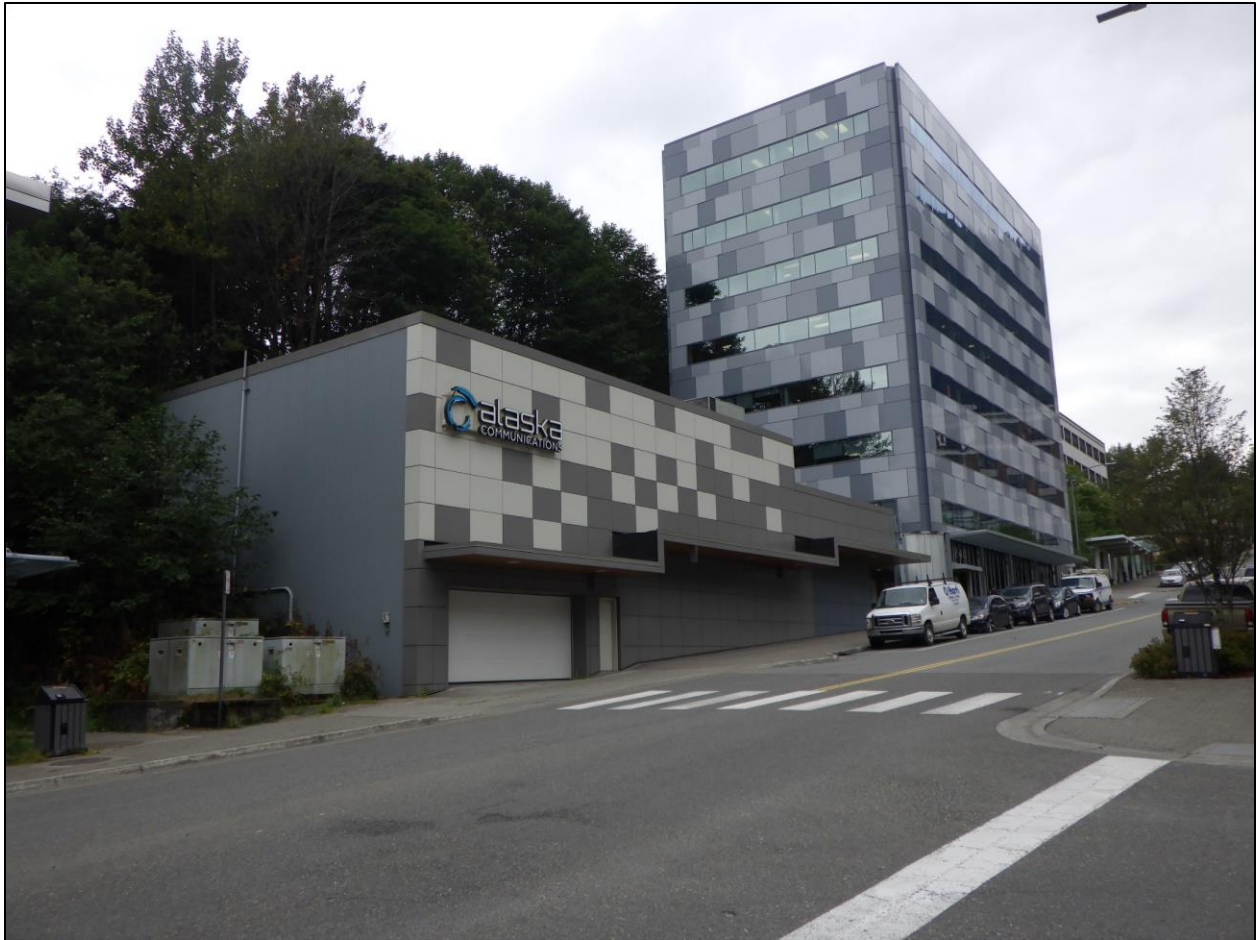
During the 2023 site visit, the location of the Flag of All Nations Site (JUN-00080) shown on the AHRS was found to be in the center of the intersection of Second and Main Sts. (Figure 19).

**Figure 19. Looking roughly north west at the location of the Flag of All Nations Site (JUN-00080) (NLURA photograph). The AHRs point is in the center of Main St. .The Juneau and Douglas Telephone Company (JUN-01012) is the lower building in the foreground (NLURA photograph).**

During the 2023 site visit, the Juneau Douglas Telephone Company (JUN-01012) (Figure 19) was still standing but showed evidence of a recent refurbishment. Additional research would be required to determine how much the building has been altered since its period of significance, if it is eligible for listing on the NRHP, and if it is a contributing or non-contributing element to a historic district or districts.

Additional research is recommended for this site/building to determine the integrity required for listing on the NRHP or to be a contributing or non-contributing element to a historic district.

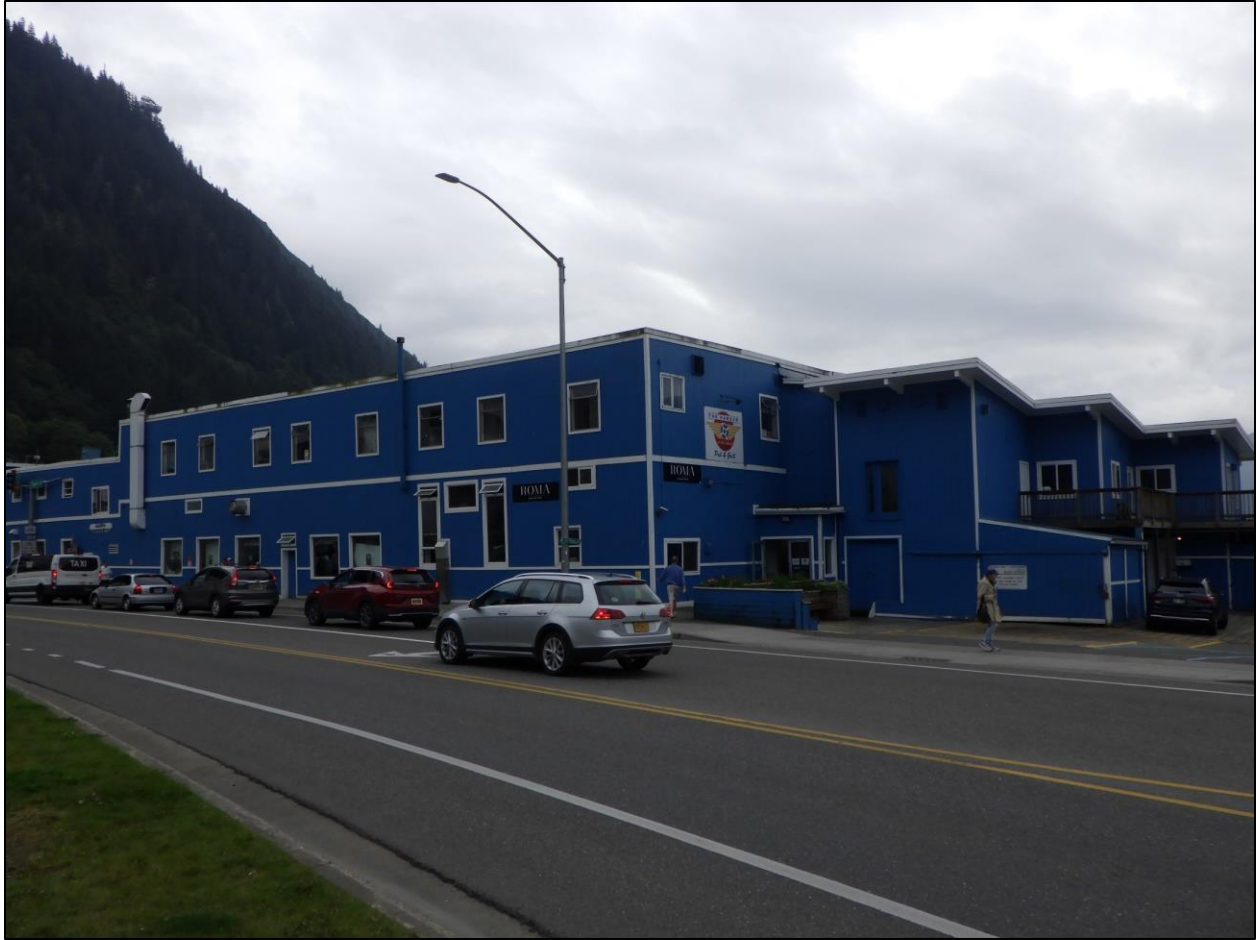
During the 2023 site visit, the Pacific Coastal Steamship Wharf (JUN-00120) was still standing and in the condition described on the AHRs card (Figure 20). No additional research is recommended for this building as it has been determined not eligible for listing on the NRHP.

**Figure 20. Looking southeast at the Pacific Coastal Steamship Wharf from Egan Ave. (JUN-00120) (NLURA photograph).**

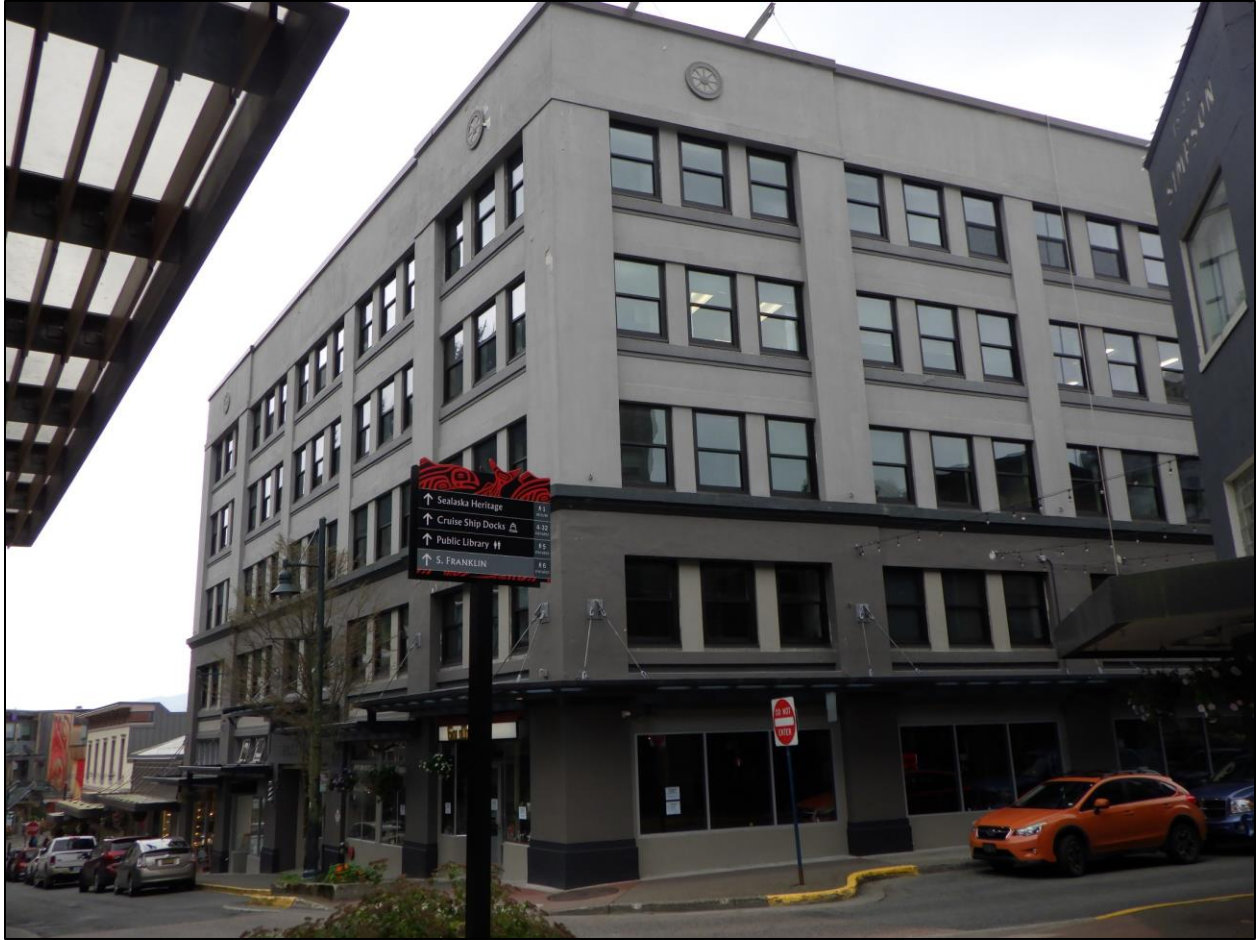
During the 2023 site visit, the Goldstein Building (JUN-00180) was standing and appears to retain its post 1946 appearance (Figure 22). Additional research would be required to determine how much the building has been altered since its period of significance, if it is eligible for listing on the NRHP, and if it is a contributing or non-contributing element to a historic district or districts.

**Figure 22. Looking Southwest at the Goldstein Building (JUN-00180) from the intersection of Seward and 2nd Sts. (NLURA photograph).**

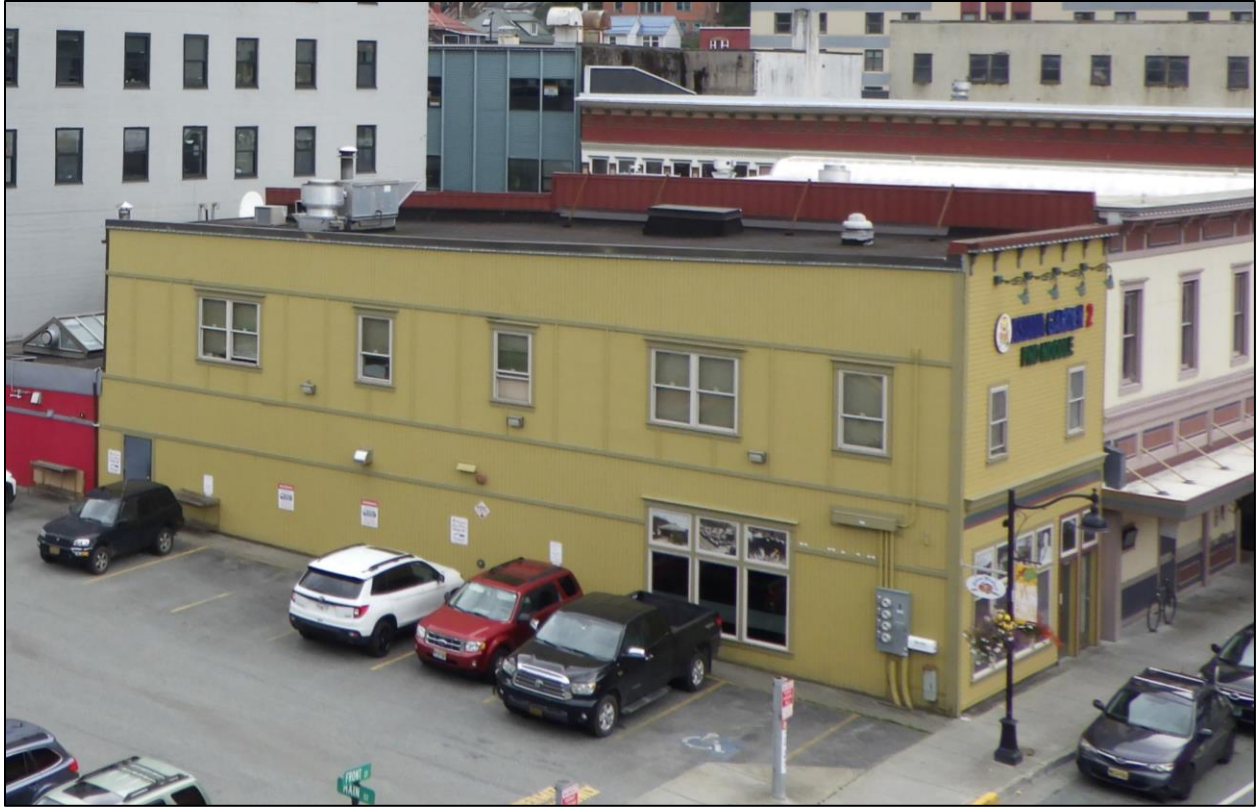
During the 2023 site visit, the AHRs point for the Kubach/Studebaker Building (JUN-00182) was found to be in an adjoining parking area along Main St.. However, the building was standing and appeared to retain its original massing, and cornice. Additional research would be required to determine how much the building has been altered since its period of significance, if it is eligible for listing on the NRHP, and if it is a contributing or non-contributing element to a historic district or districts.

**Figure 23. Looking northwest at the Kubach/Studebaker Building (JUN-00182) from the top of the parking garage (NLURA photograph).**

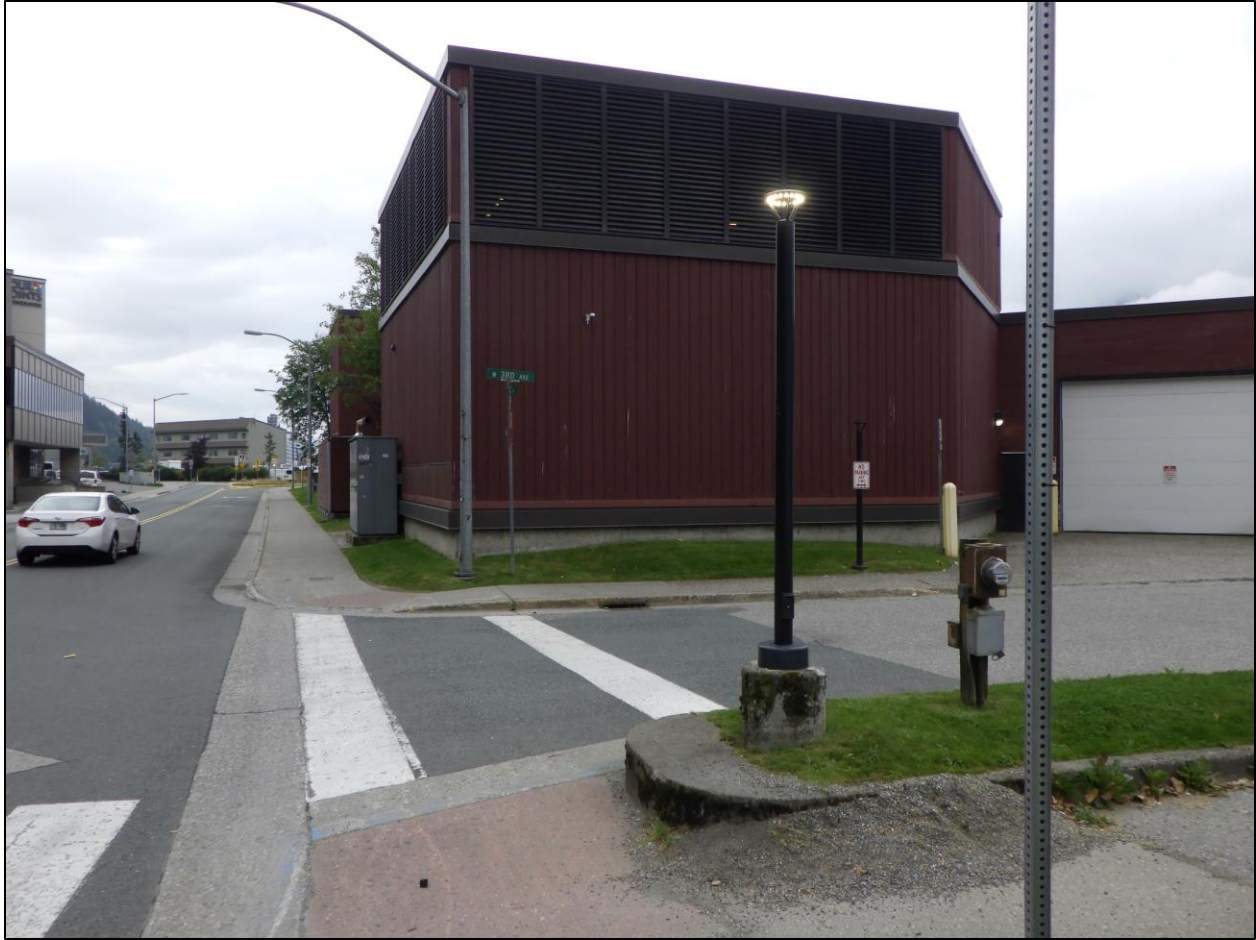
During the 2023 site visit, the I.L.W.U. Hall (JUN-00188) was found to have been demolished (Figure 18). No additional research is recommended for this building as it lacks the integrity required for listing on the NRHP or to be a contributing or non-contributing element to a historic district.

**Figure 24. Looking southeast along Willoughby Ave. at the former site of the I.L.W.U. Hall (JUN-00188) (NLURA photograph).**

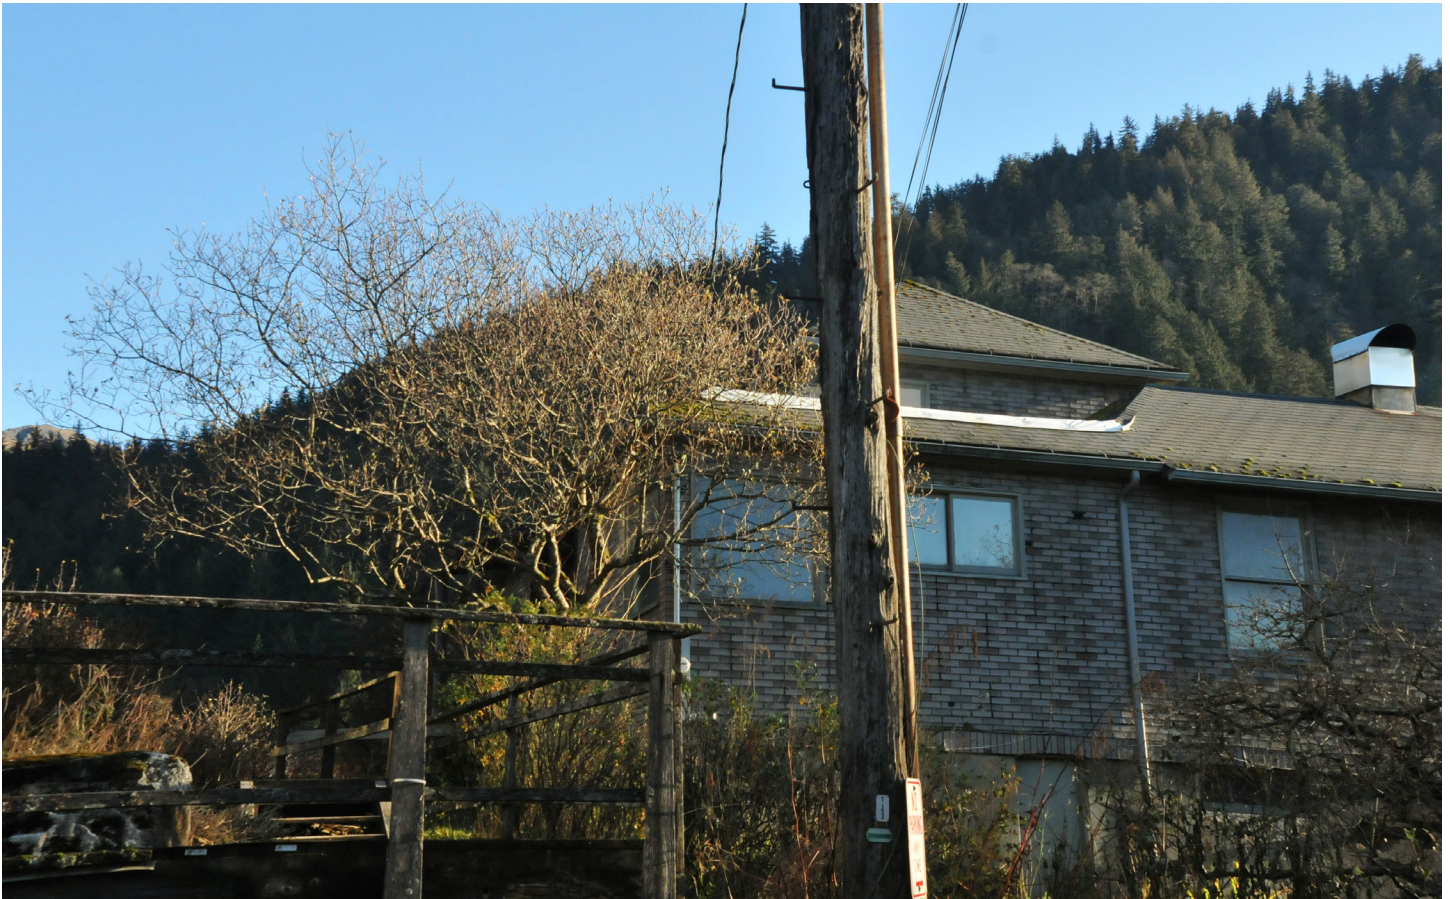
West Facade; Higher roofline reflects the initial, two-story house. Lower roofline shows later renovation encompassing the original house.  
Edward Webster House, 2023

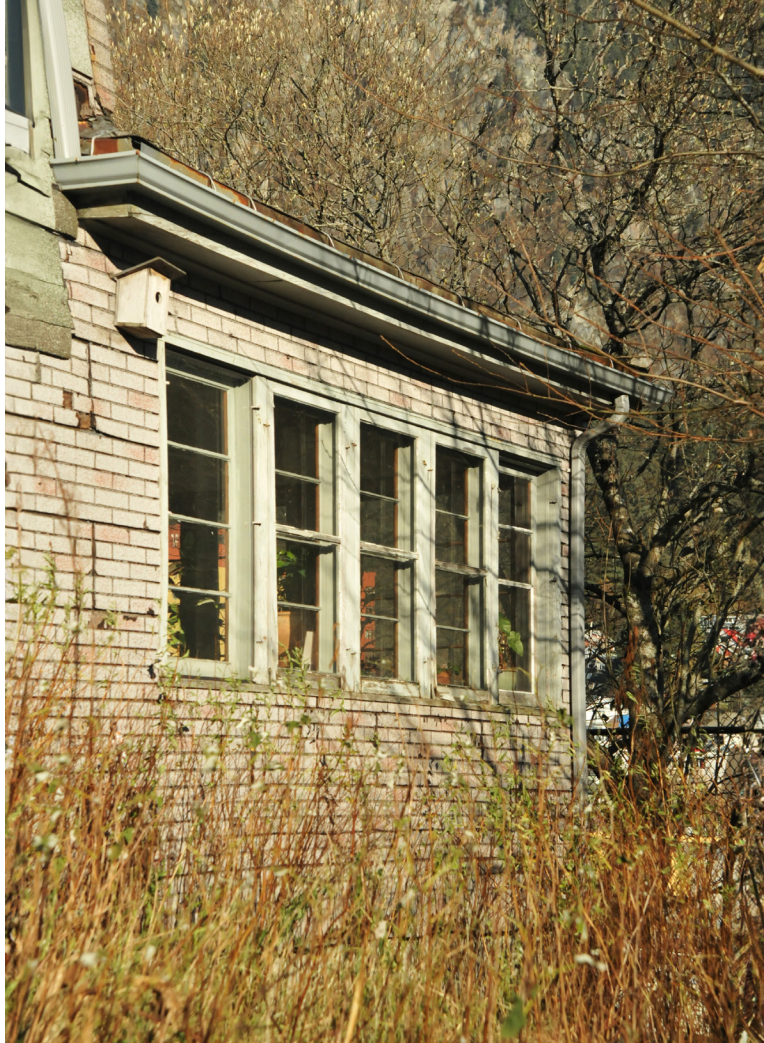
Enclosed sun porch, added in 1946.  
Edward Webster House, 2023

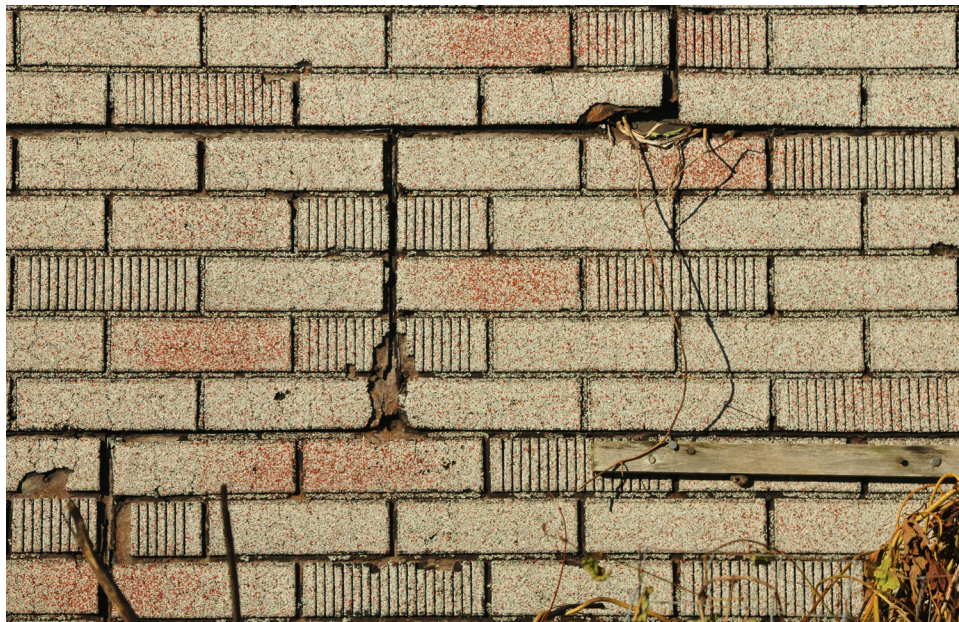
Asphalt-shingle siding covers the original clapboard siding. Therefore the residence does not retain the key exterior materials dating from the period of its historic significance.  
Edward Webster House, 2023

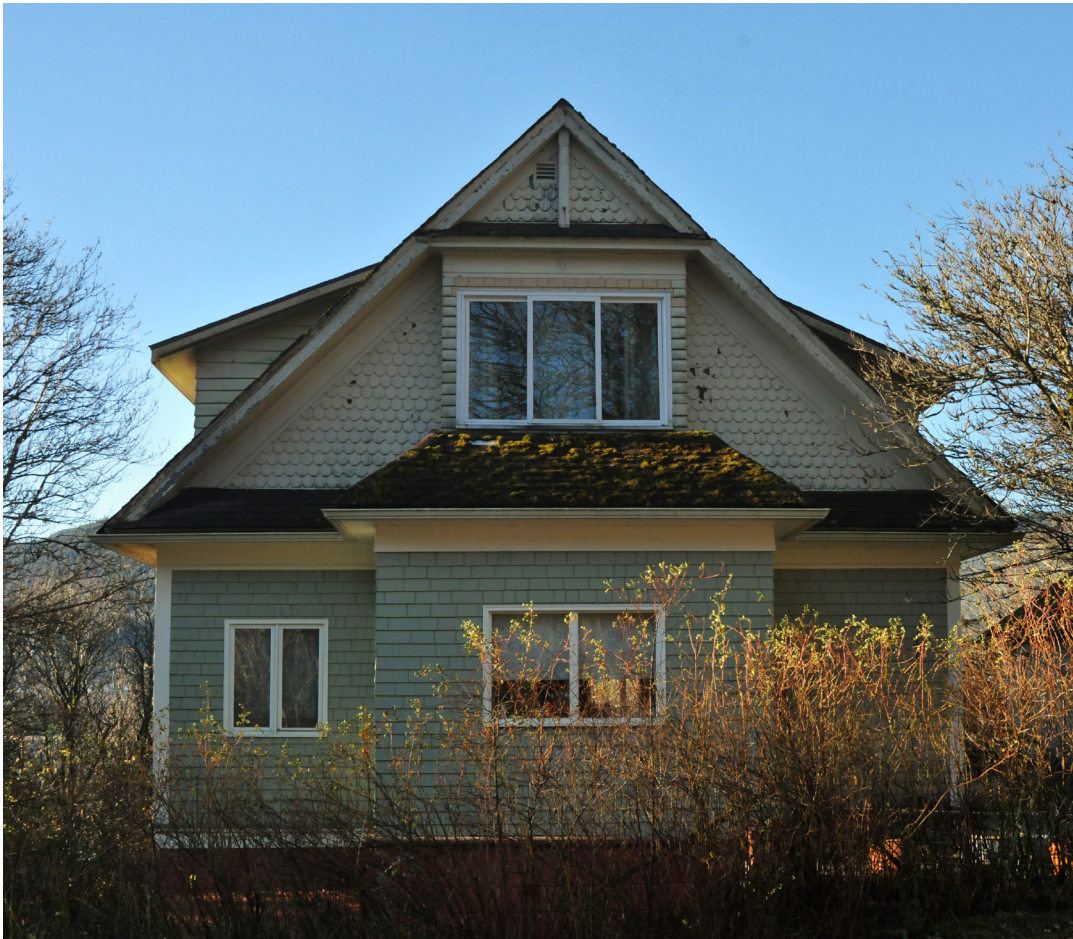
D-03: Bosch-Carrigan House

East Facade  
Bosch-Carrigan House, 2023

Throughout the evolution of the property, certain windows have been replaced. Notably, a decorative bay window on the south facade has been substituted with a large picture window, contributing a contemporary element to the structure. Additional fixed-sash windows have been added on the front and rear facades.

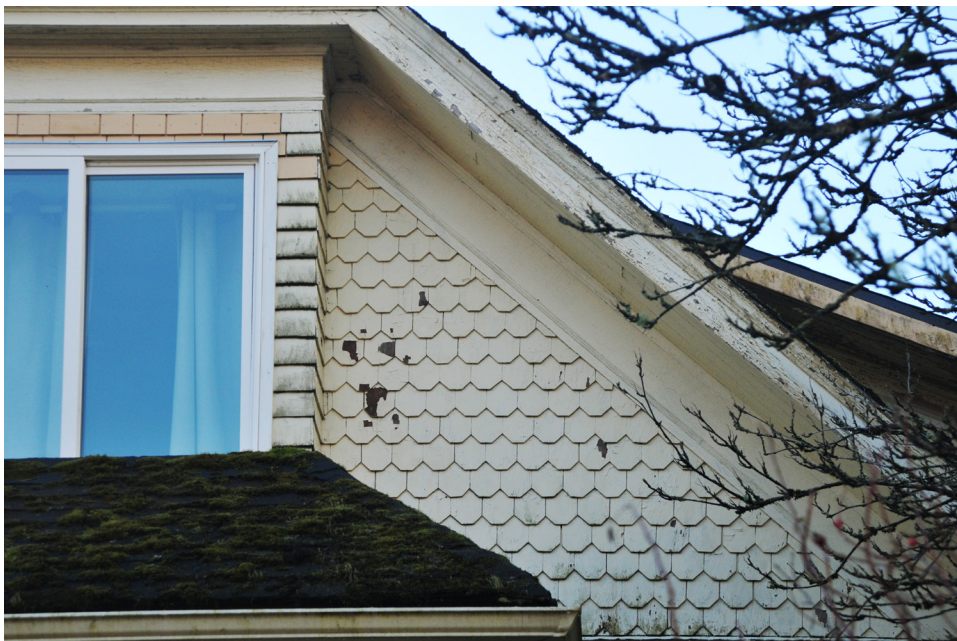
Original scalloped/fish scale siding retained  
Bosch-Carrigan House, 2023

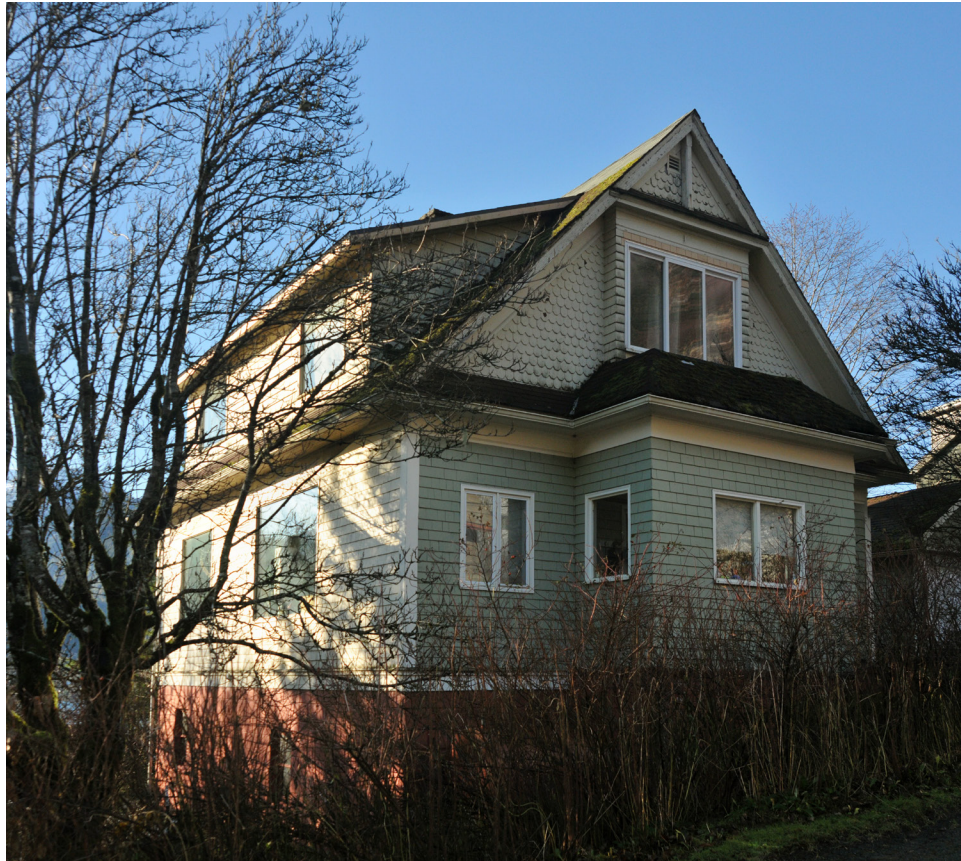
Contemporary additions include the picture windows  
and dormer on the south facade  
Bosch-Carrigan House, 2023

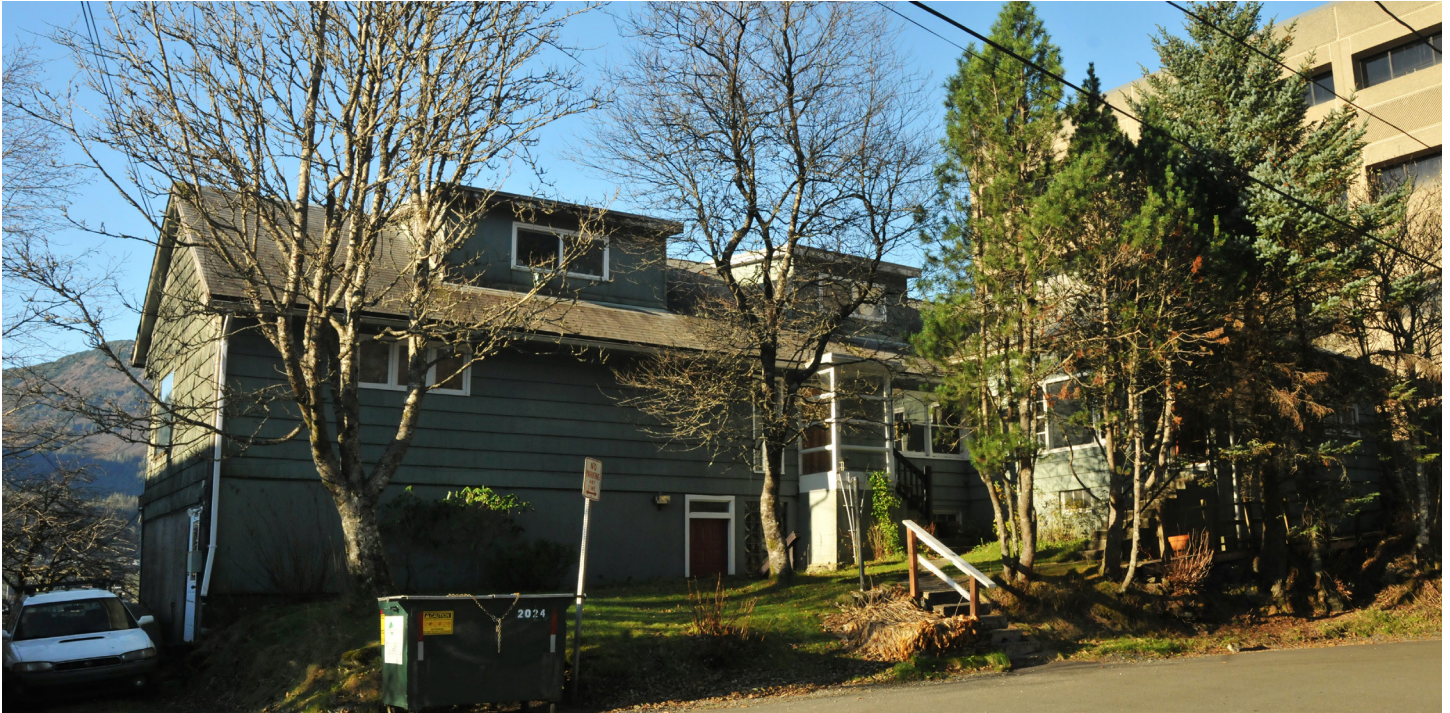
### D-04: Peterson-Kasnick House

East Facade. Additions have encompassed the original residence.  
Peterson-Kasnick House, 2023

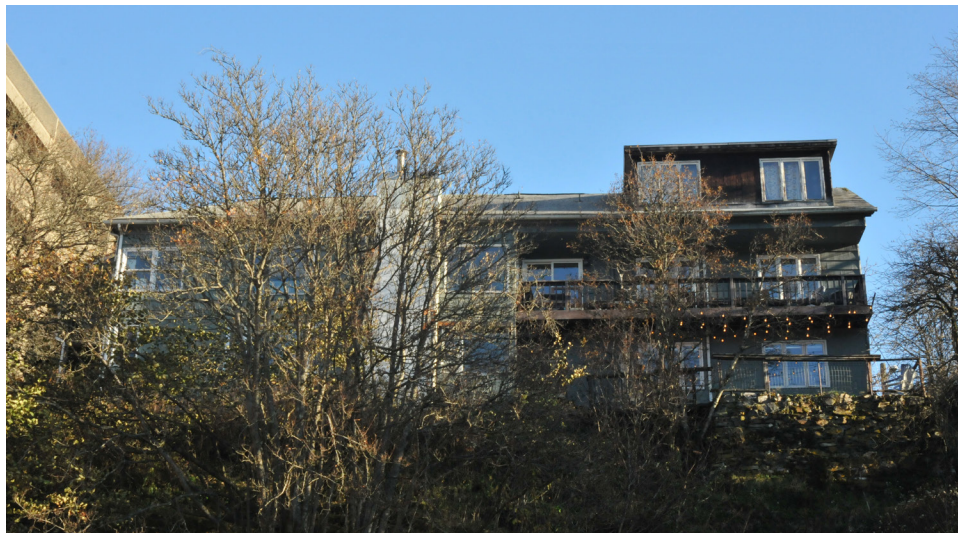
West Facade. Contemporary decks added to allow access to the three basement apartments. The dormer is also a contemporary addition.  
Peterson-Kasnick House, 2023

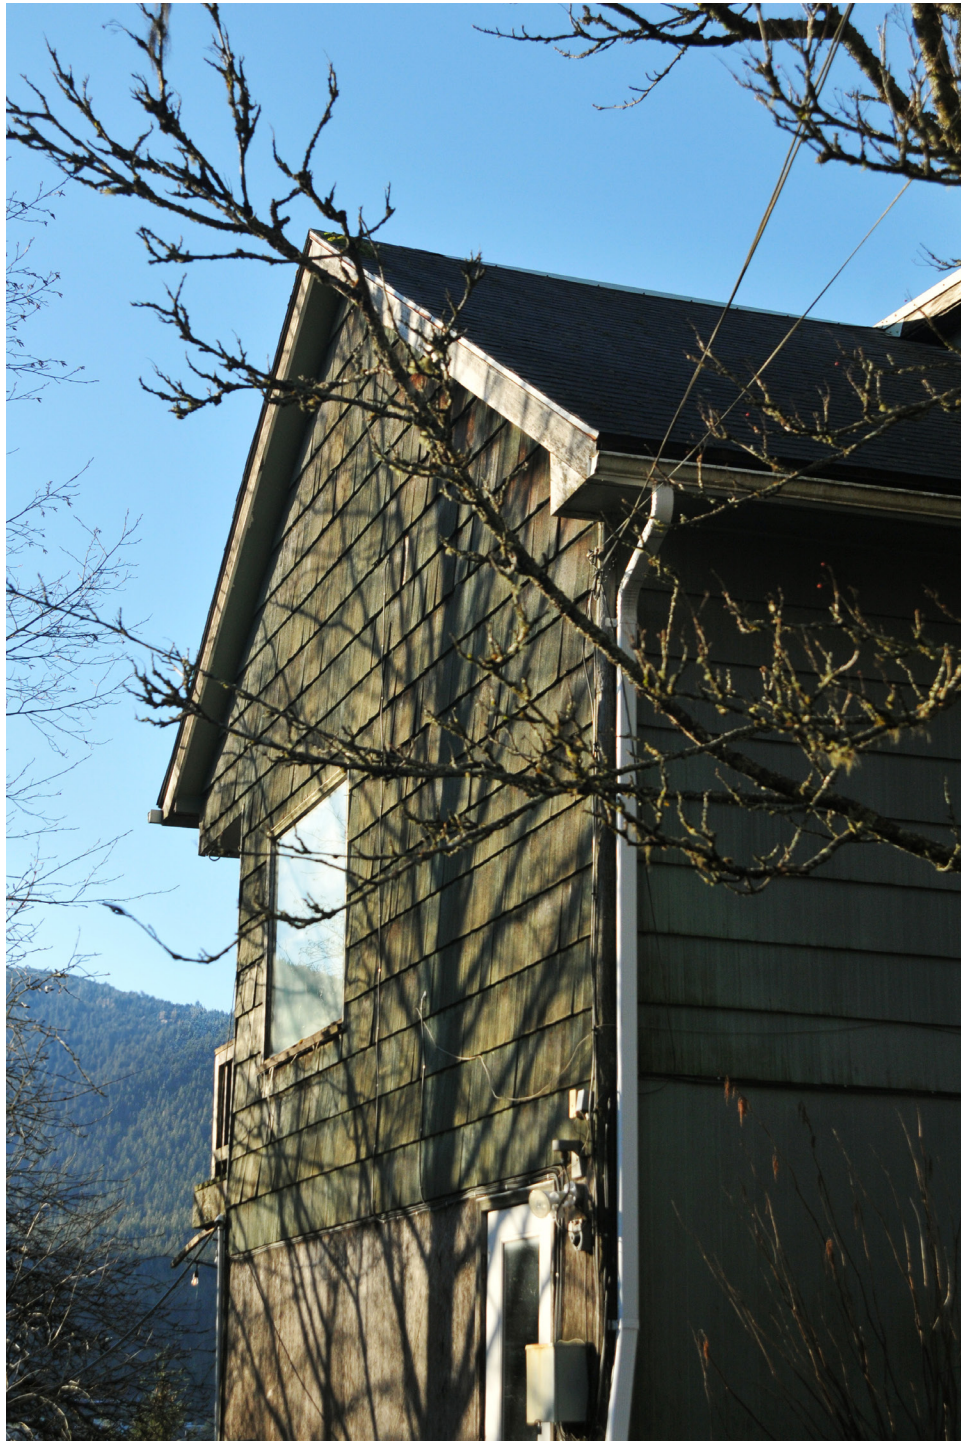
South Facade featuring a contemporary picture window and an entrance to one of the three basement units. Shake-Shingle siding covers the entire residence. Peterson-Kasnick House, 2023

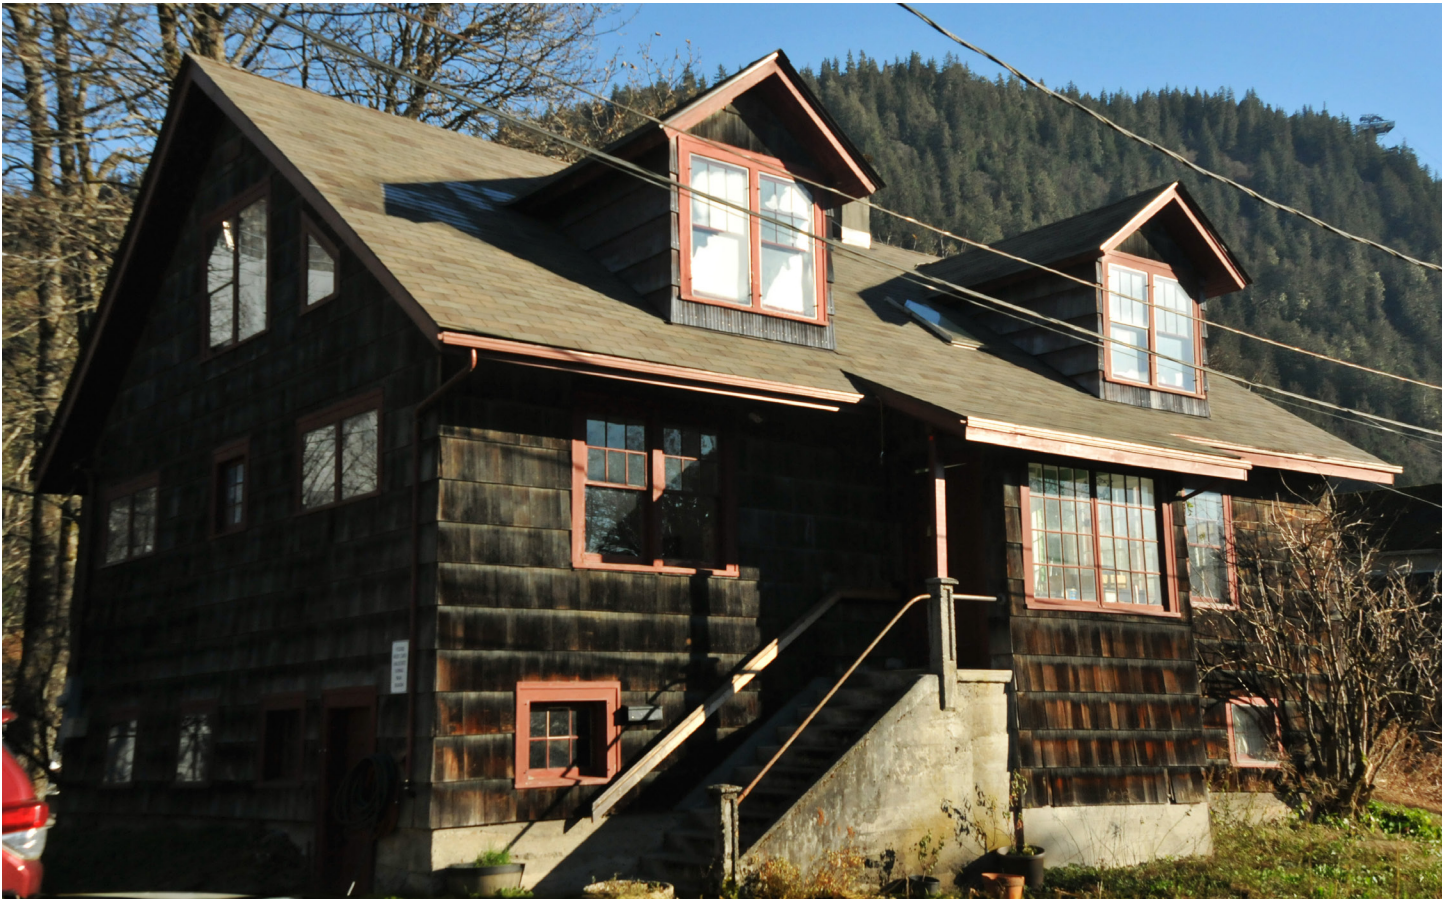
D-05: Bayless-Powers House

South Facade. Original, double-hung sash windows and original cedar shake siding retained. Wooden gutter has been replicated and replaced in the 1980s.  
Bayless-Powers House, 2023

Throughout its history, 211 Dixon Street has seen some maintenance. According to a local resident, the property underwent a painting process in the mid to late 1990s. Additionally, the wooden gutters, a unique feature of the residence, have been replaced twice within the last 30 years.

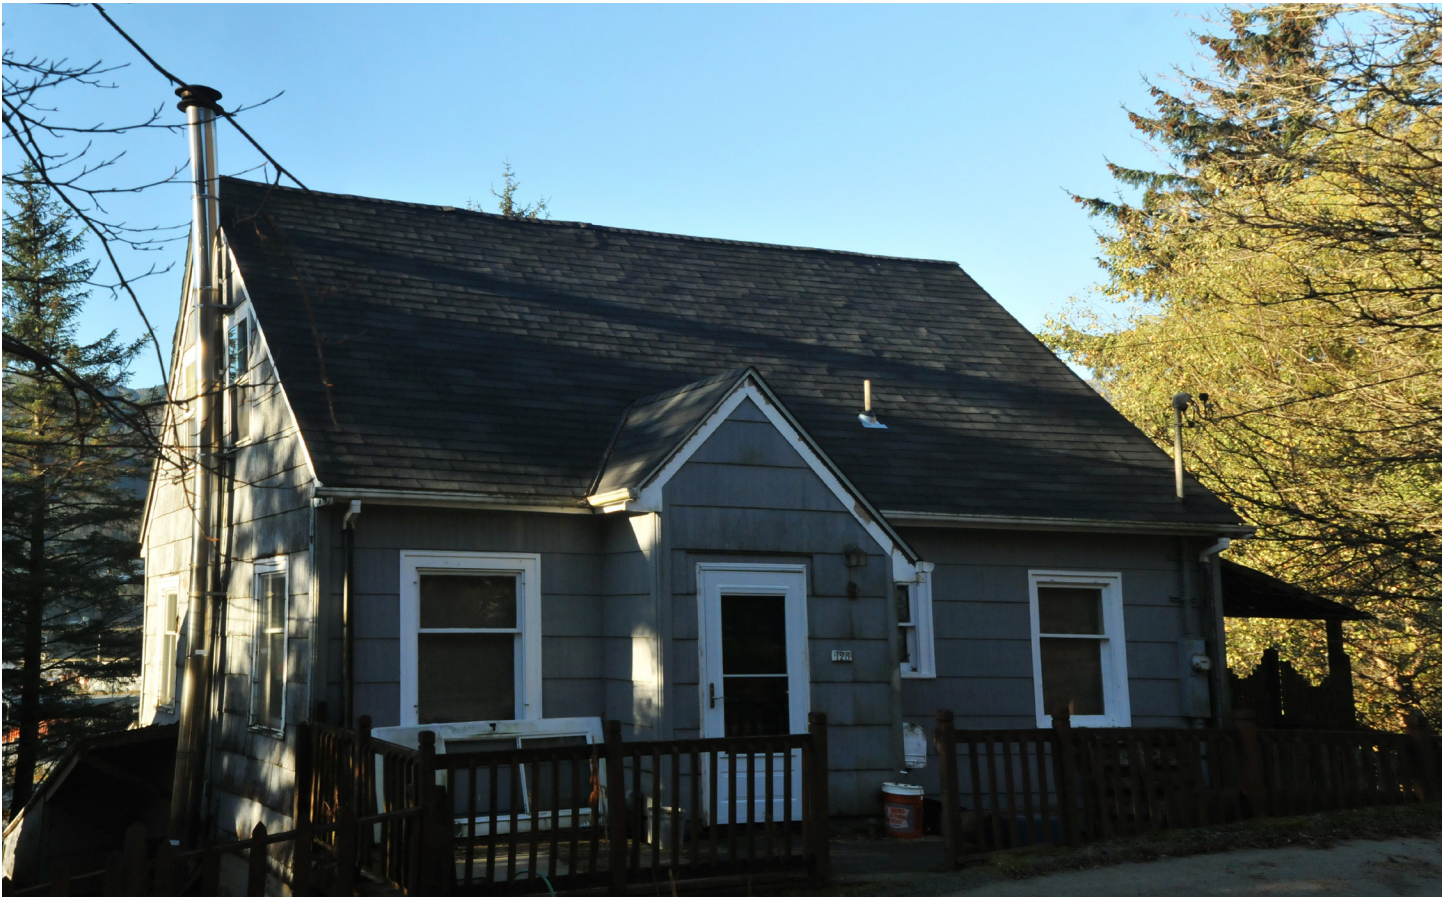
D-06: Martin-Johnston House

East Facade. Contemporary windows replace originals. Contemporary wooden deck added.  
Martin-Johnston House, 2023

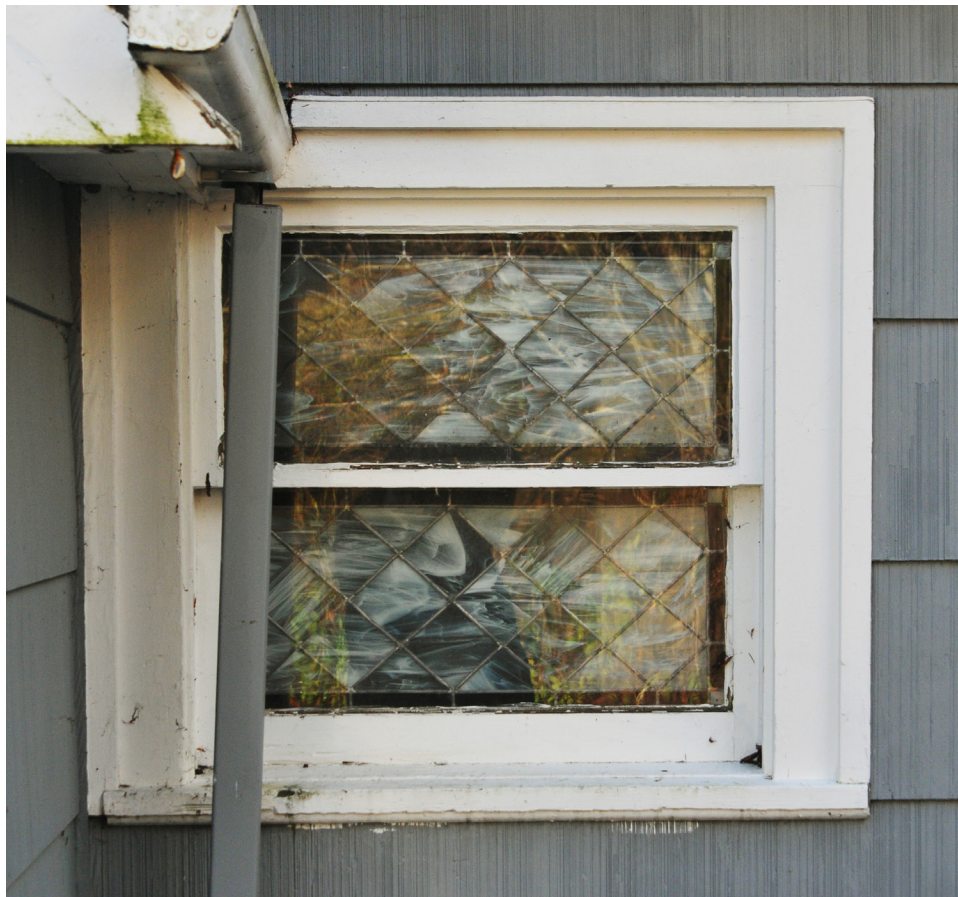
East Facade. Retention of diagonal leaded glass  
patterned window.  
Martin-Johnston House, 2023

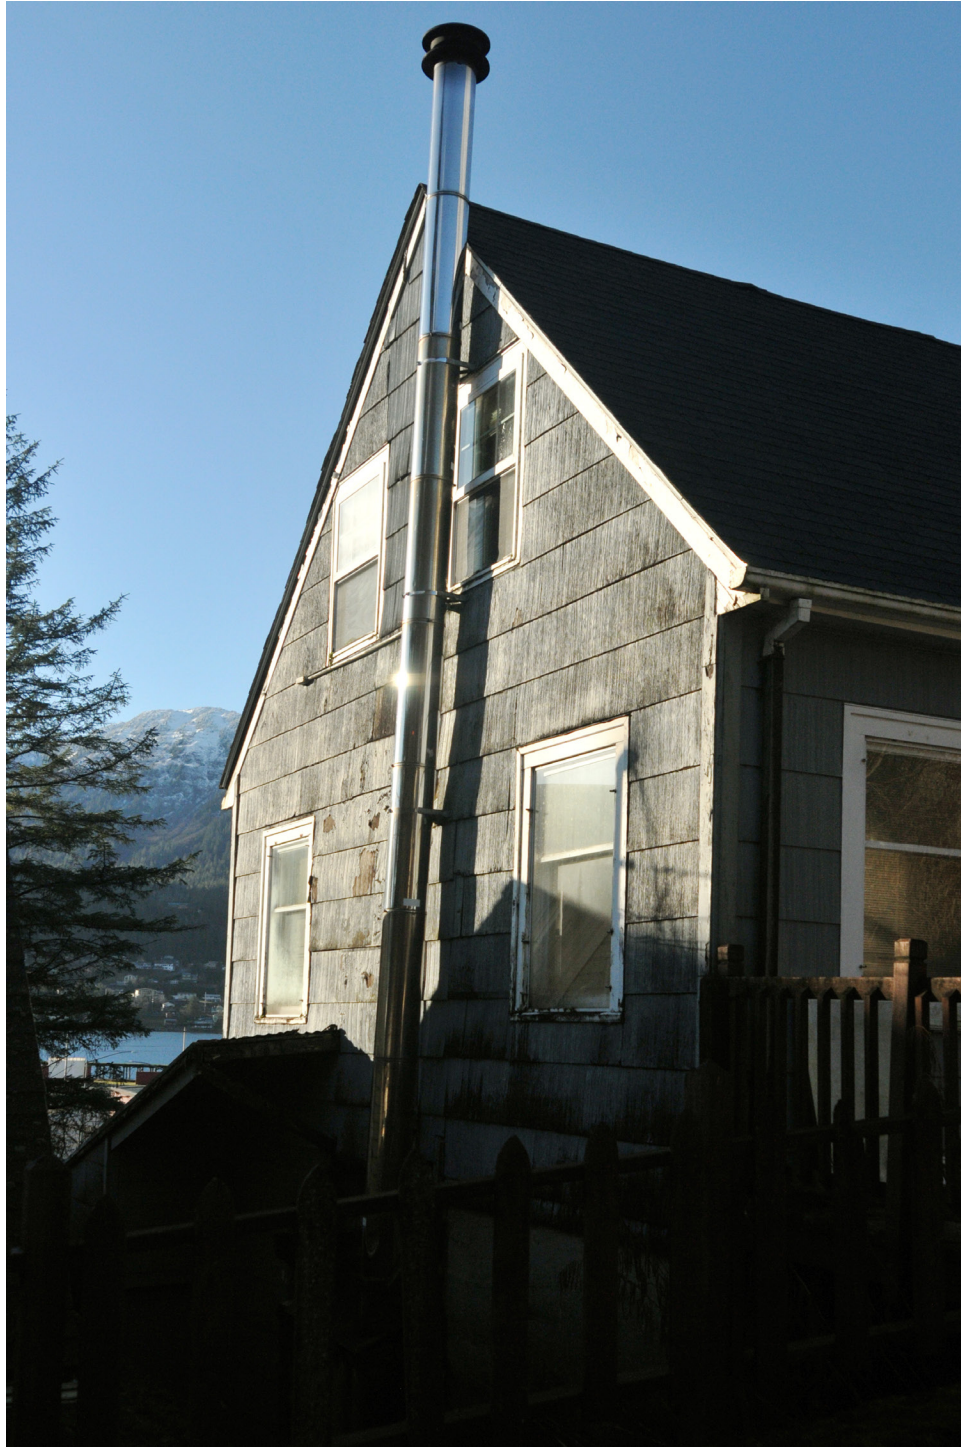
overlapping front gable. A linked-top, cement block chimney situated along the south facade has been replaced with a metal chimney since the 1984 Survey.

South Facade. A metal chimney has since replaced the original cement block chimney.  
Martin-Johnston House, 2023

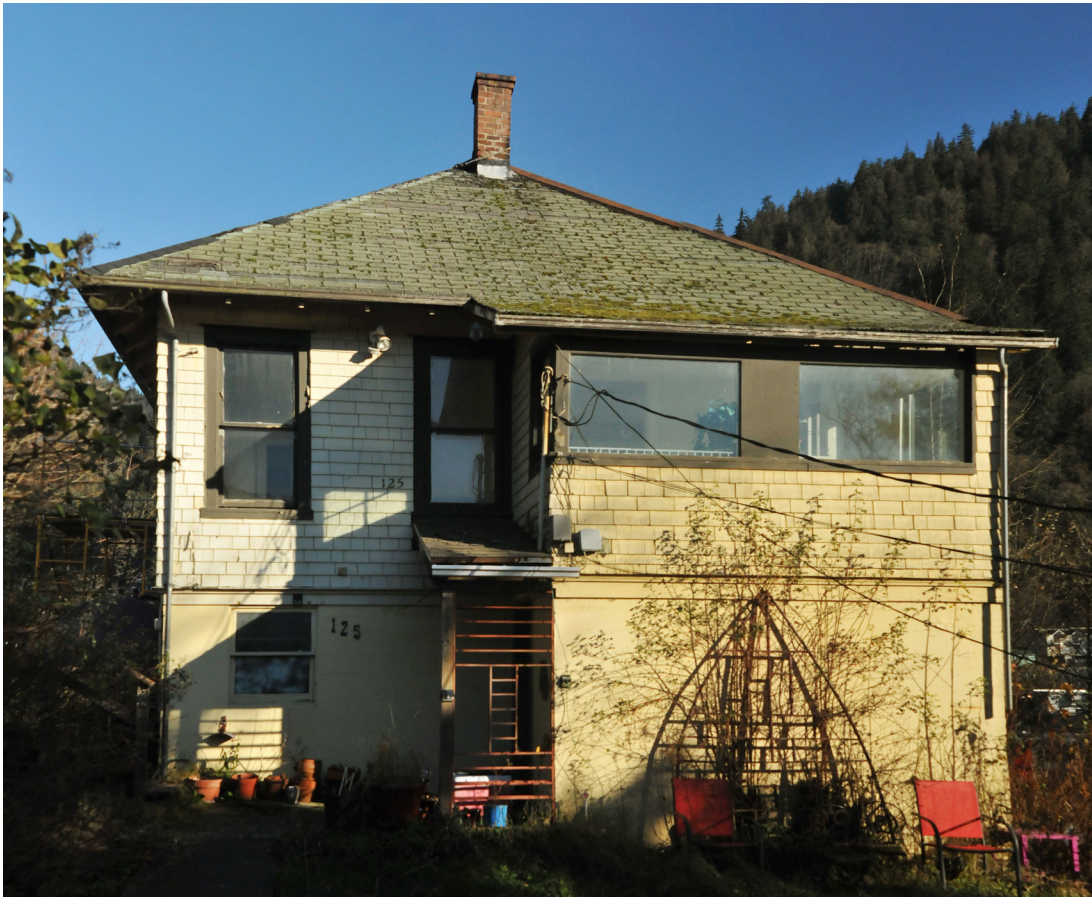
### D-07: Worthen-Hurley House

West Facade. Cedar shingles cover original clapboard siding. The large, picture windows in the upper left are part of the open porch that was enclosed in the 1950s.  
Worthen-Hurley House, 2023
