## **Historic Resources Advisory Committee Agenda**

February 22, 2024 at 5:00pm

# STRUCTURAL CONDITION SURVEYS

Project Number I1817.23001; RSI-3411

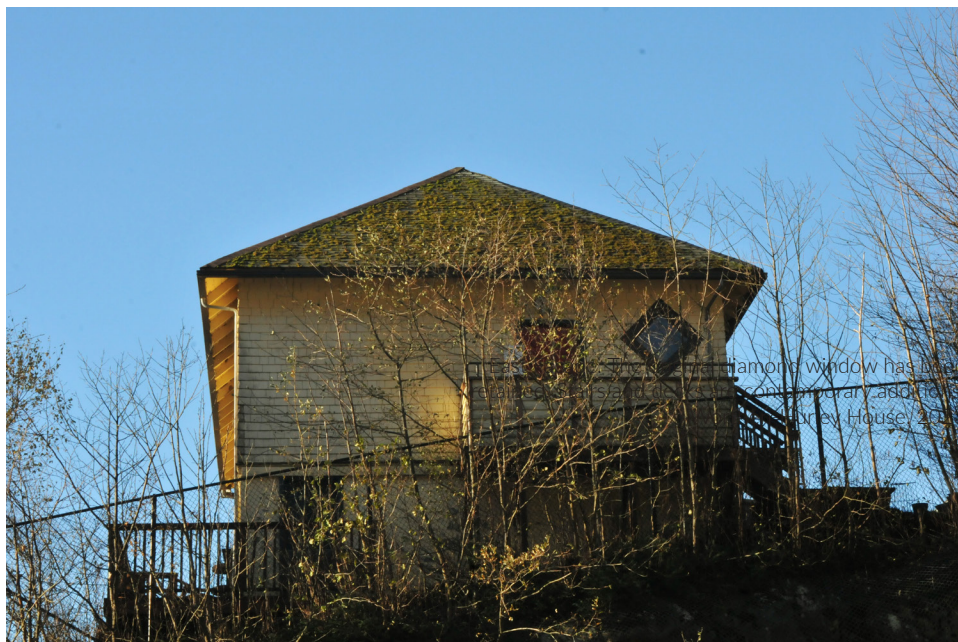
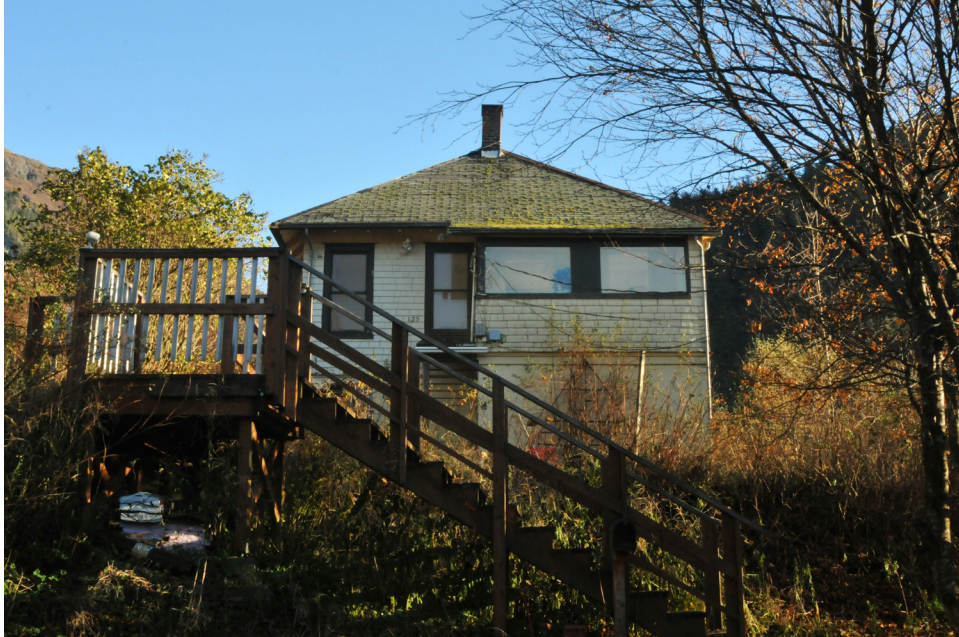
West Facade. Stairs and decks are contemporary additions.  
Worthen-Hurley House, 2023

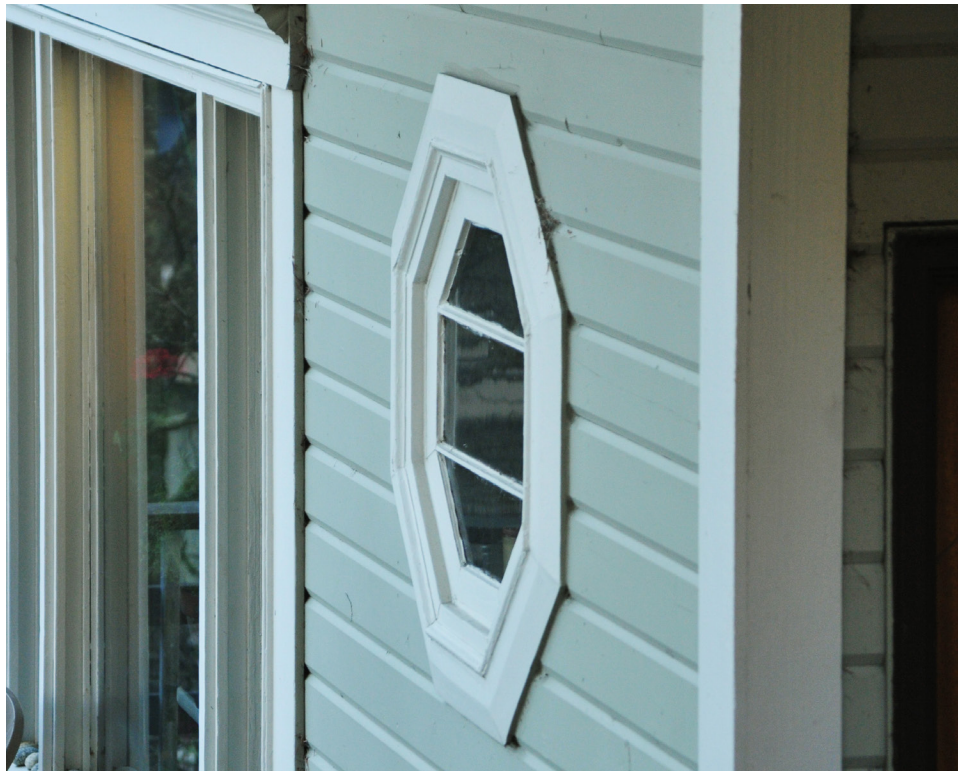
South Facade. Contemporary vinyl siding clads the residence.  
Augustus-Brown House, 2023

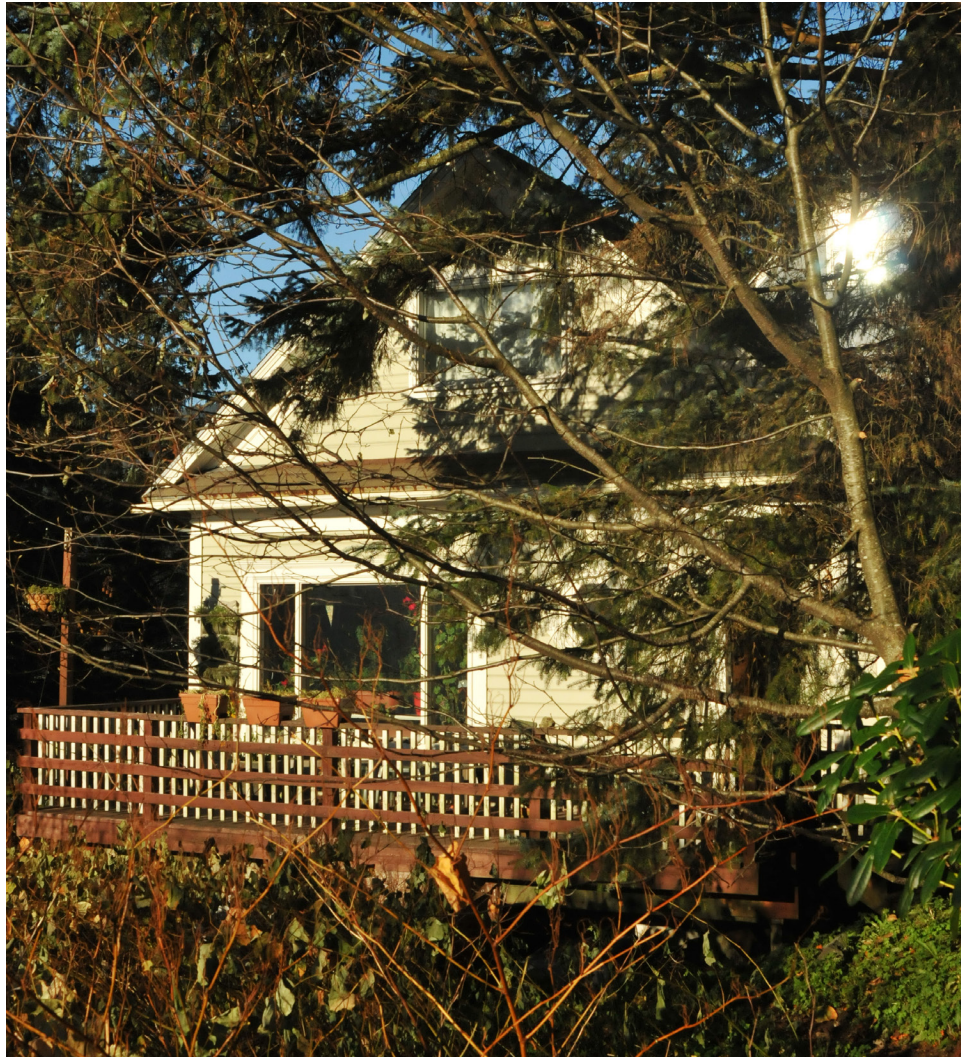
South Facade. Picture windows are placed under the gable and at the main level of the residence.  
Augustus-Brown House, 2023
