# Town of Lake Park, Florida

## Historic Preservation Board Meeting Minutes

23-002: QUASI-JUDICIAL PUBLIC HEARING ON A PETITION TO RESCIND THE LOCAL HISTORIC DESIGNATION, GRANTED IN 1998, FOR THE ARNOLD BUILDING LOCATED AT 918 PARK AVENUE, LAKE PARK, FLORIDA, 33403 (8PB9607), AND TO REMOVE IT FROM THE HISTORIC DESIGNATION SURVEY AND FLORIDA MASTER SITE FILE.

# STRUCTURAL ASSESSMENT

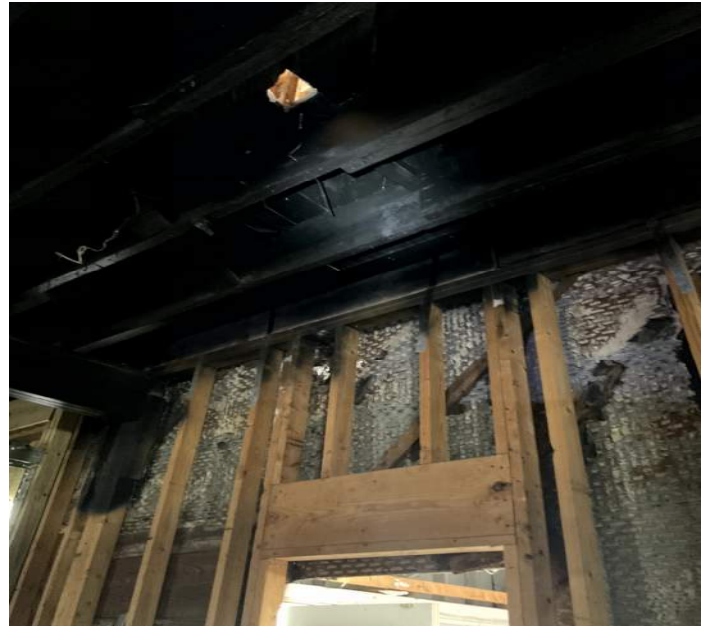
Original rear wall framing, exposed stucco lath, unfinished  
PHOTO NO. 20230710\_180812979
