Town of Lake Park, Florida

Special Call Historic Preservation Board Meeting

HPB 24-001: QUASI JUDICIAL HEARING TO CONSIDER A REQUEST FOR A SPECIAL CERTIFICATE OF APPROPRIATENESS TO ALLOW THE REPLACEMENT OF A ROOF FOR A LOCALLY HISTORICALLY DESIGNATED HOME LOCATED AT 250 FORESTERIA DRIVE

STRUCTURAL ASSESSMENT

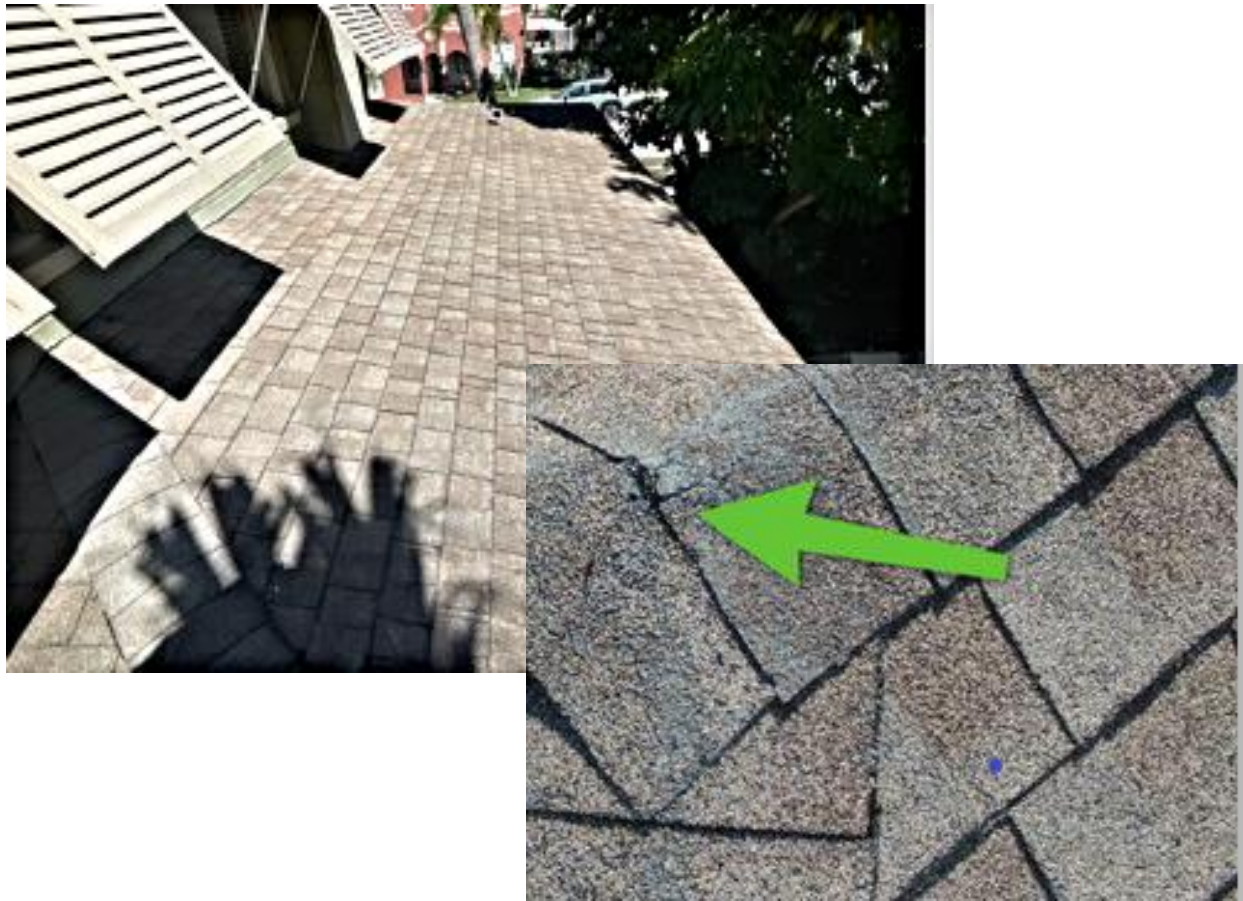
EXISTING ASPHALT SHINGLES

PROPOSED REPLACEMENT ASPHALT SHINGLES

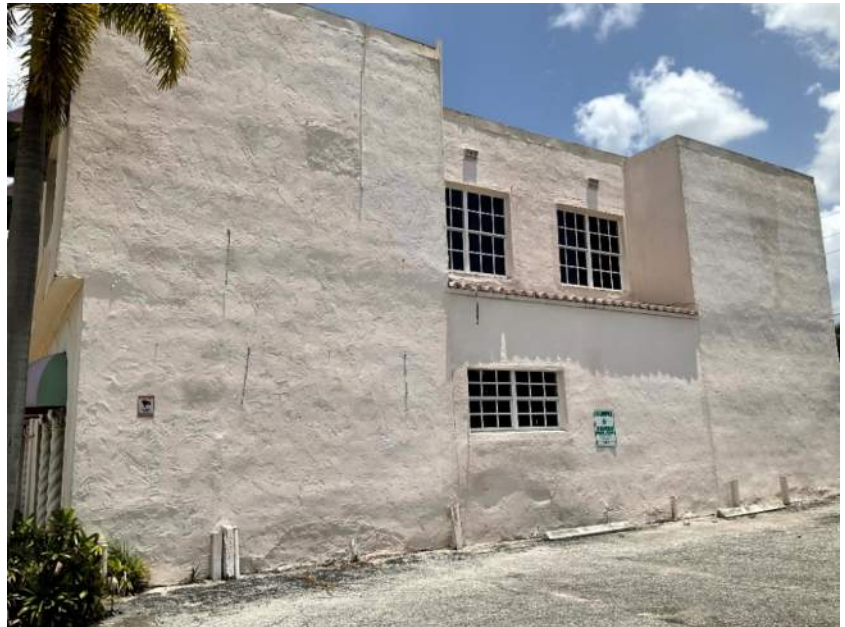
Photo No. 010
Date Taken: 07/10/2023
File Name: 20230710_174453683
Description: Large indentation on stucco finish

Comments: Presumed vehicle impact. Wall framing needs to be inspected for damage.

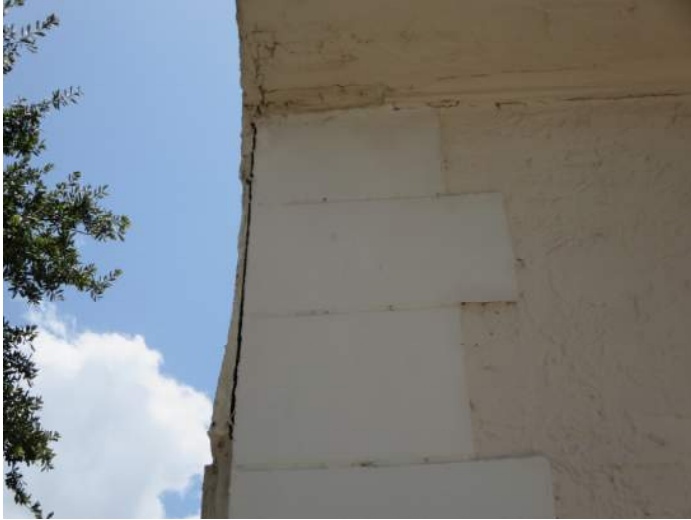
Finish separation
PHOTO NO. IMG_7919

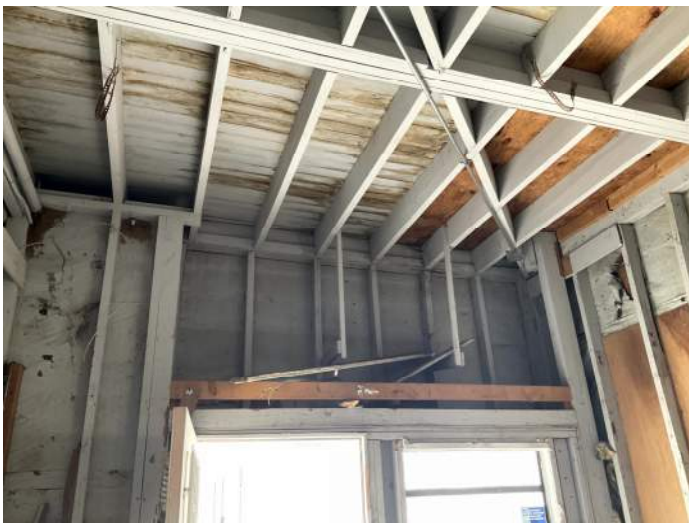
Rear expansion floor framing from underside
PHOTO NO. 20230710_175601186

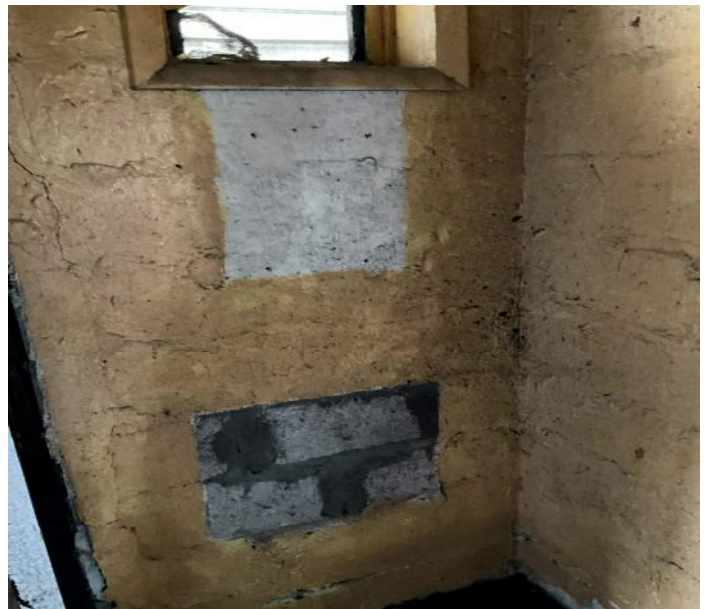
Rear expansion masonry wall
PHOTO NO. 20230710_180038560
