**Item:** Sandalwood Stormwater Evaluation

**DAM AND CULVERT REPORT  
FOR  
SANDALWOOD TOWNHHOMES**

**SHOAL CREEK TRIBUTARY 4.1**

### APPENDIX A - Visual Existing Condition on Dam

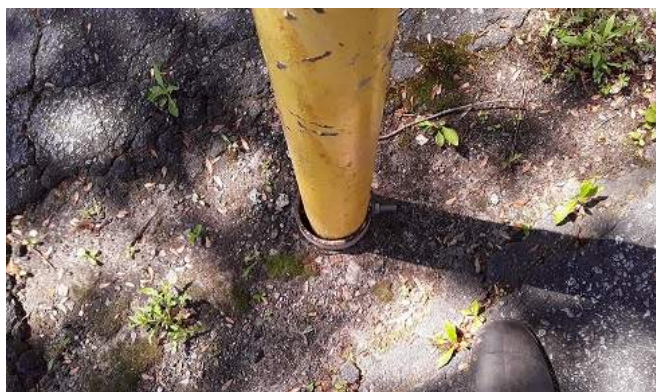
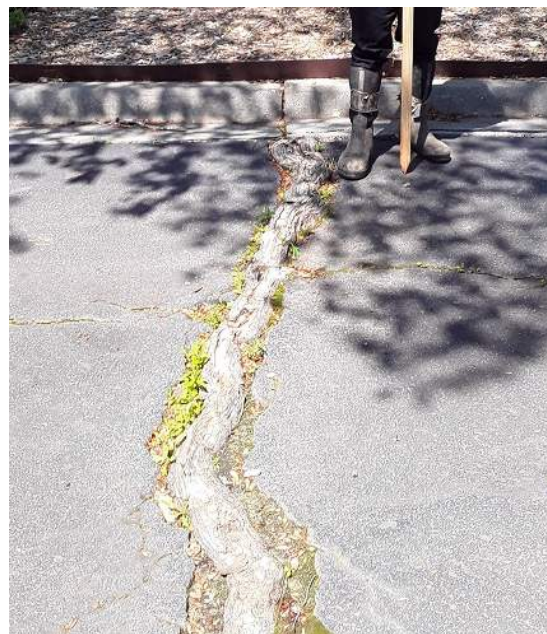
The top of the dam is comprised of a 13' back-to-back road with curb and gutter.

This road is blocked on both sides by removable bollards. It is assumed that the road is to be used in emergencies to provide access for properties on the adjacent side of the lake that would become stranded if one of the large culverts fails.

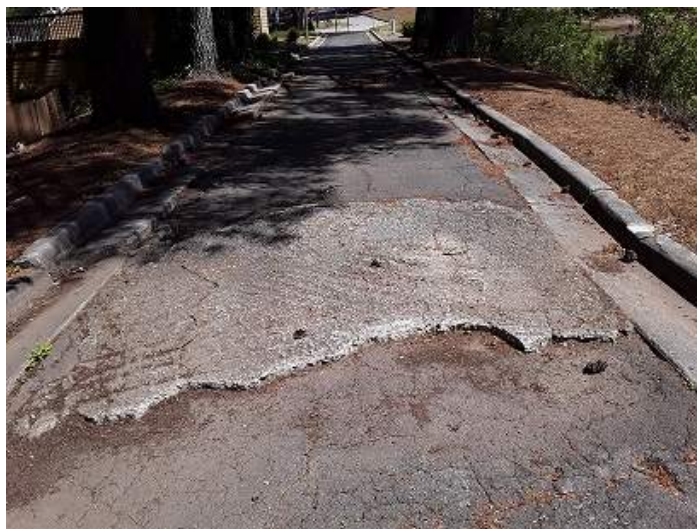
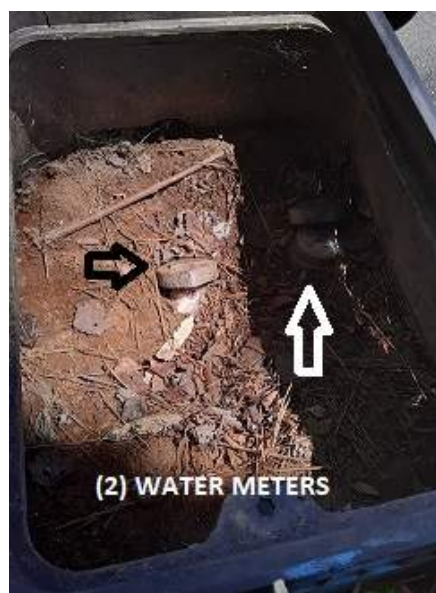
Over the years several large trees have grown up along the road causing root intrusion into the paving and buckling of curb and gutter.

The road has been patched in places for unknown reasons. A waterline is shown on Gwinnett GIS as crossing over the dam; however, utility locators were unable to locate the line.

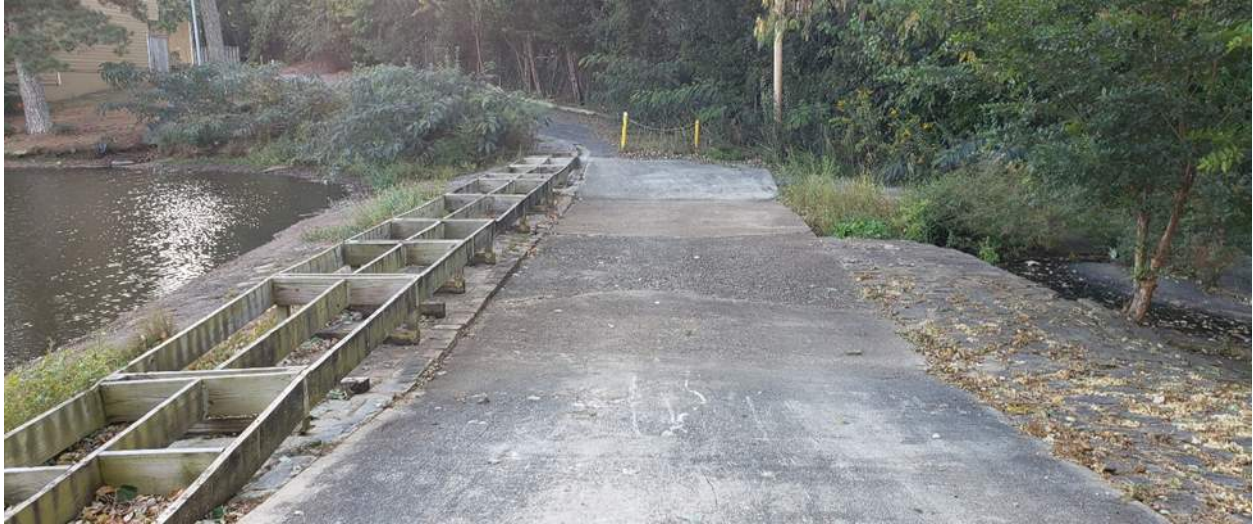
A wide concrete weir provides the primary discharge control for the dam. It has a ~ 44' width and flat side slopes ~8:1 that enable vehicles to pass in an emergency. The base of an old foot bridge crosses the weir.

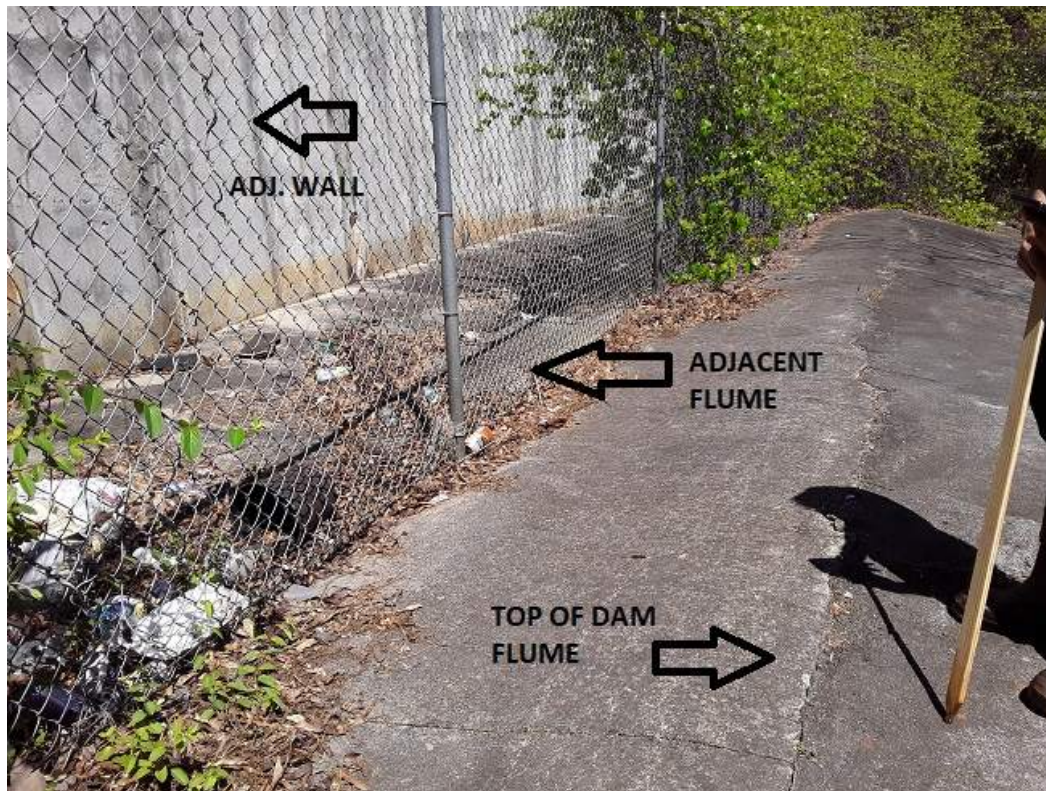
The weir section discharges to a wide concrete flume approximately 2' deep. Cracking can be seen across the flume and along the edge of the flow path.

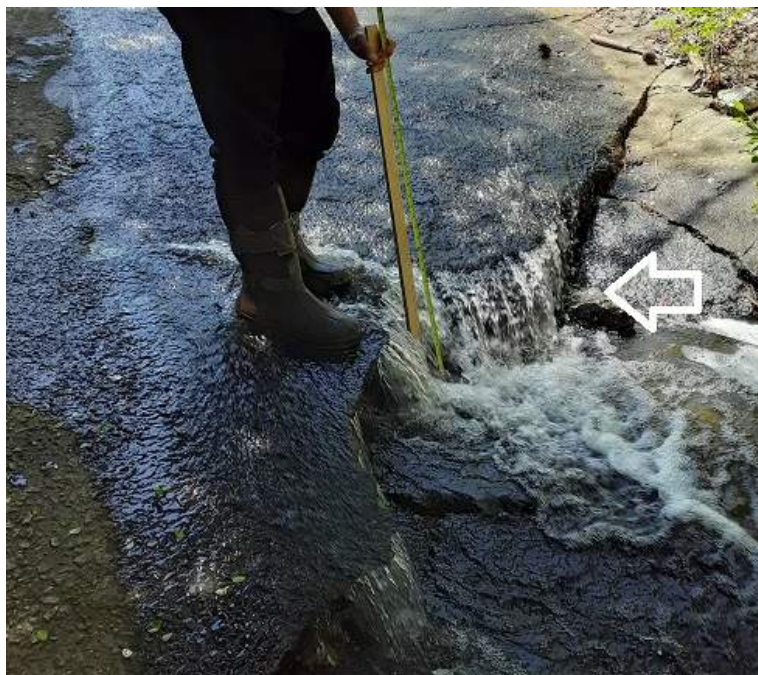
The flume is paved to the top and then proceeds to connect to a concrete flume on the adjacent property.

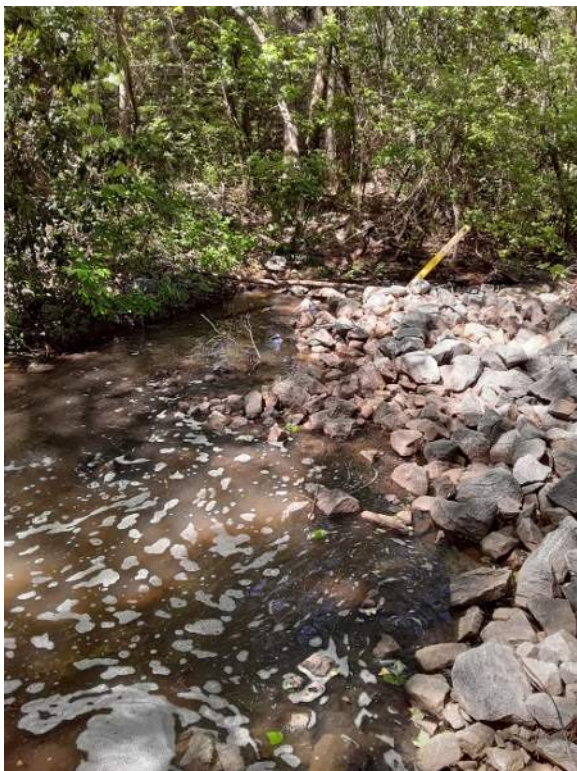
At the bottom, there is a rip rapped basin backed up by stacked cement bags to protect the retaining wall that supports the pool.

The runoff must turn 90 degrees at the bottom to continue downstream.

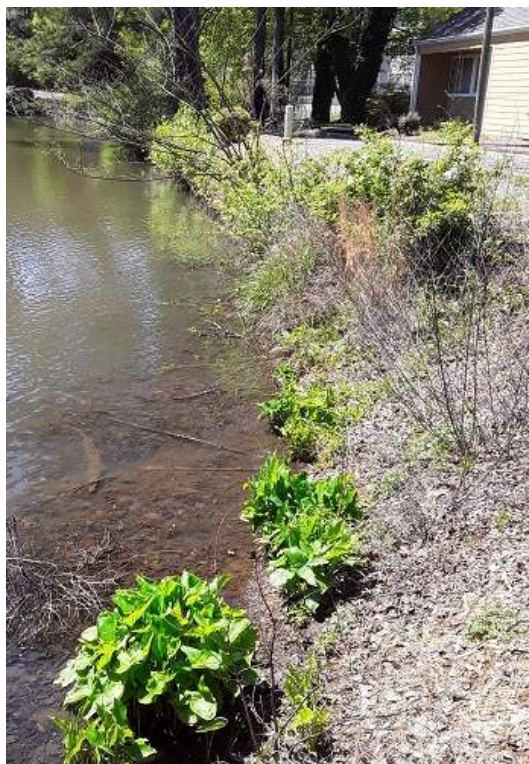
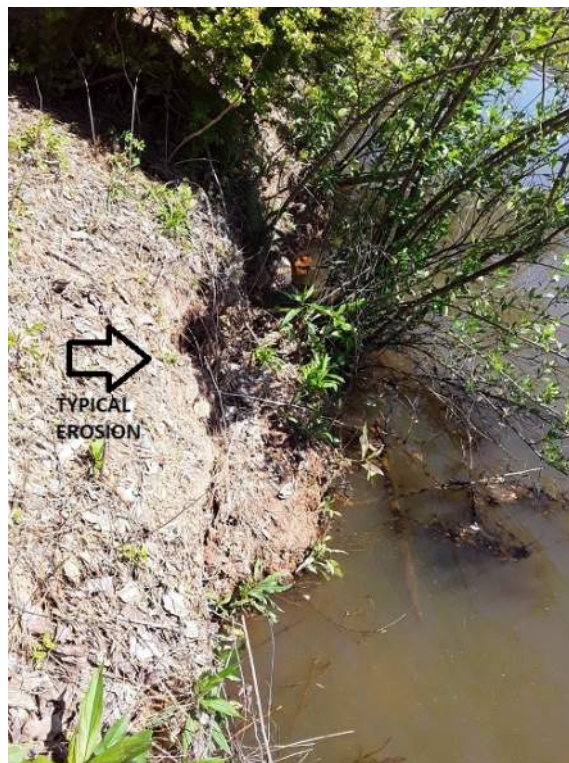
The face of the dam is covered with brush or small bushes. The slope is steep and weak, and erosion is present.

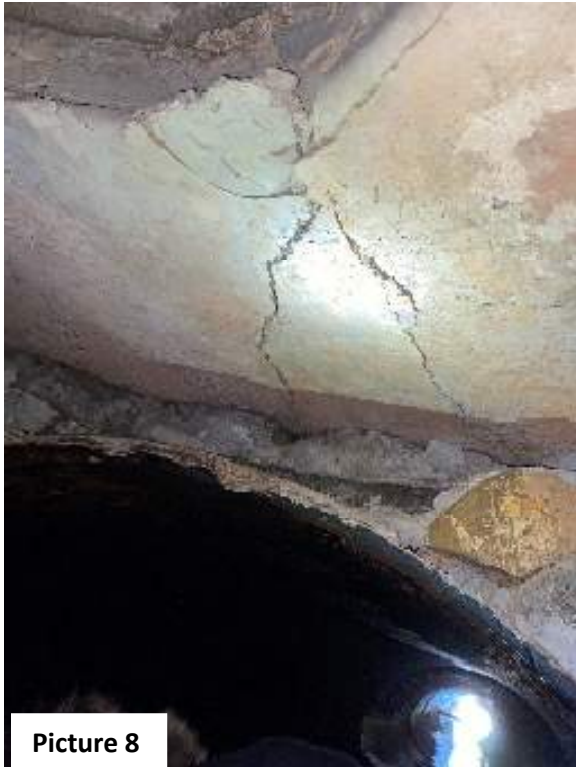
Picture 8

**Pictures 8 thru 11:** Concrete slab/roof of junction box is cracking. Multiple cracks visible on the corners of the slab. Grout appears to be missing between the bricks at the base of the manhole. No sediment visible.

Replace the grout at the base of the junction box.

Monitor the cracking in the junction box roof.

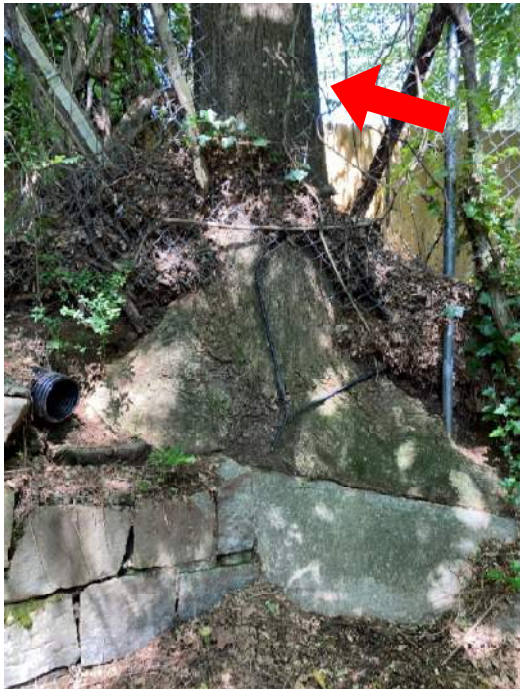
**Picture 14:** Large tree on right side of upstream headwall.

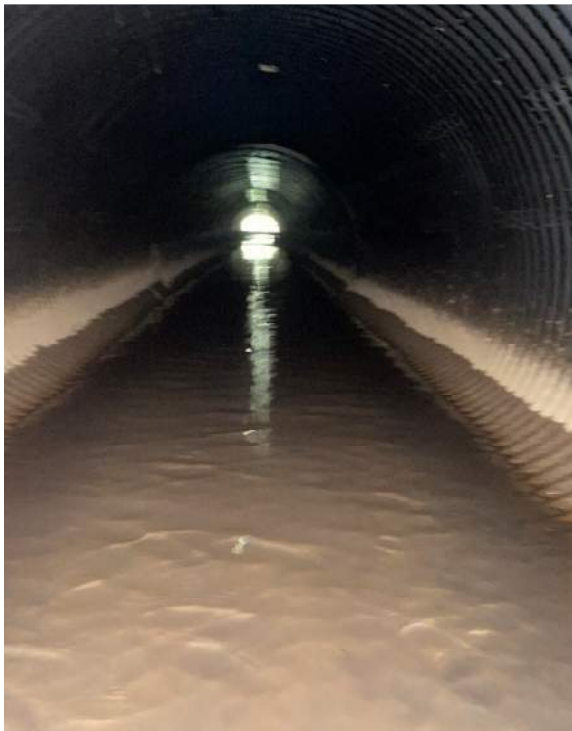
**Picture 7:** Sediment increases in depth upstream of the turn.

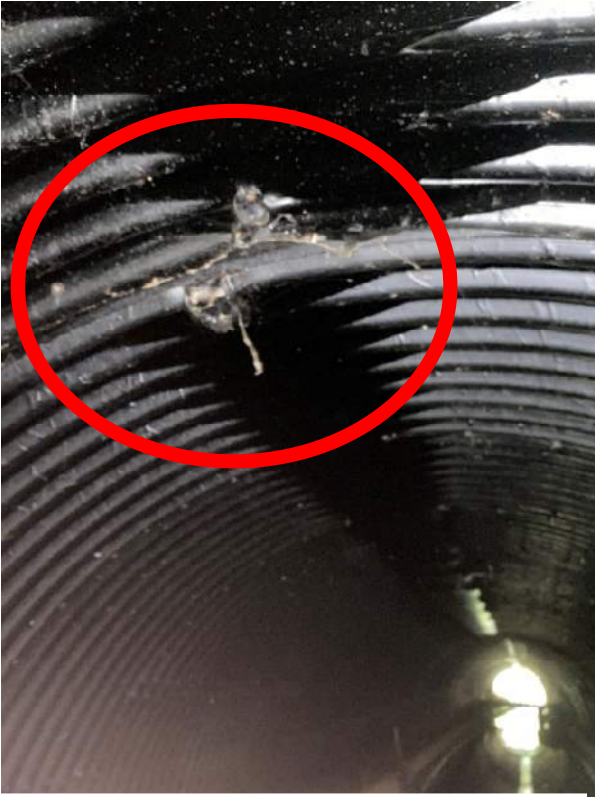
**Picture 9:** Bulge

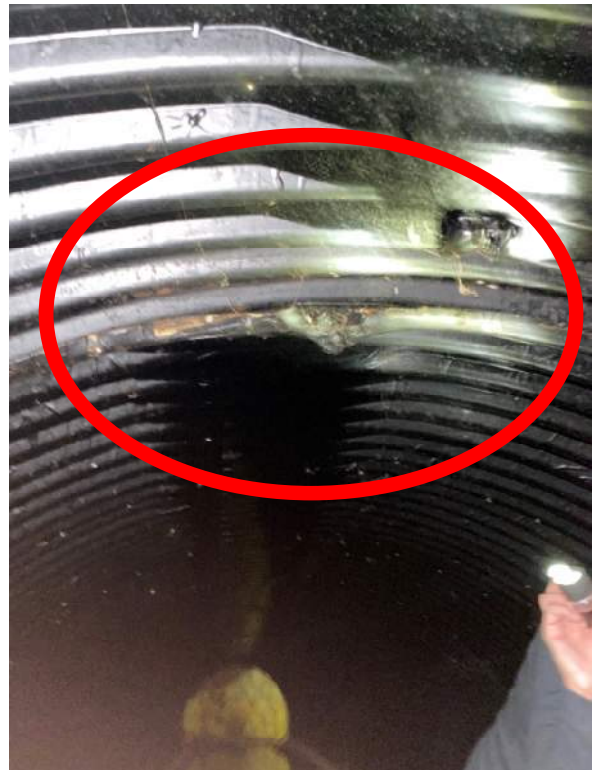
**Picture 10:** Second bulge

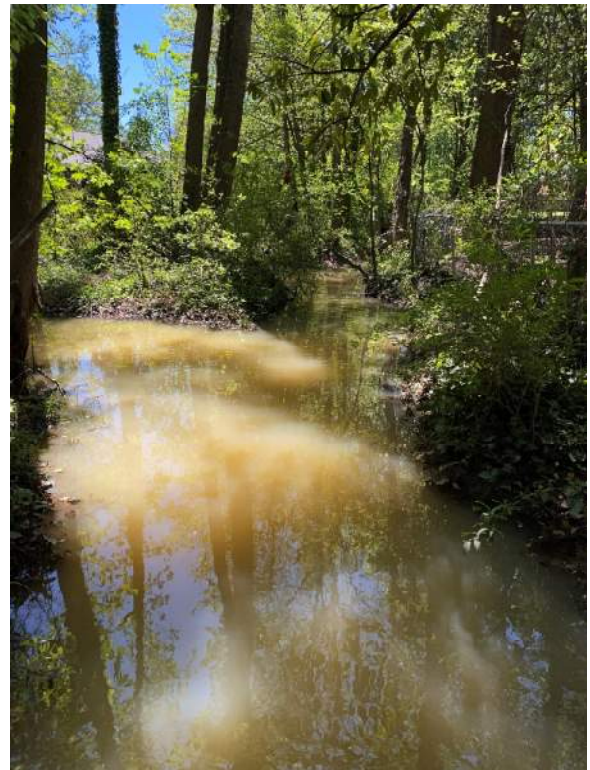
**Picture 20:** Upstream swale.

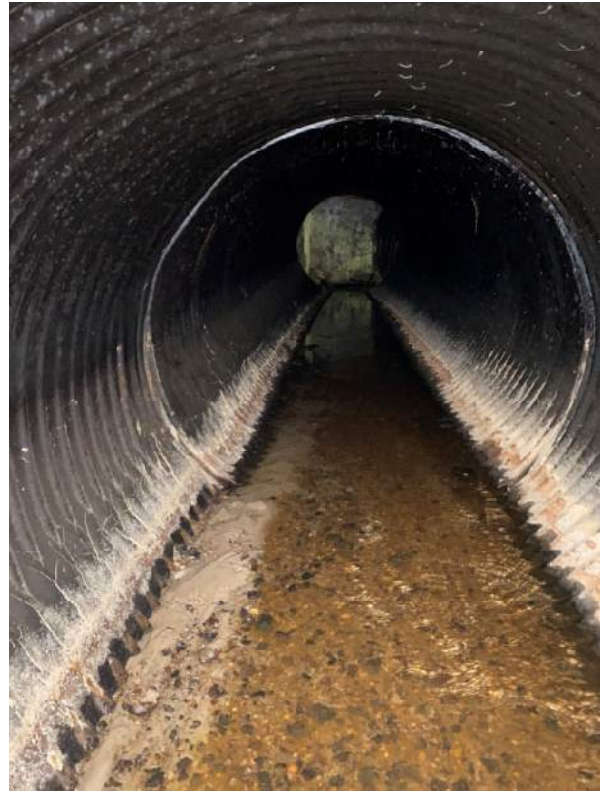
**Picture 8:** Some sediment is visible.
