CITY AND BOROUGH OF WRANGELL BARGE RAMP CONDITION ASSESSMENT

MARCH 2025

Subject: Wrangell Barge Ramp – Condition Assessment

WRANGELL BARGE RAMP CONDITION ASSESSMENT

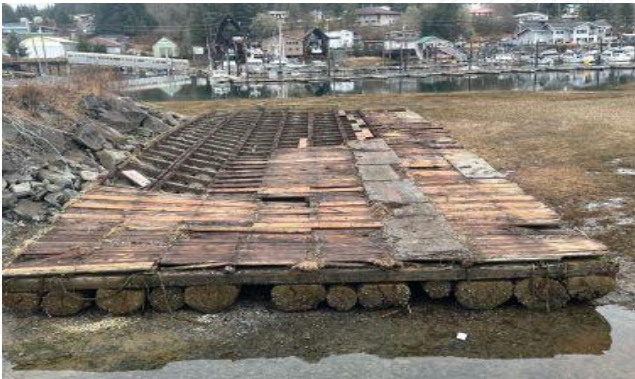
Demolition of the old net dock is also nearing completion. The crew has been dismantling the float structure one truckload at a time during low tide, which is the only feasible time to bring a vehicle onto the beach. All decking has been removed and disposed. The next phase involves disassembling the underlying log float structure.

Figure 2 Net Float Decommission

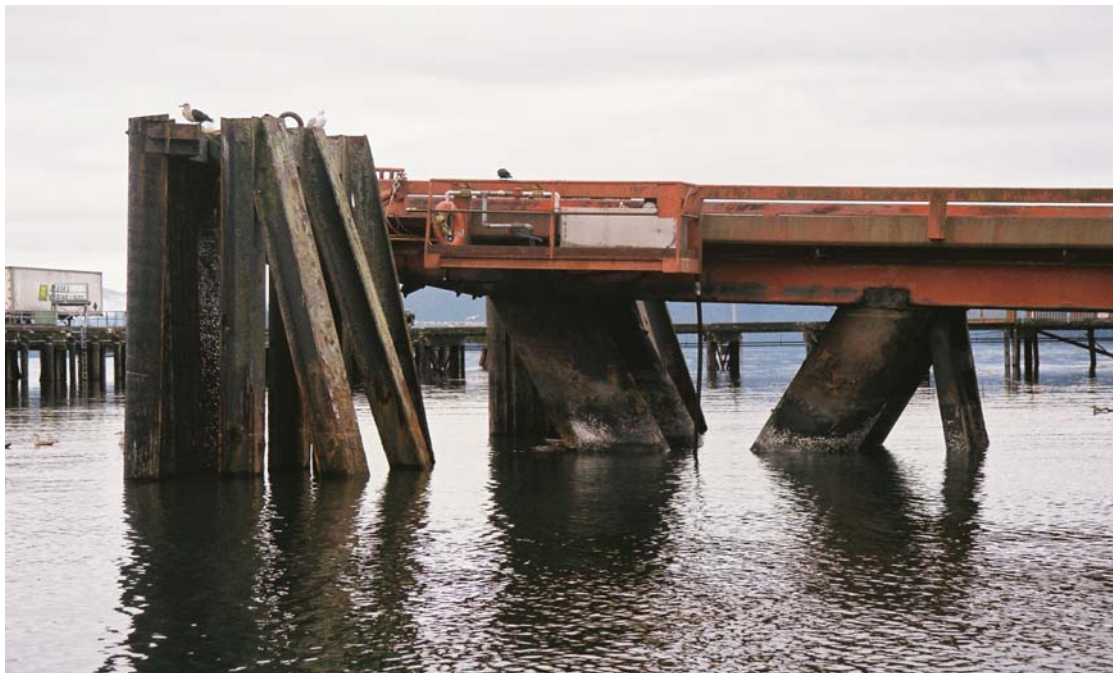
PHOTO No. 2: Barge Facility Transfer Span – Note the large diameter pipe struts that connect to a nine foot diameter floatation tank located ~3 feet below the surface. The square tube struts shoreward of the pipe struts connect to a second smaller pontoon (7 foot diameter). Also note Dolphin F in the foreground.

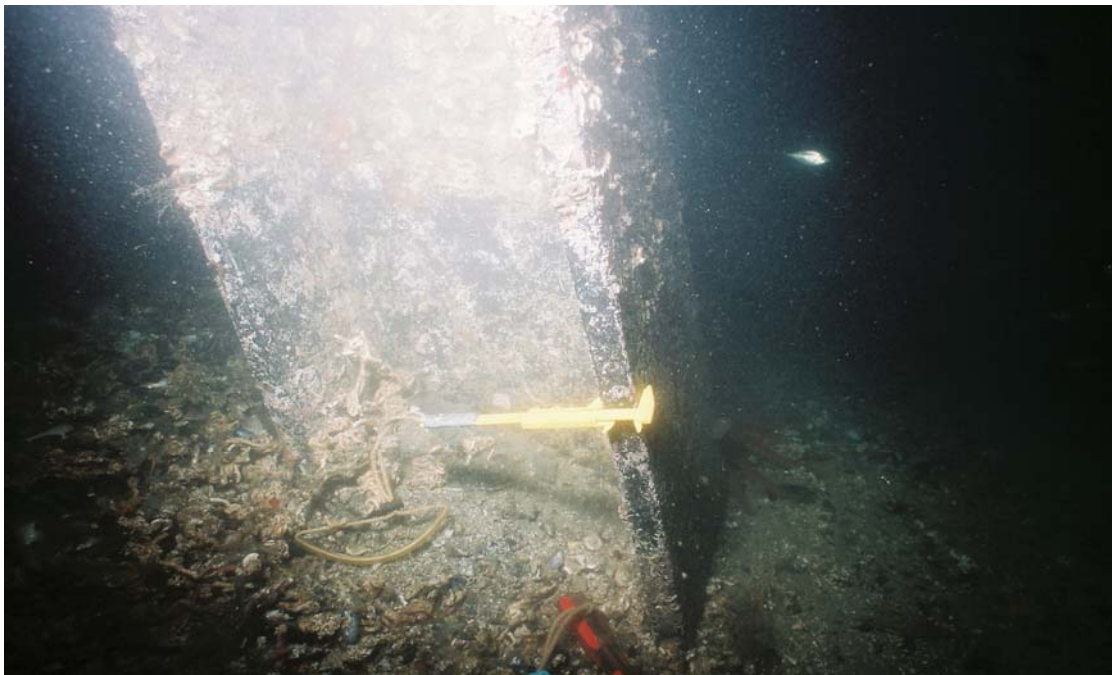
PHOTO No. 14: Breasting Dolphin C, Pile 3 Batter – Level II cleaning of this pile at the mudline found it to be in good condition with an estimated 90% of the epoxy coating intact at the mudline.
